**NATIONAL TRANSPORTATION SAFETY BOARD
OFFICE OF HIGHWAY SAFETY
WASHINGTON, D.C.**

FACTUAL REPORT OF INVESTIGATION

Vehicle #2: 2017 Navya Arma Transit Shuttle

NTSB #: **HWY18 F H001**

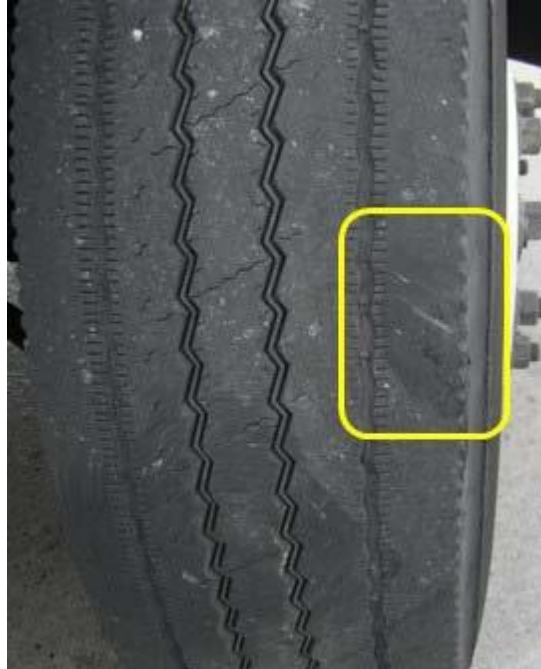
Figure 4. Abrasion on Right Front Tire of Truck Tractor (NTSB photograph)

At the time of inspection, investigators were told no body or mechanical damage was sustained by either the truck tractor or semitrailer; no such damage was apparent at the time of inspection. Investigators located a minor abrasion on the outboard shoulder of the right-side tire on axle 1 (the steer axle). The abrasion is depicted in Figure 4.

Employees of US Foods who observed the combination vehicle at final rest placed the truck, tractor, and steer axle in their approximate relative positions following the crash. In this orientation, the steering wheel was turned to the left. With the vehicle so oriented, investigators measured the distance from the axle 1 right side fender to the outboard tire shoulder as approximately six inches. The abraded portion of the right front tire extended from the shoulder inboard approximately 1.75 inches.

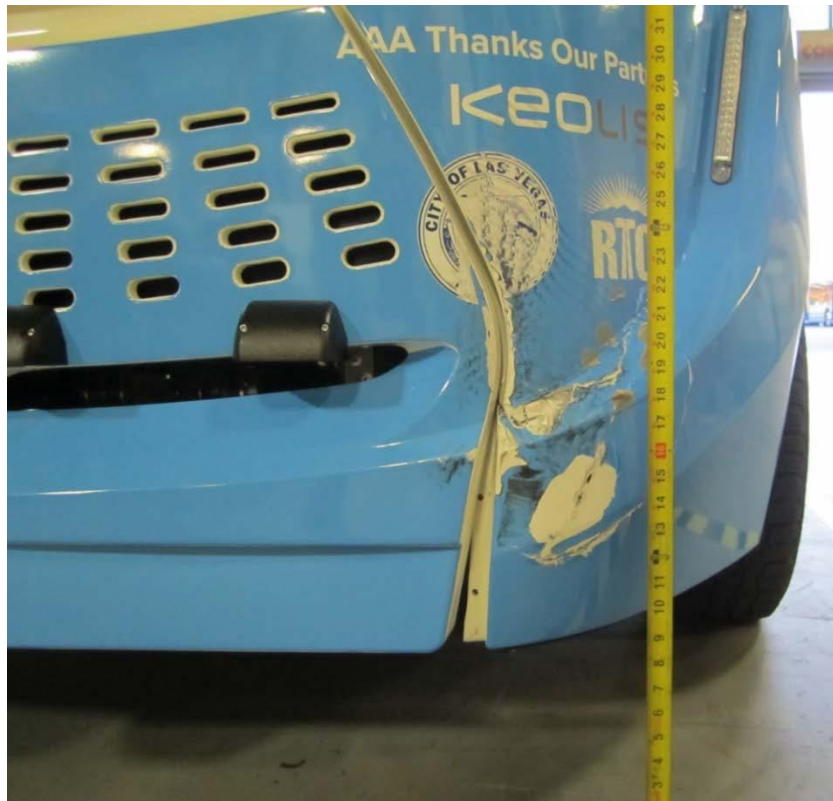
Figure 5. Transit Shuttle Damage

At the time of inspection, there was visible damage to the left front fiberglass body of the shuttle. The left front fiberglass panel was displaced to the left, leaving a 1.375-inch gap between the center access door and the left-side fiberglass body. There was also a 1.125-inch gap between the center access door and the left-side fiberglass body. Black transfer marks could be seen on the fiberglass. The damage to the vehicle is shown in Figure 5.
