**FACTUAL REPORT OF INVESTIGATION
TESLA MODEL X RUN-OFF THE ROADWAY AND COLLISION
WITH PRIVATE HOME RESULTING IN POST CRASH FIRE**

Lake Forest, CA

HWY17FH013

**NATIONAL TRANSPORTATION SAFETY BOARD
OFFICE OF HIGHWAY SAFETY
WASHINGTON, D.C.**

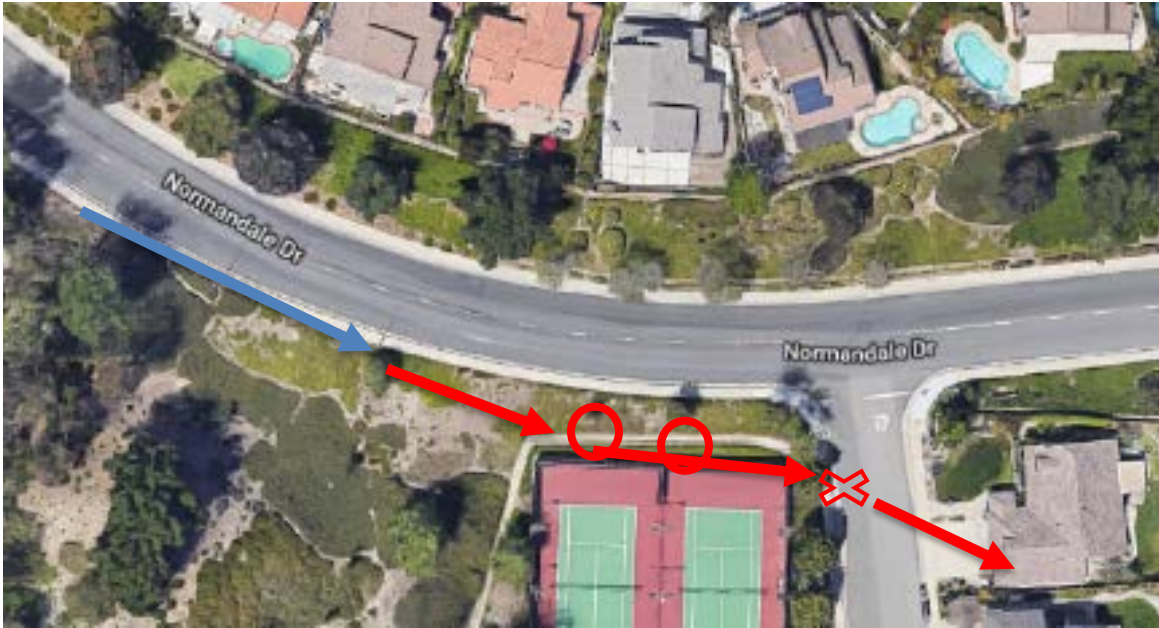
Figure 1: Google Maps Satellite View of Crash Location

Figure 1 illustrates the location of the crash with the approximate path of the Tesla, impact with two small trees (circled in red), impact with the drainage culvert (indicated by a red X), and impact with the BMW and residence where the Tesla came to rest and location of the post crash fire.

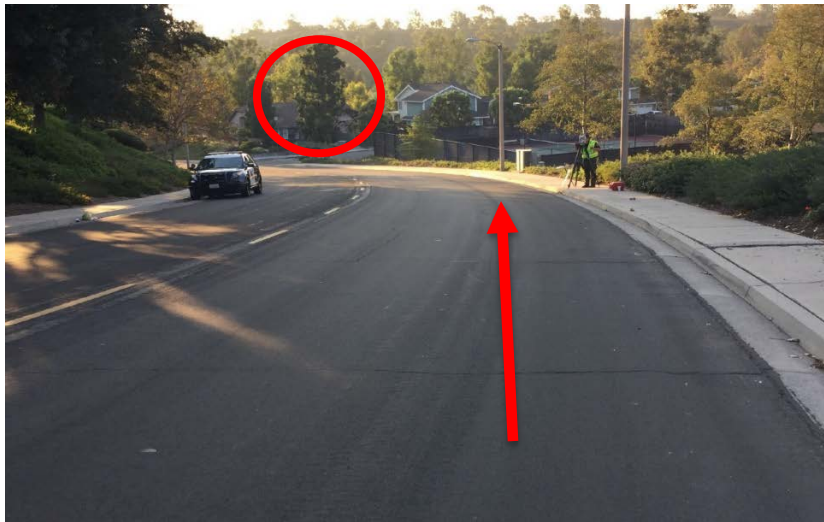
Figure 2: Normandale Drive Approaching Countryside Drive

Figure 2 provides a view from the top of Normandale Drive approaching Countryside Drive. The left hand curve in which the Tesla departed the roadway is indicated with a red arrow, and the residence is indicated with a red circle. Figure 3 provides a view of the drainage culvert struck by the Tesla (indicated with a red arrow), and the residence (indicated with a red circle).

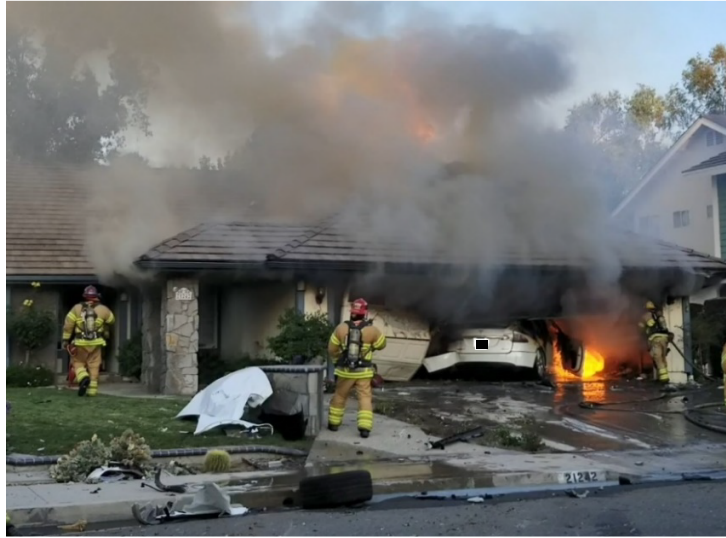
Figure 4: Southbound View of Residence (Source: Orange County Sheriff’s Department).
Note: photograph timestamp did not reflect the actual date/time.

The Tesla caught fire and ignited the BMW and the home. Figure 4 provides a view of the Tesla in the garage with visible flames emanating from the lower front portion of the vehicle, with home structure also on fire. Further information regarding the post crash fire is provided in section 5 of this report.

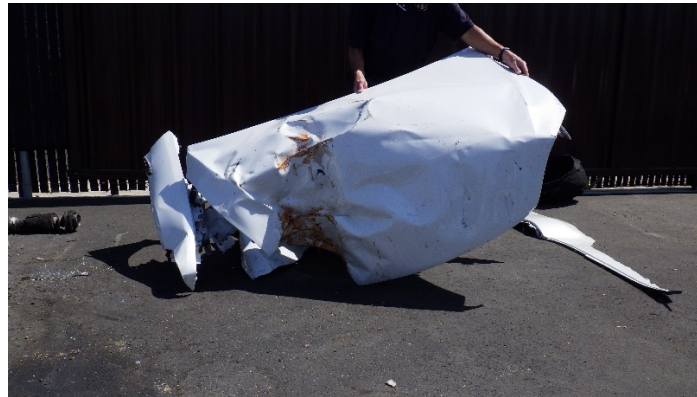
Figure 6: Tesla hood and a portion of the right front fender

A basic description of the vehicle damage is provided here, and more detailed information and a complete inspection of the high voltage battery is provided in the Vehicle and Battery Group Factual Report, available in the crash docket. The hood, front, and both front fenders were displaced during the crash sequence and did not exhibit fire damage. There was a half circle shaped crushed area just to the right of the center of the hood at the front, as shown in figure 6. It was approximately 9 inches in diameter and contained a red-orange colored residue which was confirmed to be tree bark and sap from the small trees at the scene.

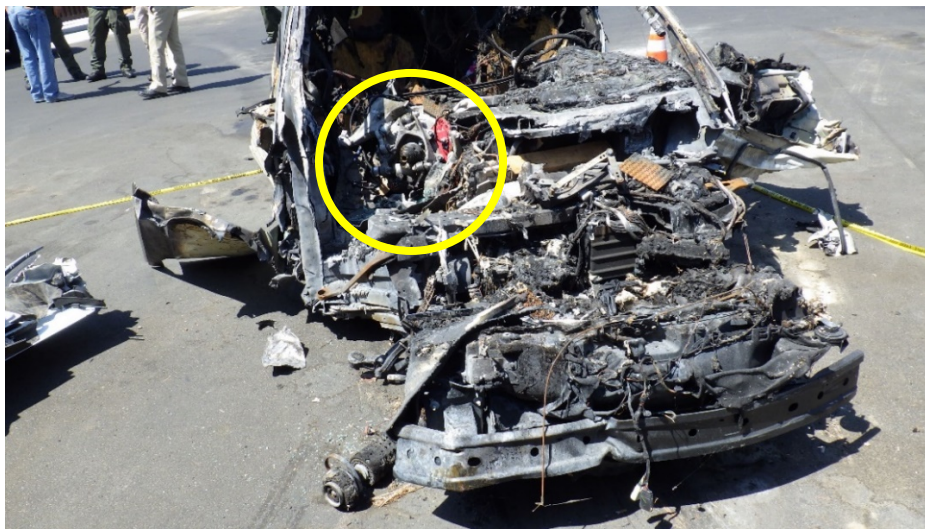
Figure 7: Front of Tesla with portions of right front wheel and other associated components circled in yellow

The entire front of the vehicle extending to the firewall sustained extensive fire damage. Non-metallic components were burned away or charred. The windshield glass had broken and partially melted, with portions resting on the dashboard and interior. The front wheels, hubs, and brake assemblies were displaced, with the left front components found in the street next to the sidewalk in front of the house and without fire damage. The right front hub with portions of wheel, disk brake assembly, and portions of the steering and suspension components were found resting at the front passenger firewall and dashboard area, as shown in figure 7 and identified by a yellow circle in the figure.

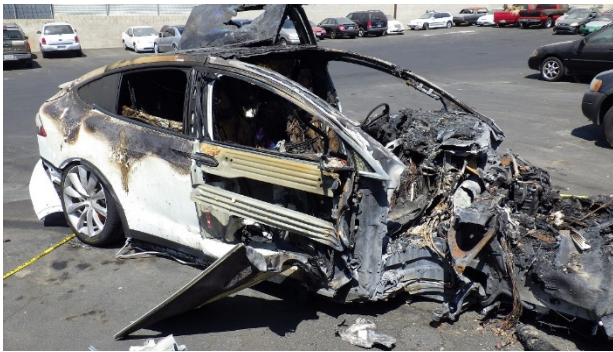
Figure 8: Right front view of Tesla

The exterior body panels of the front passenger door were displaced and hanging from the door structure, which remained on the hinges, as shown in figure 8. The driver door was found open and severely deformed with the exterior panel displaced, as shown in figure 9. The right rear passenger door was closed and mostly intact, but with the main glass panel missing. The exterior handle was missing. The left rear door was a partially open. The right rear passenger door had extensive thermal damage at the front extending about the width of the door handle. The right rear exterior door handle was missing. The paint on the rest of the door was intact.

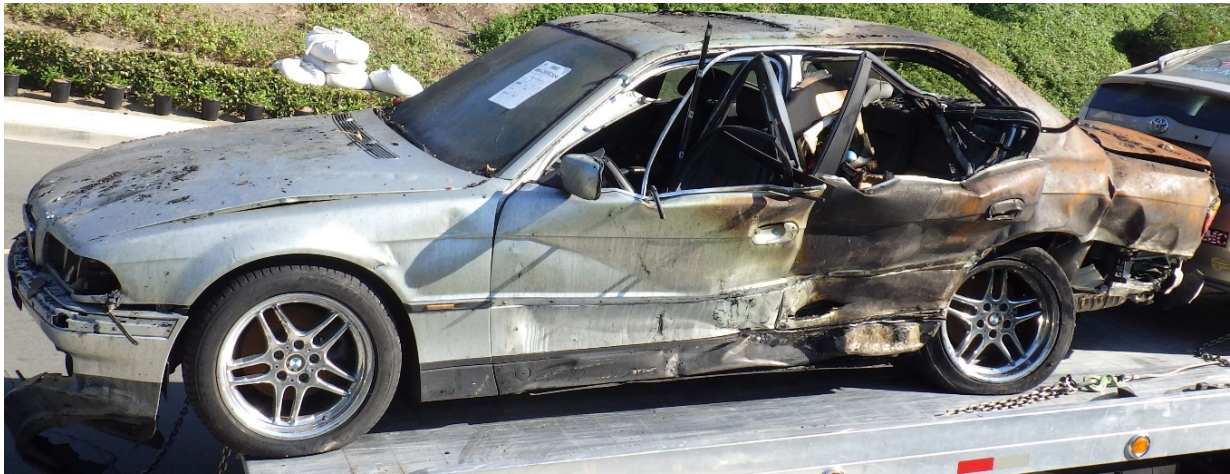
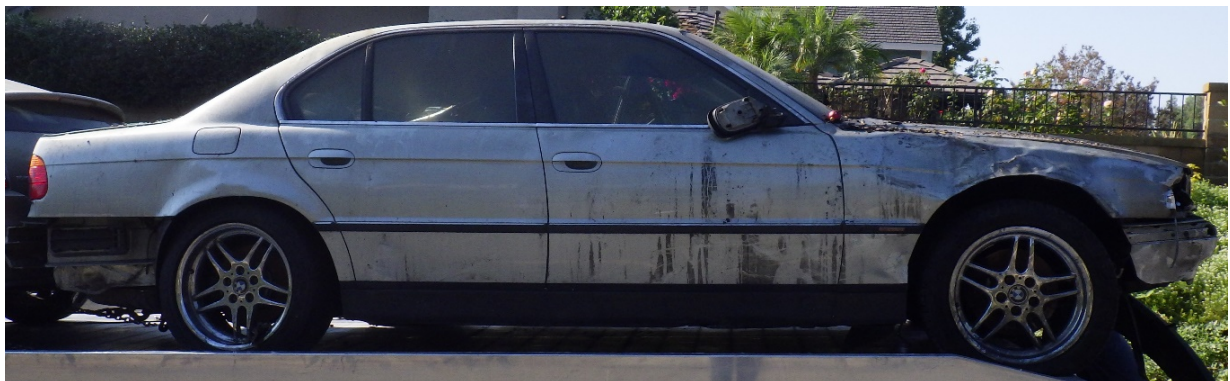
The 1997 BMW that was parked in the garage and struck by the Tesla had VIN WBAGF8328VDLXXXXX. It was struck on the left rear corner and was pushed further into the garage. It sustained impact damage at the rear and left sides. There was additional damage from other debris and extrication from the garage. It also sustained fire damage, which was most severe at the back half. Figure 10 and Figure 11 provide a left and right side view of the BMW, respectively.

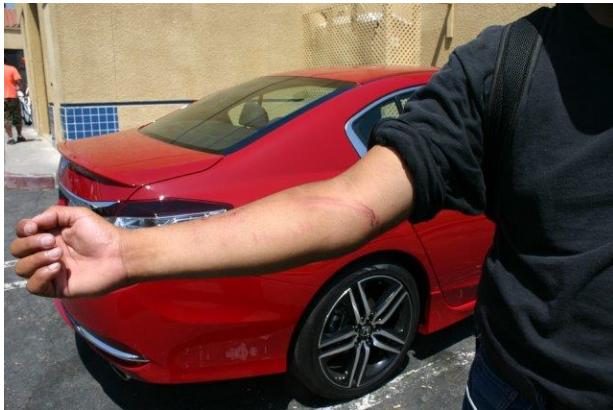
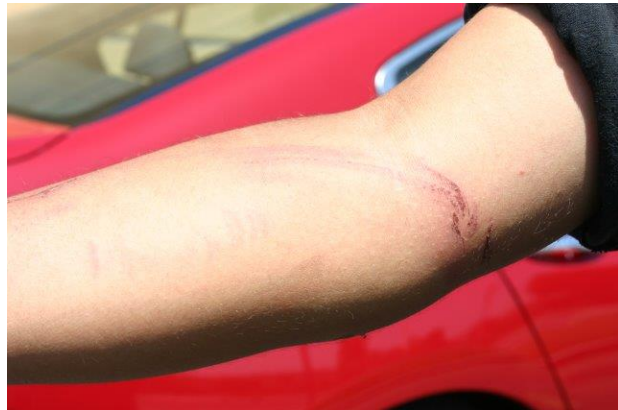
The Tesla passenger was a 27-year-old male, seated in the front passenger seat during the collision. He was wearing his seat belt and sustained minor injuries consisting of abrasions to his right arm and refused medical treatment. Figures 12 and 13 show views of the passenger's arm, as photographed by the OCSD on August 26, 2017.

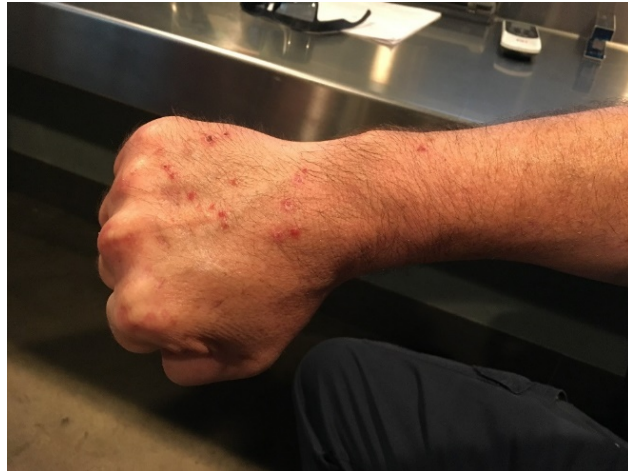
Figure 14: Tow truck driver right hand and wrist

further information about the re-ignition events. During the response to the re-ignition event, the driver was exposed to smoke and venting gas and combustion materials from the vehicle and suffered burns on his hand and arm. He did not seek medical attention. He allowed an NTSB investigator to photograph his injuries as shown in Figure 14, which was taken on September 6, 2017, 12 days after the event.

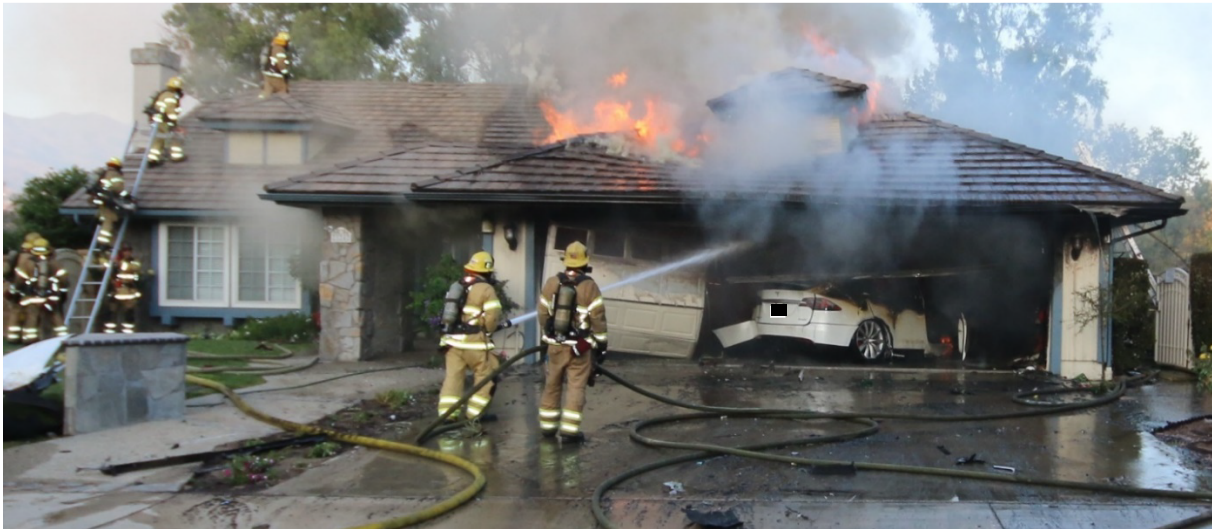
Figure 16: Residence and Tesla at approximately 6:56 p.m. (source: OCFA)

It was noted at 6:55 p.m. that the garage fire continued to grow. After the structural fire progress was stopped, the fire under the Tesla continued to re-ignite on and off until cooling measures were temporarily successful. It was reported by HR6 that the Tesla battery pack compromise was the primary source of fire. Figure 16 shows the house with the Tesla in the garage from a photo taken by the OCFA with a time stamp of 6:56 p.m. The fire in the upper portion of the garage appeared to be separate from the vehicle, but flames can still be seen at the bottom front end of the Tesla. Note that the photograph has been cropped from their original form.

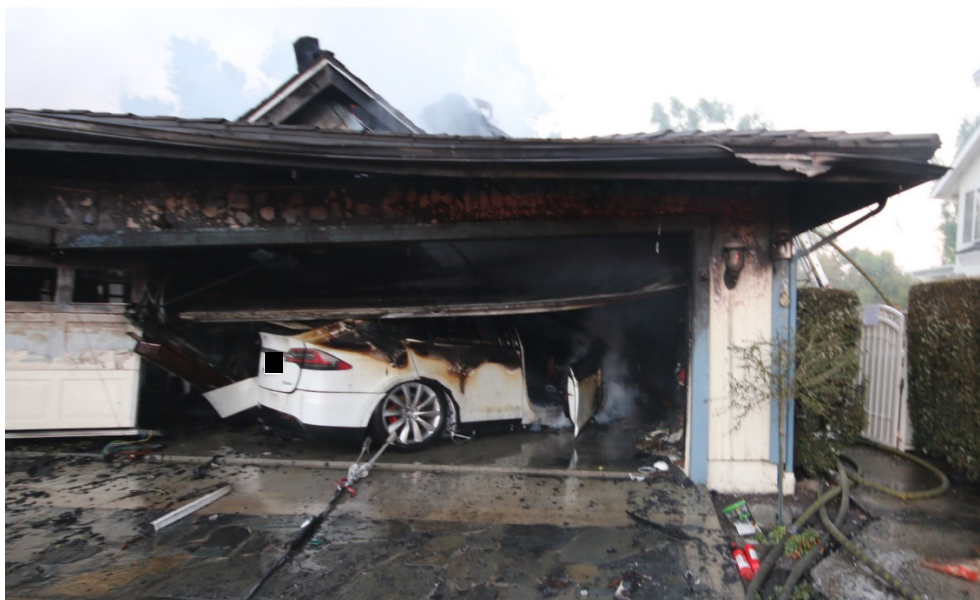
Figure 17: Garage and Tesla at approximately 7:26 p.m. (source: OCFA)

Notification of building officials and utility company occurred from 7:03 p.m to 7:10 p.m. HR6 placed two spot shores under the sagging garage headers to stabilize the wall of the garage. B7 responded with All Clear on the garage and residence at 7:17:52 p.m. Once the building was stabilized, focus turned to the removal of the Tesla. Figure 17 shows a view of the garage and Tesla with a winch cable connected to the right rear wheel of the Tesla, and the photograph was taken by the OCFA with a timestamp of 7:26 p.m.

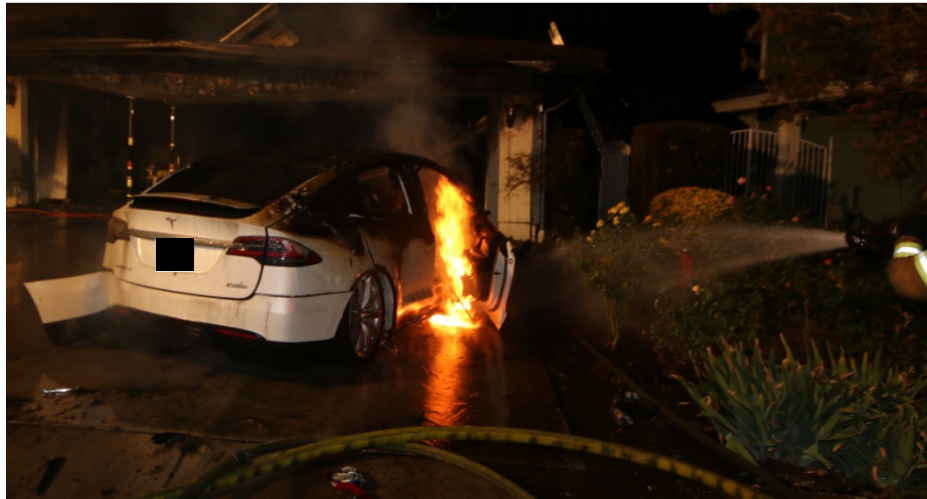
Figure 18: Tesla at approximately 8:05 p.m. (source: OCFA)

At 8:04 p.m. the Tesla had been removed from the garage with the winch on HR6, and the Tesla battery was noted as still on fire. The structure was still deemed unsafe to enter by the Incident Commander. Figure 18 shows the Tesla as photographed by the OCFA at approximately 8:05 p.m. The vehicle was now on the driveway and has fire emanating from the bottom of the car.

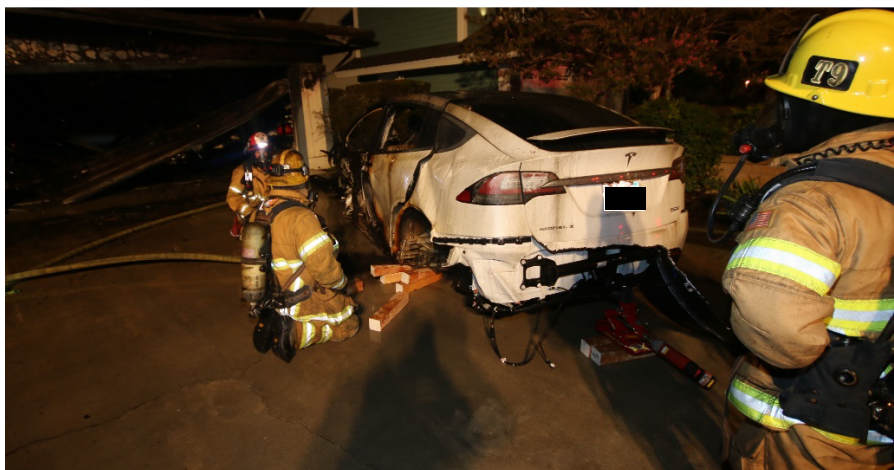
Figure 19: Tesla at approximately 9:13 p.m. (source: OCFA)

When it was extinguished, a skid steer was requested at 9:02 p.m. for use in accessing the underside of the car, however the estimated arrival time for this equipment was 1.5 to 2 hours. Instead, Fire Fighter (FF) propped up the car with cribbing blocks and a floor jack. The skid steer did arrive later and was used to reposition the Tesla as well as the other car that was in the garage during the collision. Figure 19 shows the Tesla being cribbed up in a photograph taken by the OCFA at approximately 9:13 p.m.

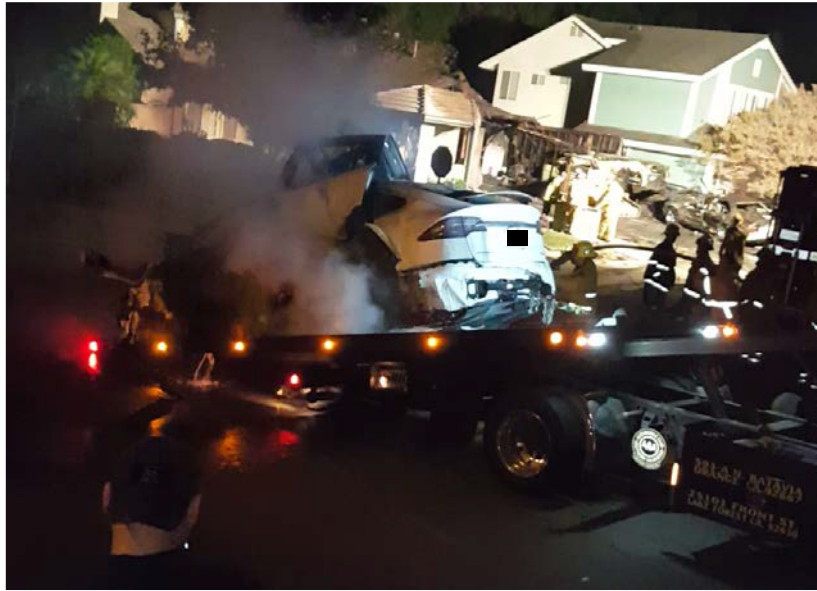
Figure 20: Tesla reignited on the flatbed towtruck. (source: OCFA)

The Southside Towing dispatch log (shown in section 3.2 of this report) indicated that they received the call to tow the Tesla at 10:40 p.m., and the tow truck arrived at 11:09 p.m. The IC noted that the Tesla began to smoke again, as the vehicle was being loaded onto the tow truck. Figure 120 shows a still image frame of a cell phone video taken by a Southside Towing worker, which shows a view of the Tesla on fire while partially loaded onto the tow truck. This still image shows the vehicle mostly on the flatbed, with the bed near the ground.

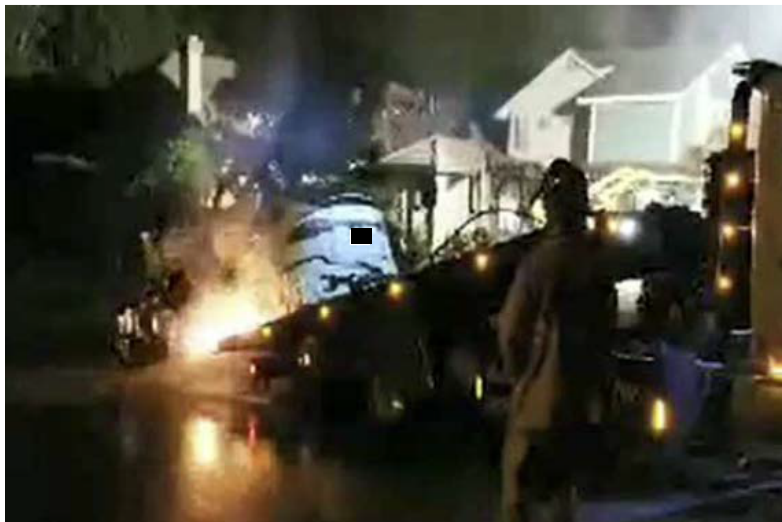
Figure 21: Tesla reignited on the flatbed tow truck. (source: OCSD)

As described by the tow truck driver, the Tesla was raised in elevation and the Tesla unloaded further off the flatbed in order to open up space underneath the car for better application of water. Figure 21 shows a still image from a video taken by an OCSD officer of the same event. This image is later in time, and shows the Tesla further off the truck with the flatbed raised.
