NATIONAL TRANSPORTATION SAFETY BOARD
OFFICE OF AVIATION SAFETY

FACTUAL REPORT OF ON SCENE CABIN DOCUMENTATION

A. ACCIDENT : ERA12FA056
LOCATION : Key West, Florida
DATE : October 31, 2011
TIME : 1940 Eastern Daylight Time (EDT)¹
AIRPLANE : Gulfstream G-150, N480JJ

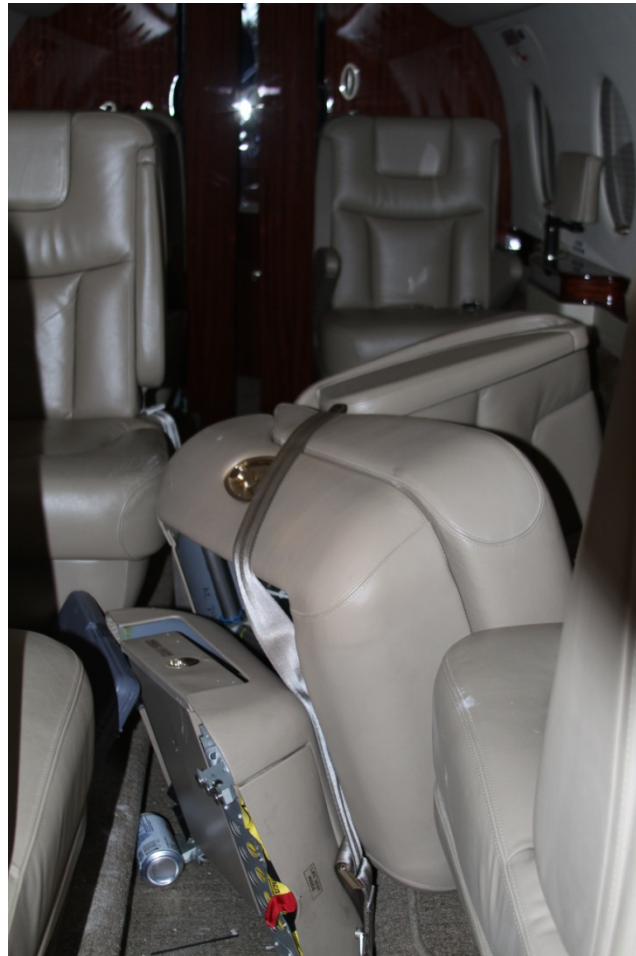
- The LH Seat #2 was lying on its side in the aisle and was not secured to the floor (See Figure 1). The seat was reported by aircraft occupants to have come loose from the tracks during the accident. Inspection of the seat found that both the seat tracks and seat attachment hardware were in very good condition. The (4) seat locking pins (plungers) which screw into the track with hex screws were found to be not screwed down at all (See Figure 2). Inspection of the other 5 passenger seats showed them to be properly installed with these locking pins fully screwed down into the seat attachment bracket and seat tracks.

Figure 1: LH # 2 Seat as Found

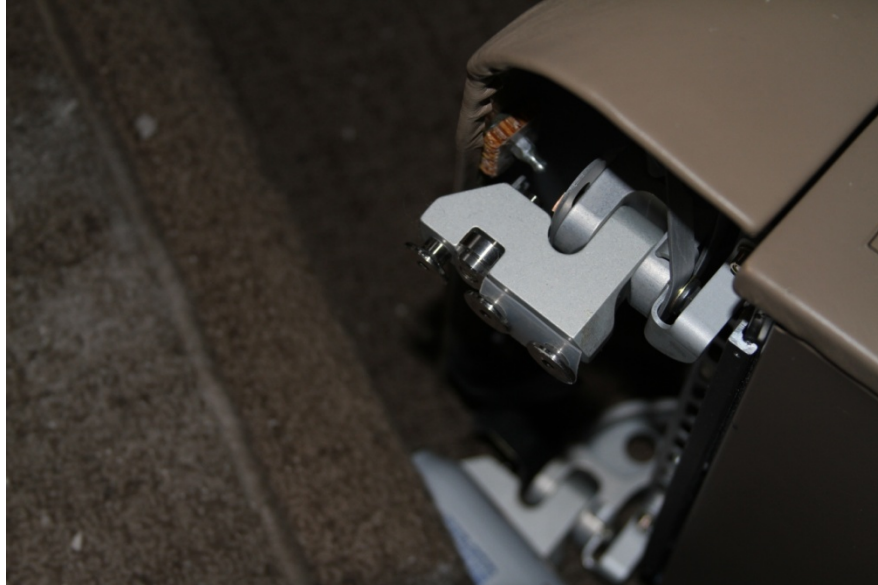
Figure 2: One of Four Seat Plungers on LH #2 Seat
