National Transportation Safety Board

CSX train Derailment on Metro-North Railroad

DCA-13-FR-009

Factual Report

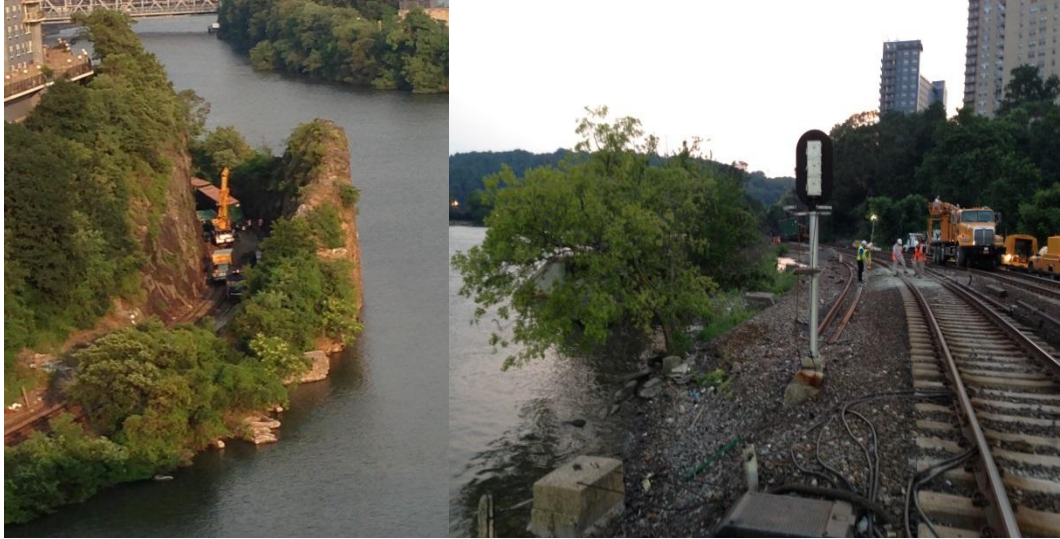
Figure 2: Derailed cars in cut (left). Point of derailment area (right).

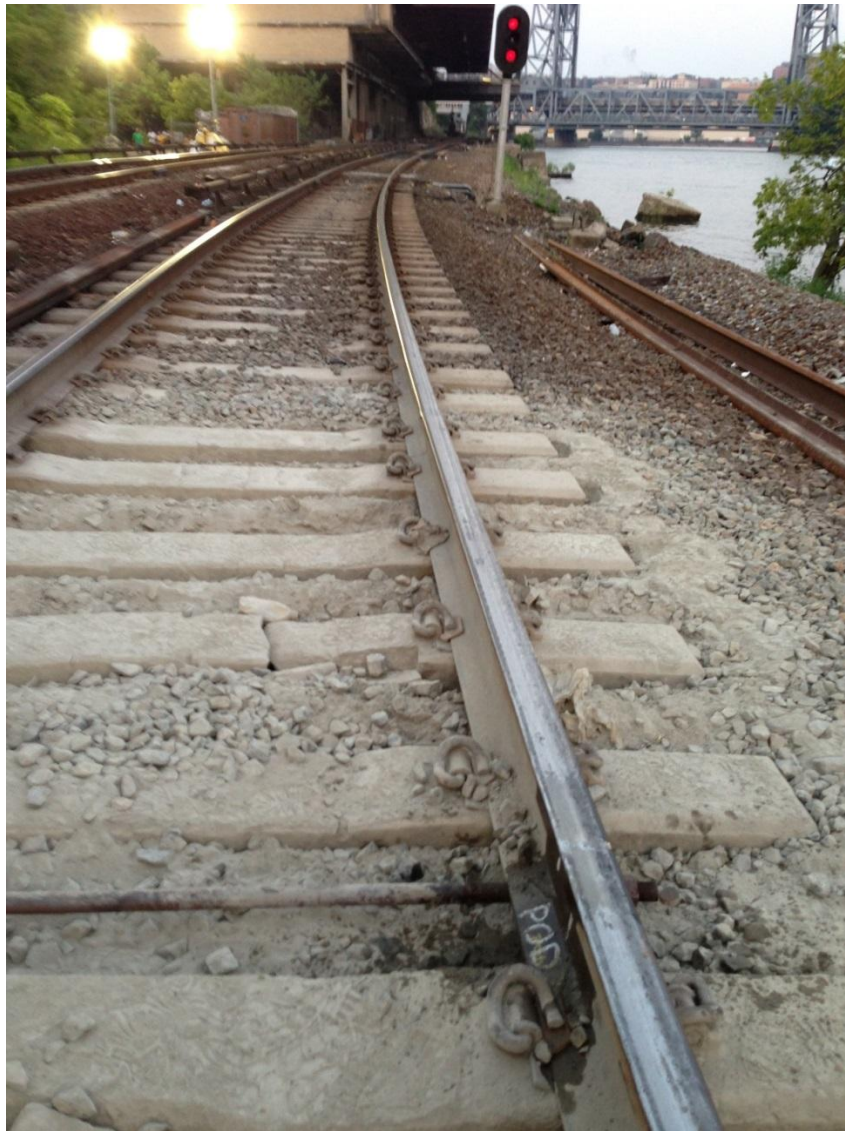
6 The point of derailment (POD) was determined by a wheel flange mark on the inside base
7 of the west rail at MP 9.99 (72 feet 10 ¼ inches north of CP 10).

Figure 6: Point of Derailment (POD) showing south home signal for CP 10 in background (Note: gage rod was installed after the derailment)

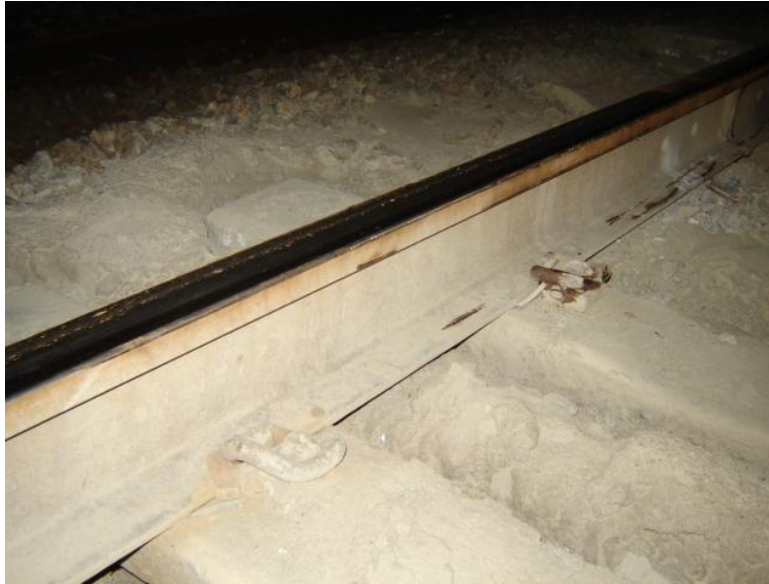
Figure 7: Marks on gage side of base of low rail at POD

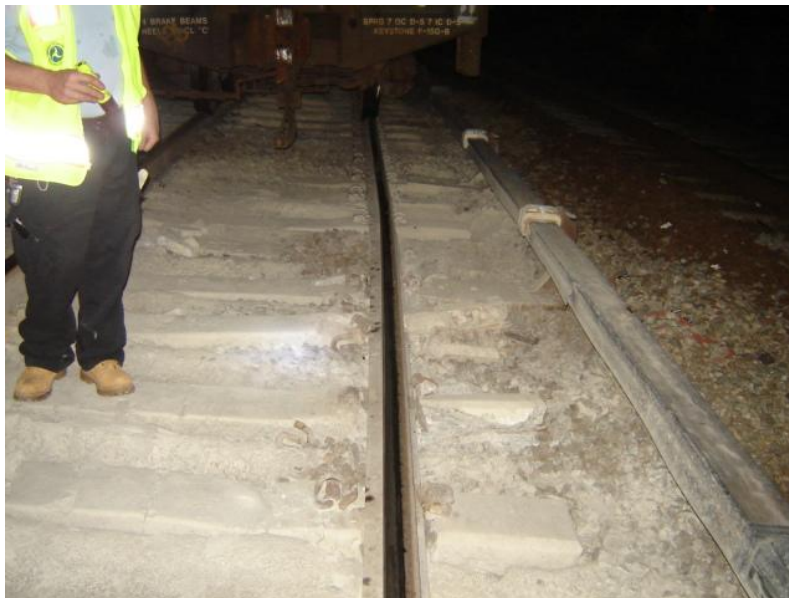
Figure 8: View of POD area

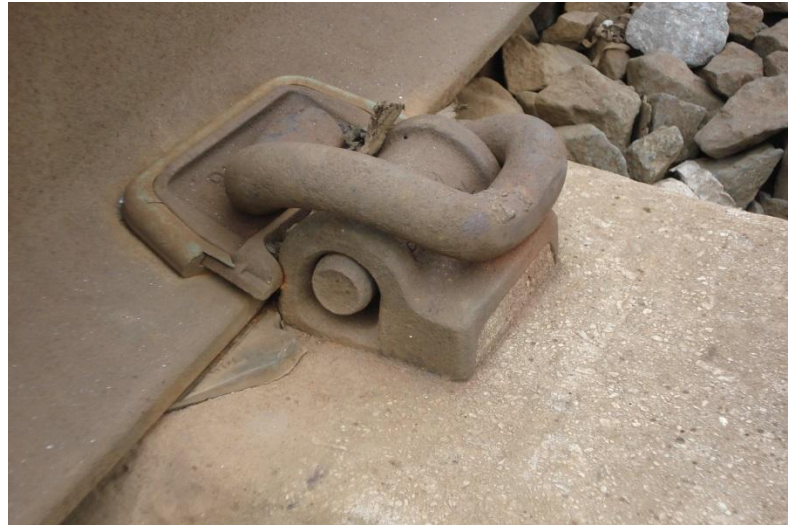
19 In the vicinity of the POD, it was noted that the rail base had slipped under the insulator
20 clips on the inside curve rail which added approximately 5/16 inch to the gage. The high side rail
21 had a mixture of the same insulator clips and some that were modified with metal inserts.

Figure 9: Insulator between pandrol clip and rail base of the type with metal insert. Note that insulator has slipped above base of rail on field side.

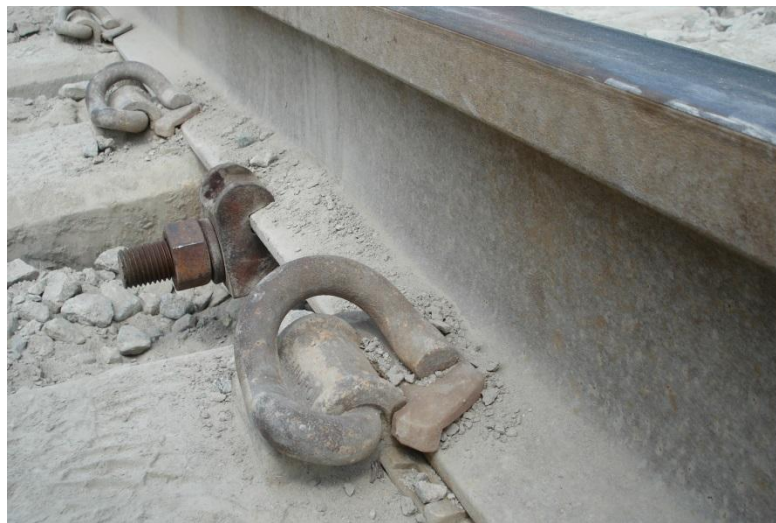
Figure 10: Insulator between pandrol clip and rail base of the type without metal insert. Note that insulator has slipped above base of rail on field side.

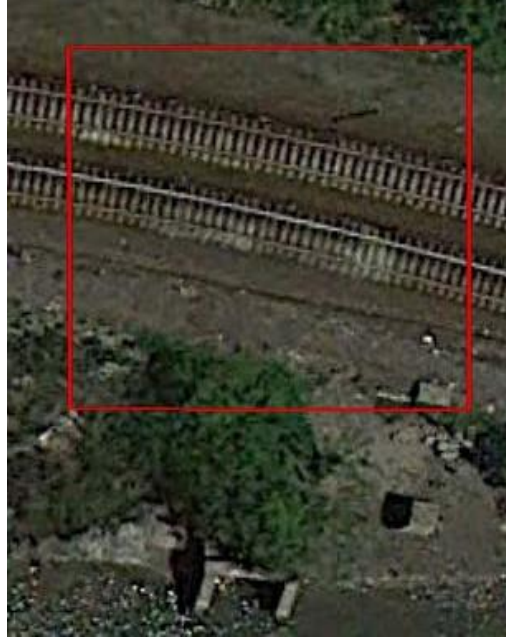
Soil intrusion into the ballast (fouled ballast) was noted in the derailment area. Satellite images⁷ from June 2010 (4 years before the derailment) were examined and showed the fouled ballast at the point of derailment.

Figure 11: Satellite image from 2010 showing fouled ballast at POD

Fouled ballast occurs when inadequate drainage results in a buildup of water in the track sub-structure. Hydraulic action (“pumping”) during train movements over the area results in fine soil particles rising to the surface and contaminating the ballast. In addition, the powdery substance that was observed throughout the track structure in the POD area appeared to be from concrete tie abrasion and ballast stone abrasion. Samples were sent to the NTSB laboratory for further analysis and the results will be entered as a separate docket item.

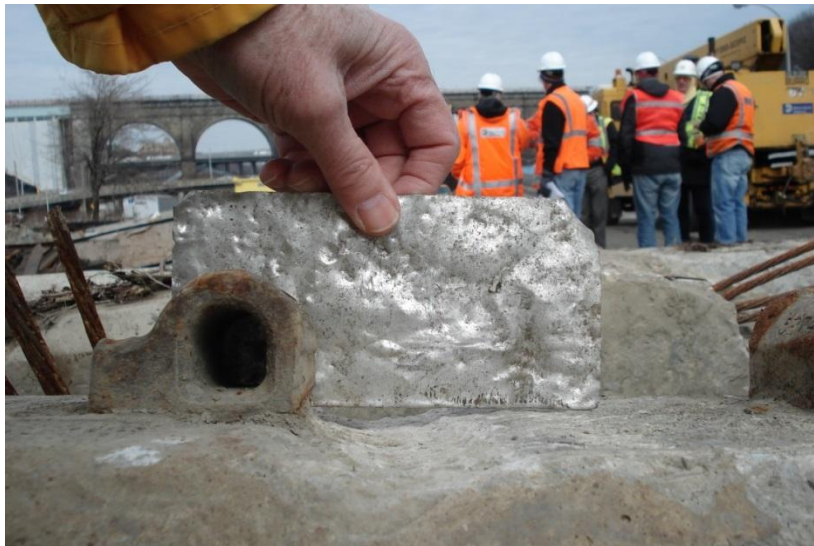
Track panels from the derailment site were preserved and later disassembled at Metro-North High Bridge Yard. Wear in the rail seat area was noted on many of these ties along with a worn trough on the field side of the rail seat.

Figure 14: Groove worn into field side of rail seat

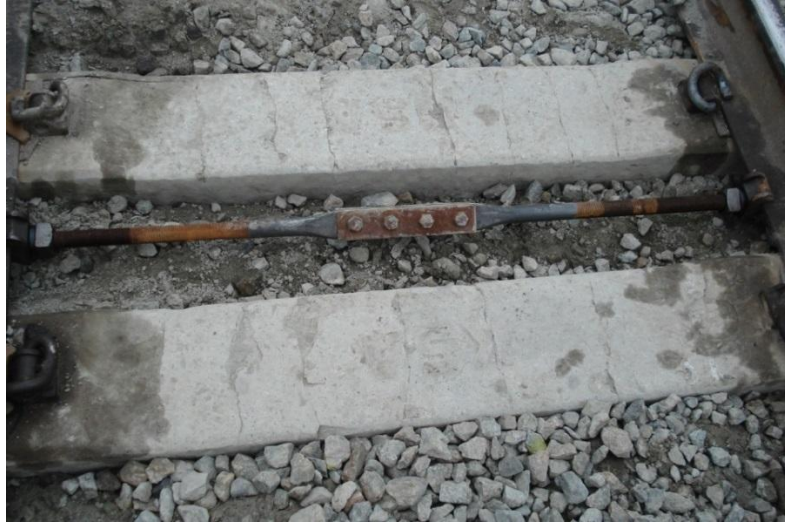
Center cracking was evident on a number of ties and the cross section of the ties was reduced by abrasion on the bottom of the ties.

2 **Figure 15: Cracks at centers of ties at POD (Note: gage rod was**
3 **installed after the derailment)**

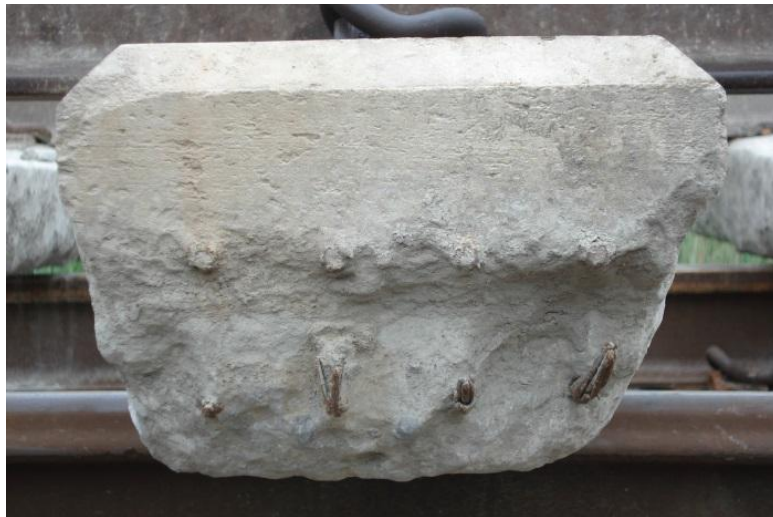
Reduced cross section was more pronounced at the ends of ties. Steel tensioning strands
5 were exposed on the ends of many ties.

7 **Figure 16: Tie from POD area with reduced cross-section and**
8 **exposed tension strands**
