RE: DCA97MA055, Fedex Pilots Association Submission

Federal Express Flight 14, McDonnell Douglas MD-11 N611FE
Newark International Airport, Newark, NJ
July 31, 1997, 0131 EDT
DCA97MA055

Fedex Pilots Association
Submission

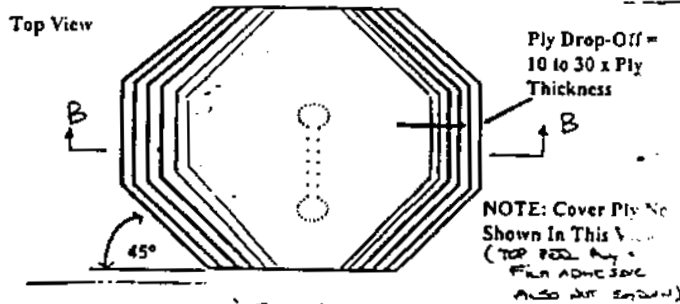
Fig. 1
Showing Boron Doublet Repair

BORON DBLR REPAIR
