## **Factual Report Figures**

Aaron McCarter Air Safety Investigator Eastern Region Aviation

May 1, 2019

Subject: ERA18FA120- Figures for Factual Report

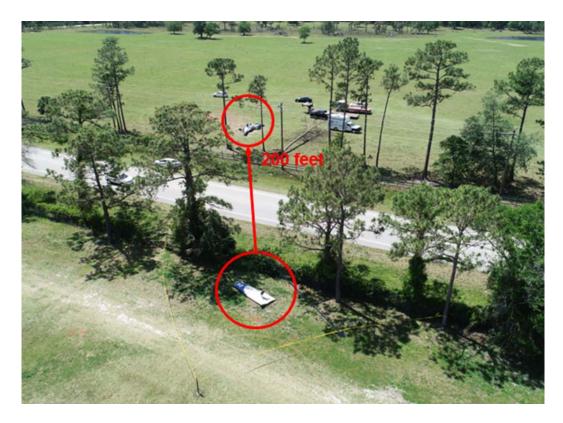
Figure 2. Photograph showing the separated left wing in foreground and main wreckage in background.

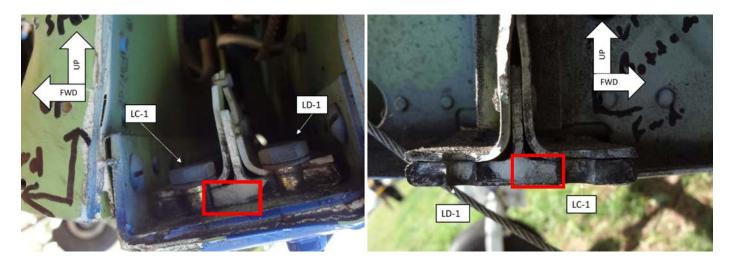
**Figure 3.** Left-wing fuselage lower spar cap (left frame) and left wing lower spar cap (right frame) with red boxes highlighting areas visually inspected on scene that showed fatigue regions.

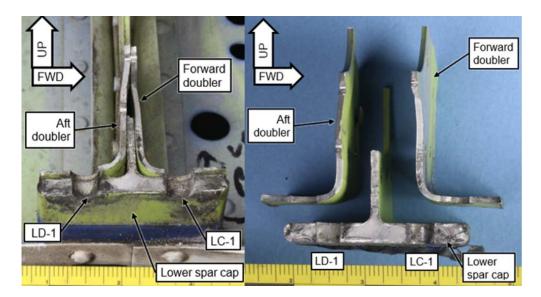
**Figure 4.** Photographs showing pieces of the accident left-wing lower spar cap and doublers before (left) and after (right) sectioning and rivet removal to facilitate examination.

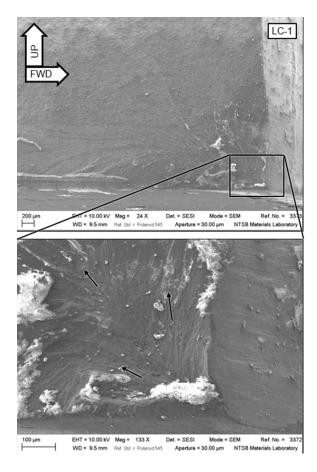
**Figure 5.** SEM images of fracture features at the aft side of hole LC-1 with a view of the origin area shown at higher magnification (lower image). Unlabeled arrows indicate local directions of crack propagation.

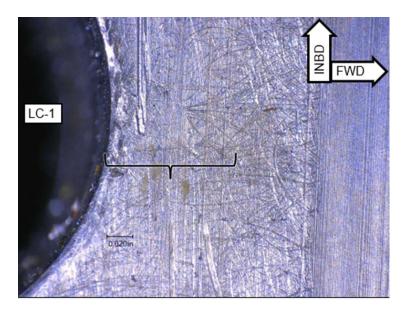
**Figure 6.** Magnified image showing a crack feature on the lower surface of the left-wing main spar from airplane N104ER.
