Loss of Control
Sundance Helicopters, Inc.
Eurocopter AS350-B2, N37SH
Near Las Vegas, Nevada
December 7, 2011

NTSB/AAR-13/01
PB2013-103890

Aircraft Accident Report

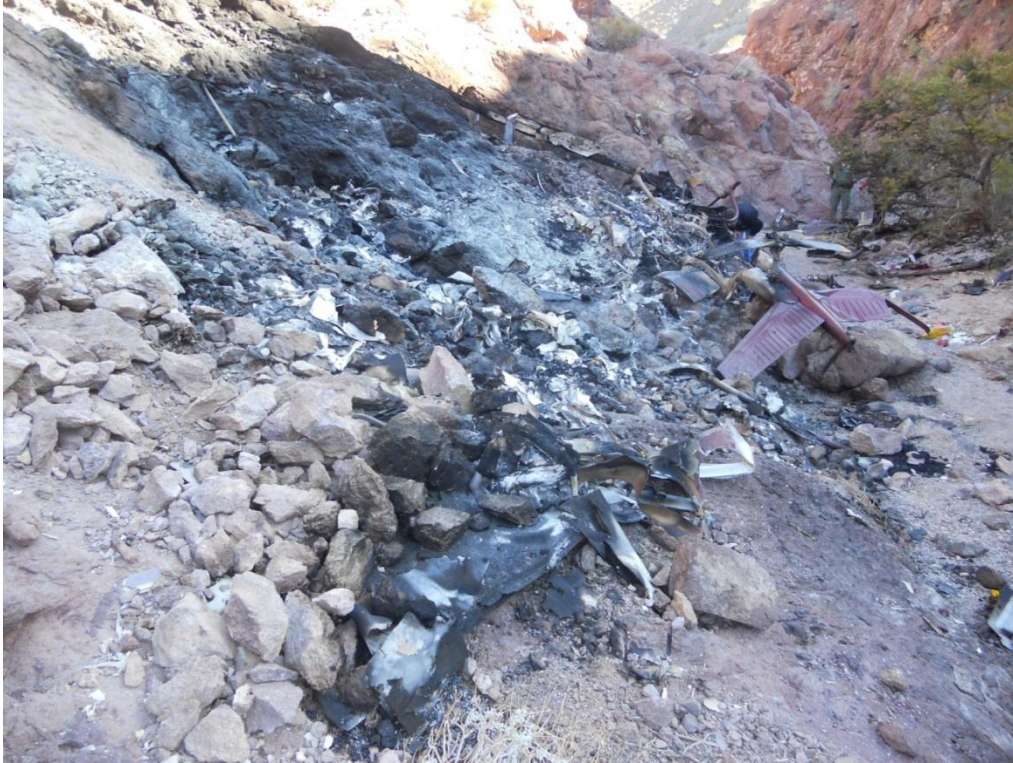
The helicopter crashed in a ravine between Henderson, Nevada, and Lake Mead.⁹ The helicopter impacted the terrain in a nose-low attitude on an approximate north-easterly heading. The cockpit area and predominate helicopter structure were found in the immediate wreckage area. A large amount of the structure forward of the horizontal stabilizer was consumed by postimpact fire. See figure 2 for a photograph of the main helicopter wreckage.

Figure 2. Photograph of the main helicopter wreckage.

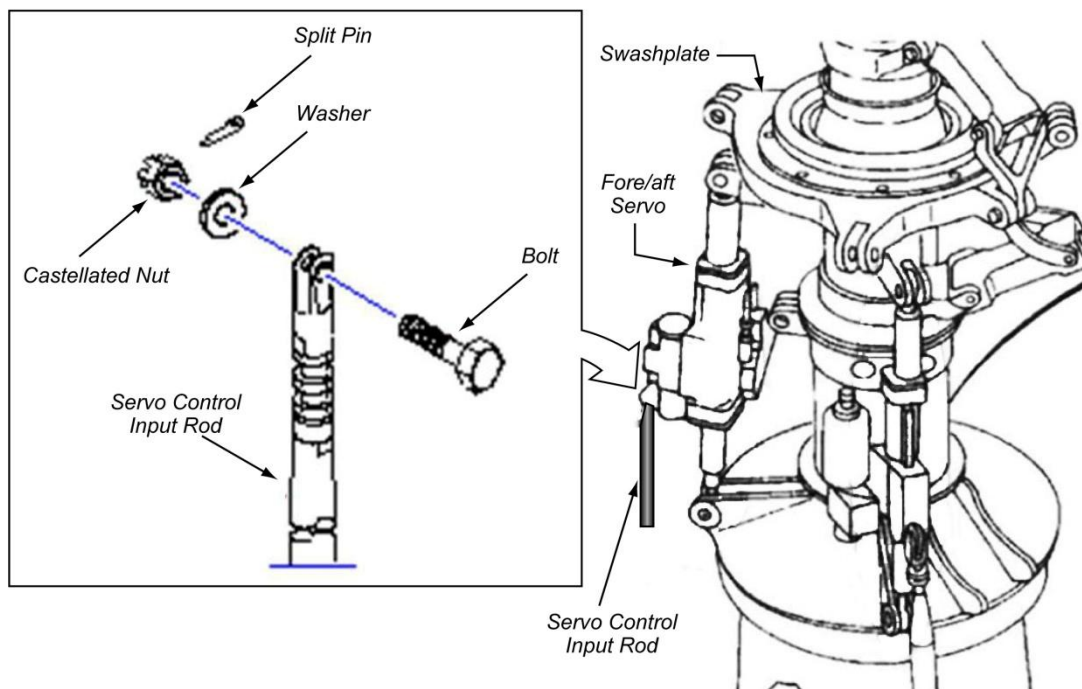
Figure 3. Schematic of the main rotor servo assembly and the fore/aft main rotor servo's input rod assembly.

At the accident site, the fore/aft main rotor servo’s control input rod was found disconnected from the input lever, and the connection hardware (bolt, washer, self-locking nut, and split pin) was not found. The fore/aft servo connection hardware also was not found during subsequent comprehensive and detailed examinations of the wreckage and engine.¹⁴ (The NTSB notes that the main rotor transmission area of the helicopter is not sealed. Therefore, if the connection hardware separates during flight, it most likely would not be contained.) The control input rods for both of the main rotor lateral servos and the tail rotor servo were found properly connected to their respective servo input levers.

The fore/aft servo’s control input rod was found in two pieces: one piece was an approximate 14-inch section of the upper input rod end that was found disconnected from the fore/aft servo input lever, and the other piece was an approximate 3-inch section of the lower end of the input tube that was found correctly attached to its linkage. Examination of the 14-inch section of the upper input rod end revealed no visible elongation of the bolt hole. The separation points on both sections of the input rod were consistent with overload/impact damage.

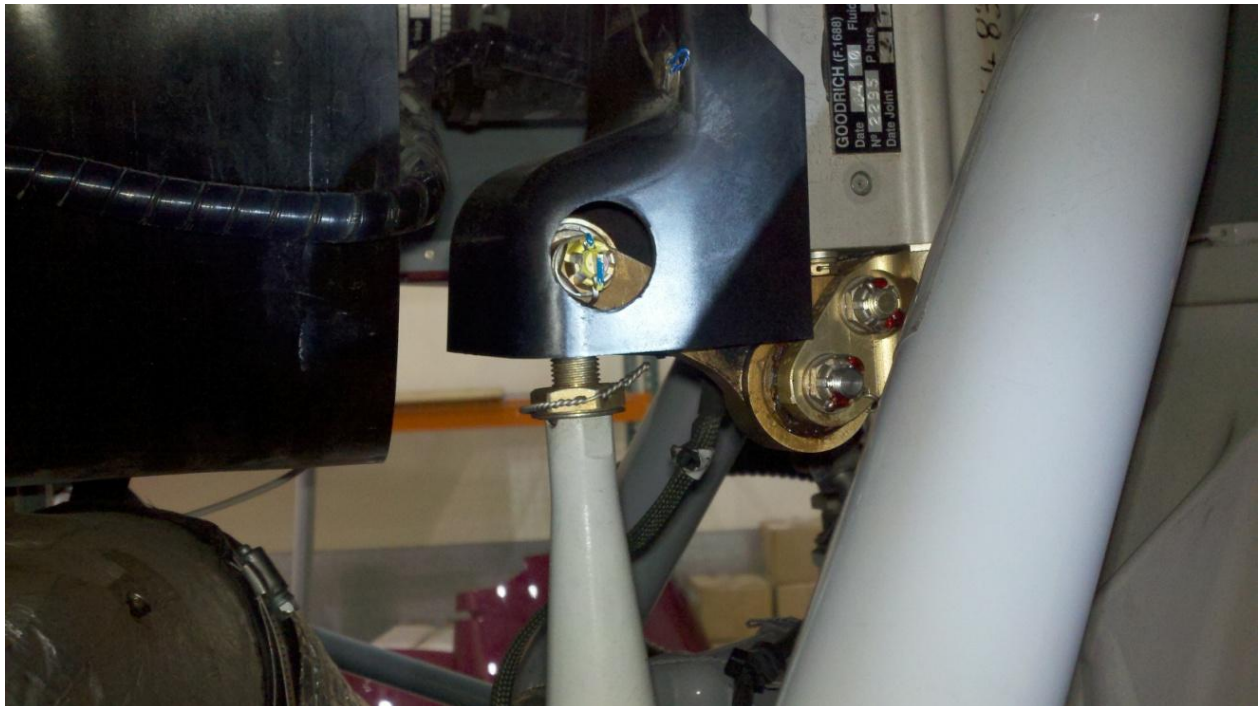
Figure 4. Photograph showing the nut and split pin of the fore/aft servo input rod connection hardware visible through the cutout of the ice shield (about eye level for a pilot inspecting the left MGB area).

The NTSB concludes that the mechanic, inspector, and check pilot each had at least one opportunity to observe the fore/aft servo self-locking nut and split pin; however, they did not note that the split pin was installed improperly or not present.

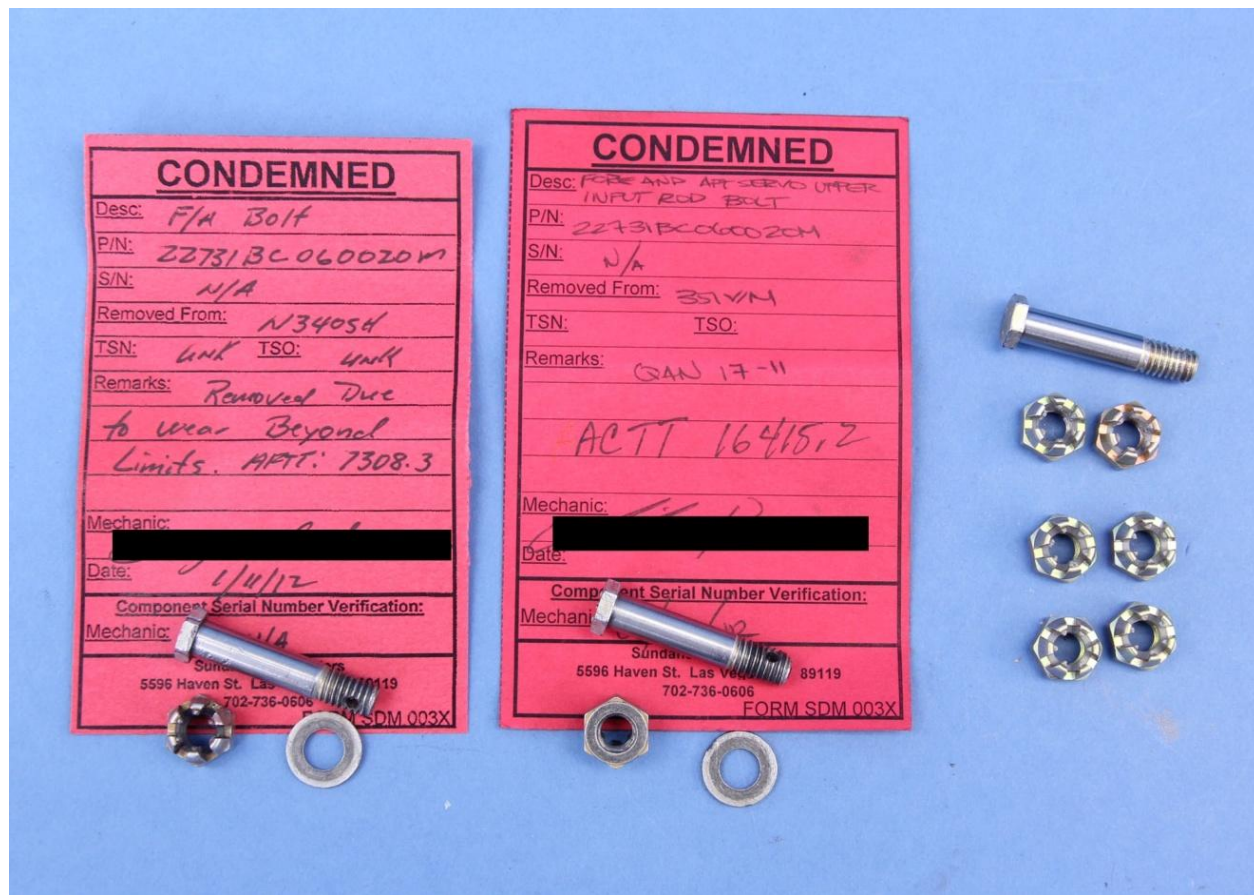
Sundance Helicopters provided the NTSB with self-locking nuts from two of the examined helicopters (N340SH and N351WM) that could be easily and fully tightened or loosened on the accompanying bolts with finger pressure. This indicates that the nuts from the two helicopters were not suitable for reuse because new nuts restrict movement by hand after two to three turns. In addition, torque measurements found that the turning resistance of the nuts on the bolts was about 1 in-lbf (inch pound force) or less in both directions. Figure 5 shows the nuts, upper input rod bolts, and washers removed from N340SH and N351WM next to a new bolt and nuts.

Figure 5. Photograph showing the nuts, upper input rod bolts, and washers removed from N340SH and N351WM next to a new bolt and nuts.

On the basis of this evidence, the NTSB concludes that at the time of the accident, Sundance Helicopters was not following Eurocopter and FAA self-locking nut reuse guidance, which led to the repeated improper reuse of degraded nuts on its helicopters.

helicopter with over 5,000 flight hours and that replacement of the hardware was to be accomplished at each 5,000 flight hours thereafter. Further, the alert notice stated that any time an input rod is disconnected from any of the servos, the nut must be replaced with a new nut.
