Building Explosion and Fire
Silver Spring, Maryland
August 10, 2016

Accident Report

NTSB/PAR-19/01
PB2019-100722

Pipeline Accident Report

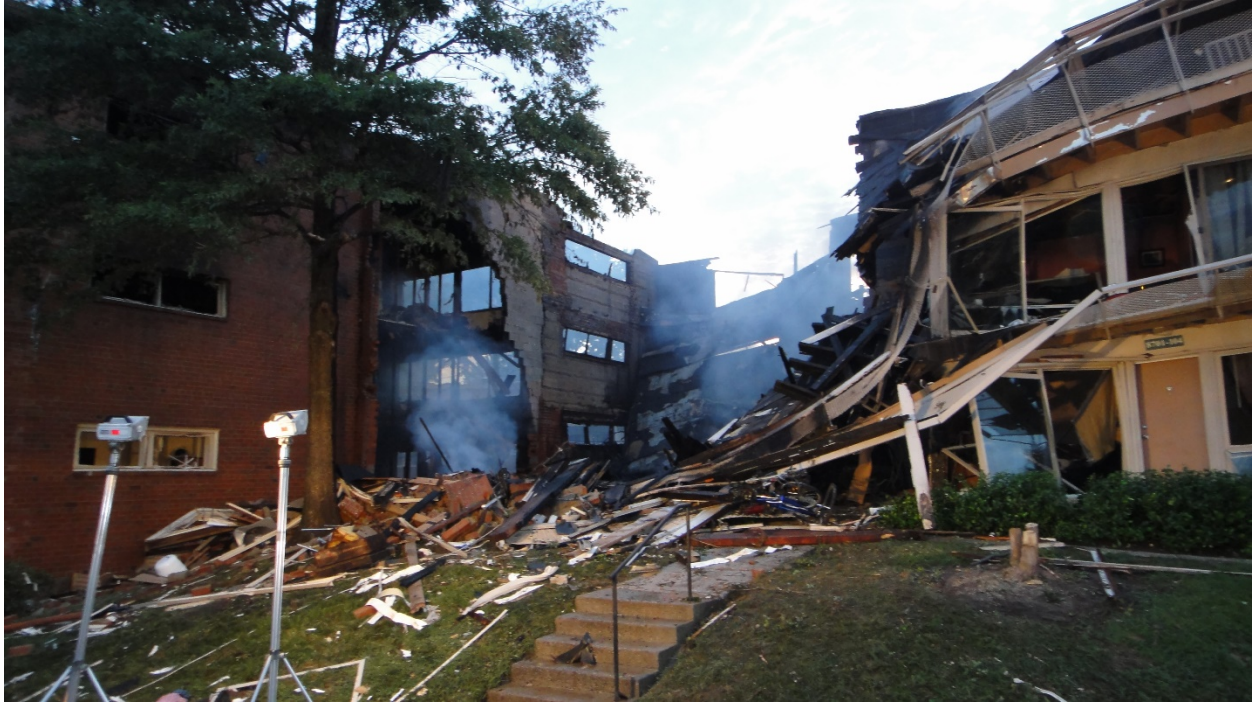
The explosion and fire also heavily damaged an adjacent apartment building, 8703 Arliss Street, which shared a common wall with building 8701. (See figure 2.)

Figure 2. Buildings 8701 (right-center) and 8703 (left) Arliss Street, Silver Spring, Maryland, after the explosion and fire. (Photograph provided by the Public Service Commission of Maryland.)

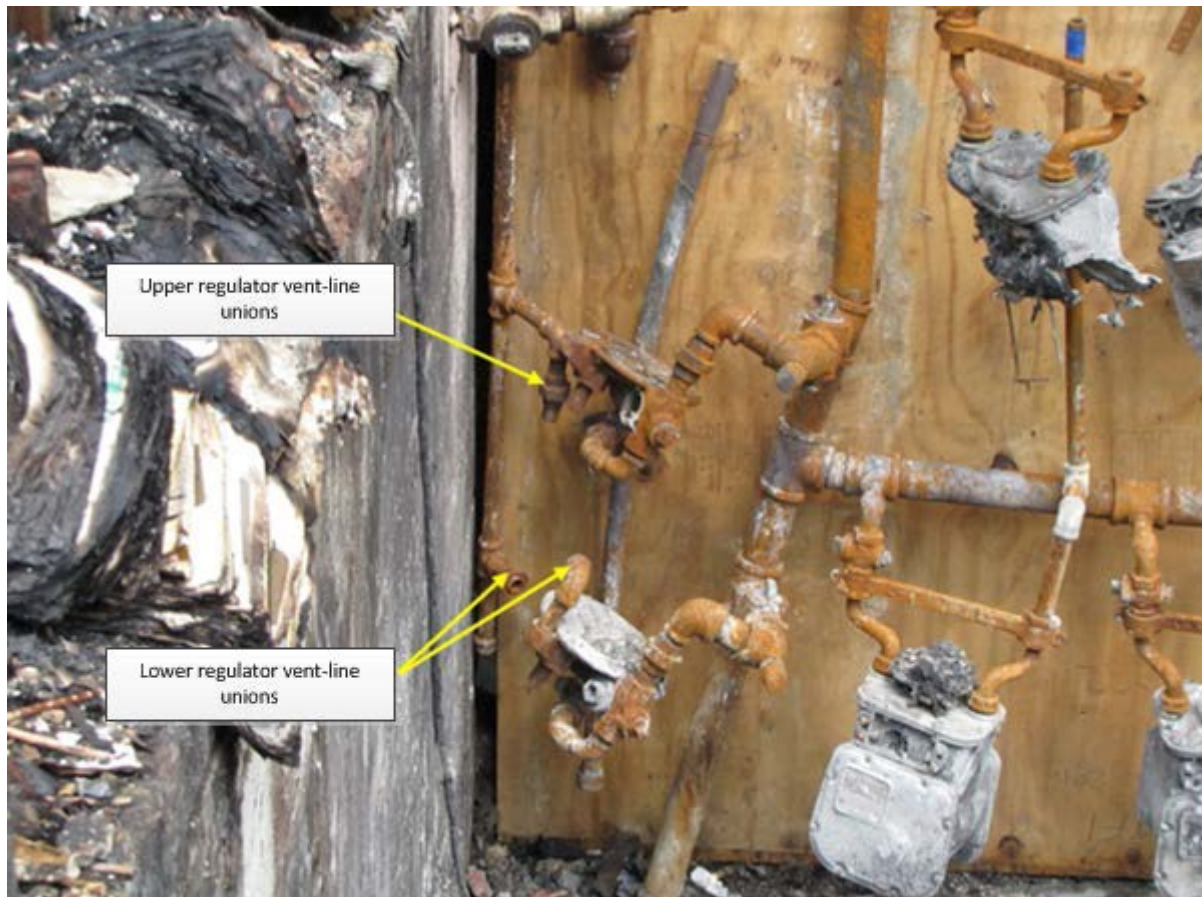
NTSB focused on the gas service equipment and appliances in the meter room because the ATF's investigation ruled out all other potential fuel sources in the room and the evidence indicates that the explosion originated in the meter room. During the inspection of the basement level of building 8701, NTSB investigators found burned and damaged components of the gas meter assembly, which included the mercury service regulators. A detailed inspection revealed that the vent line connection to the upper mercury service regulator was fractured below the coupling/union assembly, and the lower mercury pressure regulator was not connected to the regulator vent line at the coupling/union assembly, as shown in figure 5.²⁴

Figure 5. Portions of mercury service regulators and gas meters in building 8701 showing heat/fire/explosion damage and the unconnected lower regulator vent line.

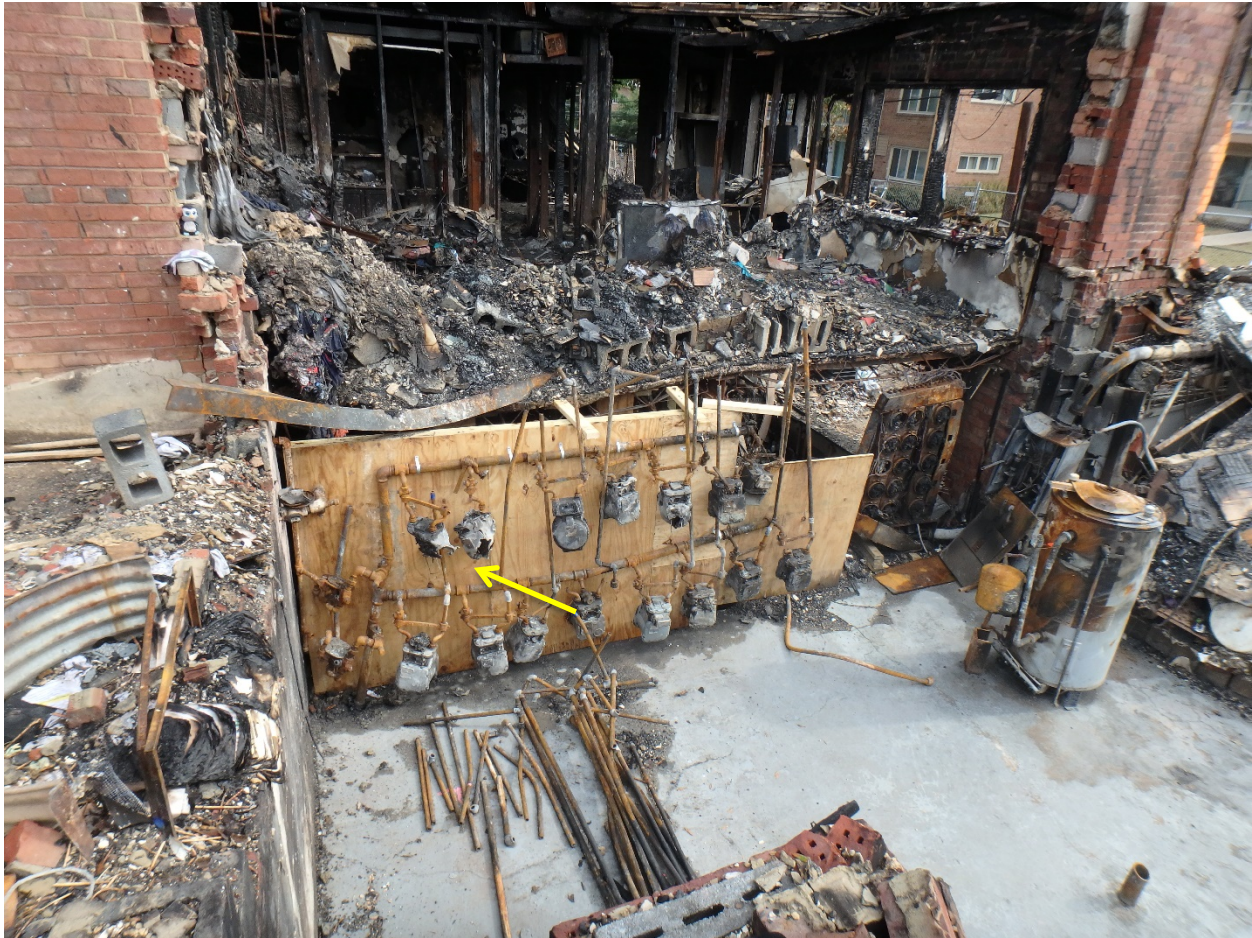
ATF reconstructed the natural gas meter rack, piping, electric meters, and water heater. The gas meters on the upper row of the meter rack near the regulators showed significant fire and heat damage, particularly when compared with the gas meters farther away from the point of the explosion at the west wall. (See figure 6.) The water heater showed significant fire and heat damage and was found in the northeast quadrant of the meter room, about 6 feet from the nearest customer gas meter. The water heater was placed by ATF at its pre-explosion location.

Figure 6. Building 8701 after debris removal and ATF reconstruction. The first two gas meters (designated with a yellow arrow) show substantially more heat/fire damage than other meters. (Photograph provided by ATF.)

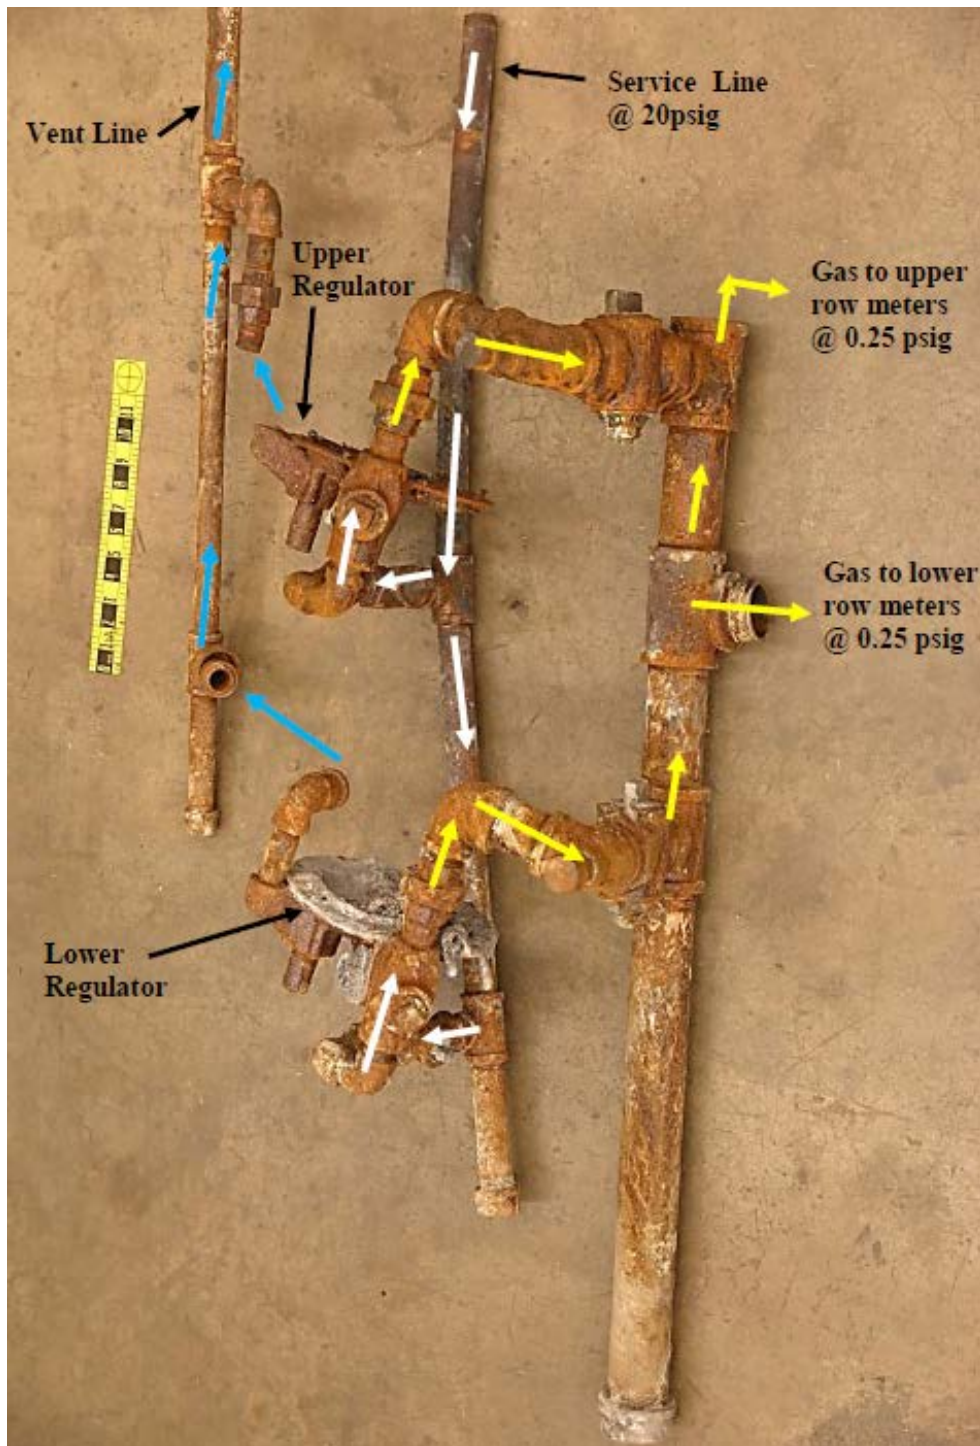
Figure 10 is a photograph of an approximate reconstruction of the preaccident configuration of the service regulators, service line, pipeline to the meters, and vent line. The white and yellow arrows pictured show the direction of the gas flow through the service line during normal operation; the blue arrows show the direction of the gas flow under an over-pressure scenario through the vent line.

Figure 10. Mercury service regulators, service line, jurisdictional pipeline, and vent line after the accident.

(Moses 1978). The top cover and 2-inch diameter plug for the upper and lower gas regulator assemblies were both melted from exposure to heat from the fire.²⁸ Based on this observation, the temperature in the general area of the gas regulator assemblies reached at least 1,220°F. This also explains why mercury was not found in the reservoir cups of the upper and lower gas regulator assemblies. Mercury exists as a liquid at room temperature and has a boiling point of about 674°F, where it evaporates. The mercury most likely evaporated as a result of heat exposure from the fire.

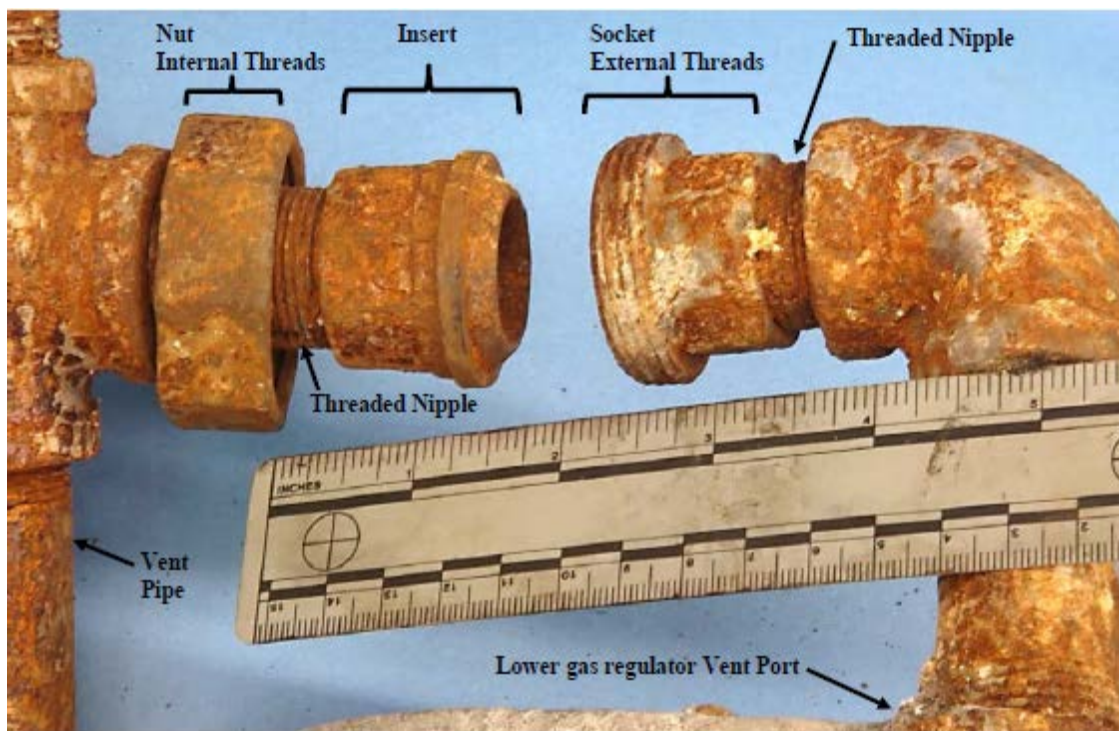
The two regulators that serviced building 8701 were connected to one vent line, but each regulator had its own union assembly. A union assembly is made up of three components: an internal threaded nut, an insert, and a mating external threaded socket. Figure 11 shows a photograph of the lower regulator union assembly parts before cleaning. The separation was between the internal threaded nut (on the left) and the external threaded socket (on the right) of the lower assembly.

Figure 11. Photograph of the lower regulator union assembly parts (before cleaning).

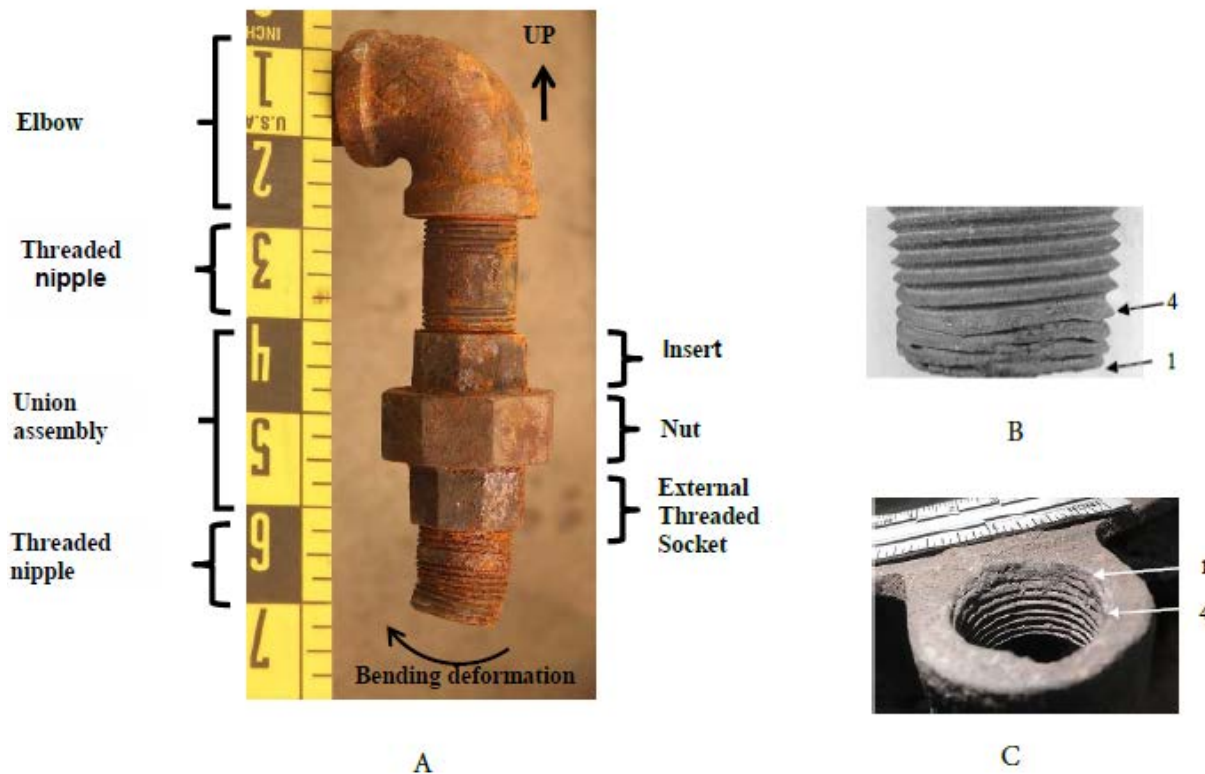
as shown in figure 12-C, showed thread damage that coincided with the damage observed on the nipple. (See figure 12-B.) The observed damage is consistent with the damage that could occur if the threaded nipple was forcefully pulled out of the mating regulator vent port.

Figure 12. A photograph of the exposed external threaded nipple from the upper regulator union assembly.

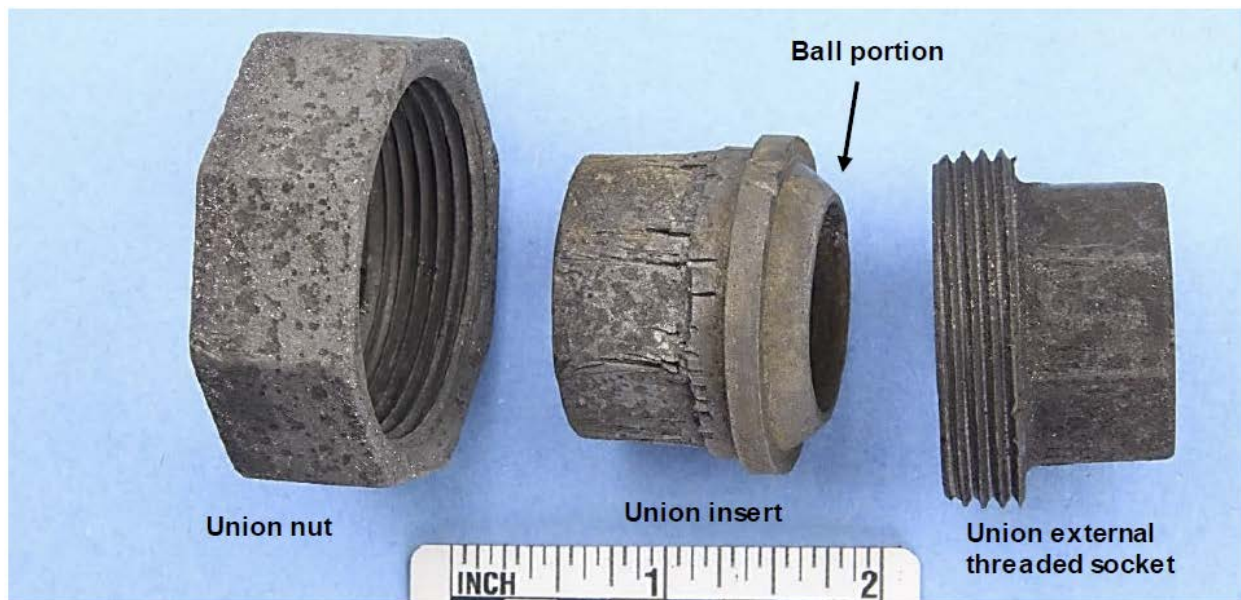
Figure 13 shows the union assembly components after cleaning. The external threads of the socket contained two dents; and the crown portion of the first two full external threads of the socket showed minor deformation.³⁰ The external threaded socket showed no evidence of major deformation. On one side of the nut, the crown portion of the first three internal threads showed evidence of minor metal flow deformation; and NTSB investigators observed similar deformation on an isolated area of only one thread on the diametrically opposite side. When mating threads are pulled apart by force, fracture or deformation by shear of the threads can also be expected.³¹ However, NTSB investigators observed no evidence of deformation or fracture of the threads in the nut and corresponding mating threads on the socket (compare figures 12 and 13 for thread damage). Had the force of the explosion, falling debris, or a building collapse caused the disconnection of the lower union assembly, there would be evidence of mechanical damage or deformation through a significant portion of the engaged threads, as seen with the threaded nipple for the upper regulator union assembly.

Figure 13. Photograph of the disassembled union assembly for the accident lower gas regulator after cleaning.

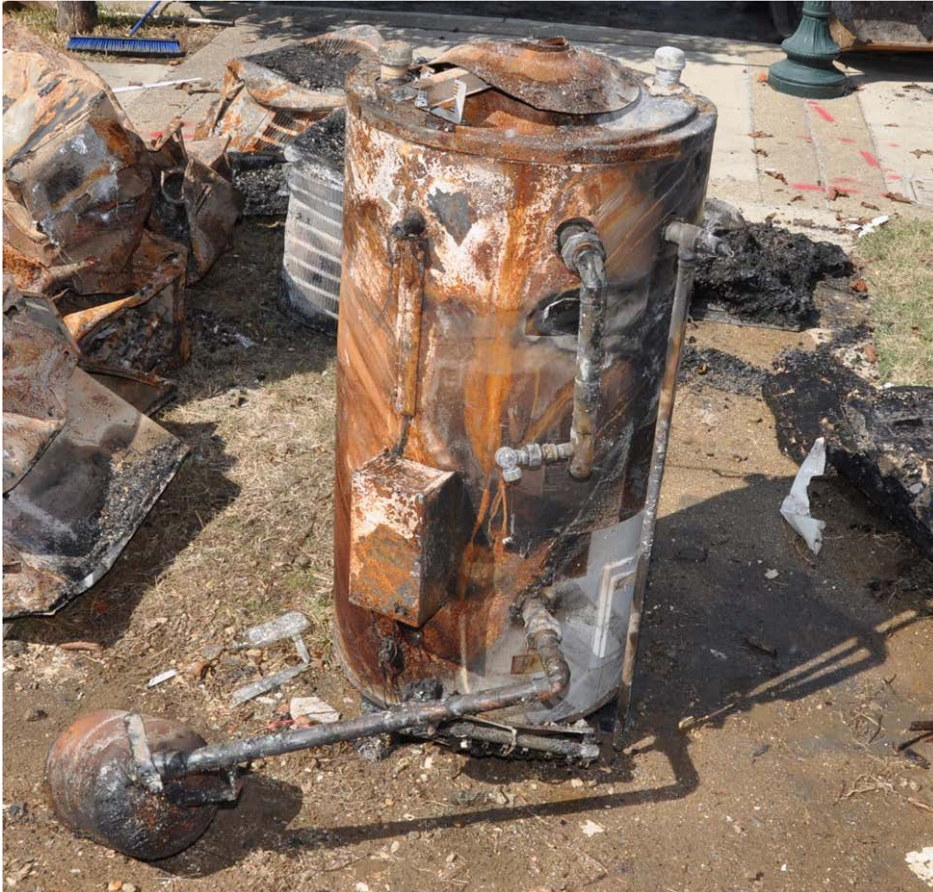
In a postaccident examination, NTSB investigators observed that nearly half of the water heater was covered with a U-shaped pattern of thermal damage. Visual examination of the water heater by investigators showed no evidence of bulging or significant body deformation.³⁶ (See figure 14.)

Figure 14. Hot water heater at the accident scene after the explosion. (Photograph provided by ATF.)

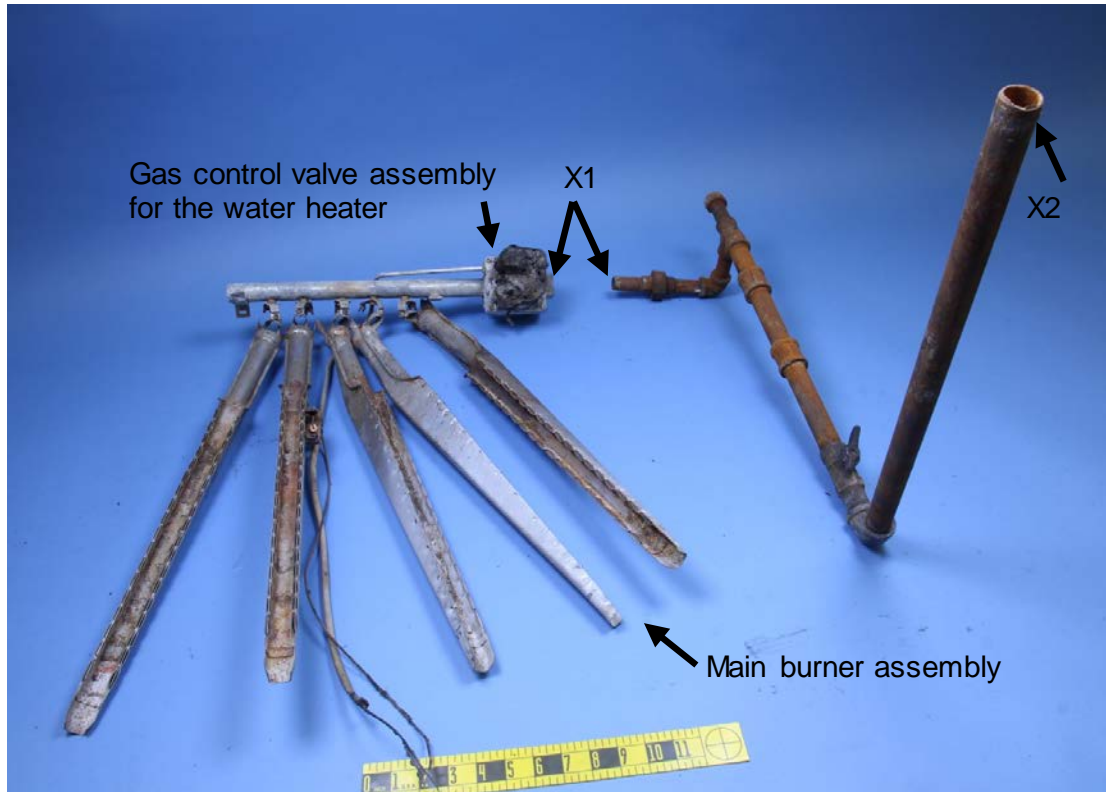
In addition, a length of gas piping, which included the gas shut-off valve, was still attached to the water heater. All the recovered piping associated with the water heater was heavily oxidized, consistent with heat exposure, and all piping connections were found to be attached and threaded completely. The recovered gas piping to the water heater had a full-diameter, through-thickness fracture at the end of the section where the piping connected to the inlet on the gas control valve assembly, near the bottom of the water heater. Figure 15 shows the main burner assembly and pipe segment that separated from the gas control valve assembly. The fractured end of the pipe segment

showed evidence consistent with an overstress separation.³⁷ Therefore, the NTSB concludes that the gas piping to the water heater was most likely separated at the control valve due to overstress forces resulting from the explosion. Furthermore, the NTSB concludes that the water heater did not fail prior to the explosion and was not the source of the natural gas release in the meter room.

Figure 15. The main burner assembly, including the separated pipe and the gas control valve assembly. The arrows labeled X1 and X2 indicate the pipe segment fractures at the threaded portion.
