Collision of BNSF Coal Train With the Rear End of Standing
BNSF Maintenance-of-Way Equipment Train
Red Oak, Iowa
April 17, 2011

NTSB/RAR-12/02
PB2012-916302

Railroad Accident Report

Abstract: On April 17, 2011, about 6:55 a.m. central daylight time, eastbound BNSF Railway coal train C-BTMCNM0-26, BNSF 9159 East, travelling about 23 mph, collided with the rear end of standing BNSF Railway maintenance-of-way equipment train U-BRGCRI-15, BNSF 9470 East, near Red Oak, Iowa. The accident occurred near milepost 448.3 on main track number two on the Creston Subdivision of the BNSF Railway Nebraska Division. The collision resulted in the derailment of 2 locomotives and 12 cars. As a result of collision forces, the lead locomotive's modular crew cab was detached, partially crushed, and involved in a subsequent diesel fuel fire. Both crewmembers on the striking train were fatally injured. Damage was in excess of \$8.7 million.

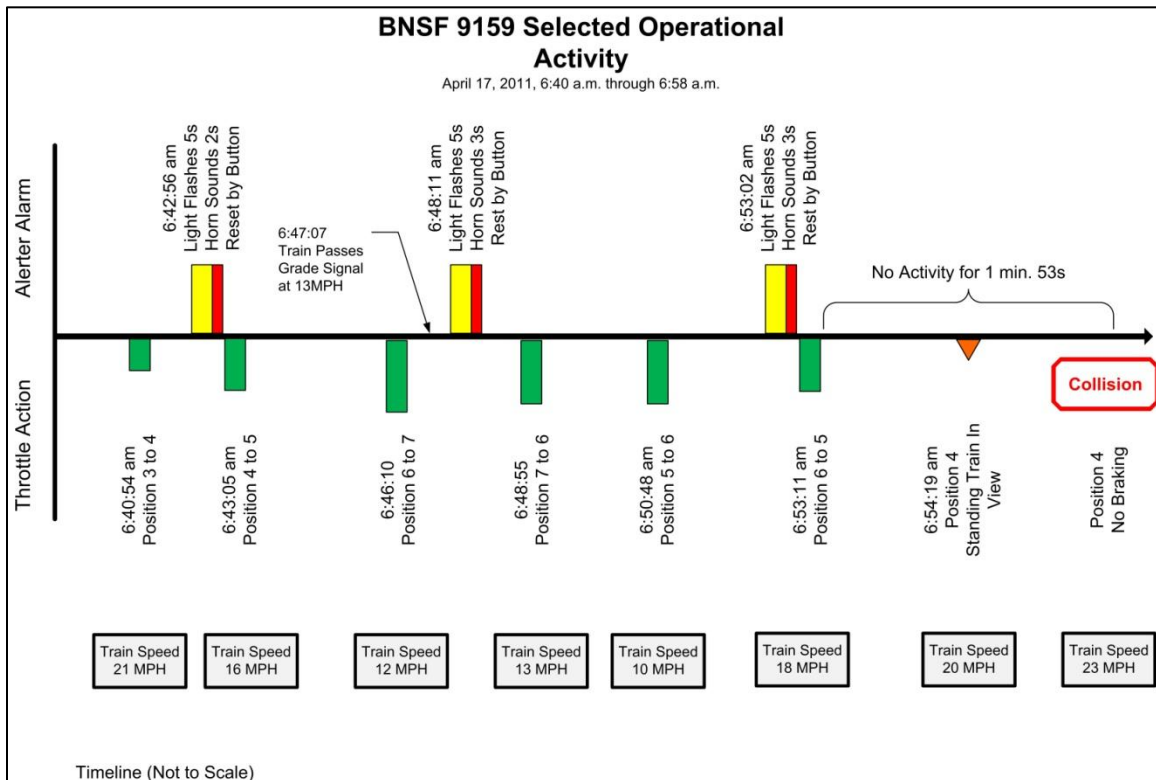
Signal system recorder data indicated that the striking coal train passed a yellow approach signal at CP 4535 and then the red “restricting” grade signal at MP 450.38 that protected the rear end of the standing MOW equipment train. Locomotive event recorder data indicated that the striking coal train had passed CP 4535 while moving about 30 mph in throttle position 1. The striking coal train’s speed reduced to about 12 mph, and its throttle was in position 7 when the train passed the red restricting grade signal at MP 450.38 approaching the top of the 0.6-percent grade. The speed reduction was consistent with the signal indication, grade, tonnage, and the amount of power the engineer had applied. Until reaching MP 449.4 the striking coal train engineer maintained the speed at between 11 and 12 mph using throttle adjustments. As the striking coal train crested the grade, train speed increased from 11 mph to 23 mph at the point of collision. There were several throttle adjustments during the last 15 minutes of the trip as shown in figure 4, but no activity was detected during the last 1 minute 53 seconds. At impact, the throttle was in throttle position 4, and brakes had not been applied.

Figure 4 was developed from event recorder data from the striking train’s lead locomotive and shows when the engineer manipulated the controls of the locomotive between CP 4535 and the point of collision. The event recorder data is shown in tabular form at appendix C.

Figure 4. Event recorder data from locomotive of striking train.

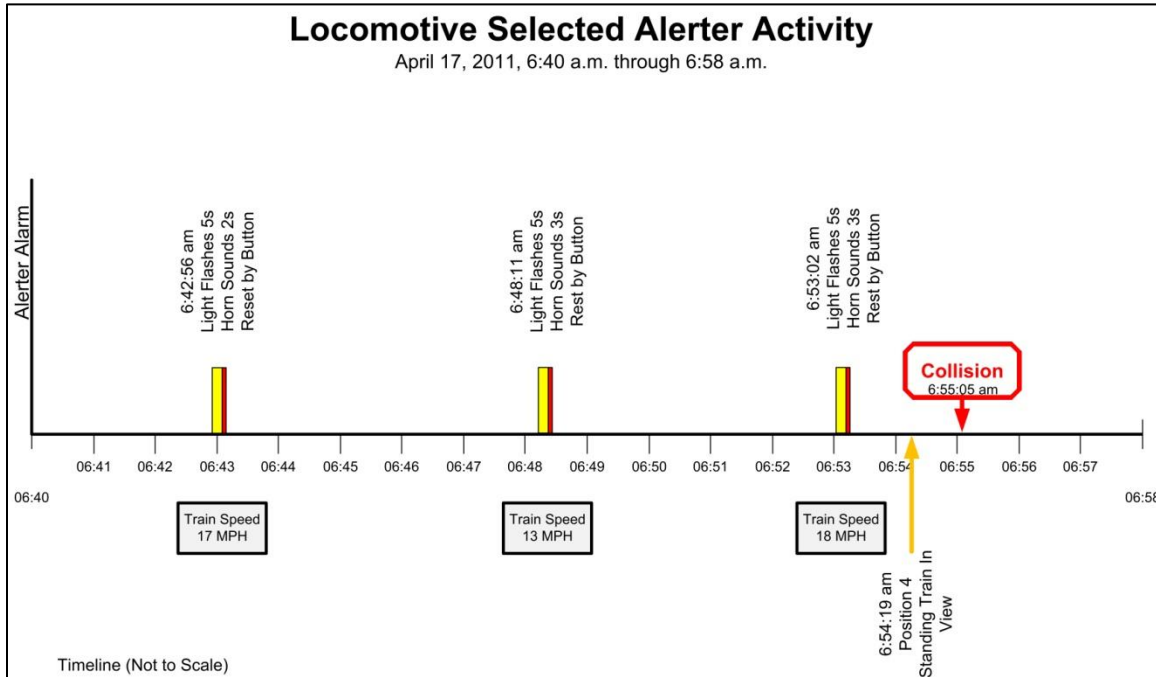
Data from the striking train’s (BNSF 9159) event recorder show that during the 15 minutes prior to the collision, the striking train’s lead locomotive alerter alarmed three times after periods of engineer inactivity and was reset using the alerter reset button after a strobe displayed for 5 seconds and an audible alarm sounded for an additional 2 to 3 seconds. The collision occurred 1 minute 53 seconds after a throttle movement, and the alerter would have been due to alarm in about 7 seconds had the collision not occurred. Figure 5 shows the alerter alarm events that occurred during the last 15 minutes before the collision.

Figure 5. Alerter alarm events from striking train locomotive event recorder during last 15 minutes before collision.

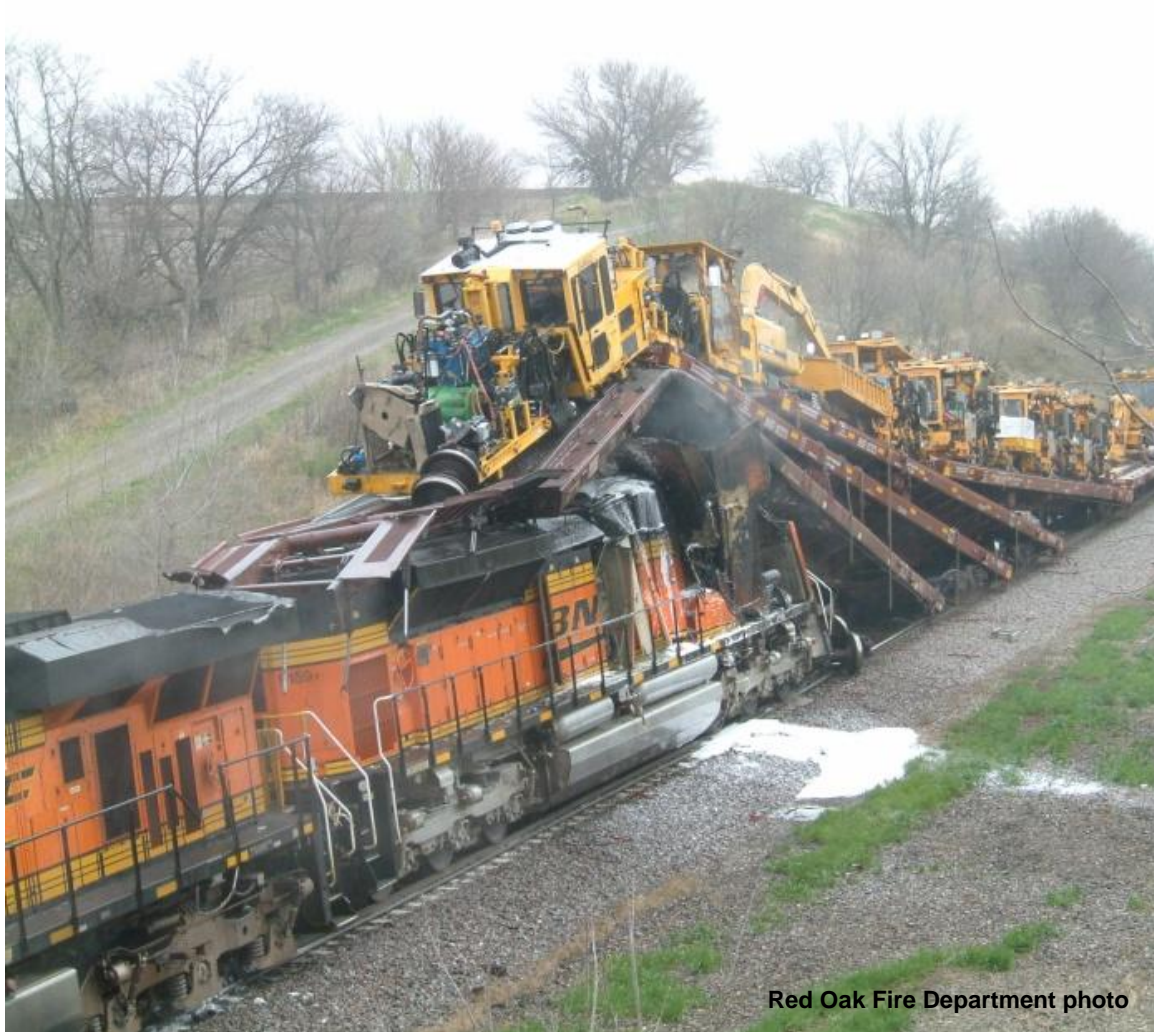
The next four cars (the 29th through the 32nd cars behind the locomotive) were 89-foot-long flatcars loaded with MOW equipment that were derailed and displaced to the north side of track two near the Highway M 37 overpass. (See map in figure 2 and figures 7 and 8.) Much of the cargo on these cars (MOW equipment) broke free from securements and was scattered along the right-of-way.

Figure 7. View of wreckage from highway overpass facing east.

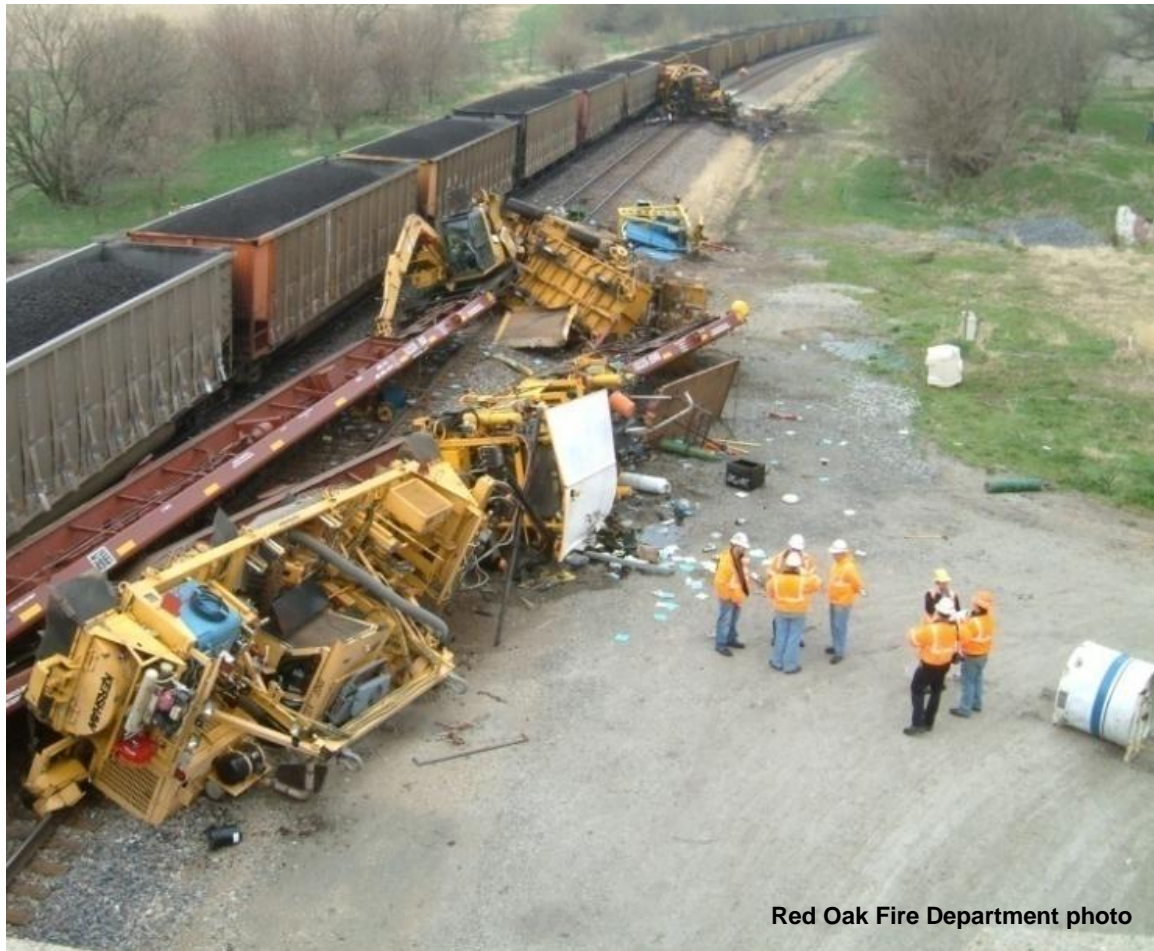
Figure 8. View of wreckage from highway overpass facing west.

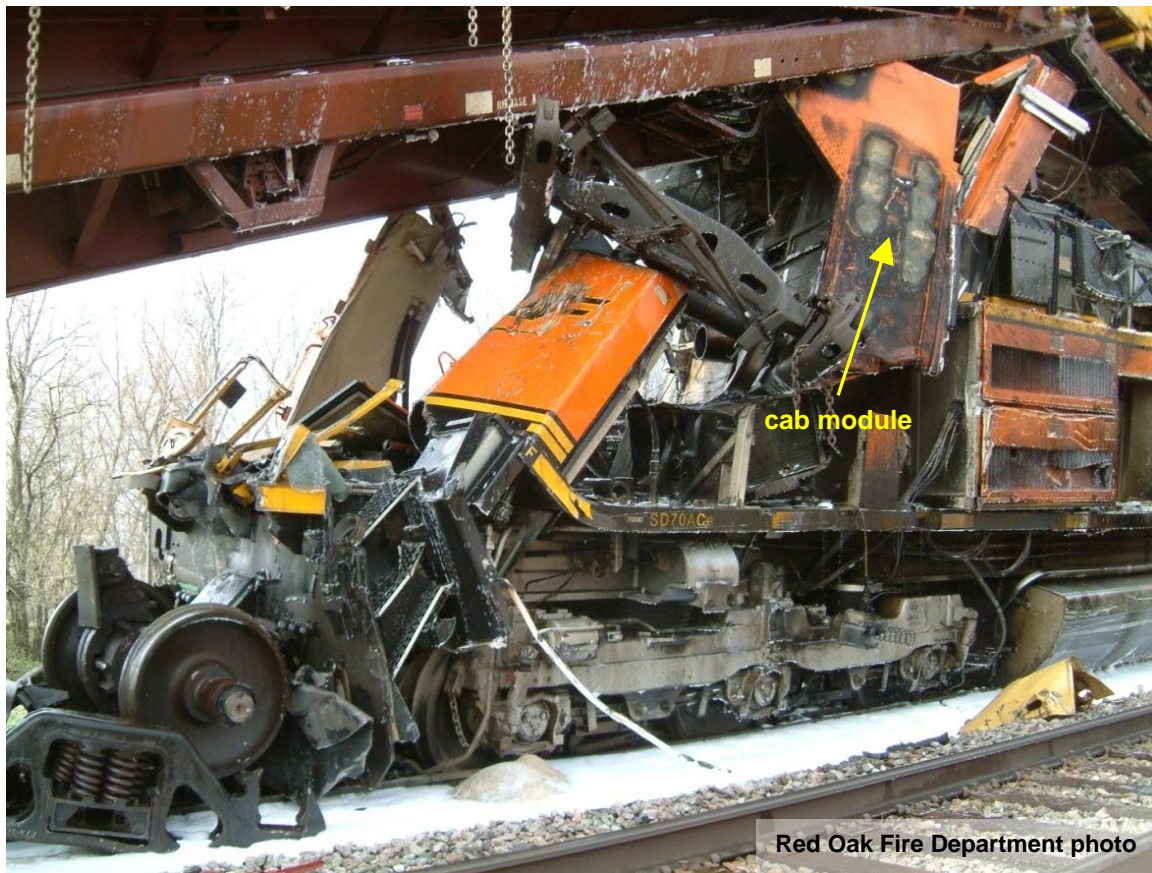
The modular cab of the locomotive sustained a substantial loss of occupied space. The cab was separated from the deck of the locomotive, and the bottom half of the cab rotated up just over 90 degrees. (See figure 11.) The cab was crushed at the rooftop, and the left rear corner of the cab was crushed in. The side walls remained intact to the point of the window line, which is about 4 feet from the roof. The underside of the cab was relatively intact and undamaged. The entire cab had extensive fire exposure and damage.

Figure 11. Upended striking train locomotive (BNSF 9159) modular operating cab.

The rear of the cab module abuts the electrical locker. The general condition of the electrical locker indicated that it had been subjected to severe longitudinal forces, and it was crushed at the upper right side. The locker became separated from the floor mounting system and was pushed back more than 2 feet.

The interior of the cab was severely damaged by fire.¹² The general condition of the modular cab attachment fixtures indicated that they had been subjected to severe vertical forces and shear. The rear posts were broken along the welds that hold the cylindrical posts to the deck. The forward-mounted floor brackets had indications of deep scoring on the inboard sides in a manner consistent with vertical loading. The modular cab assembly was examined, revealing the remaining volume of survivable space to be an estimated 65 cubic feet. Both the engineer's and the conductor's sides of the cab were severely damaged and burned. The engineer's seat was sheared from the floor mounts, and the control panel was bent downward and inward. The conductor's seat remained attached, and the desk area was crushed toward the floor.

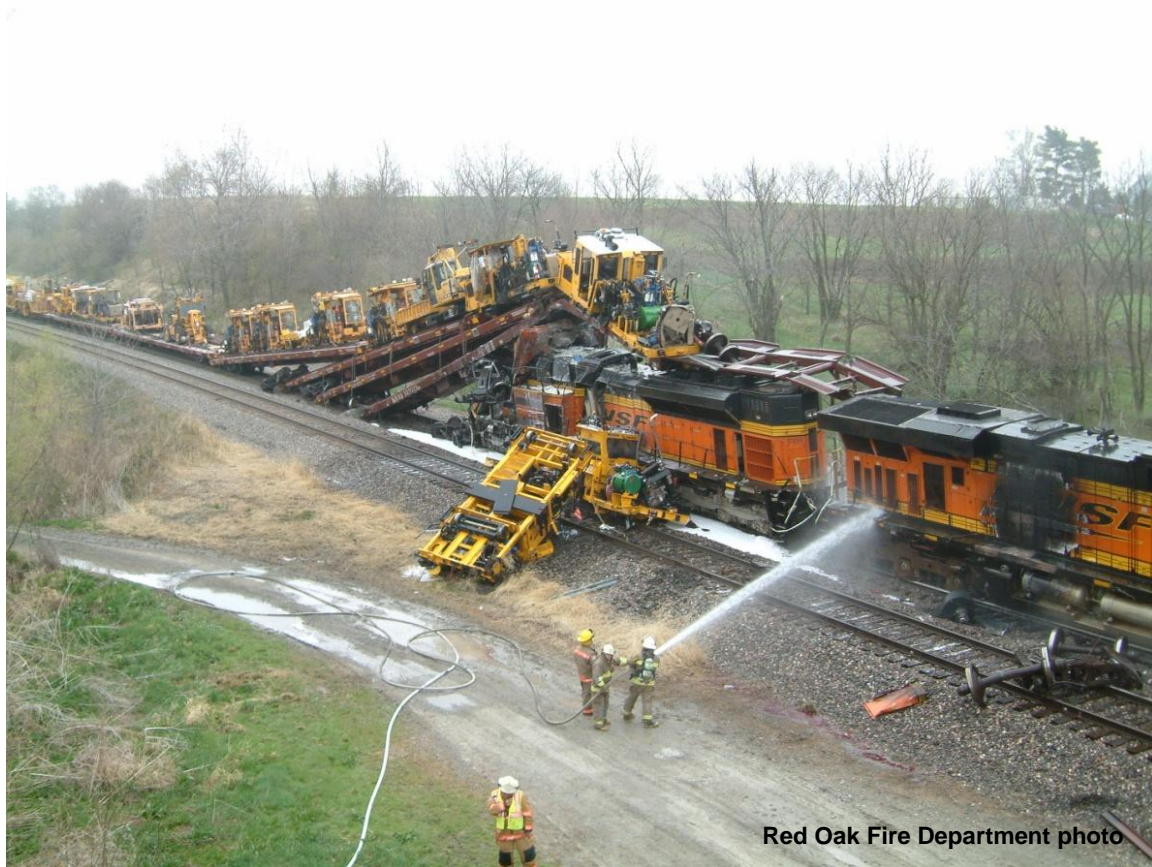
The IC reported that it took about 2 hours to fully extinguish all the fires. Fire suppression began about 7:15 a.m., using 50 gallons of class A foam³⁰ at 1.5 percent concentration. (See figure 22.) A supply of class B foam arrived on scene about 30 minutes into the response, and 150 gallons were consumed at 3 percent concentration. Fire suppression was complete about 9:15 a.m.

Figure 22. Red Oak Fire Department applying foam after collision.
