Crash During Experimental Test Flight  
Gulfstream Aerospace Corporation GVI (G650), N652GD  
Roswell, New Mexico  
April 2, 2011

NTSB/AAR-12/02  
PB2012-910402

# Aircraft Accident Report

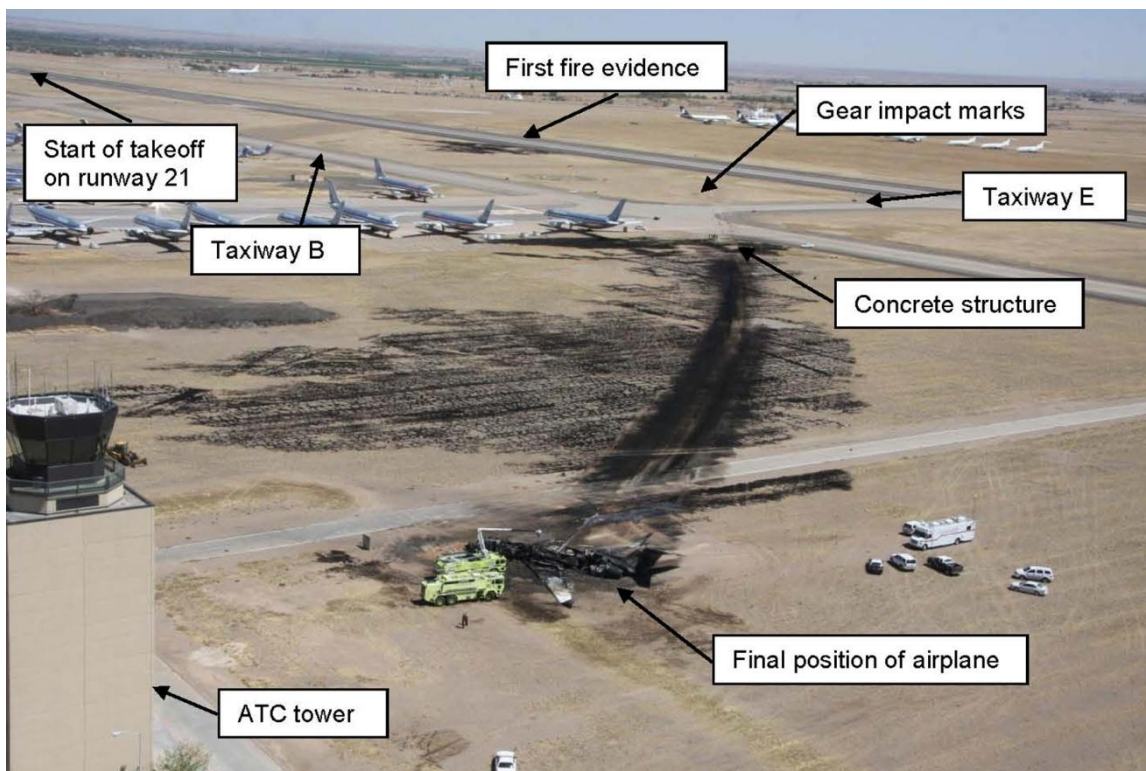
**Figure 4.** Aerial view of wreckage path.

Recorded flight data and ground scars and markings on the runway and airport property indicated that, shortly after rotation, the airplane's right wing contacted the runway. The airplane subsequently yawed to the right, departed the right side of the runway, traveled along about 3,000 feet of airport property, and came to rest about 8,404 feet from the runway 21 threshold and 1,949 feet to the right of the runway centerline. Figure 4 shows the airplane's wreckage path and final position.

The airplane continued through the taxiway intersection and into a grassy area where the airplane impacted a runway boundary and taxiway location sign and a concrete structure (used for underground electrical access) located about 1,000 feet from the runway 21 centerline. Impact with the concrete structure caused extensive structural damage to the center wing box, including rupture of the fuel tank. Gulfstream personnel in the telemetry trailer observed black smoke and fire coming from the airplane after it hit this structure. The airplane also impacted an airport weather station, compromising the left wing fuel compartments. The airplane continued to slide until it came to rest about 300 feet from the ATC tower and on a heading of about 90° from the wreckage path.

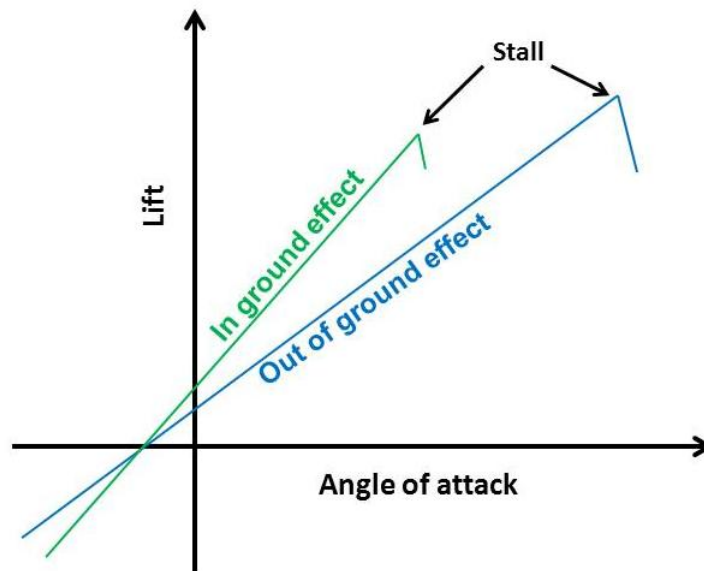
**Figure 5.** Airplane lift versus angle of attack in and out of ground effect.

As stated in section 1.1, ground effect refers to changes in the airflow over the airplane resulting from the proximity of the airplane to the ground. Ground effect results in increased lift and reduced drag at a given AOA as well as a reduction in the stall AOA; thus, the stall AOA is lower for airplanes in ground effect compared with the stall AOA for airplanes in free air (out of ground effect). Ground effect decreases as the distance from the ground increases and is generally negligible above a height equivalent to the wing span of the airplane (which is about 100 feet for the G650). Figure 5 depicts the changes in the airplane's lift and stall AOA due to ground effect.

Gulfstream's postaccident CFD analysis also indicated that the decrement for the in-ground-effect stall AOA at flaps 10 (the accident flap setting) was as much as 3.25°, which was about twice the 1.6° estimate that Gulfstream was using at the time of the accident.<sup>72</sup> The NTSB concludes that, if Gulfstream had performed an in-depth aerodynamic analysis of the cause of two previous G650 uncommanded roll events, similar to the analyses performed for roll events during previous company airplane programs, the company could have recognized that the actual in-ground-effect stall AOA for the accident flight test was significantly lower than the company predicted.
