National Transportation Safety Board

Alagasco Natural Gas Release with Ignition, Birmingham, Alabama

Operations Group Factual Report

DCA-14-MP-001

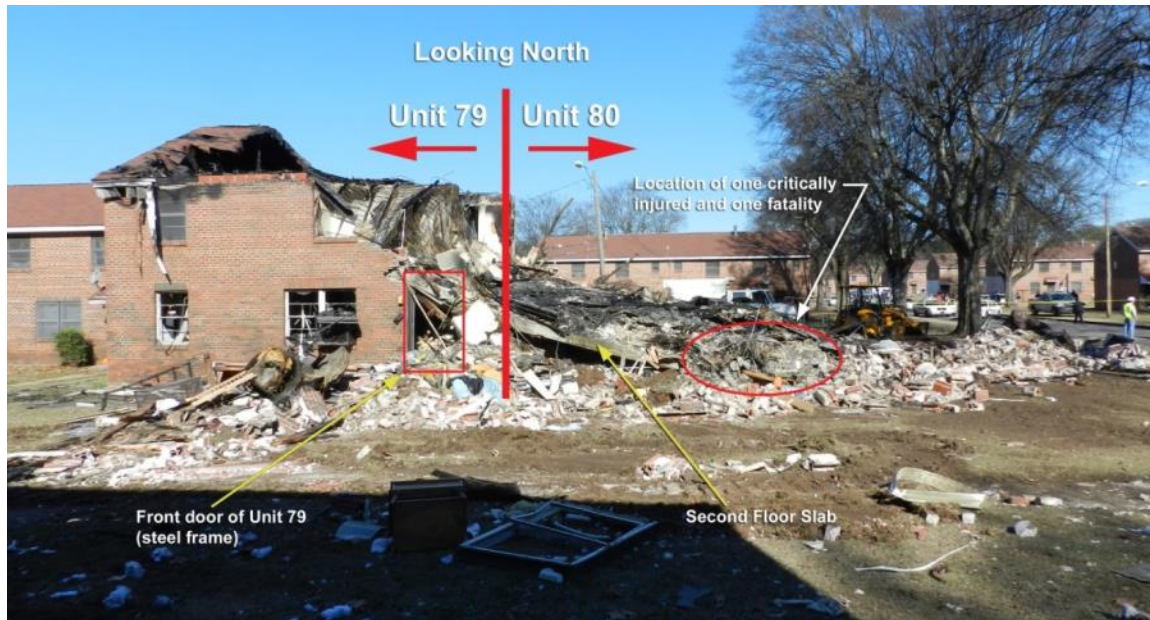
Figure 1: Collapsed Units 79 and 80 apartments in Gate City Community.

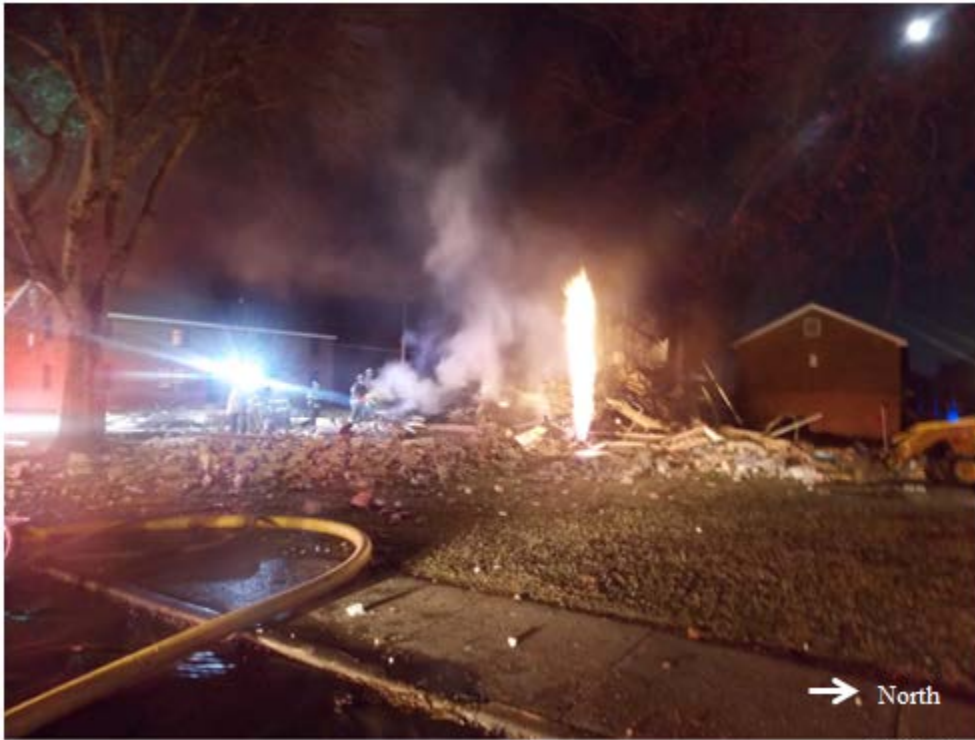
Figure 3: Destroyed Unit 80 with burning gas from the service riser and construction backhoe.³² Source: Alagasco emergency response.

During the gas emergency situations Alagasco could not locate to operate the installed curb or maintenance valve required by Federal regulations. Figure 3 shows the incident unit riser valve fire that burned because the gas service curb valve or an alternative valve was not located. The Federal regulation requires that distribution system be equipped with valves as stated below:

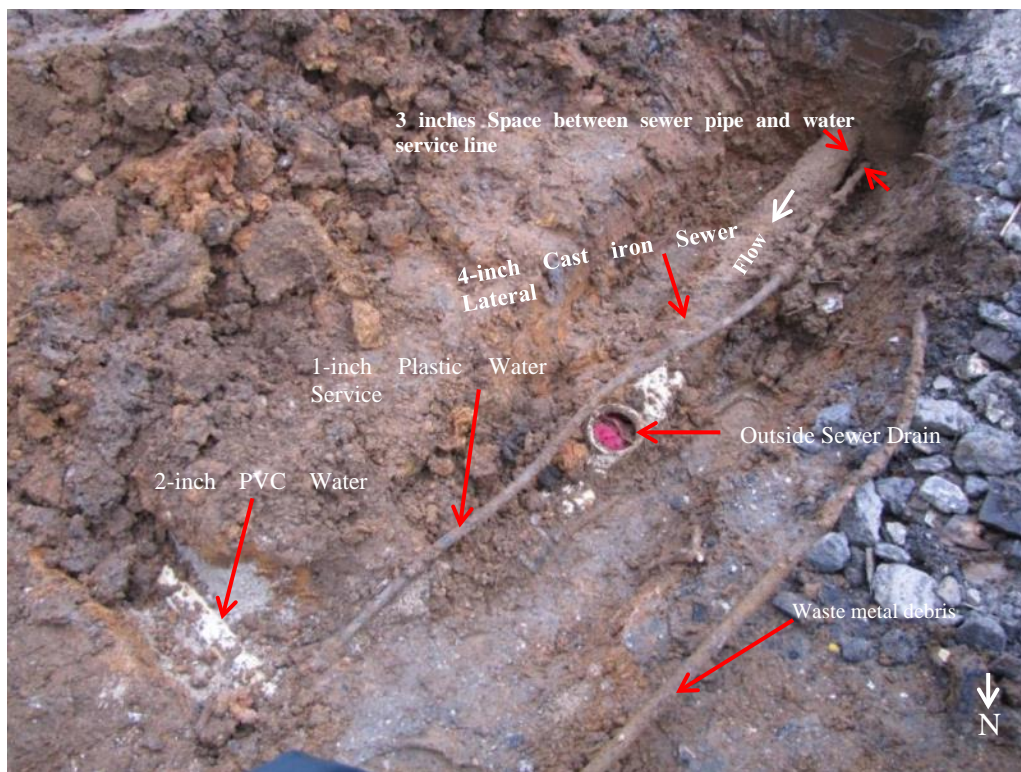
Figure 5: East side 2-inch PVC water main, 4-inch sewer lateral and a cleanout, and 1-inch plastic water service.

The excavation in Figure 5 revealed that the 2-inch PVC water main pipe was above the Terracotta section of the 4-inch sewer lateral. The water main pipe was backfilled with sand along the exposed trench. The 4-inch sewer lateral of cast iron construction exited the Unit 80 foundation wall and transitioned to PVC pipe and sloped to the Terracotta pipe where it then turned north.

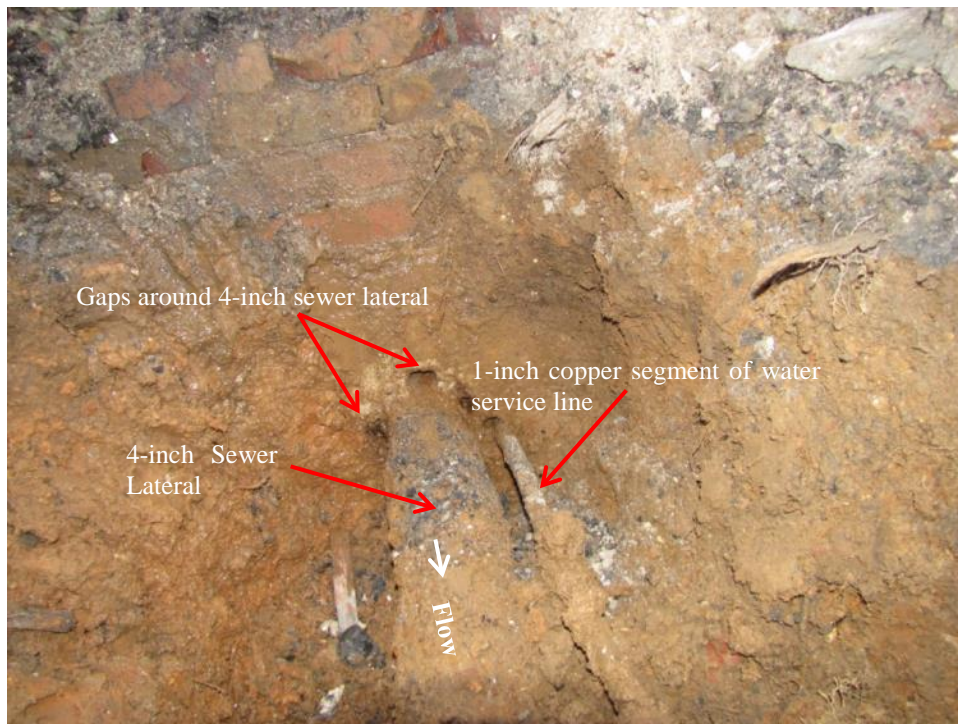
The east foundation wall of Unit 80 is where the sewer and water service pipe shown in Figure 6 entered the dwelling about 12 inches below grade. Openings were observed around the pipes at the entrance into the foundation wall.

Figure 6: Utilities enter at east foundation wall to Unit 80 containing opening.

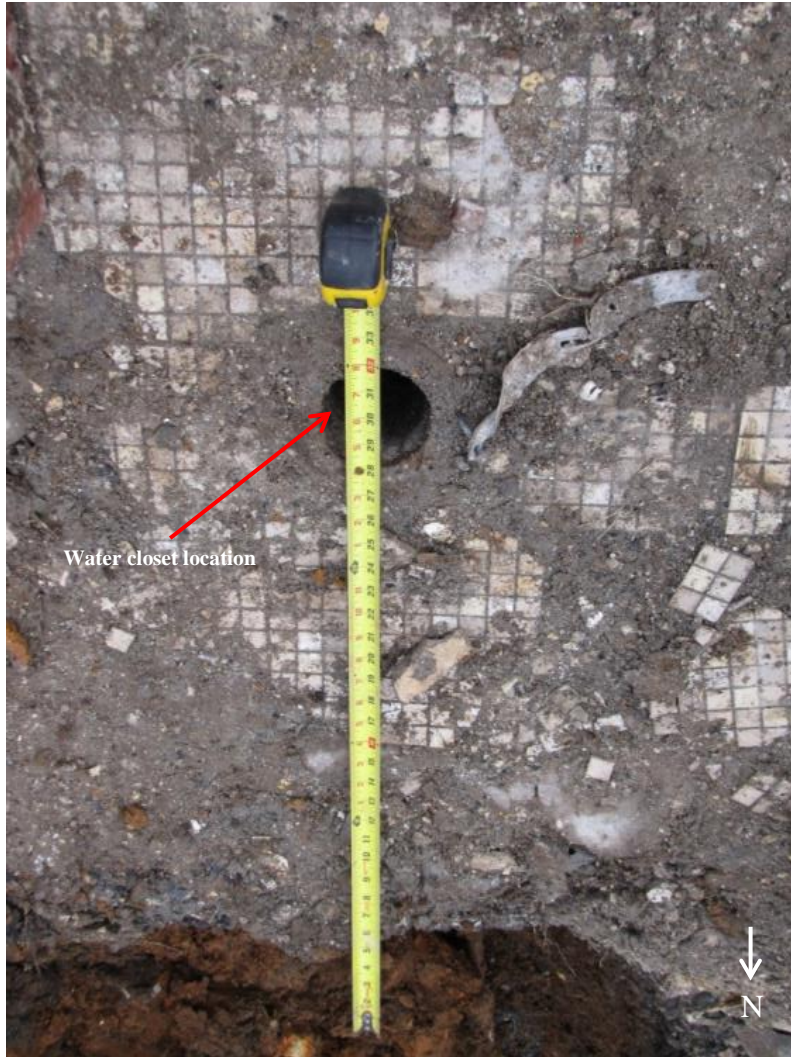
Figure 7: Water closet drain is positioned about 30 inches from east foundation wall of Unit 80.

The dedicated water closet sewer drain Figure 7 for Unit 80 that serviced the first floor was located about 10 feet south of the 2-inch PVC water main pipe or about 30 inches from the east foundation wall corner.

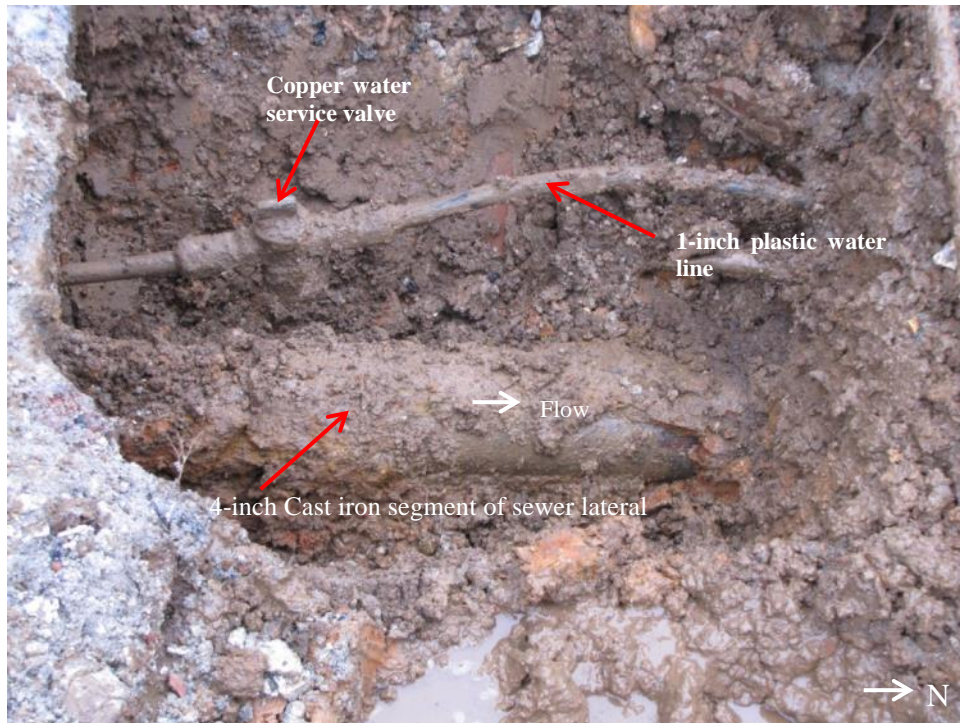
Figure 8: West foundation excavation with 4-inch sewer lateral and 1-inch water service.

Figure 8, the west end of Unit 80 excavations shows a 1-inch plastic water service line and a 4-inch sewer lateral. Both of these utilities were shared by the two adjacent units 79 & 80 to service part of the first and second floors of the apartments. The utilities entered at the point of the dividing wall between the units and about 29 feet from the east end services entry to Unit 80.

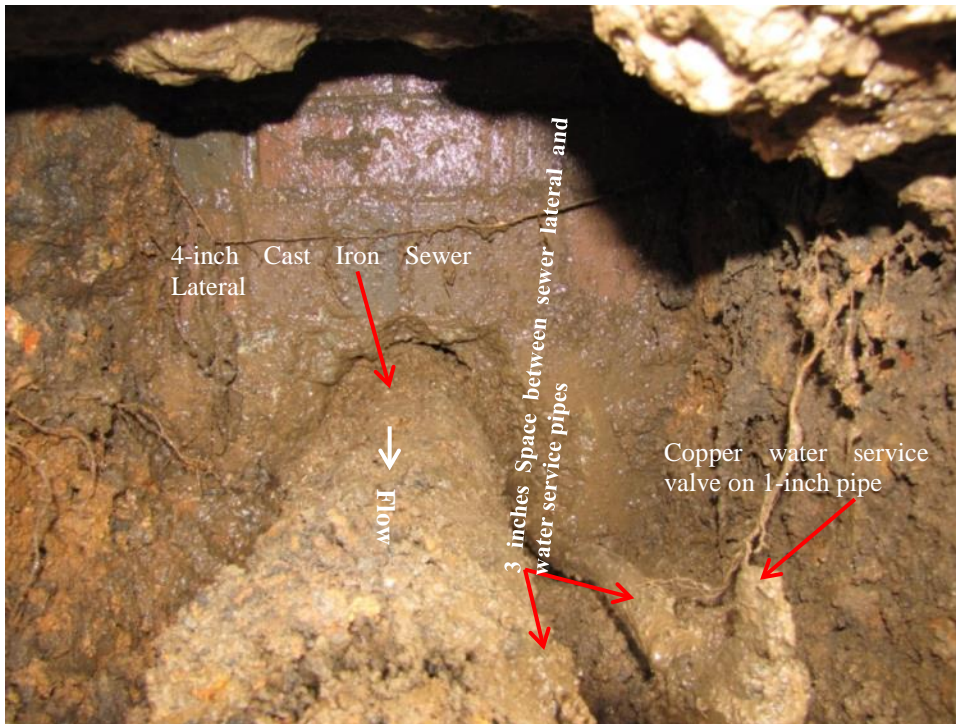
Figure 9: Entry of the west side 4-inch sewer lateral and 1-inch water service line serving Unit 79 and 80 looking south.

Figure 9 above shows the 4-inch sewer lateral passing through the foundation wall openings under the slab. This pipe also entered the wall with about 3 inches clearance from the 1-inch plastic water service pipe to its right (west side) similar to the east end utilities entries of the unit.

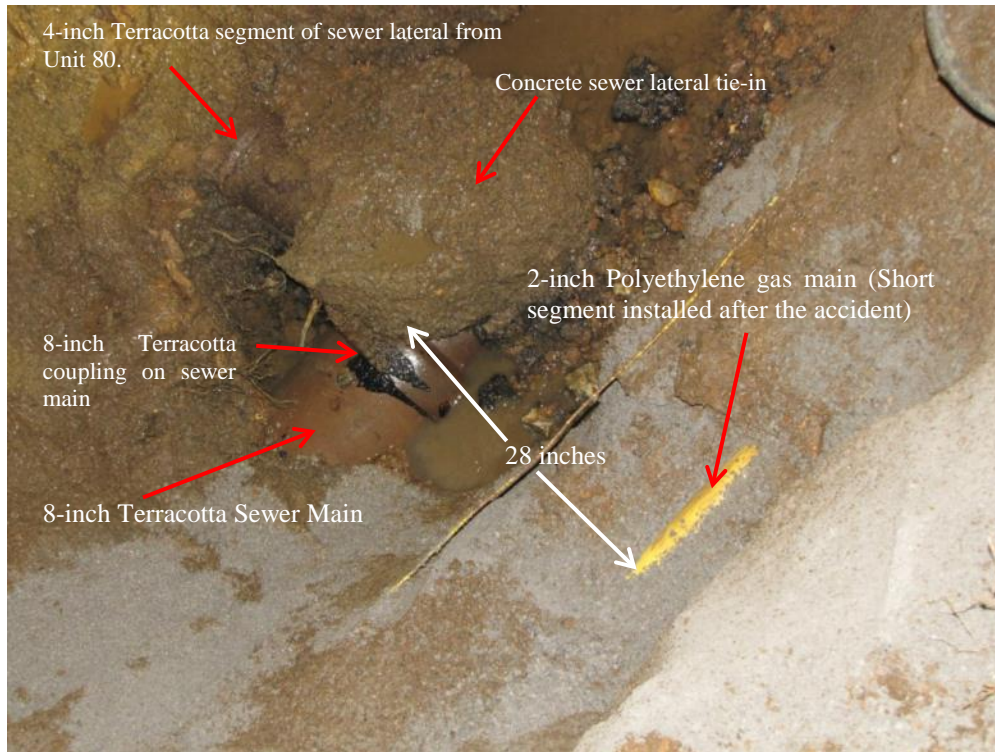
Figure 10: Tie-in for 4-inch east end sewer lateral to 8-inch sewer main with concrete and newly installed 2-inch polyethylene gas main segment.

Figure 10 above shows the east side 4-inch sewer lateral to Unit 80 that ran south to north and tied in with concrete to the 8-inch sewer main that ran east to west and perpendicular to the lateral. The sewer main also ran parallel with the newly installed section of 2-inch polyethylene gas pipeline that replaced the cracked 2-1/4-inch cast iron main located about 47 feet from north foundation wall of Unit 80. The sewer lateral tie-in position mirrored the location of the cracked cast iron pipe which was positioned about 18 inches below and about 28 inches south of the gas pipeline.

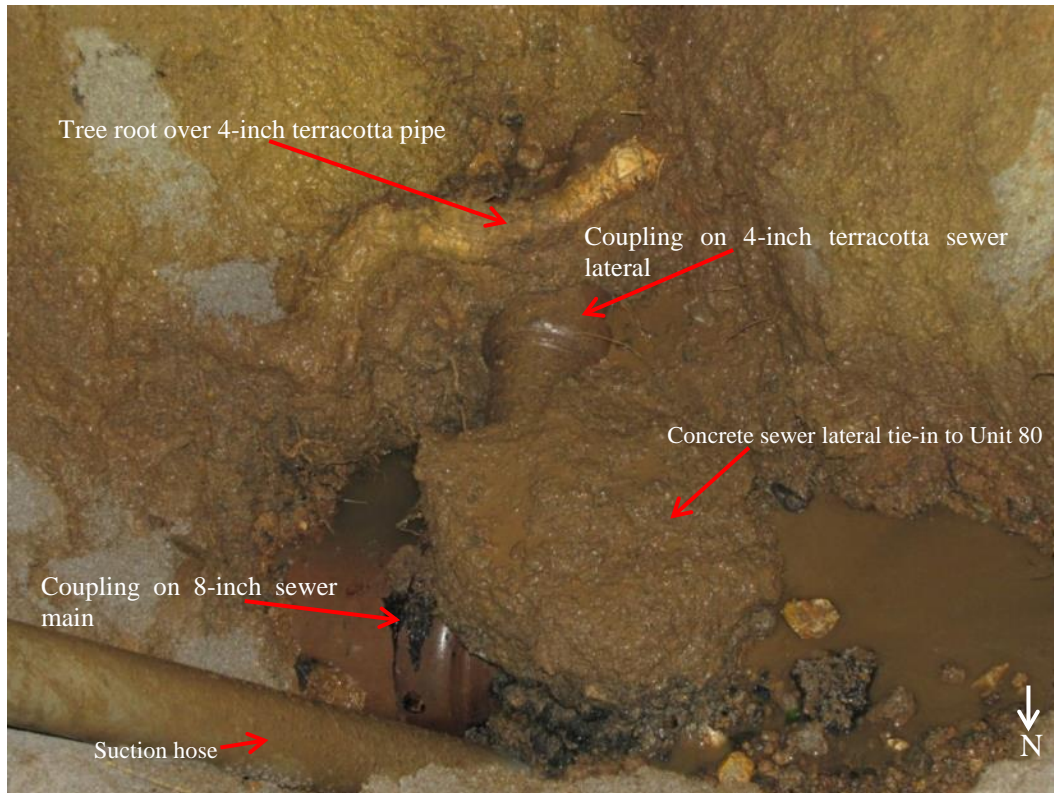
Figure 11: Two sewer couplings next to the east end sewer tie-in location of Unit 80.

Figure 11 shows the configuration of the 4-inch sewer waste connection from Unit 80 to the 8-inch sewer main. Note the mass of concrete at the location where the 4-inch sewer ties into the 8-inch sewer main. Approximately 2-1/2 inches tree root crosses about 6 inches from the male and female south facing lateral connection (Figure 12). The 8-inch sewer main male and female coupling was positioned directly beneath the concrete bond and showed indications of a black coal-tar-like compound around it (Figure 13).

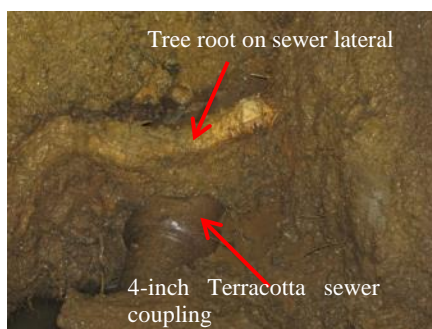
Figure 12: 4-inch sewer lateral, male and female coupling with tree root crossing over it.

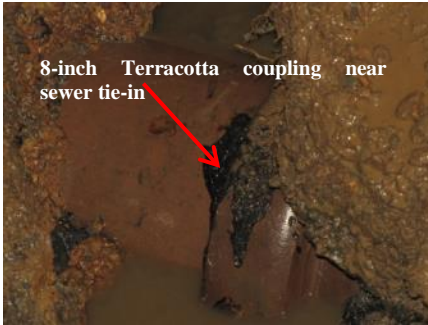
Figure 13: 8-inch male and female sewer main coupling with coal tar coating.

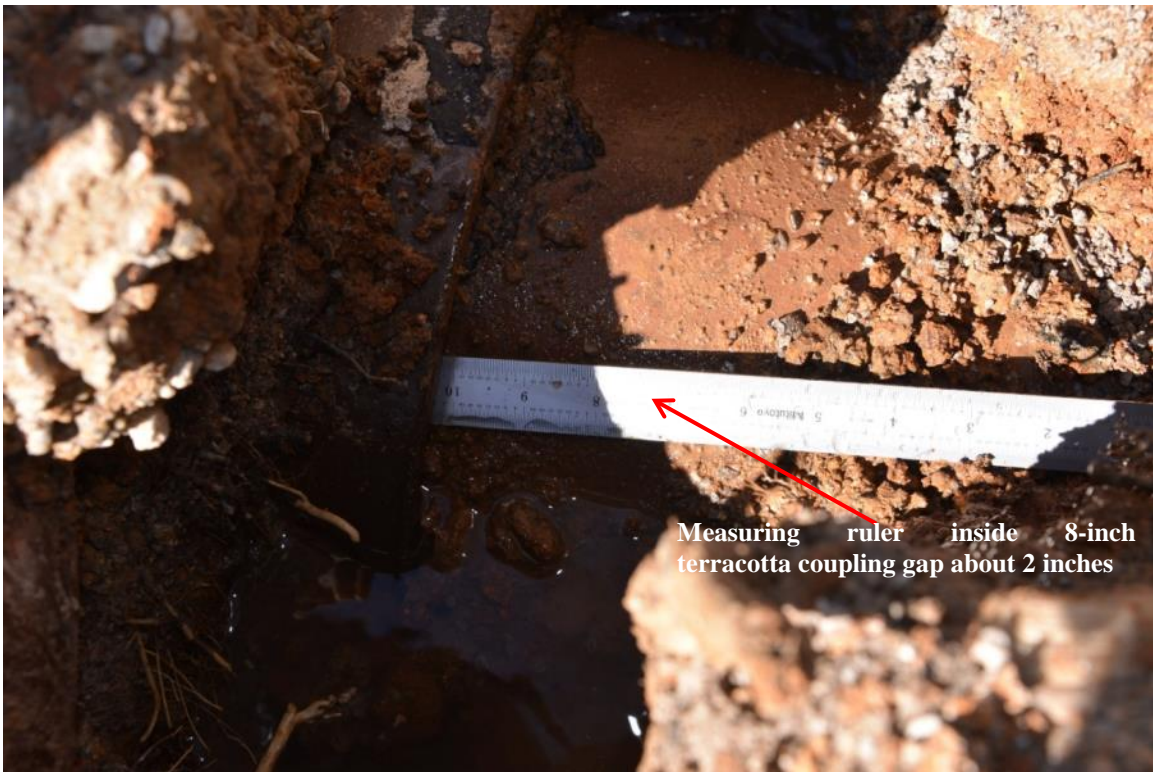
Figure 14: 8-inch sewer main with gap in the coupling. Source: HABD Insurance Forensic Excavations.

Figure 14 above, is a view of what is shown in Figure 13 but captured from different angle. During the HABD insurance forensic excavations in February 2014, a ruler was inserted into the 8-inch coupling where the compound used to join the coupling to the piping, the joint was not intact. The absence of a properly sealed joint presented a possible source of natural gas ingress and sewer content egress of the 8-inch sewer main and 4-inch sewer lateral tie-in.

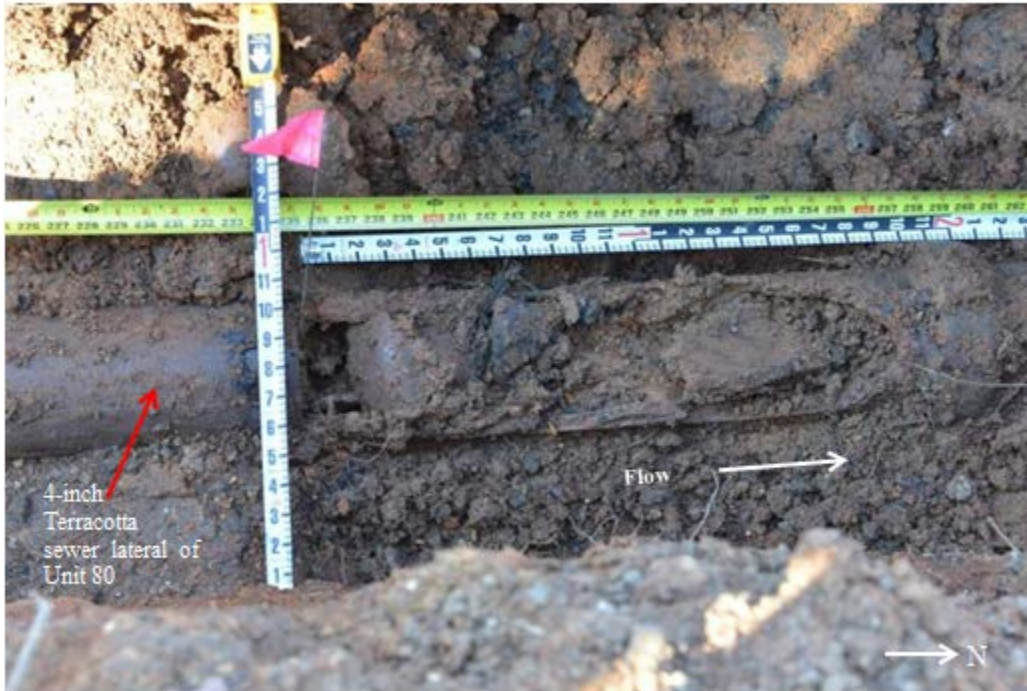
Figure 15: Measured damage section on the 4-inch" east end sewer lateral to Unit 80.
Source: HABD Insurance Forensic Excavations

Figure 15 shows the condition of the 4-inch Terracotta sewer laterals on the east side of Unit 80 that were located about 20 feet from the foundation wall. This picture was taken during an HABD insurance forensic excavation in February 2014. According to the NTSB investigator on site at the time of this February 2014, field activity, the sewer lateral exposed in the trench contained broken and damaged sections about 20 inches in length with pieces missing.

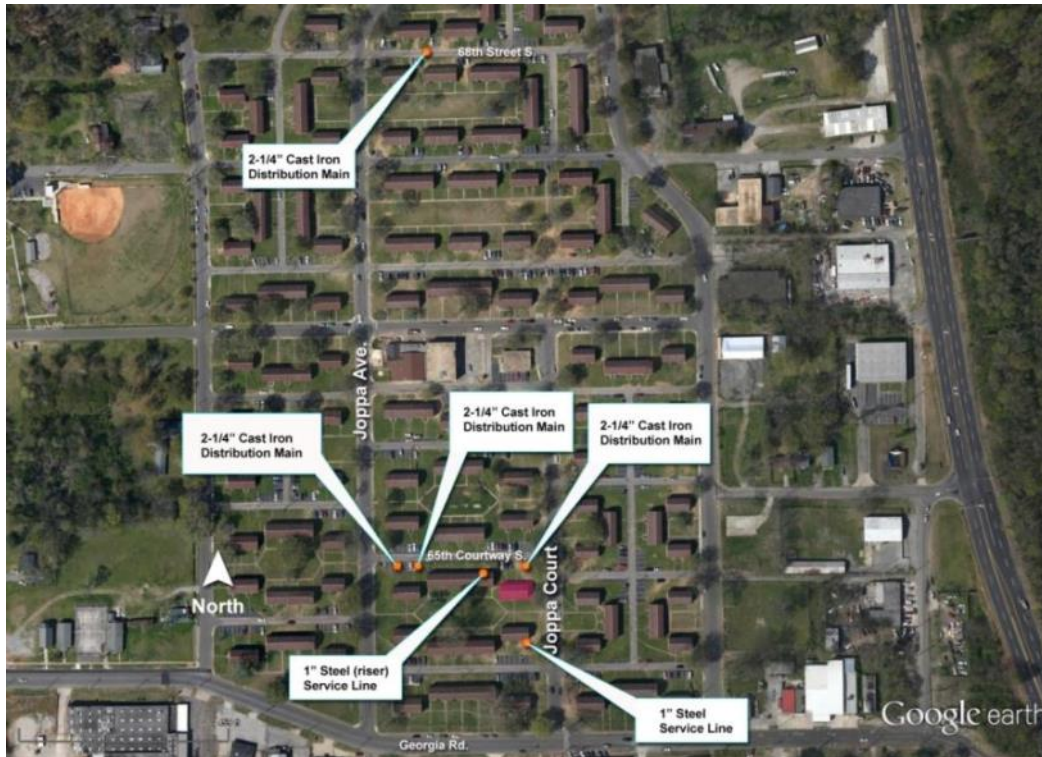
Figure 16: Locations of leaks discovered during post-accident survey near the accident site indicated in red.

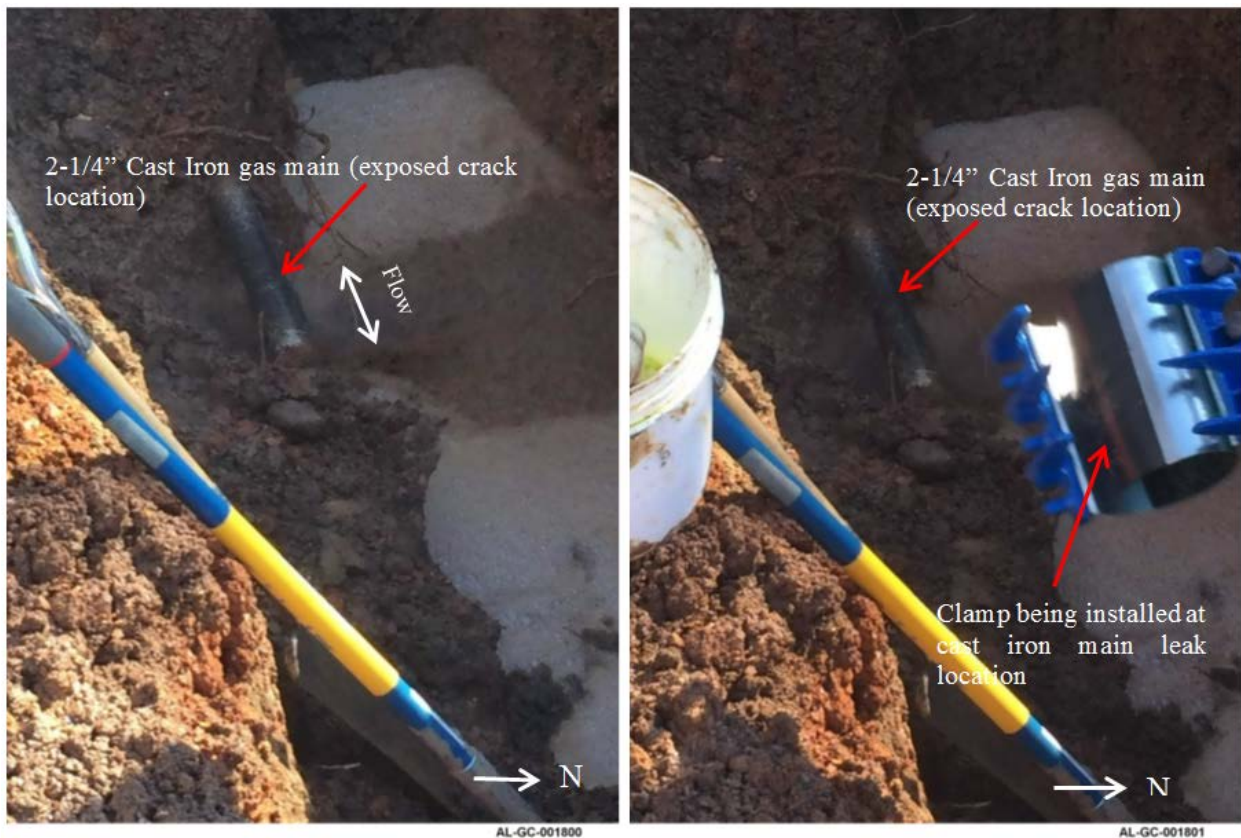
accident scene. Crews noticed bubbles near the road curb on the northeast side of the apartment. Digging revealed a 2-1/4-inch circumferential cracked cast iron distribution main.³³

³³ According to Alagasco "a tree root wrapped around it. Wedged between the tree root and the cast iron pipe was a rock, and directly across from the root/rock a crack was found."

Figure 17: The cleaned cracked location on the 2-1/4-inch cast iron main opposite Unit 80 prior to being clamped. Source: Alagasco

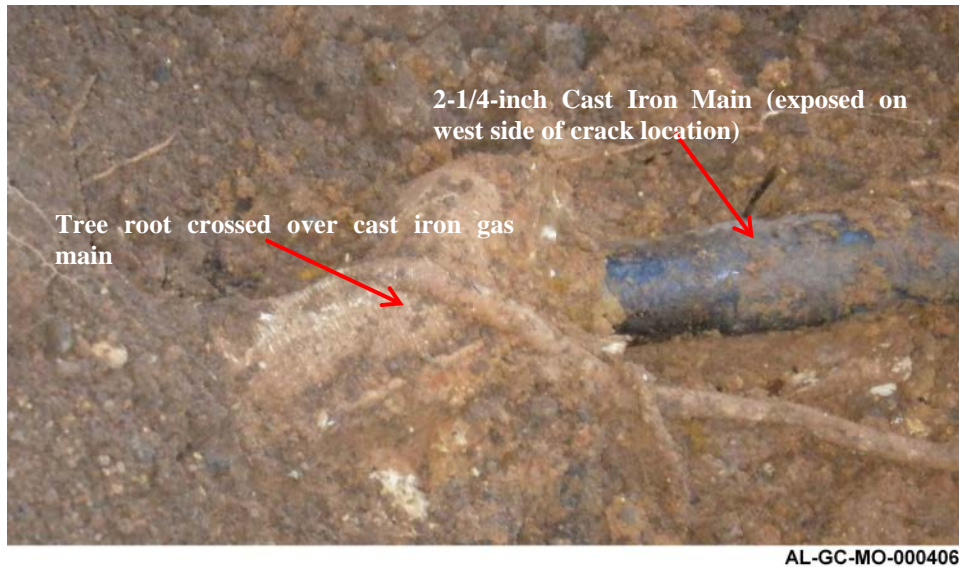
The 10 year leak data for the Gate City indicates there were few leaks previously repaired including along 64th Courtway South on the gas main.⁷⁵ Figures 18 and 19 shows root growth from a nearby tree east of the incident pipe. The 2-1/4-inch cast iron pipe was found cracked west of this location. The tree root was cut and examined by the gas company personnel as shown in Figure 20.

Figure 18: Root crossing over 2-1/4-inch cast iron main about 4 feet east of the crack location opposite Unit 80. Source: Alagasco

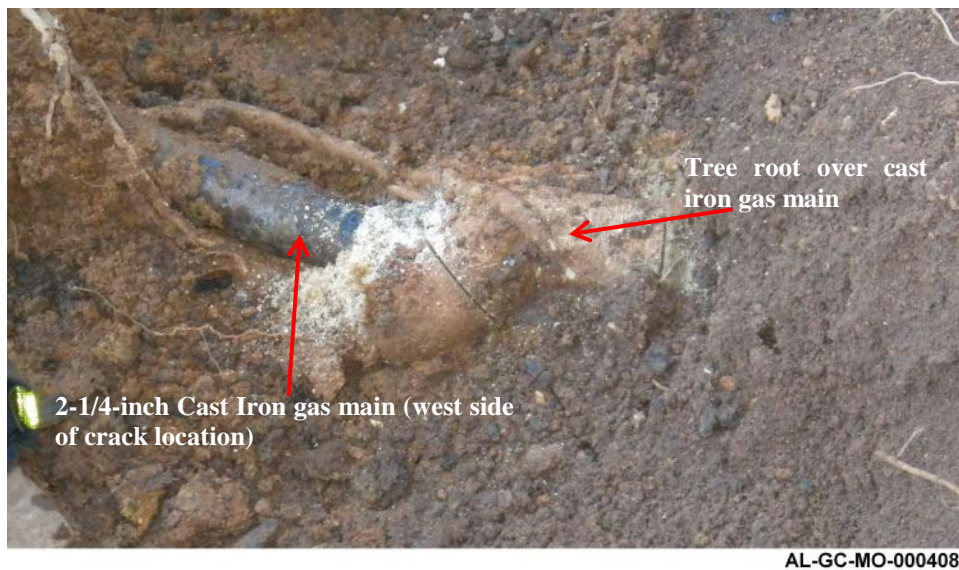
Figure 19: Tree root at the point of crossing 2-1/4-inch cast iron main opposite Unit 80. Source: Alagasco

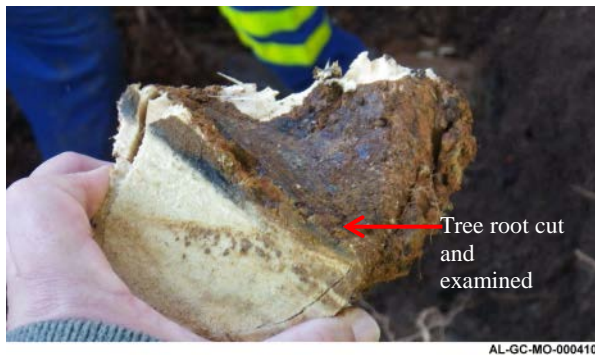
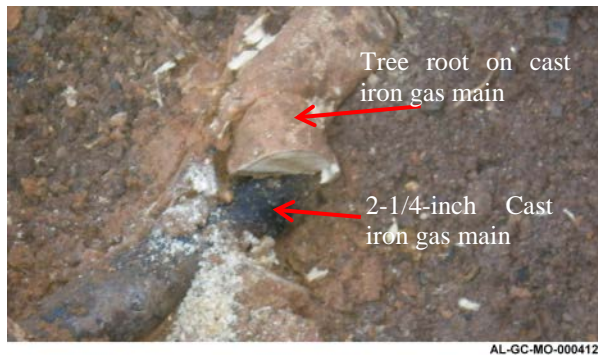
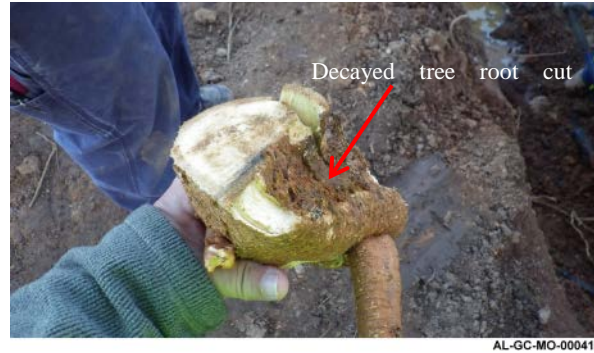
Figure 20: Surfaces of cut-out root where it rested on 2-1/4-inch cast iron main opposite Unit 80 (three photos shown). Source: Alagasco

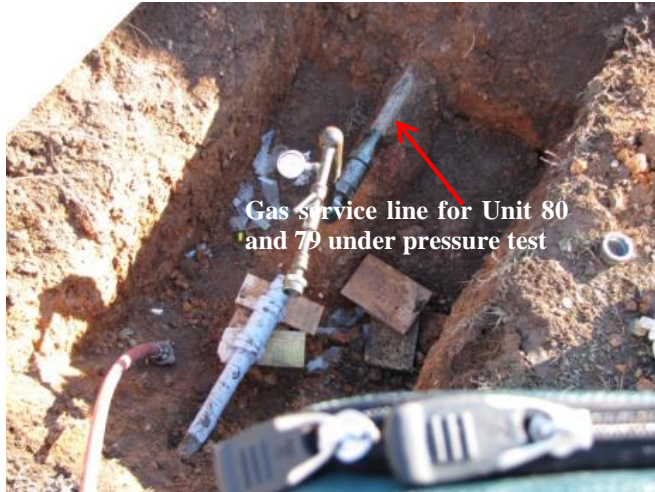
Alagasco on December 18, 2013 conducted a pressure test on the branched services to Units 79 and 80 (Figure 21). To facilitate this test the line was cut and tested at approximately 10 feet south of the 2-1/4-inch main and service tee connection. Both services were tested from this location down to their riser valves. Initial tests on these services detected leaks as observed from the pressure chart and pressure gauge used to monitor the test. A leak was detected at the riser valve outlet on up to the exploded Unit 80. A consensus of those conducting the test was reached where it was decided to remove the unit riser valve and cap it. This eliminated the leak and the pressure test conducted at operating pressure held. These tests were witnessed by the NTSB and Alabama Public Service Commission (ALPSC).

The steel service pipeline segment was cut at approximately 10 feet south of the 2-1/4-inch cast iron main, capped off and soap tested. No leaks were discovered by the leak test technicians in both the pressure gauge and the pressure test chart used as the second indicator of pressure test record; it marked-out indicated a stable pressure test result that started at 20 psig and remained at 20 psig at the end of the pressure test confirming no leak in the pipe. This location was where the branched service was isolated from the main after the riser valves were shut off during the emergency situation.

Figure 21: Gas flow isolation point where pressure tests of the branched services of Units 79 and 80 measured by pressure gauge and recorded on pressure chart.
