Highway-Railroad Grade Crossing Collision
Commerce Street
Valhalla, New York
February 3, 2015

NTSB/RAR-17/01
PB2017-102658

Railroad Accident Report

Abstract: On February 3, 2015, at 6:26 p.m., a vehicle driven by a 49-year-old woman, traveled northwest on Commerce Street in Valhalla, New York, toward a highway-railroad grade crossing. The driver entered the boundary of the grade crossing and stopped. The driver then moved beyond the boundary and stopped adjacent to the railroad tracks. The grade crossing warning system activated and the gate came down, striking the rear of the vehicle. She exited her vehicle, examined the gate, then returned to her vehicle and moved forward on to the tracks. Meanwhile, a Metro-North Railroad train approached the grade crossing. The engineer activated the emergency brakes and collided with the vehicle at 51 mph. The train and the vehicle continued north, damaging the electrified third rail which pierced the vehicle and penetrated the lead railcar. Five passengers died and nine passengers and the engineer were injured, all in the lead railcar. The driver of the vehicle also died. The NTSB made new recommendations to the Federal Transit Administrat

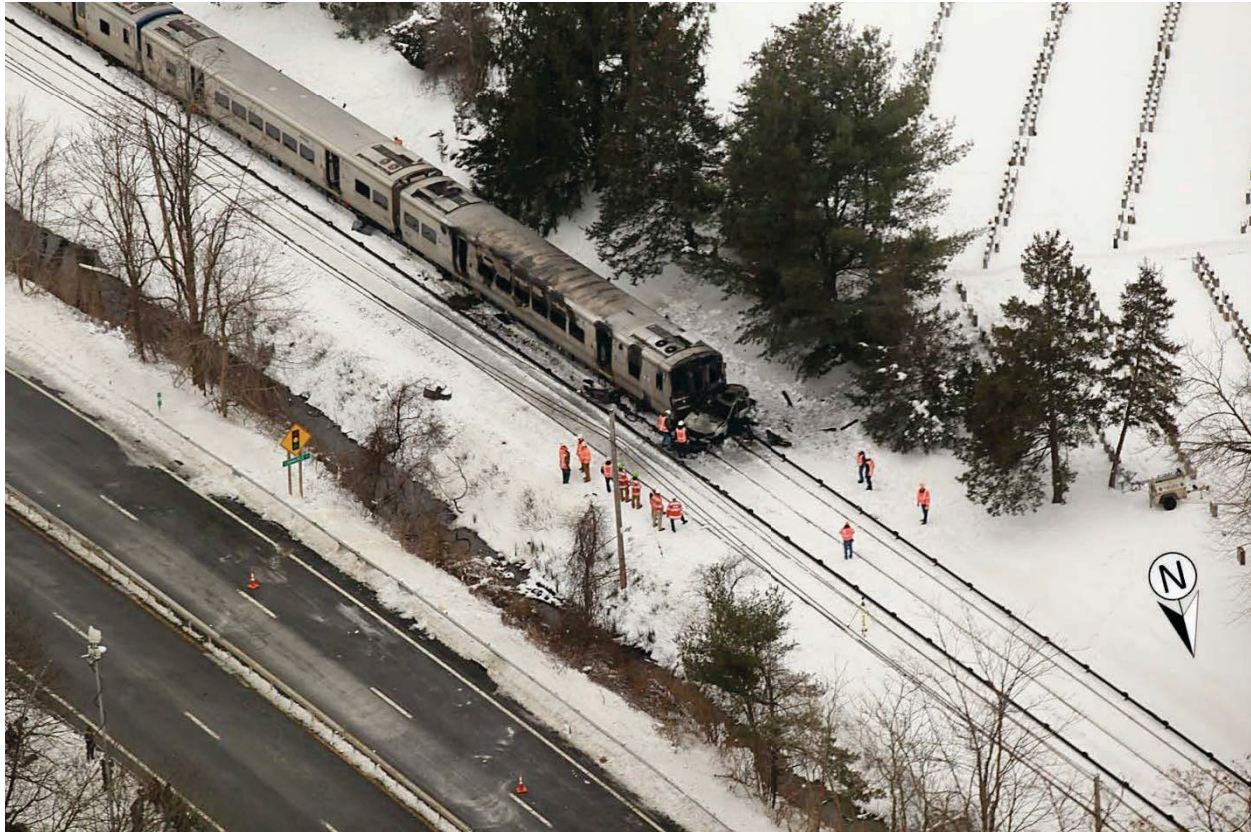
Figure 1. Metro-North train 659 on track 2 after collision with the SUV.

Metro-North train 659 was traveling north on track 2 toward the Commerce Street grade crossing when it struck the SUV on its passenger side door and pushed it about 665 feet north on the tracks before stopping. During the collision, the electrified third rail first pierced the SUV on its left side under the rear passenger seats, then pierced its fuel tank, and subsequently exited the SUV on the right side, below the frame and behind the right-side rear wheel. As the train and SUV continued to move, the rail was shoved under the left-side front portion of the lead railcar, and subsequently penetrated it from the underside in two locations near the left-side front passenger doorway. (See figure 2.)

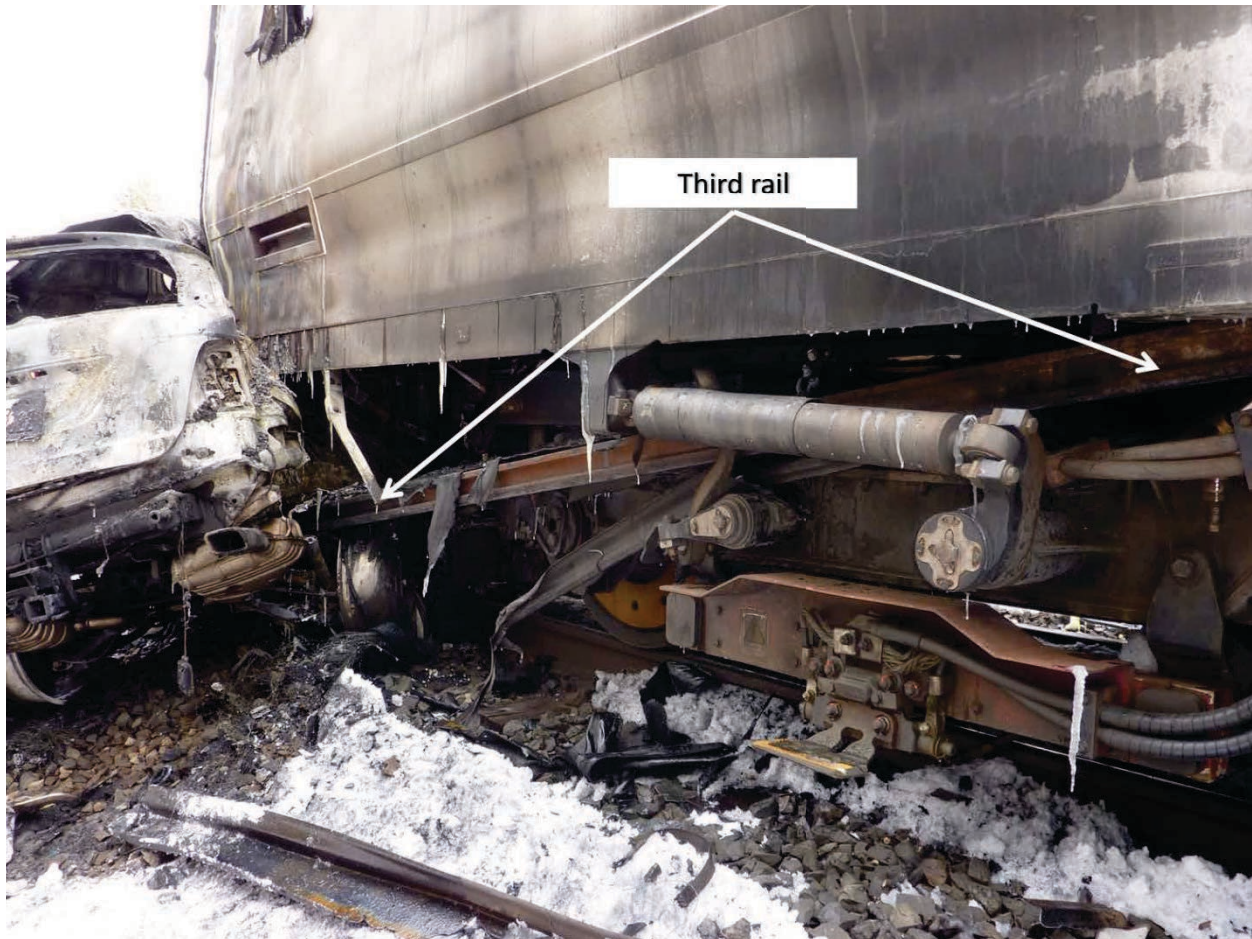
Figure 2. Photograph of the SUV and Metro-North train 659 after the collision.

An estimated 386 feet of third rail was damaged, including 11 sections totaling about 343 feet that penetrated the passenger compartment of the lead railcar. A fire ignited that consumed both the SUV and the interior compartment of the lead railcar. (See figure 3.)

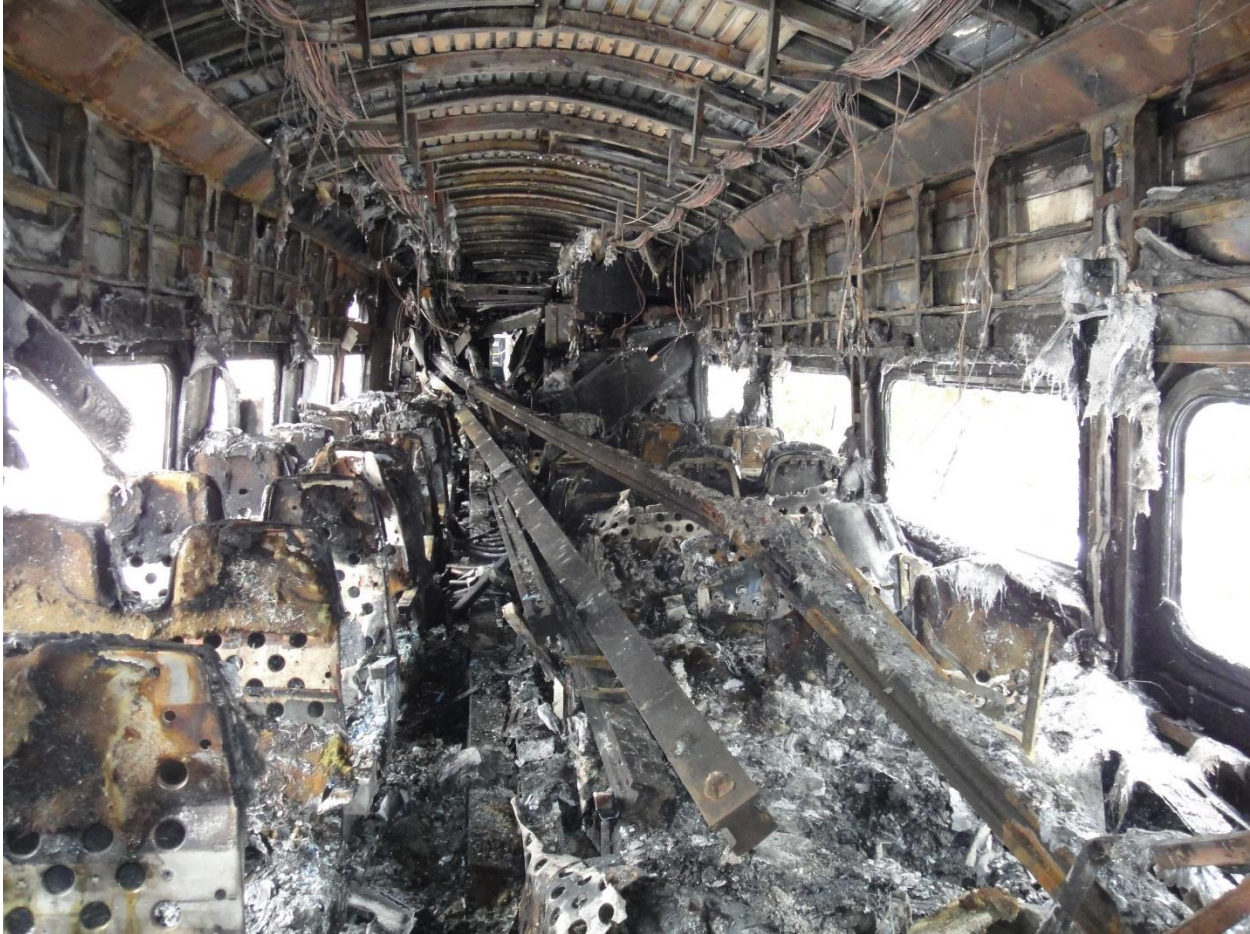
Figure 3. Postaccident photograph of the interior of the lead railcar.

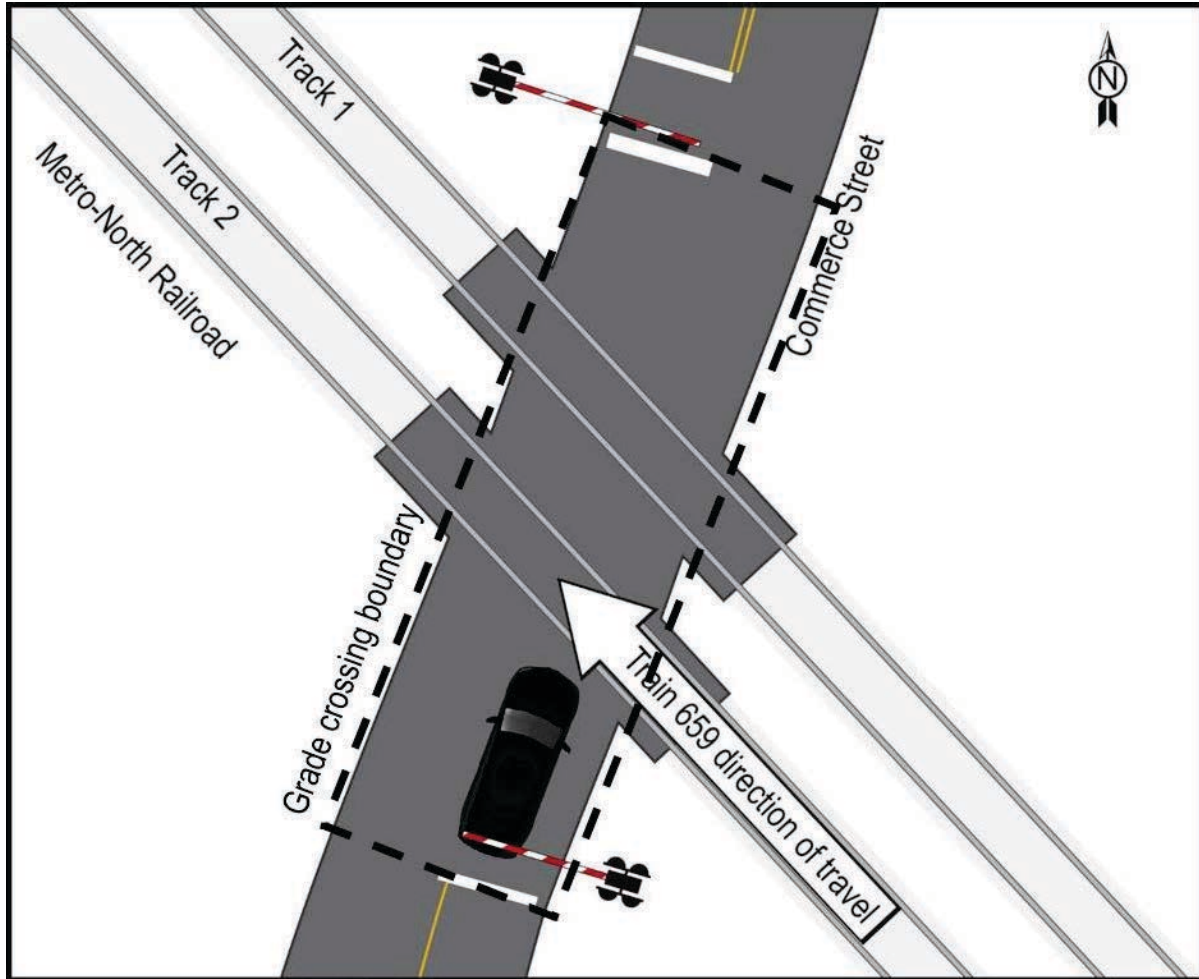
sitting within the boundary of the grade crossing when the warning system at Commerce Street activated. (See figure 5.)

Figure 5. Illustration of the grade crossing with the gate arm on the rear of the SUV. (Not to scale.)

Investigators asked the witness if the gate arm struck the SUV while it was moving; he answered, “No; it [the SUV] was stopped.” According to the witness, the gate arm lowered on to the rear portion of the SUV. The witness said he looked in his rearview mirror, saw no vehicles behind him, and backed up his vehicle, believing the SUV driver would do the same. The witness said that after he backed his vehicle up about one car-length, he saw the driver of the SUV exit the vehicle, slowly walk around to the rear of the SUV, and touch the gate arm. He characterized the driver’s behavior as calm, and presumed it was because the SUV was not on the track. He said that the front of the car was “just barely making it,” and he believed that the front of the SUV was very close to—but not on—the railroad track.

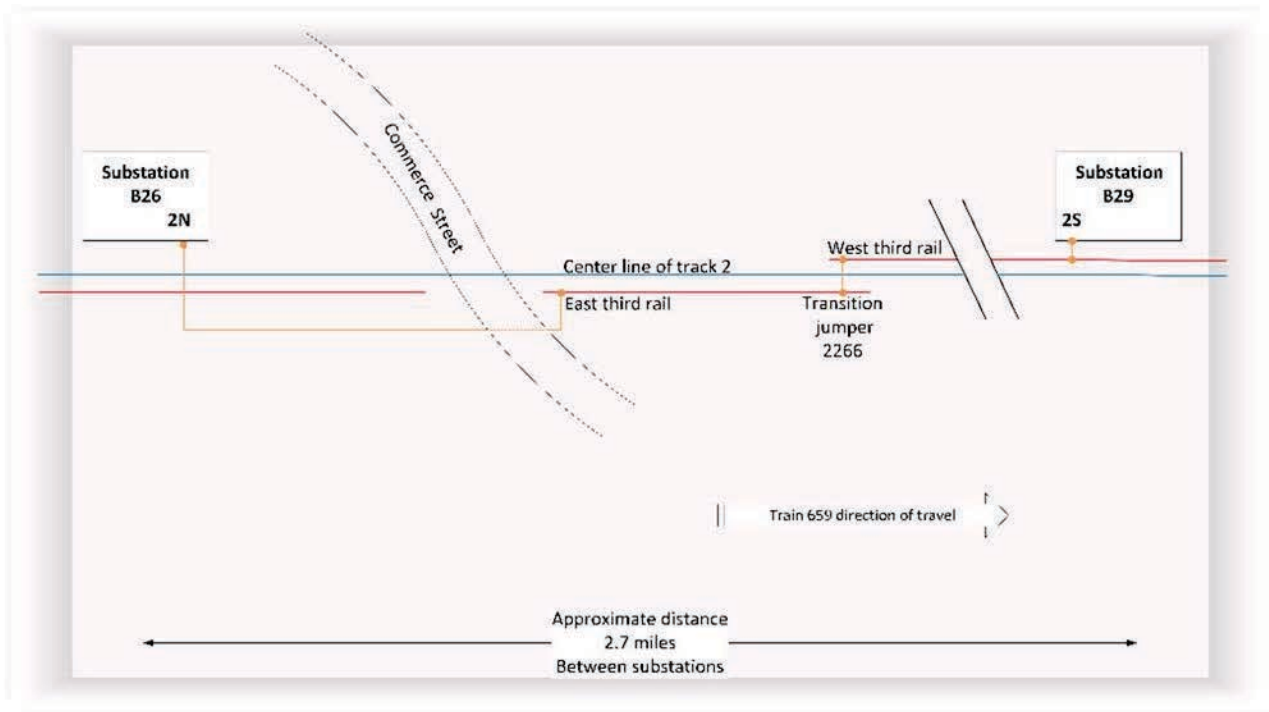
Figure 14. Simplified electrical schematic of traction power substations near Commerce Street. (Not to scale)

After the accident, as train 659 and the SUV continued to move north, they physically damaged transition jumper 2266, located about 300 feet north of the POC. (See figure 14.) The damage caused the east and west third rails to electrically disconnect from each other and isolated substation B26 electrically from the damaged west third rail.

As a result of damage to transition jumper cable 2266, the load measuring circuitry at substation B26 for the track 2 north circuit breaker was no longer detecting a fault on the east side of track 2 and re-energized. The reclose feature re-energized the east third rail at 6:26:28 p.m., 7 seconds after the circuit breaker tripped. This re-energized the last four cars of the train, which were contacting the east third rail.

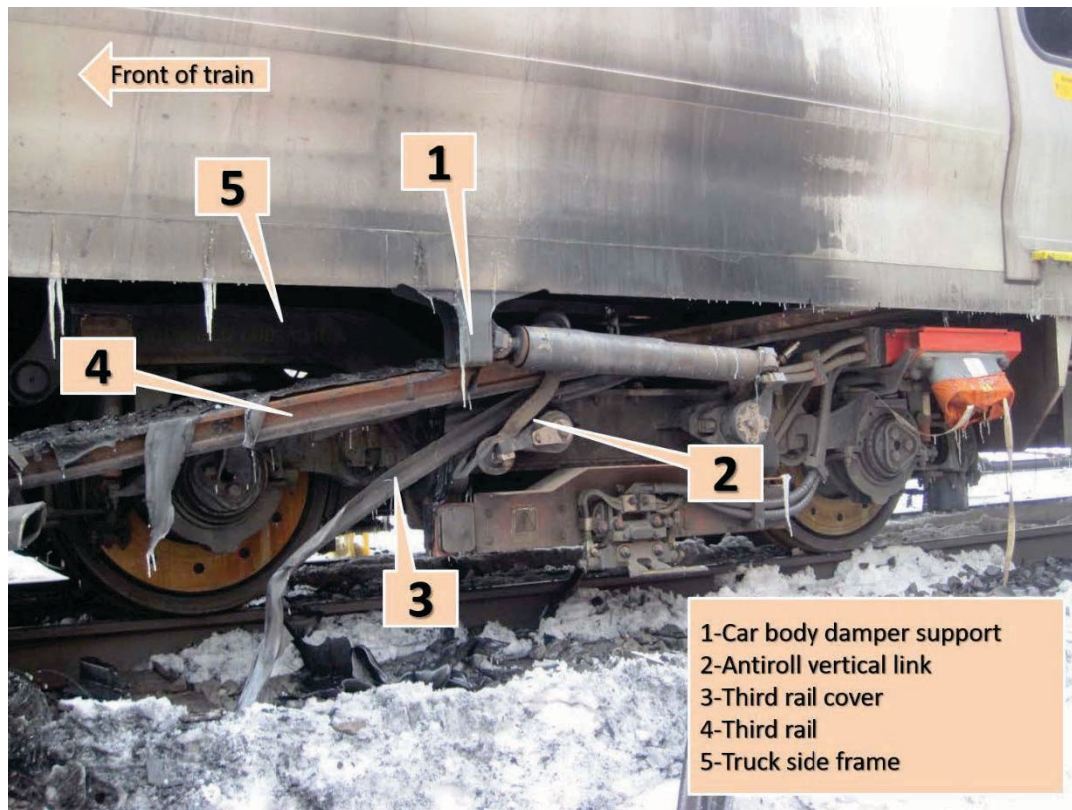
At the lead railcar, the third rail was forced between the left-side antiroll vertical link and the truck side frame assembly. (See figure 15.) Investigators found segments of burned third rail cover on top of the truck and the third rail. As the rail continued past the antiroll vertical link, it angled upward and made its first entry into the passenger compartment of the lead railcar, introducing sparks and flaming debris into the railcar, contributing to a fire, which will be discussed in section 1.8.3.

Figure 15. Path of the third rail entry into Metro-North 4333.

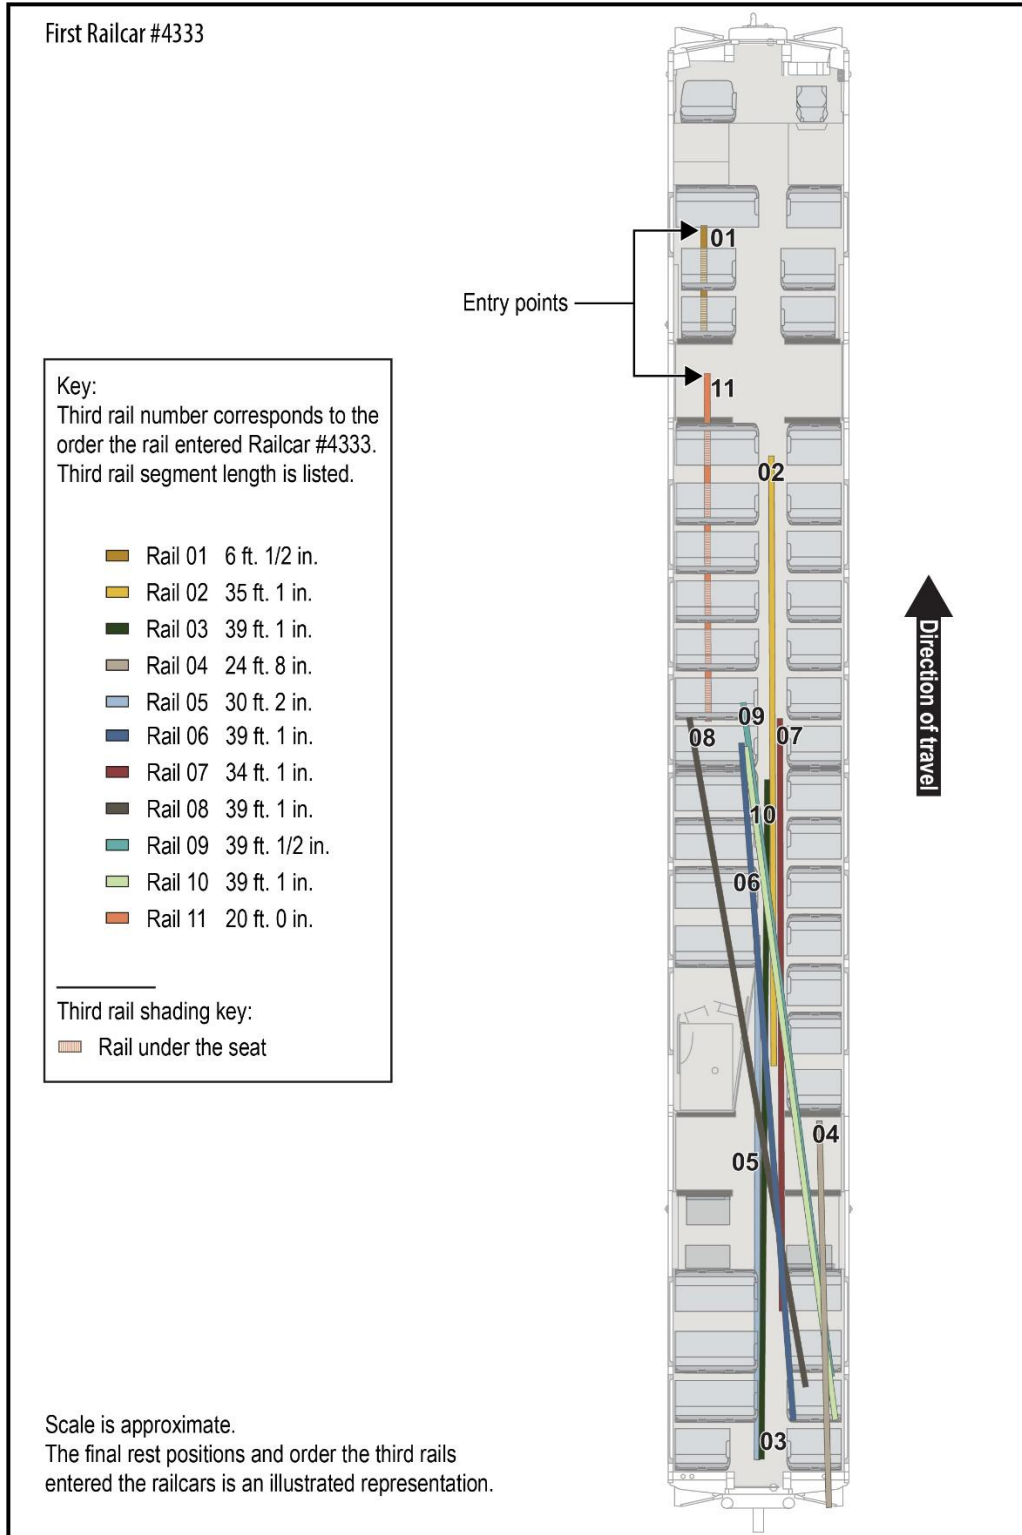
The third rail entered the lead railcar in two locations. One section of the third rail punctured a hole into the exterior subfloor under the railcar, about 8 feet from the left-side front corner of the car. (See figure 16.) This hole extended through the floor into the passenger compartment. In the interior of the railcar, the hole was located under the first row of passenger seats, behind the left-side electrical locker. At this location, the nose piece of the third rail, a segment about 6 feet-long, came to rest between the center hand holds of the second seat row.

The second entry point punctured the railcar's exterior subfloor near the left-side front passenger doorway, about 18 feet from the left-side front corner of the car. The third rail then continued into the interior of the car, under the first row of passenger seats behind the vestibule. Overall, 11 sections of third rail entered the lead railcar and came to rest in the passenger compartment. (See figure 16.)

Figure 16. Entry points and the approximate position of the third rail inside the lead railcar.

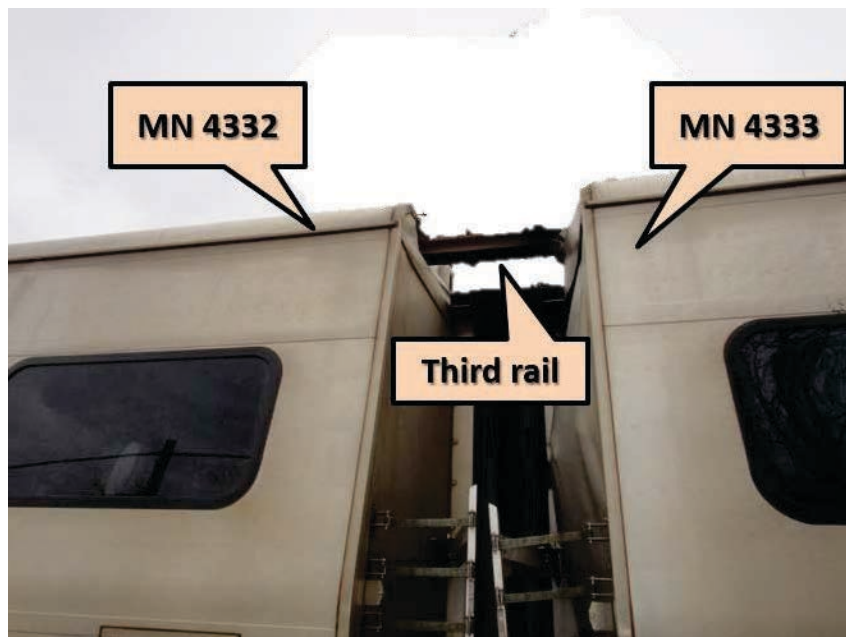
One third rail section pierced through the top right-side rear of the lead railcar and punctured the second railcar, Metro-North 4332. The third rail lodged inside the second railcar between the exterior car body shell and the interior ceiling panels. (See figure 17.)

Figure 17. Third rail between railcars Metro-North 4332 and 4333.

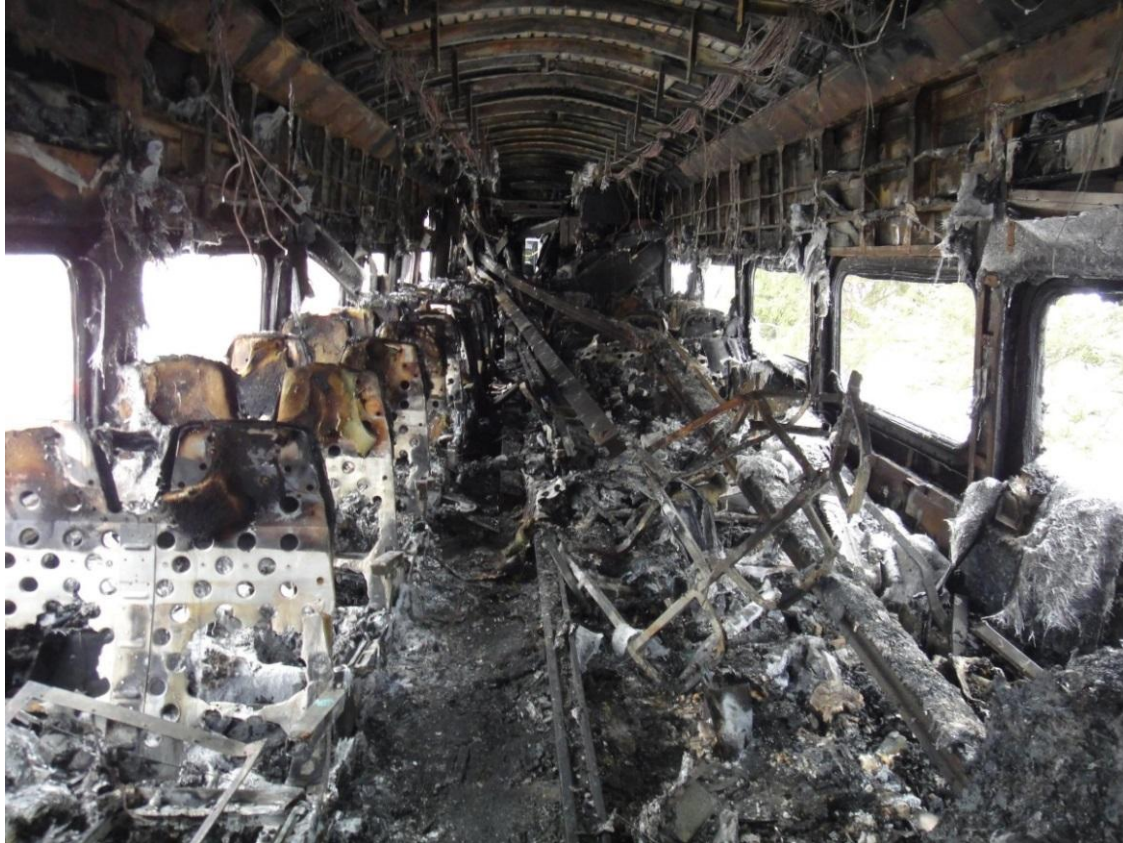
In the center section of the lead railcar, the left-side seat frames and backs bent toward the rear of the railcar. The right-side seat frames generally were secure in their correct position. Sections of broken overhead baggage racks scattered throughout the car. (See figure 18.) The railcar's rear door was impassible and could not be used because one section of the third rail prevented the door from opening.

Figure 18. Interior of the lead railcar, front to rear.

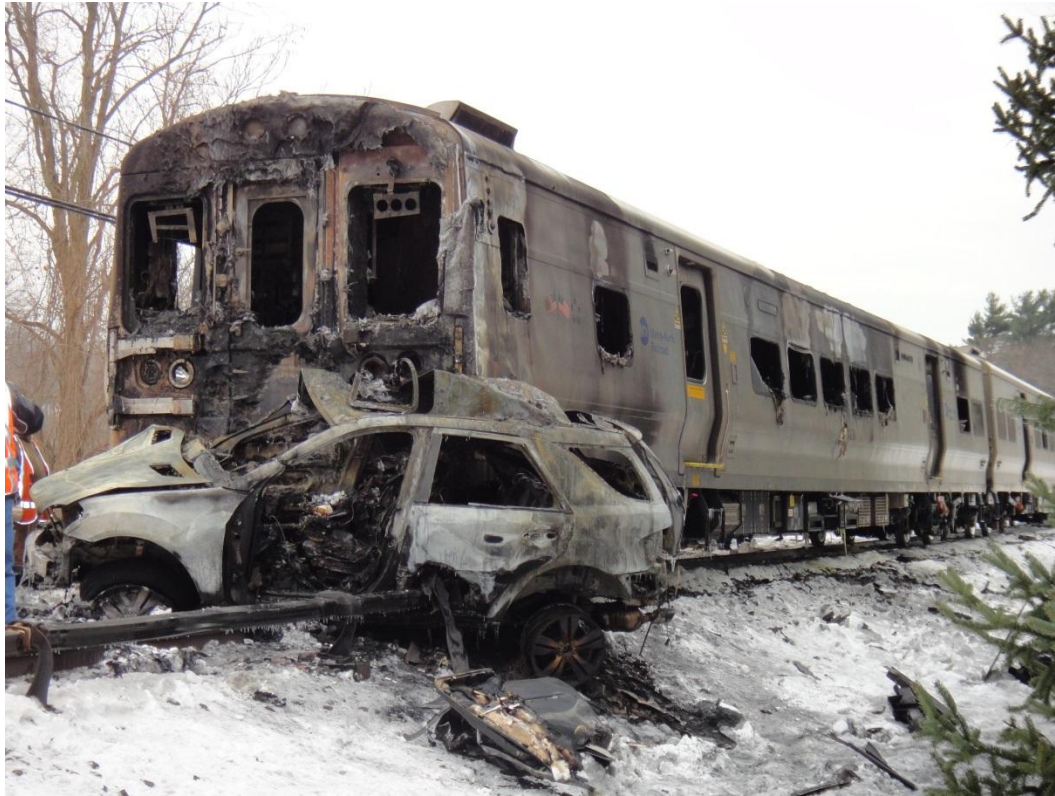
Outside the left side of the lead railcar, investigators found the rear emergency exit window on the ground; however, the accompanying zip strip and window gasket were inside.³⁴ The second window in the rear section of the railcar was in place, but all remaining windows on the left side of the railcar were melted or missing. The emergency access window from the front side passenger door was found on the ground outside of the railcar, although its exterior zip strip remained in place in the door. The left-side passenger doors would not open, and there was thick soot near the window openings on the left side of the railcar. (See figure 19.)

Figure 19. Left side of the lead railcar.

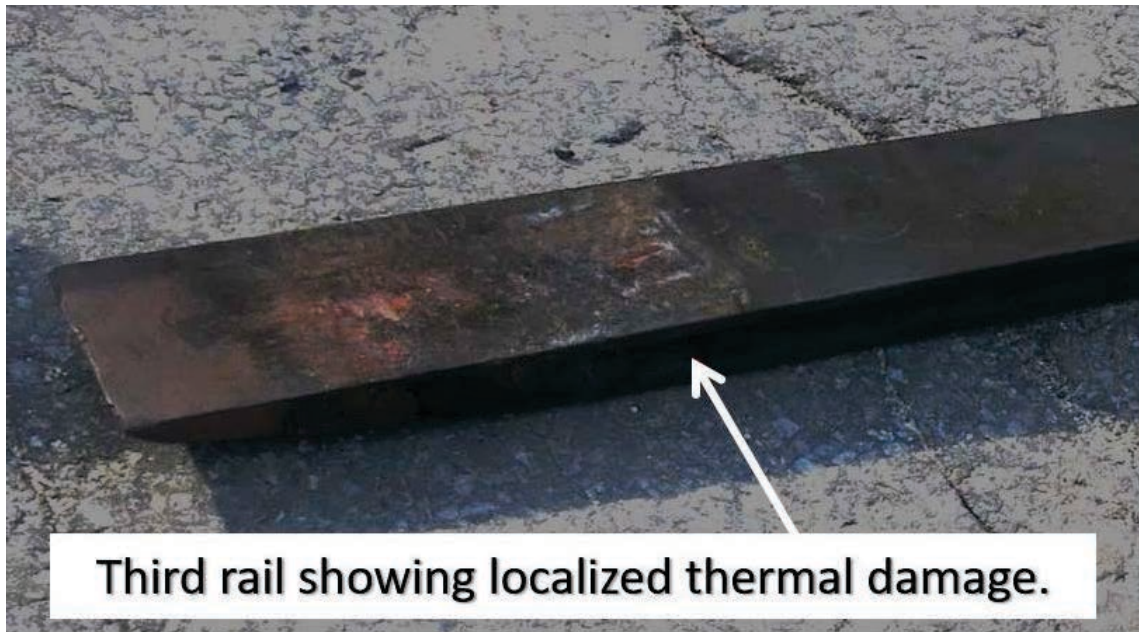
Figure 20. Localized thermal damage to the third rail nose piece surface removed from the lead railcar.

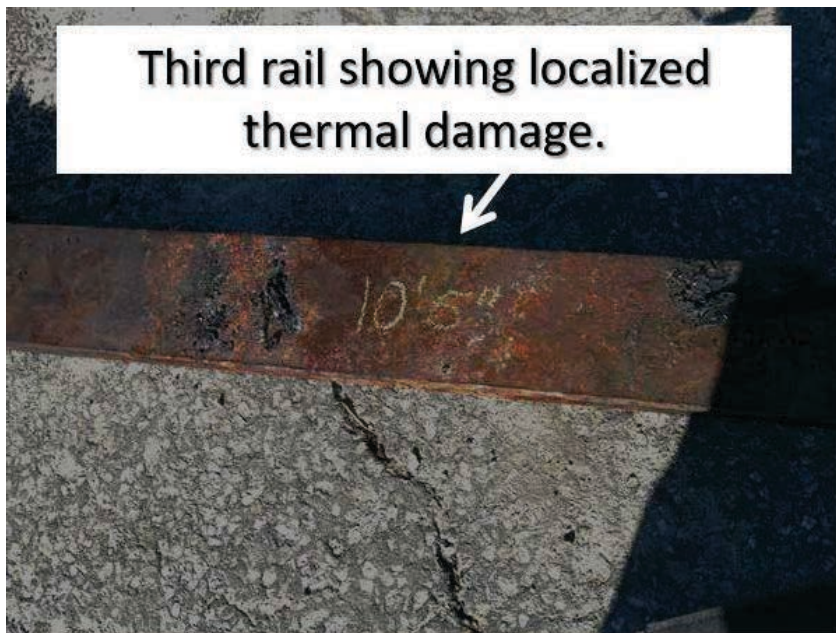
Figure 21. Localized thermal damage to the surface of the third rail removed from the SUV.

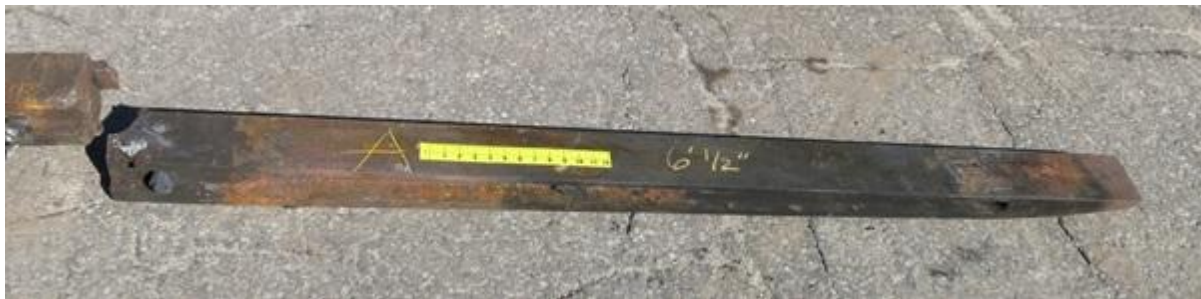
The third rail nose piece is a 6-foot section of tapered rail attached at the ends of the regular third rails to smoothly transition the current collector shoes from the trains on to the third rail. (See figure 22.) This section of the third rail was the first part to puncture the lead railcar's underside structure and enter the passenger compartment.

Figure 22. Third rail nose piece involved in this accident.

During postaccident examinations of recovered third rail sections from inside the lead railcar, investigators observed fractures in the splice bars and bolts that joined the third rail together, but found the third rail sections themselves to be intact and unbroken.

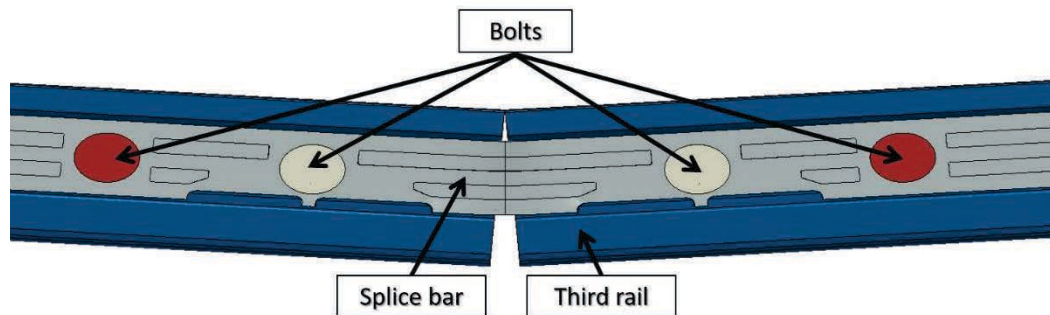
The model considered two modes of deformation: in-plane (up-and-down) and out-of-plane (side-to-side) bending. (See figure 23.) Investigators chose these modes based on the entry path of the third rail into the lead railcar during this accident. Figure 23 shows the finite element model of the third rail, splice bar, and bolts demonstrating in-plane bending.

Figure 23. Illustration of third rail and splice bar subjected to in-plane bending.

In both analyses, investigators used compressive loads to simulate the forces the SUV and the train exerted on the rail and splice bar assemblies during the accident. The analyses showed Metro-North's third rail splice bar system would have undergone large deformations before failing.
