Docket No. SA-534

Fire Scene

Factual Report

Date of Accident: September 9, 2010
Time of Accident: 6:11 pm (PDT)
Location: San Bruno, California
NTSB No.: DCA10MP008
Vehicle: Natural gas transmission pipeline

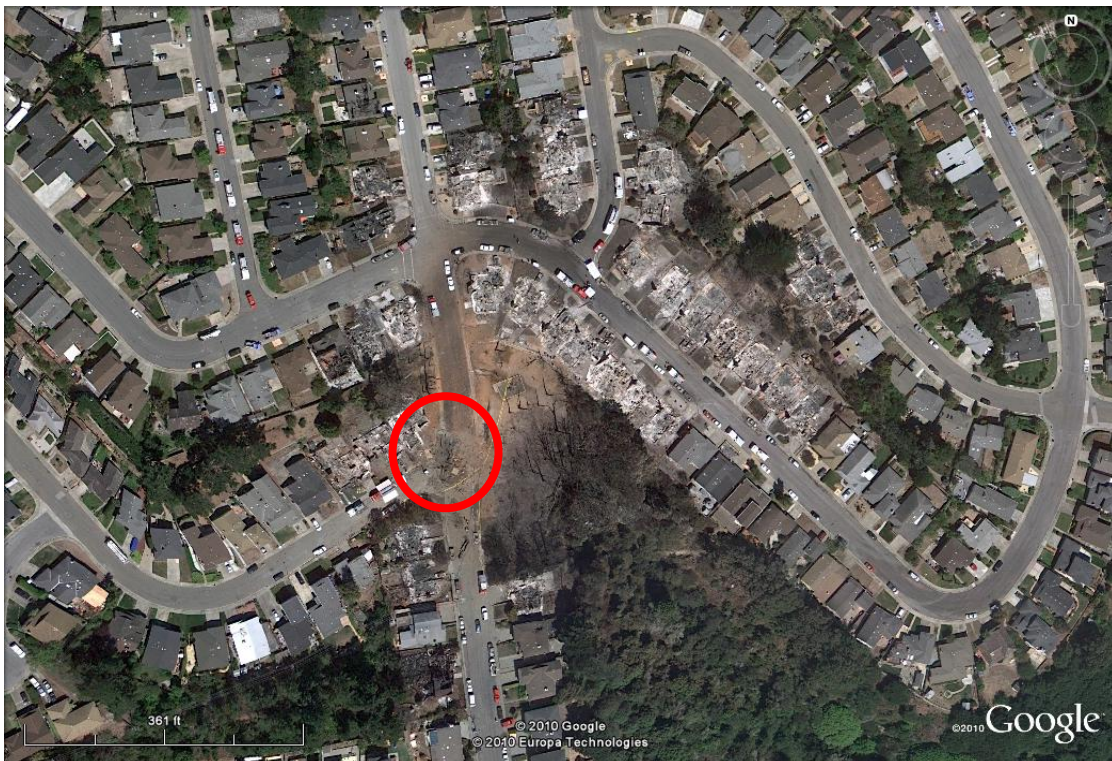
The blast crater was located near the northwest corner of Earl Avenue and Glenview Drive. The crater, prior to excavation, was approximately 59 feet (north to south) by 26 feet (east to west). The crater was excavated to enhance safety for those removing the pipe samples from the trench. An aerial photograph of the scene is below in Figure 1. The blast crater¹ is circled in red. Street level views near accident area are shown in Figures 2 and 3.

Figure 1. Aerial photograph of accident scene.

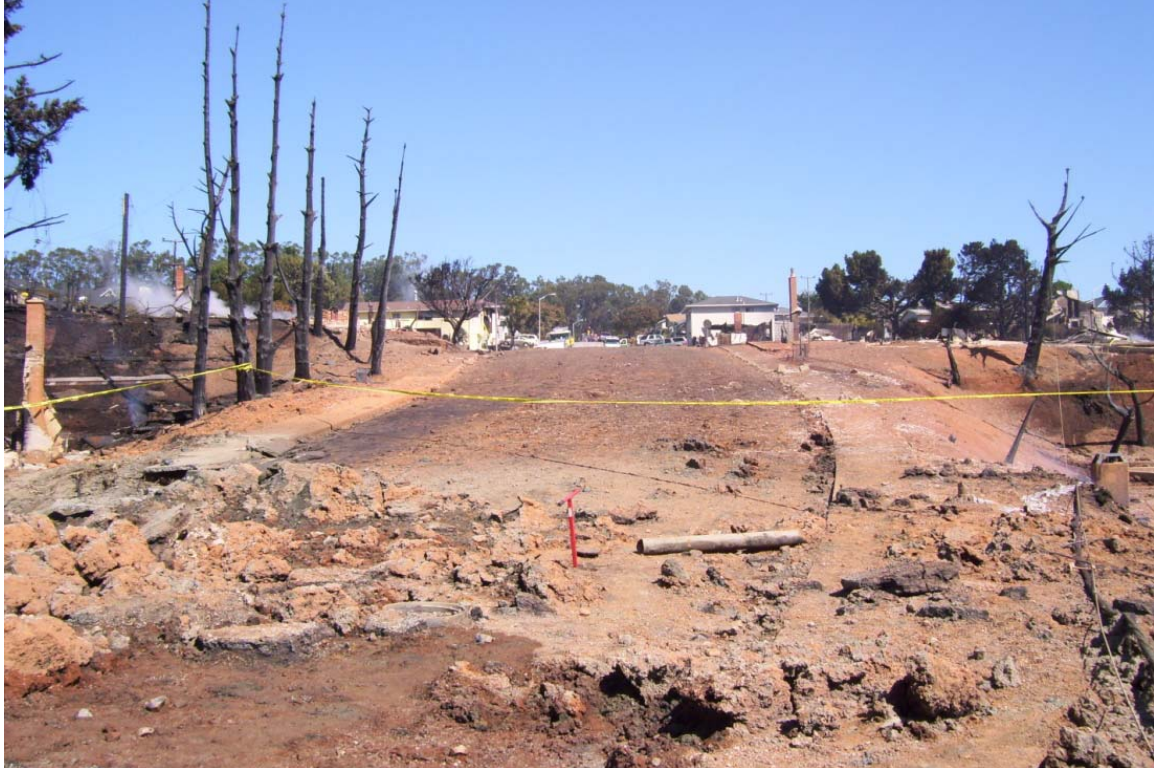
Figure 2. Photograph of area near blast crater facing north down Glenview Drive.

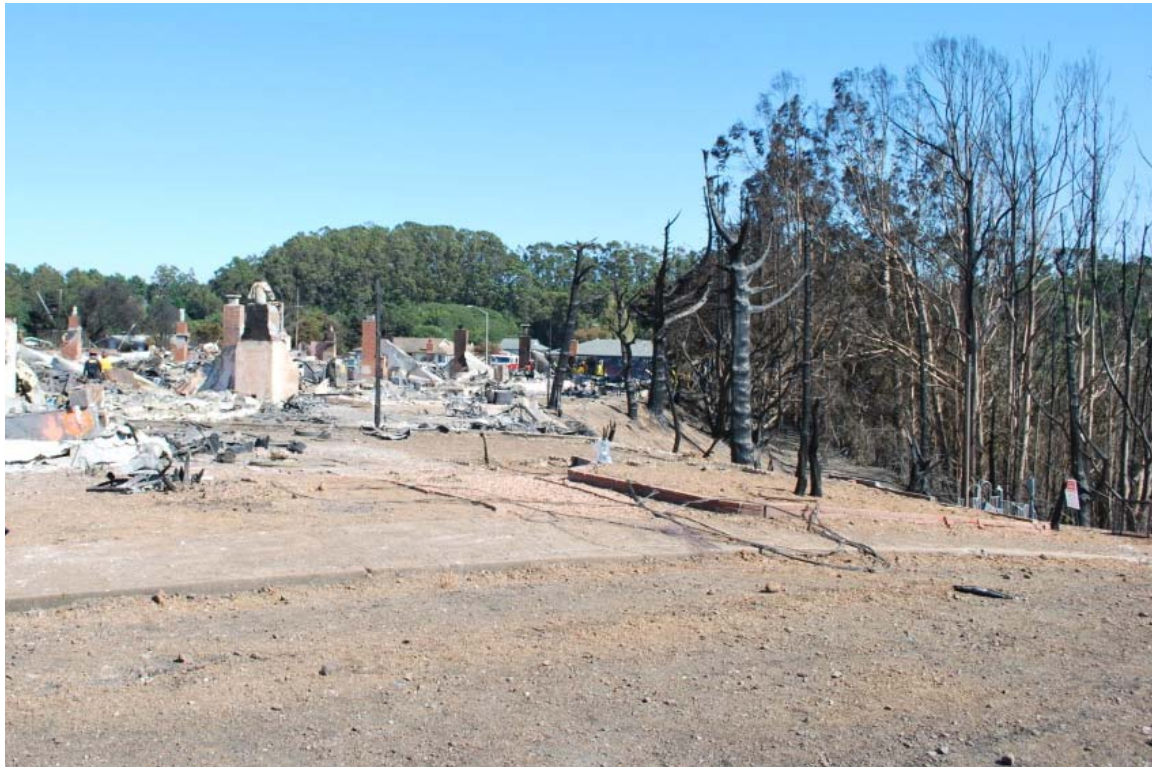
Figure 3. Photograph of the east side of Glenview Drive.

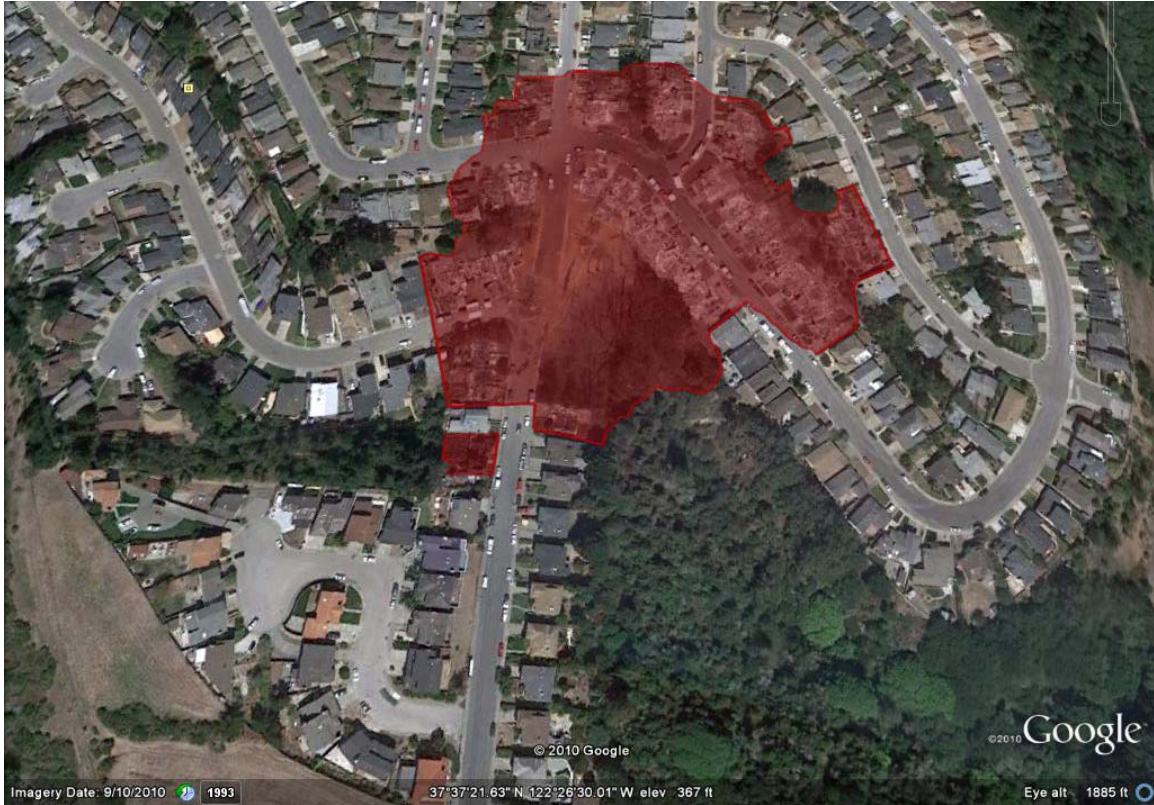
Damage to the surrounding houses, vehicles and land extended approximately 600 feet from the blast center with most of the damage radiating out in a northwest direction away from the center of the crater. Figure 4 shows the extent of the damage highlighted in red.

Figure 4. Area of damage

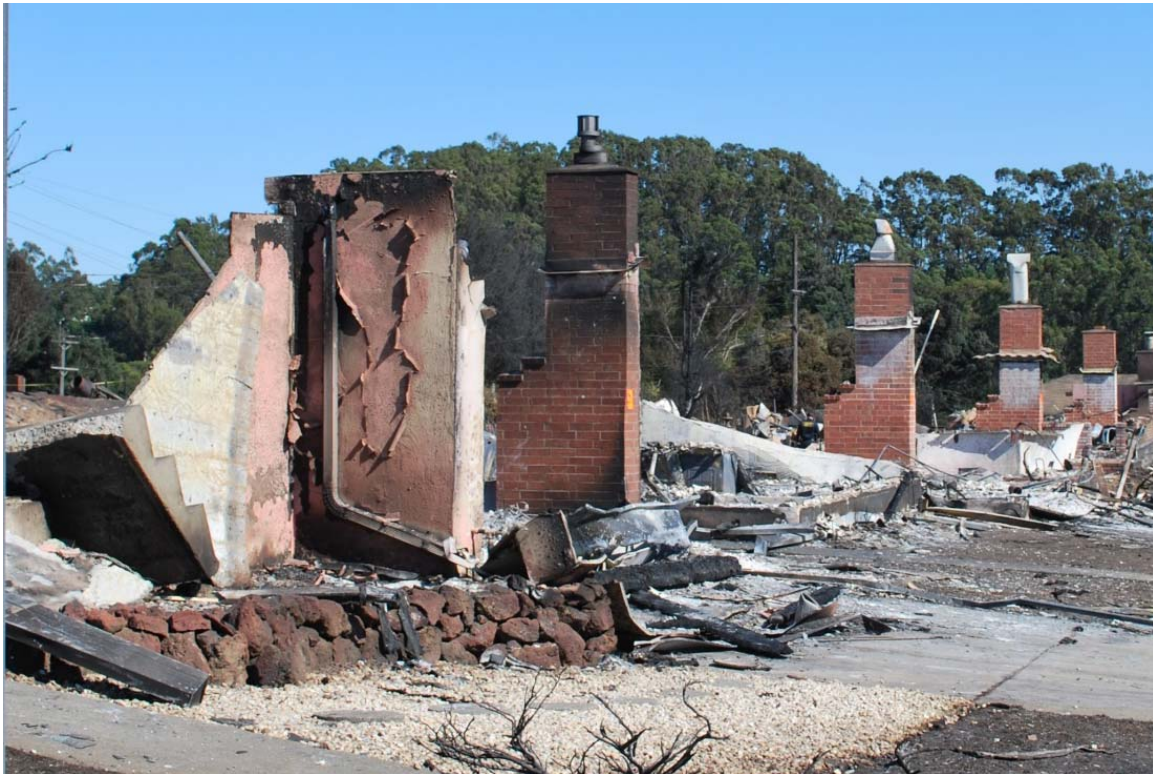
The City of San Bruno building inspection reports were reviewed to assess the level of damage done to the houses in the affected area. The damage ranged from minor physical and/or thermal damage to complete destruction. Of the 376 houses affected, 38 houses were completely destroyed during the accident such as those shown in Figure 5. Seventeen (17) houses were determined to have severe² to moderate damage and 46 sustained minor damage. A list of damaged houses is found in the table below.

Figure 5. A row of four destroyed houses on Claremont Avenue.

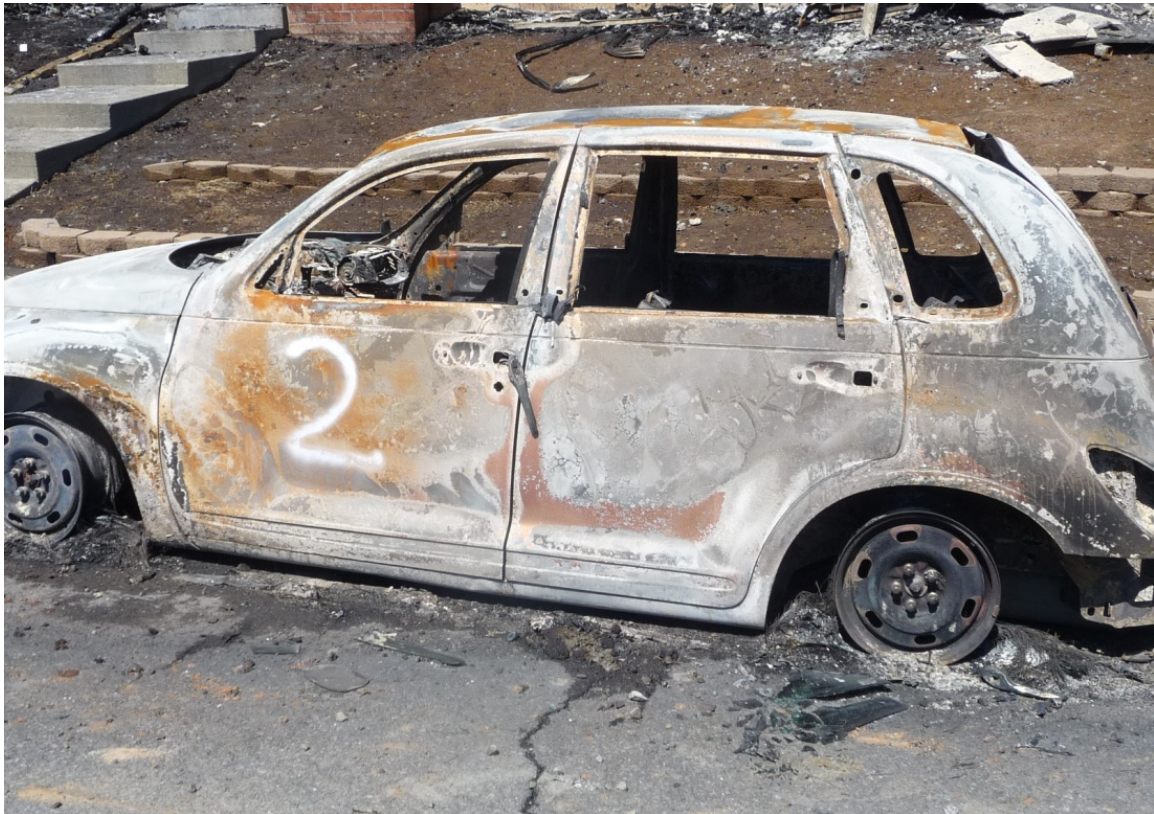
74 vehicles³ were also damaged or destroyed in the explosion and resulting fire. An example of a damaged vehicle is show in Figure 6.

Figure 6. Damaged vehicle located on Claremont Avenue near the intersection of Glenview Drive.

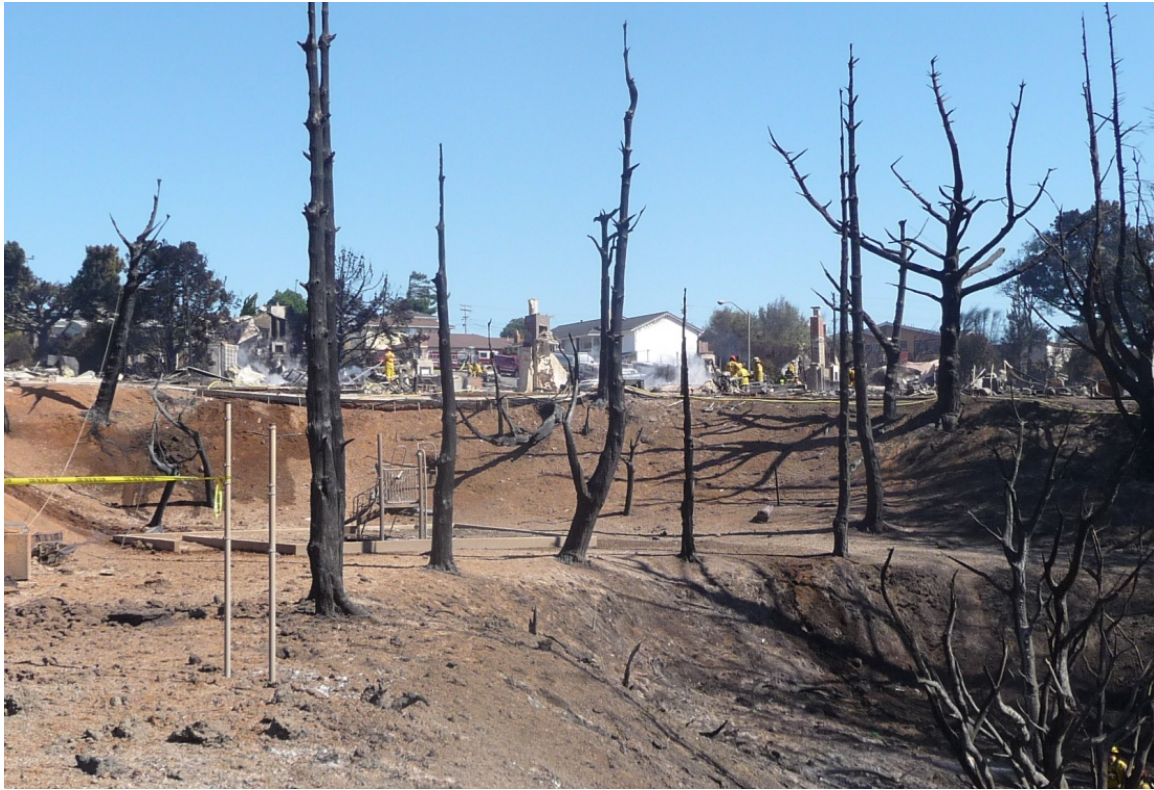
A park (Glenview Park), with woodlands located on the east side of the crater, exhibited heavy explosion and fire damage as shown in Figure 7. The trees were blackened with almost all of their smaller limbs and branches missing. The playground equipment in the park was completely destroyed. The fire damage extended down into the canyon south of the park.

Figure 7. Photograph of Glenview Park facing northwest.

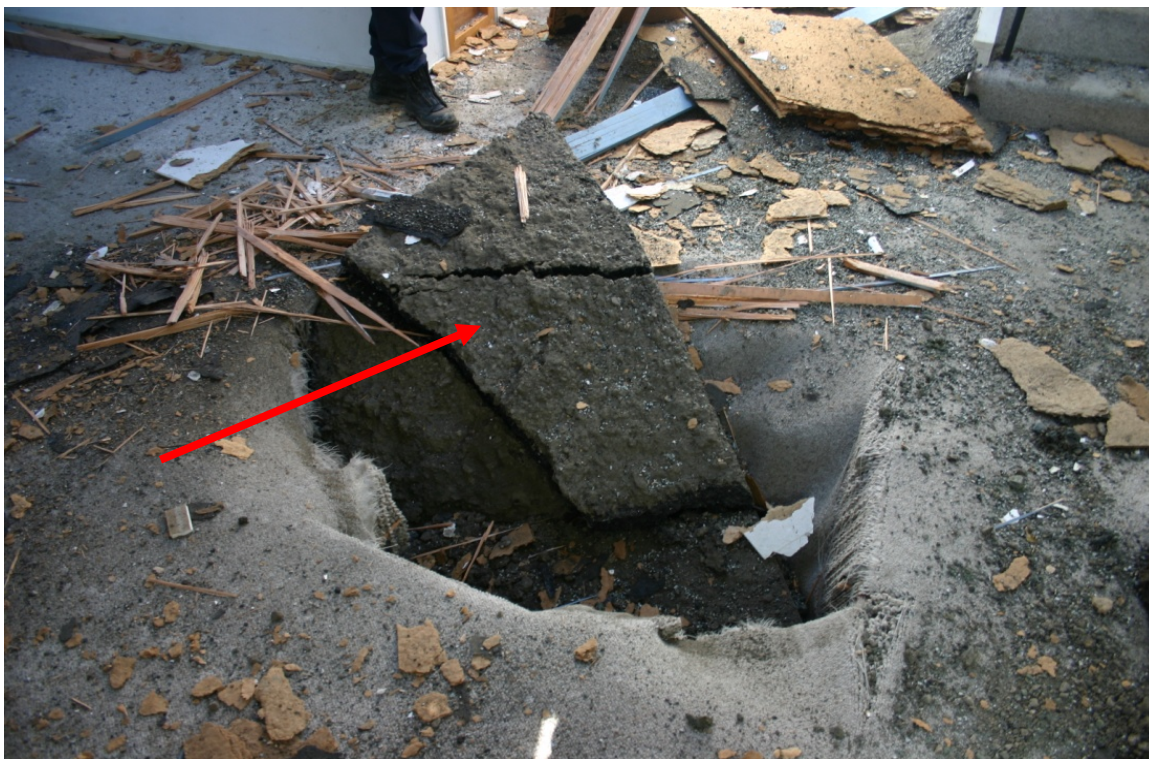
Twelve pieces of identifiable debris of significant size (several inches in diameter), mostly concrete and asphalt pieces, from the crater were found throughout the neighborhood. An example is shown in Figure 8. From the center of the crater, the extent of the debris field was approximately 300 feet to the north of the crater, 200 feet to the south, 300 feet to the east, and 60 feet to the west. The canyon below the park was not searched for debris.

Figure 8. Picture of asphalt debris (highlighted with a red arrow) that penetrated the roof of a house near the accident site.
