NATIONAL TRANSPORTATION SAFETY BOARD

FIRE INVESTIGATION FACTUAL REPORT

Report No. 18-044

Place : Fort Lauderdale, Florida
Date : Tuesday, May 8, 2018
Vehicle : 2014 Tesla Model S
NTSB No. : HWY18FH013
Investigator : Sheryl Harley

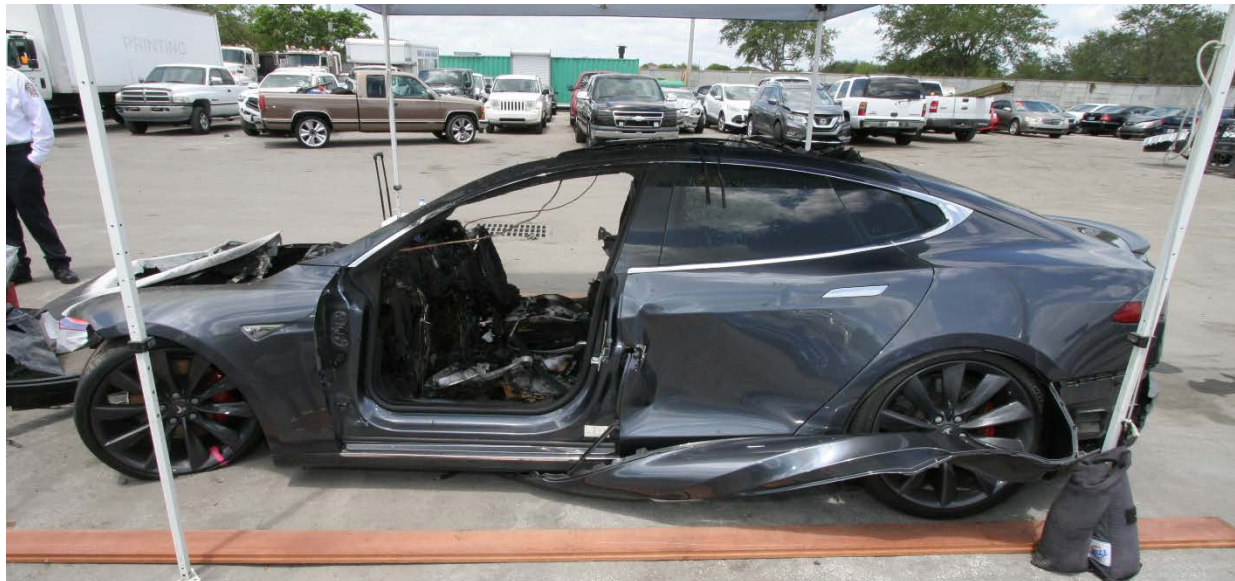
Figure 1: Driver's side of the vehicle

The Tesla passenger car exhibited deformation and fractured components consistent with a high-speed collision. The deformation and fractured components were concentrated on the passenger side of the vehicle and in particular the forward portion of the passenger side (figures 1- 6). The post-crash fire damage was also concentrated in the

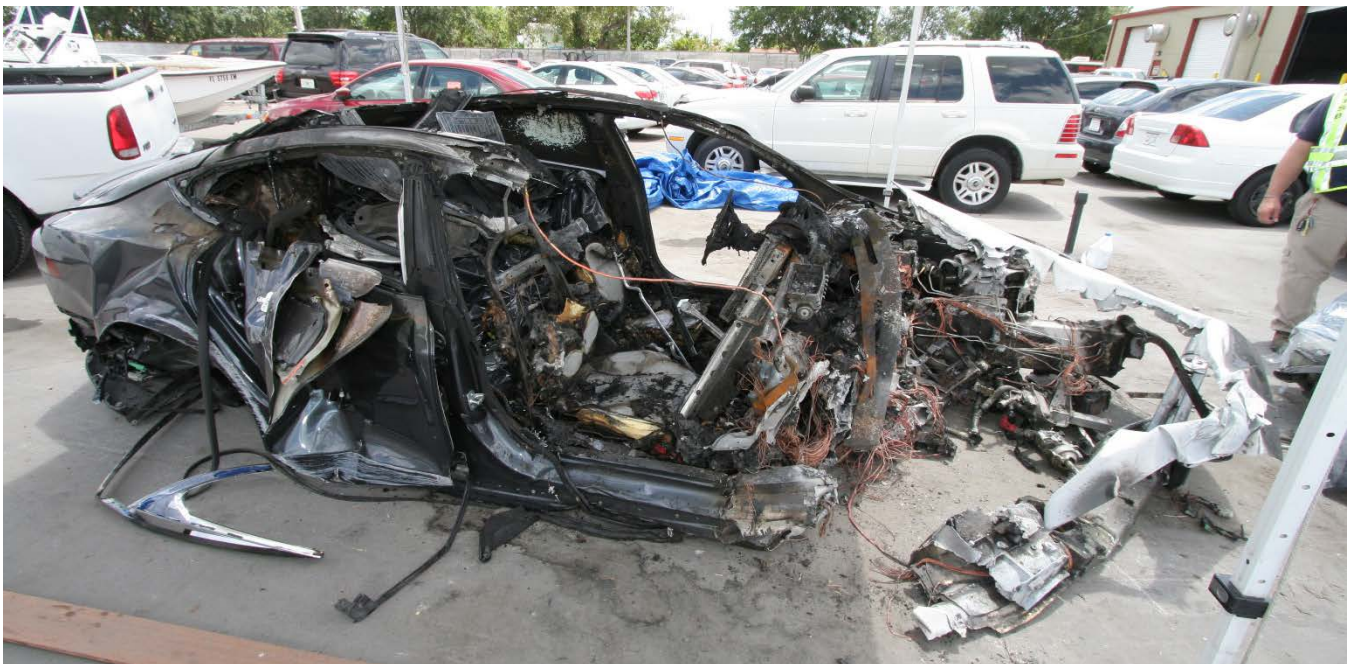
Figure 5: Passenger side of the vehicle.

forward passenger side of the vehicle and extended to the driver's side and rear passenger seat. Both wheel rims and brake rotors from the passenger side of the vehicle had separated from the vehicle. Portions of these two rims and rotors were observed among the loose vehicle debris.

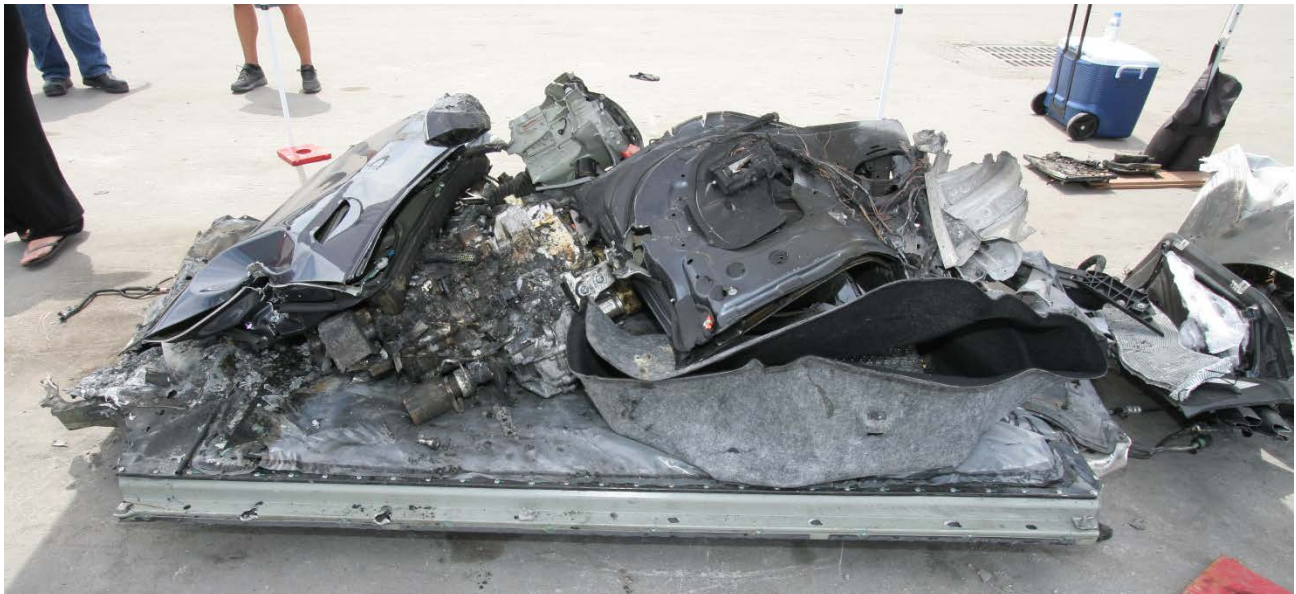
The vehicle's battery pack had separated from the rest of the vehicle (figure 7). Without disturbing the debris piled on top of the battery pack it was evident that the collision had liberated some battery modules from the overall battery pack. Each battery module consists of multiple battery cells. One of the separated battery modules exhibited signs of having been involved in a fire (figure 8). Another separated battery module that did not appear to have been exposed to fire was sitting inside a fabric material resembling a baggage compartment liner (figure 9). This material resembling baggage compartment liner did not exhibit fire damage.

Figure 7: Battery pack with vehicle debris piled on top.

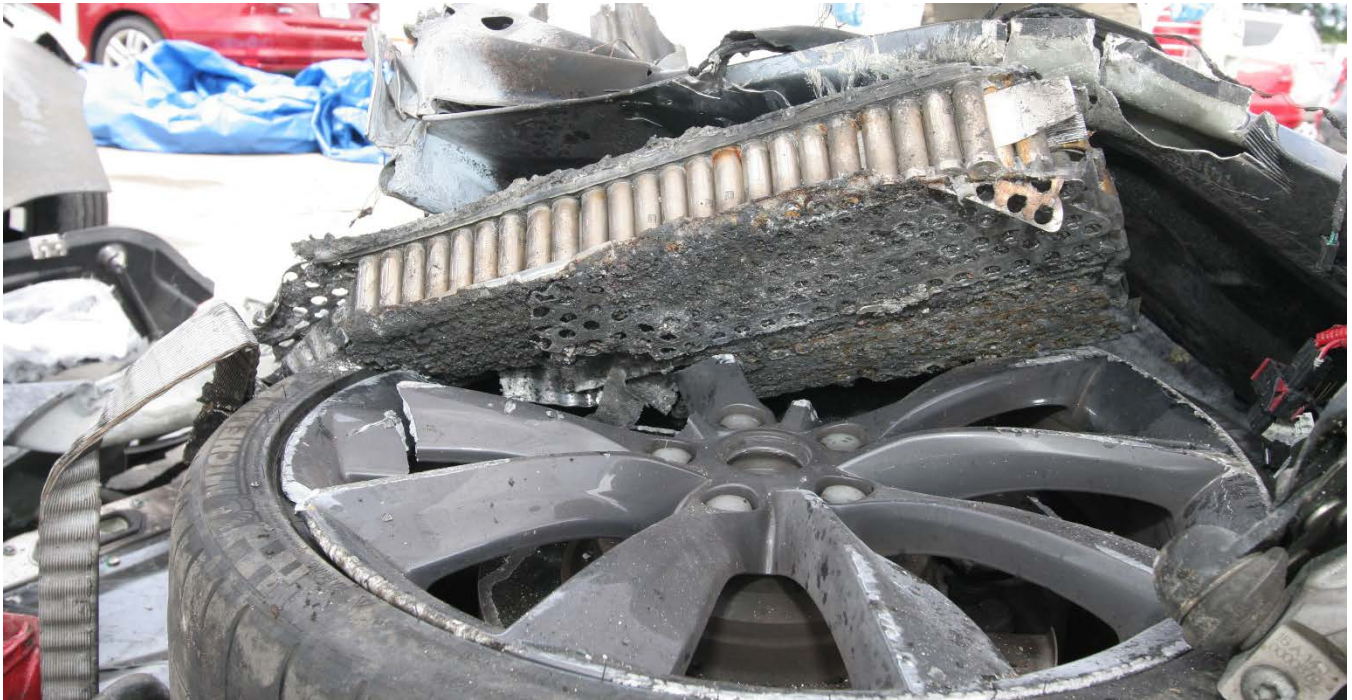
Figure 8: Fire damaged battery module.

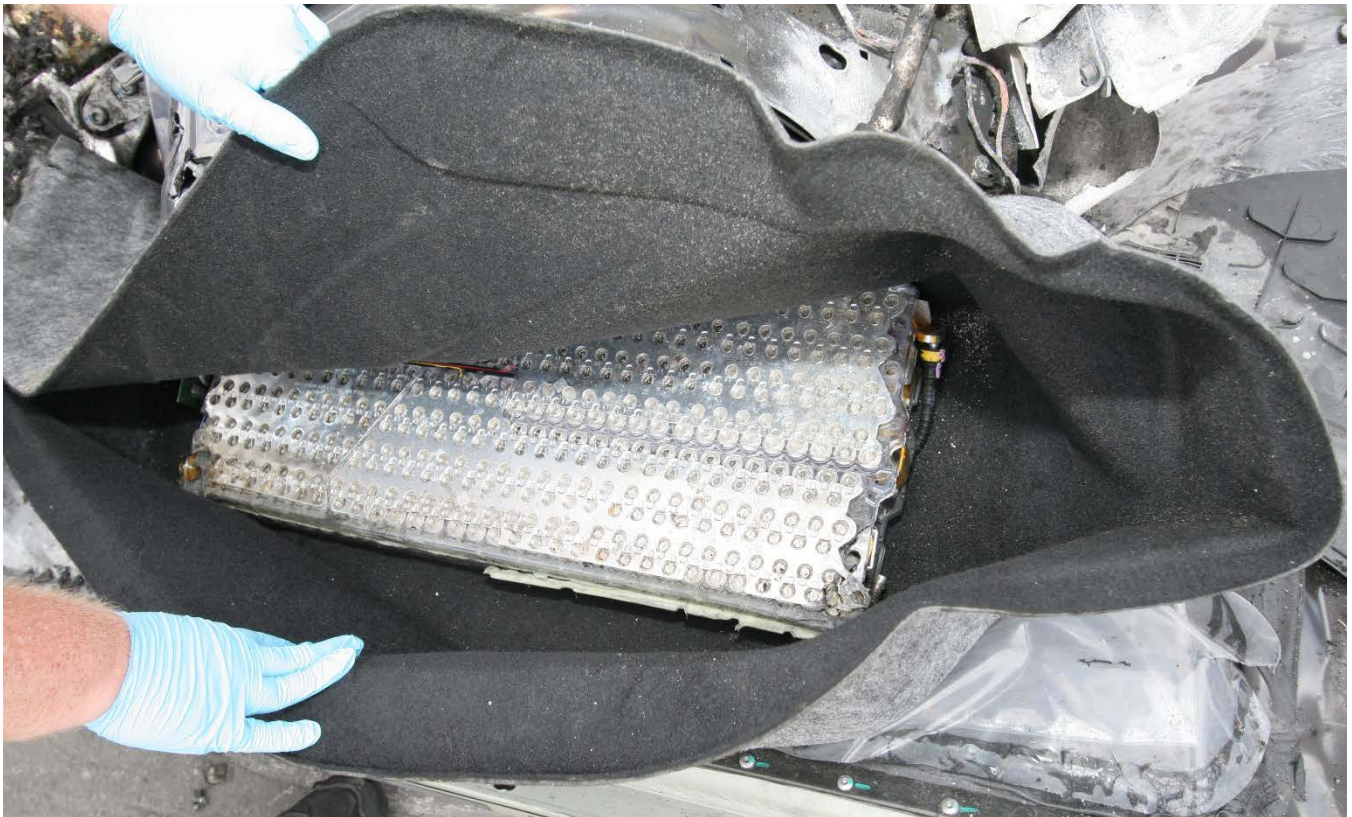
Figure 9: Battery module without fire damage.
