NATIONAL TRANSPORTATION SAFETY BOARD

FIRE GROUP FACTUAL REPORT

Report No. 15-058

NTSB #: **DCA15MR006**

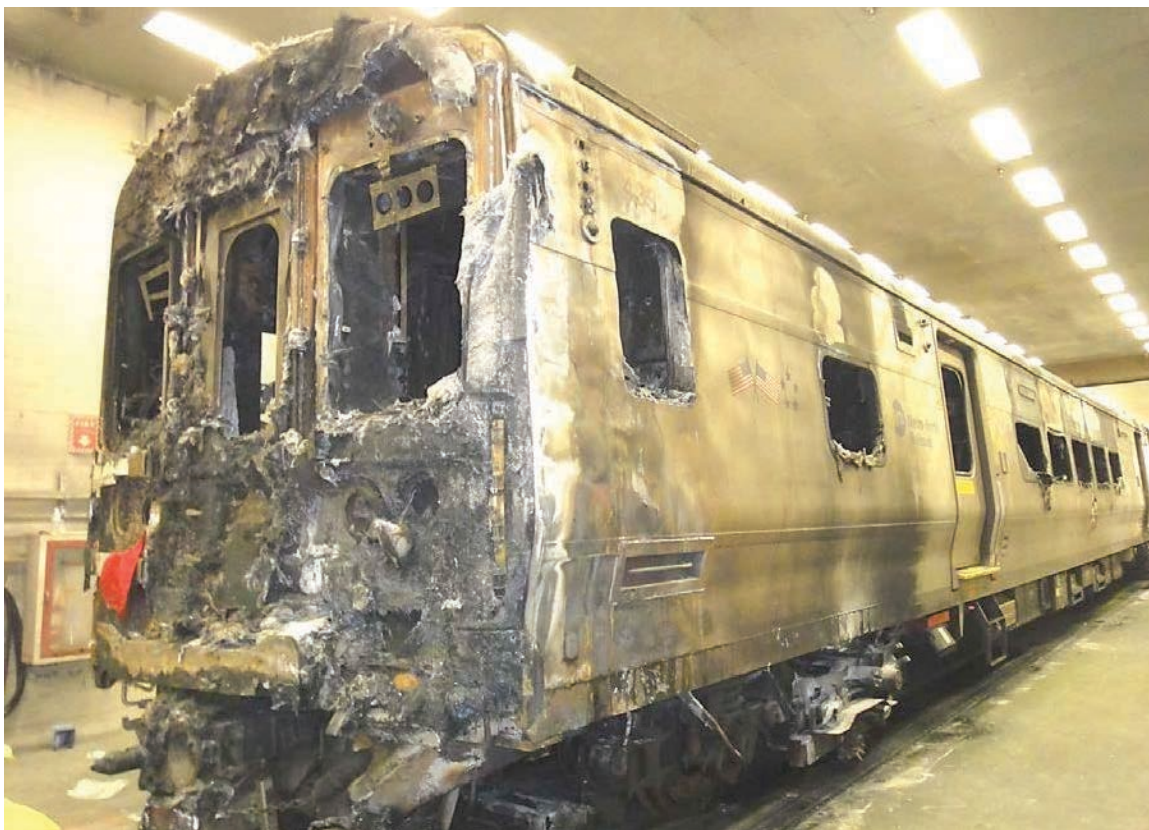
Figure 1. F-end and left side of MN 4333

The fiberglass (fiber reinforced plastic or FRP) covering (end cap) over the F-end of MN 4333 had thermal damage over the entire surface of the end cap with the resin consumed in the fire and leaving behind only the glass fiber matting. The rail car exterior at the F-end forward facing structure was comprised of stainless steel sheathing. The sheathing underneath the fiberglass end cap was thermally discolored and sooted. The rail car exterior sheathing on the both the right and left sides at the F-end were thermally discolored and exhibited some areas of deformation. There was burned debris from the SUV still attached to the lower portion of the F-end, on left side where the skirt was attached to the forward facing structure. The three forward facing windows (the glass Operator's and Observer's windows and the polymeric body end door window) were

missing¹. Some glass was found in the Operator's compartment and on the SUV. Solidified remnants of the melted polymeric window were still present in the window frame. The pneumatic horn and other accessories mounted on the F-end underframe area were either missing or heavily fire damaged. The casing of the pneumatic horn was found on the ground on-scene after the SUV was separated from the rail car. A portion the outer casing remained.

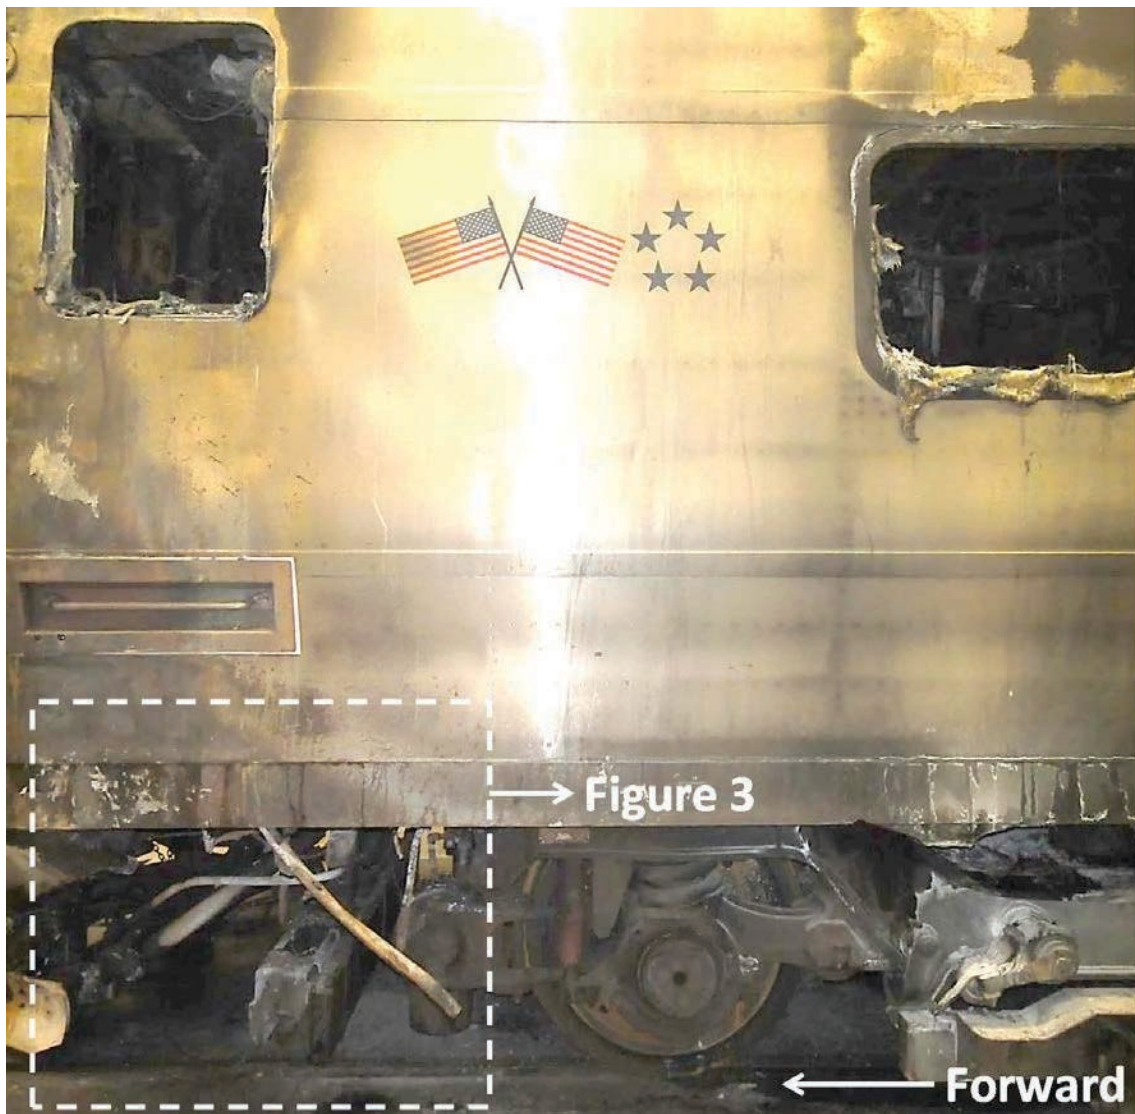
The thermal damage on the left side of the F-end underframe equipment extended from the forward face of the car to the F-end truck assembly as shown in Figures 2-3.

Figure 2. F-end left side of MN 4333 and F-end truck.

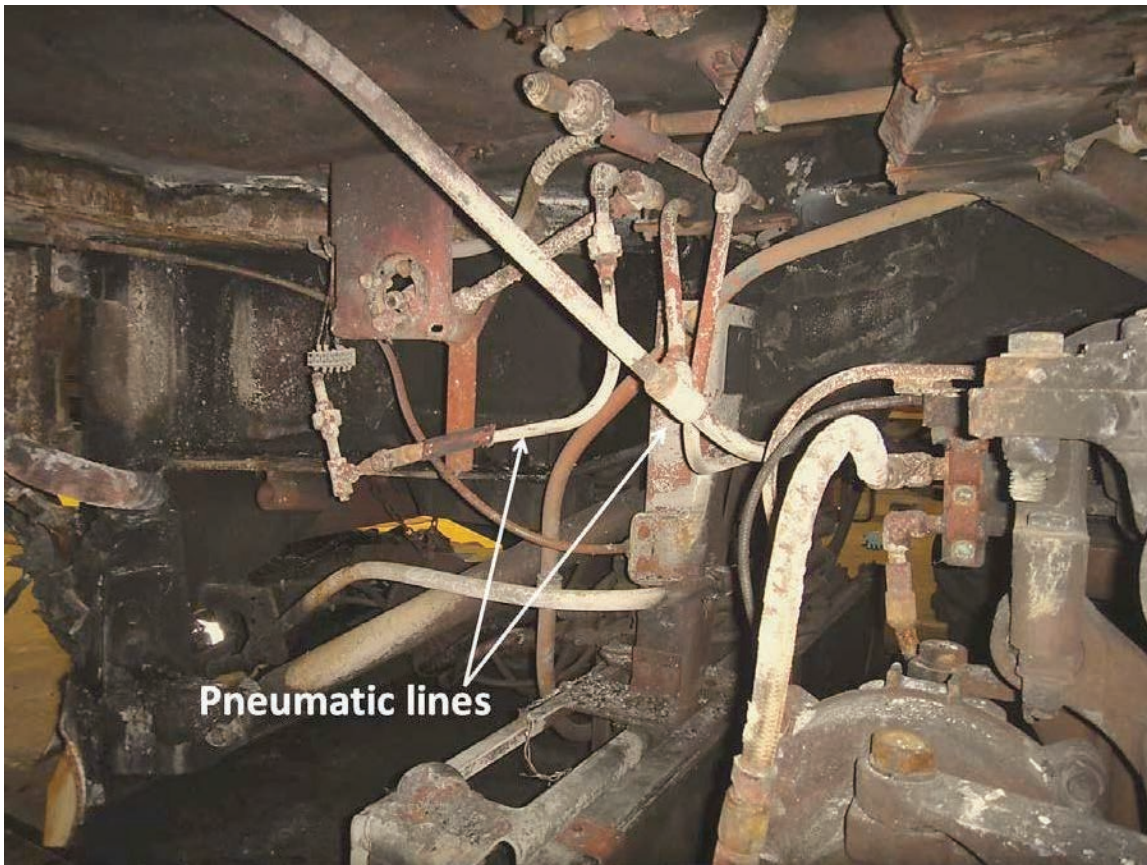
Figure 3. F-end left side underframe area of MN 4333.

Several pneumatic lines in this underframe area (lines for automatic coupler, air horn, brake pipe; fabricated of carbon steel) were dislodged, severed and exhibited brown to white thermal discoloration. In addition, truck-mounted components such as the disc brake unit (DBU), pneumatic and electrical connections exhibited similar thermal discoloration. There was extensive sooting in this area as well. The thermal damage did not extend past the midline of the undercarriage. The third rail was force-fit between the truck frame and vertical link of the front truck. There were no visual indications of erosion or localized melting after the rail was removed from this location

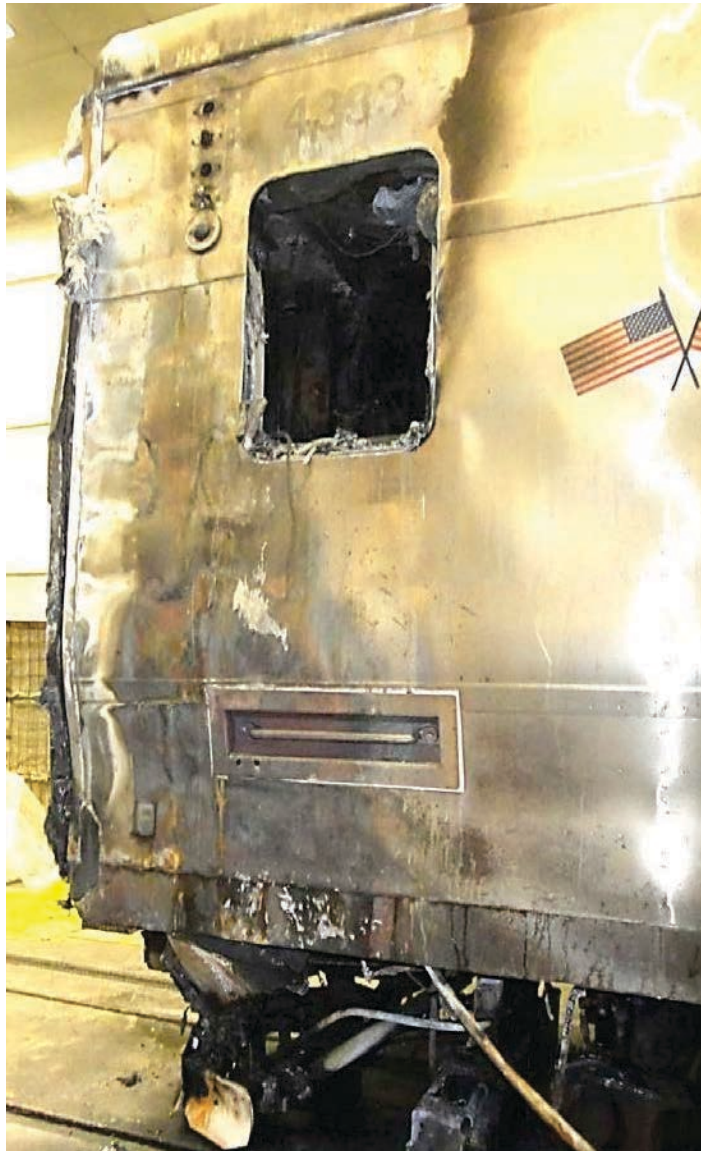
Figure 4. F-end left side corner and Observer's side drop sash window.

The Observer's drop sash window (window glazing) was melted and solidified remnants of the polymeric window remained in the window frame². The left side sheathing of the side frame structure located above the Observer's drop sash window displayed signs of distortion and sooting that extended down to the side sill of the side frame structure. The area between the Observer's drop sash window and the first passenger compartment (L1) window was sooted but had no other visible damage. The L1 window had melted and solidified remnants were present in the window frame³. Above the window, the side frame sheathing was heavily sooted and was deformed beginning at the forward edge of the window frame and extended to the midline of the window. There was sooting at the fresh

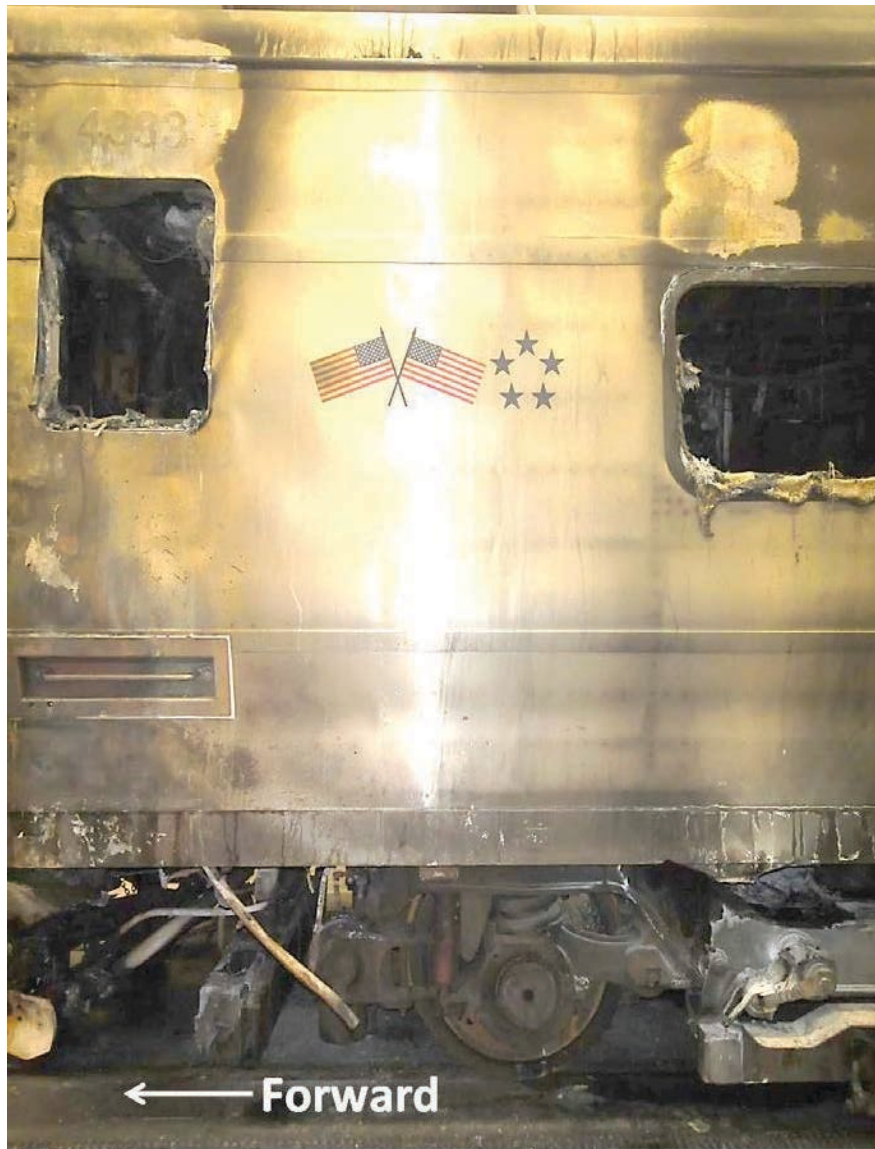
Figure 5. Left side section of exterior car body between Observer's drop sash window and first passenger compartment (L1) window.

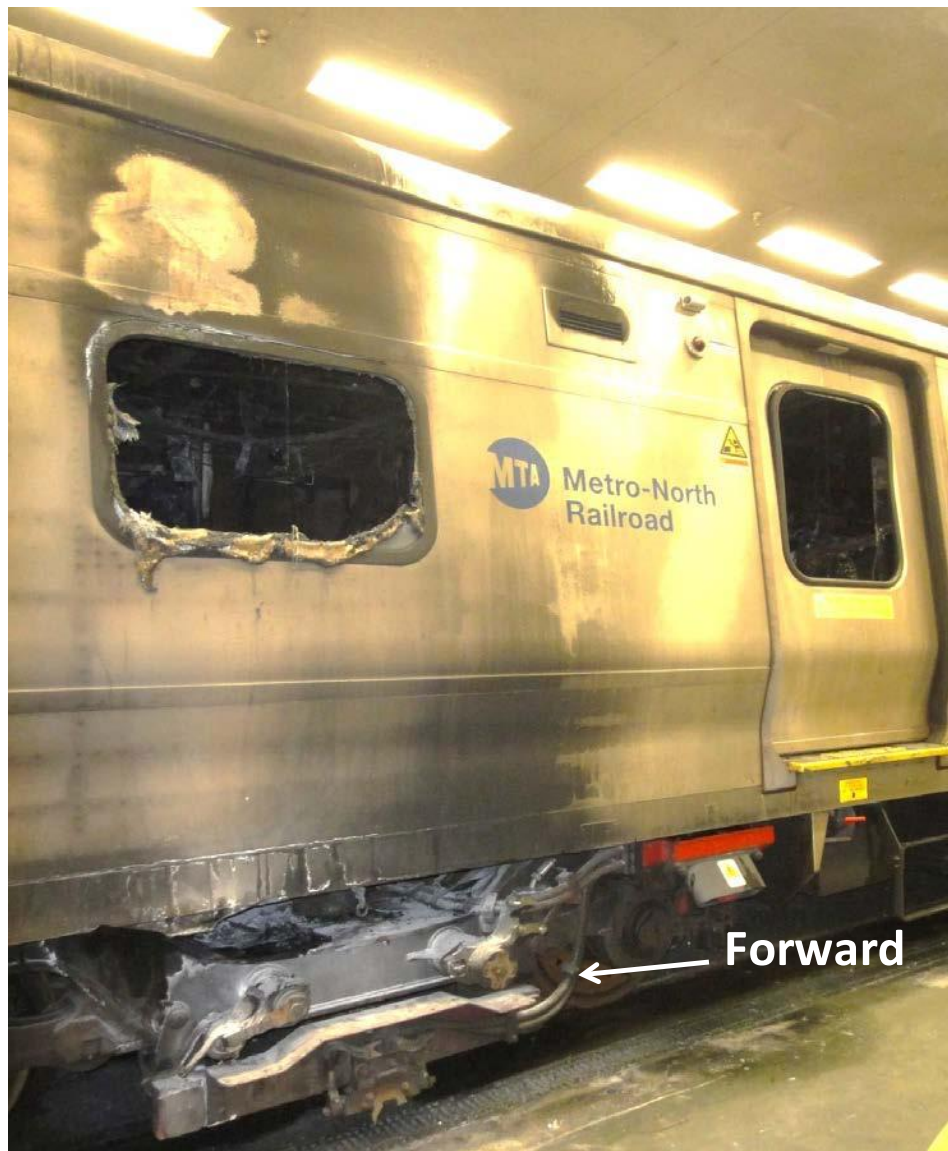
Figure 6. Left side section of exterior car body between L1 window and F-end passenger door.

air grille located between the first window and the door. The window for the forward passenger door was missing with no signs of melted material in the frame. There was sooting on the exterior above the door.

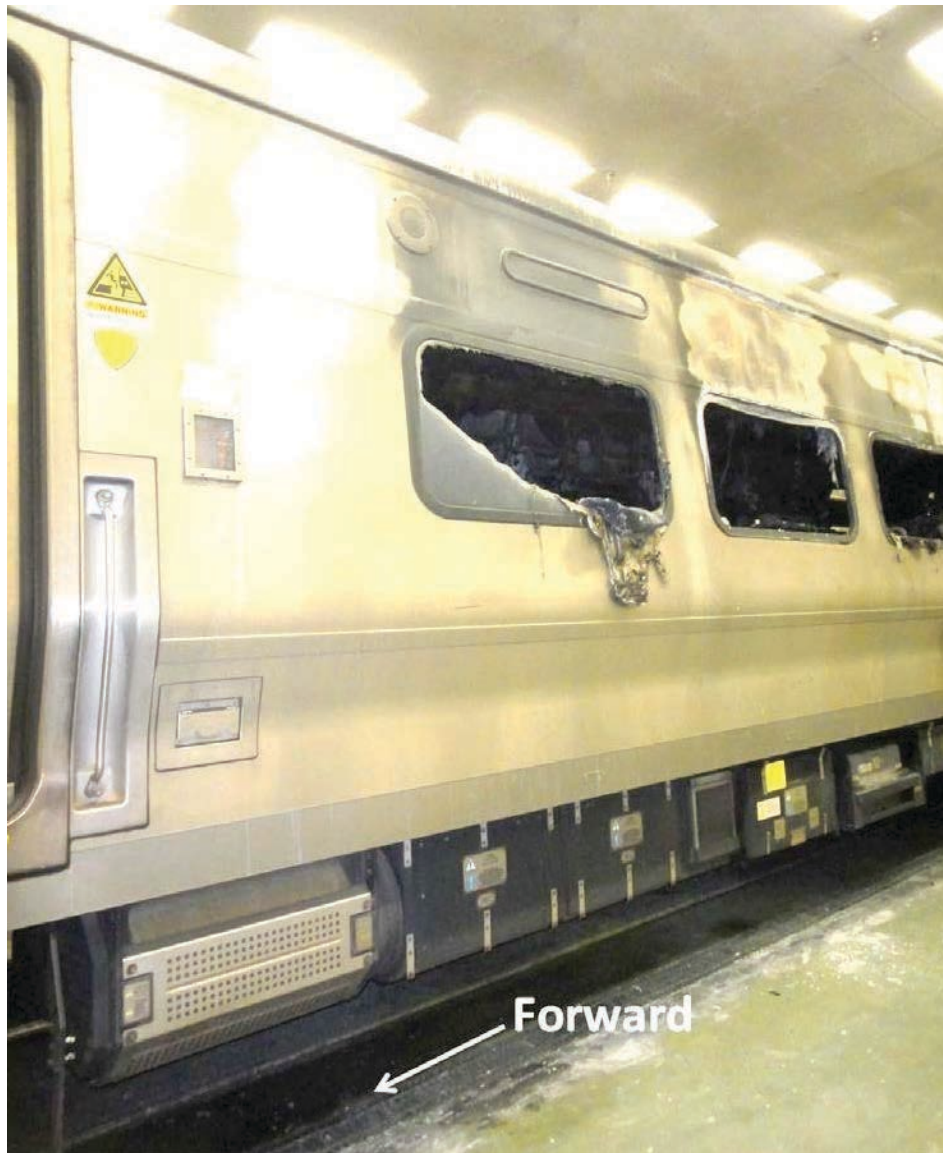
Figure 7. Left side exterior from F-end passenger door to fourth (L4) window.

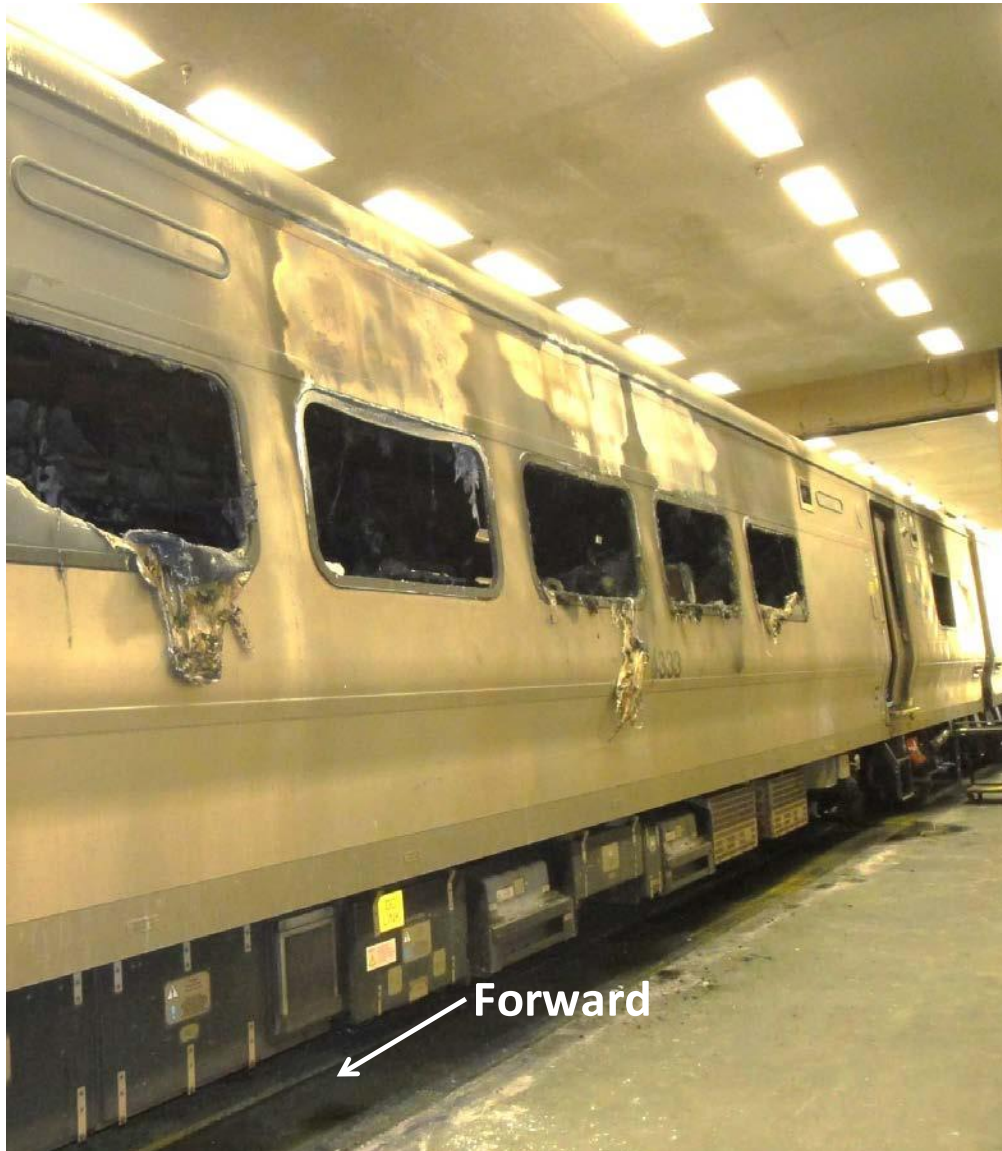
Figure 8. Left side exterior from second (L2) window to sixth (L6) window.

All passenger compartment windows on the left side were missing with the exception of the eighth (L8) window which was still intact. The second passenger compartment (L2) window (Fig. 8) was partially melted and was still attached to the window frame. The third passenger (L3) window was missing with no signs of melted material in the frame. The fourth, fifth and sixth passenger compartment (L4, L5 and L6) windows had melted and solidified remnants were present in the window frame. The window in the B-end passenger side door was intact and heavily sooted. The seventh (L7) window was missing with no signs of melted material in the frame. The intact L8 window was heavily sooted. The areas above the L3, L4 and L5 windows exhibited deformed car body side sheathing extending from the window to the roof. Areas above the second, sixth and seventh windows and the rear passenger door window exhibited sooting.

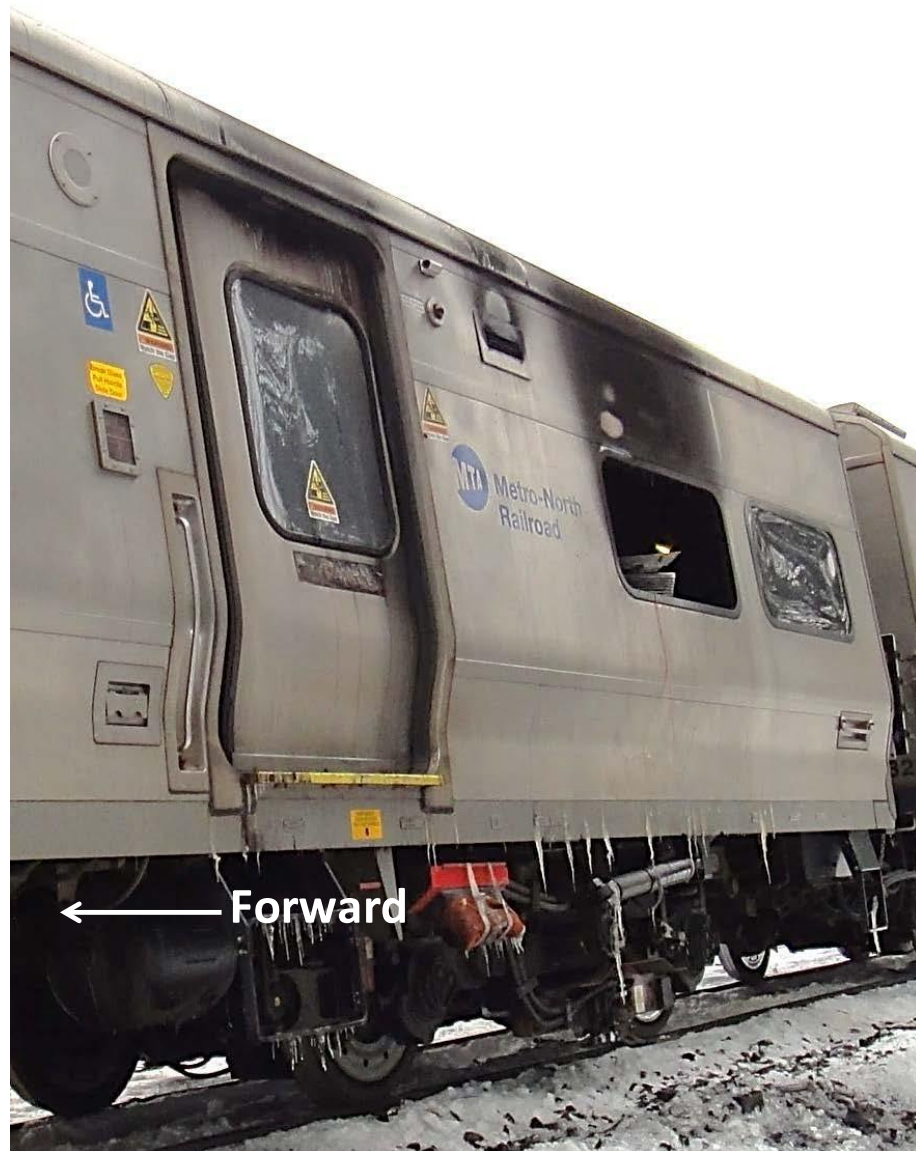
Figure 9. Left side rear passenger door and rear two (L7 and L8) windows.

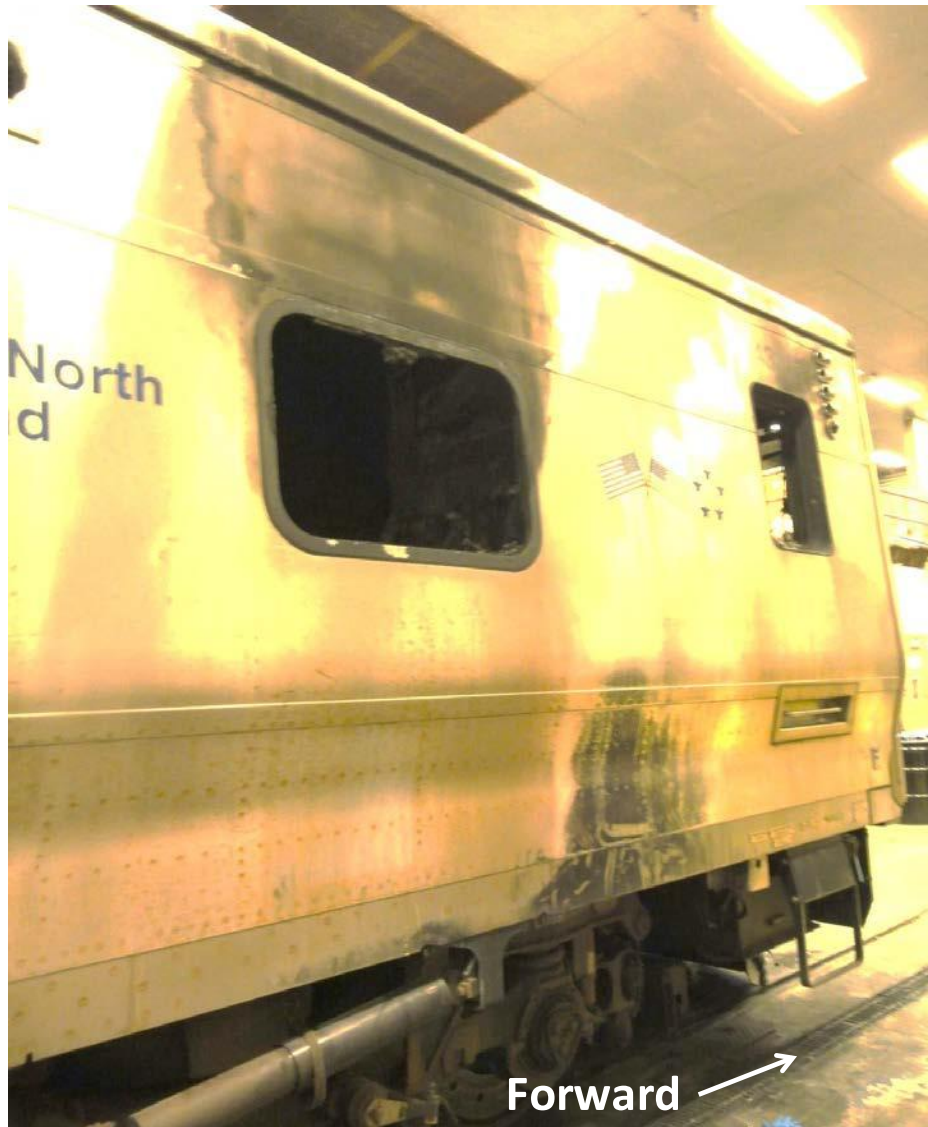
Figure 10. Right side exterior from F-end corner to first passenger compartment (R1) window.

The right side, Operator's drop sash window was melted and solidified remnants of the polymeric window remained in the window frame. The exterior body panel was deformed starting from above the Operator's compartment drop sash window and extending down to the lower edge of the side structure, side sill. A lower area of sooting (from the lower edge of the body to approximately midline of the body) between the Operator's compartment drop sash window and the first passenger compartment window was present but this area had no other visible damage. The first passenger compartment (R1) window had melted and solidified remnants were present in the window frame. Above the window, the passenger information display (PID) was missing and the exterior side sheathing was heavily sooted and was deformed beginning at the forward edge of the window frame. Discoloration on the side sheathing was evident above the PID located above the window. There was sooting at an exhaust grille located between the F-end passenger side door and second passenger compartment window. All of the passenger compartment windows on the right side were missing with the exception of the last two (eighth (R8) and ninth (R9)) windows which were still intact but heavily sooted. The second passenger compartment (R2) window was missing. This window was removed during the evacuation. The third, fourth, fifth and seventh passenger compartment (R3, R4, R5 and R7) windows had melted and solidified remnants were present in the window frame. The areas above these

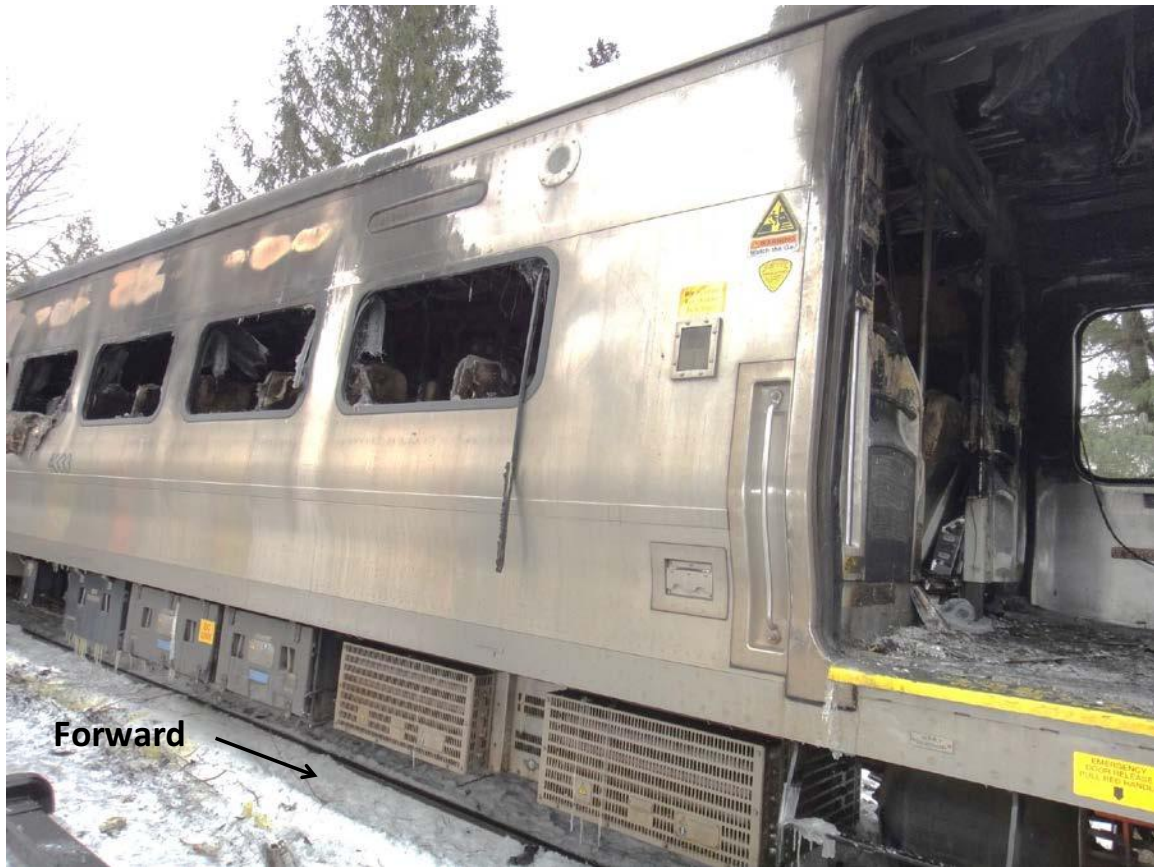
Figure 11. Right side exterior from F-end passenger side door to fifth passenger compartment (R5) window.

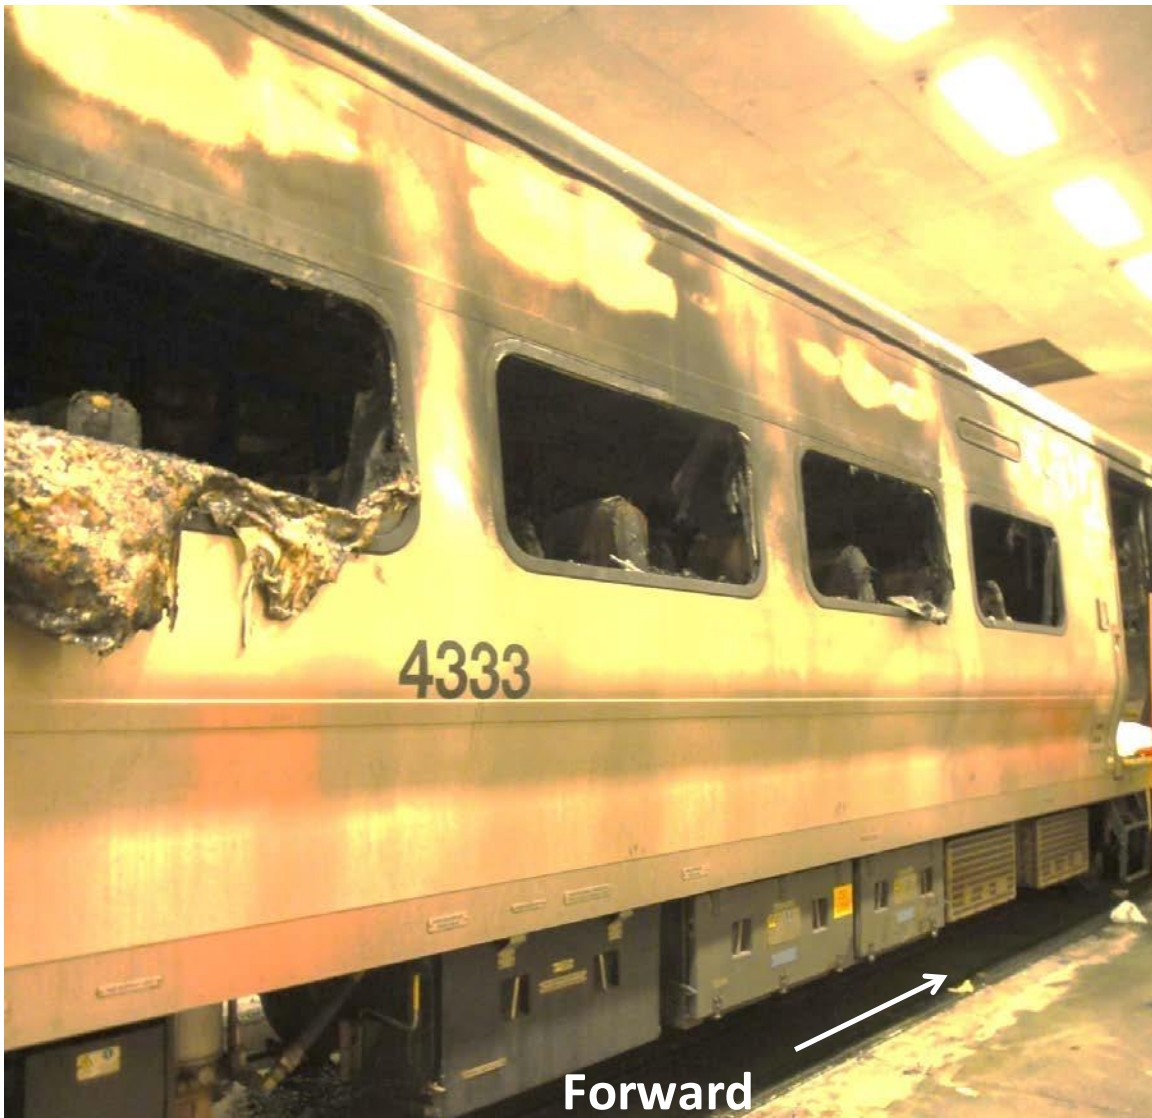
Figure 12. Right side exterior from second (R2) to fifth (R5) passenger compartment windows.

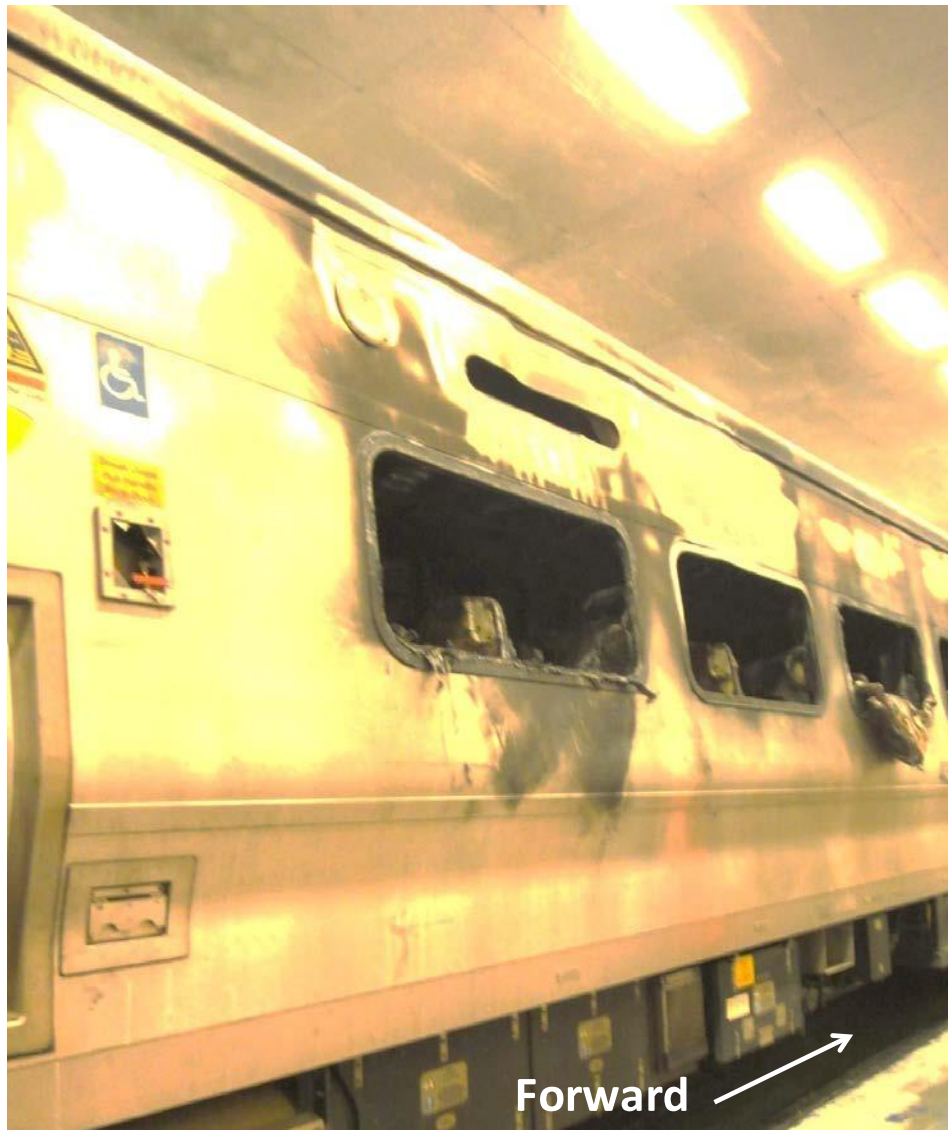
Figure 13. Right side exterior from fifth (R5) to seventh (R7) window.

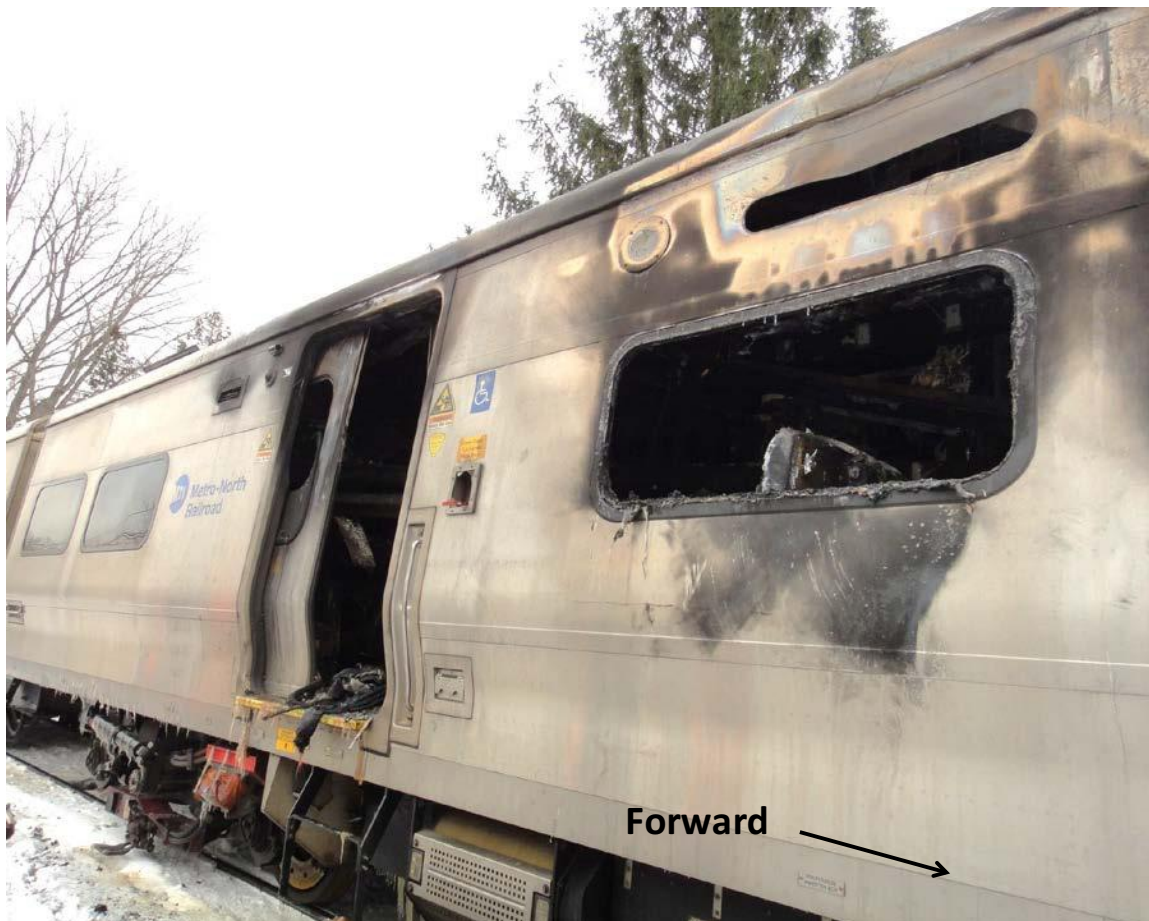
Figure 14. Right side exterior including seventh (R7), eighth (R8) and ninth (R9) windows and rear passenger door.

windows exhibited deformed car body extending from the window from to the roof. There was sooting below the seventh window. The sixth (R6) window was missing and the exterior car body above this window was deformed. The window in the B-end passenger side door was partially melted and heavily sooted. There was sooting above the door.

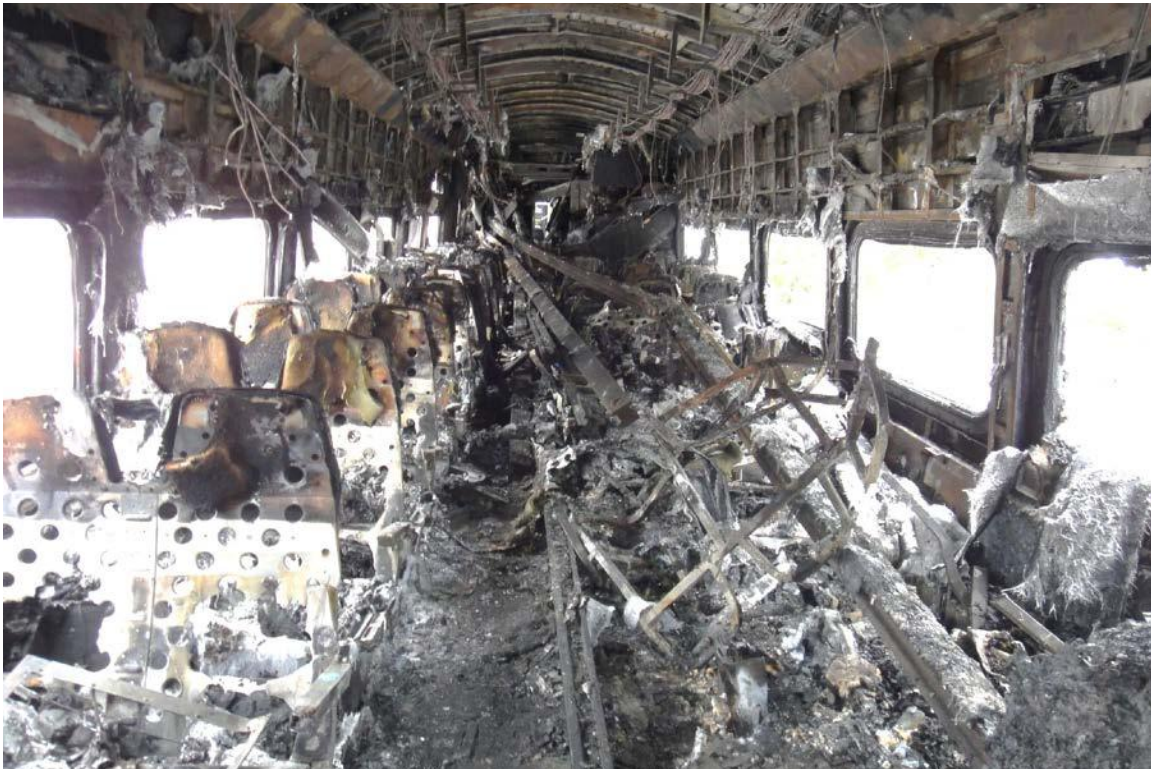
An overall floorplan of the rail car is showing in Figure 15. The interior of the Operator's and passenger compartments exhibited significant fire damage. The damage to the passenger compartment is shown in Figures 16-17.

Figure 16. Passenger Compartment - Overall interior of MN 4333 at accident site.

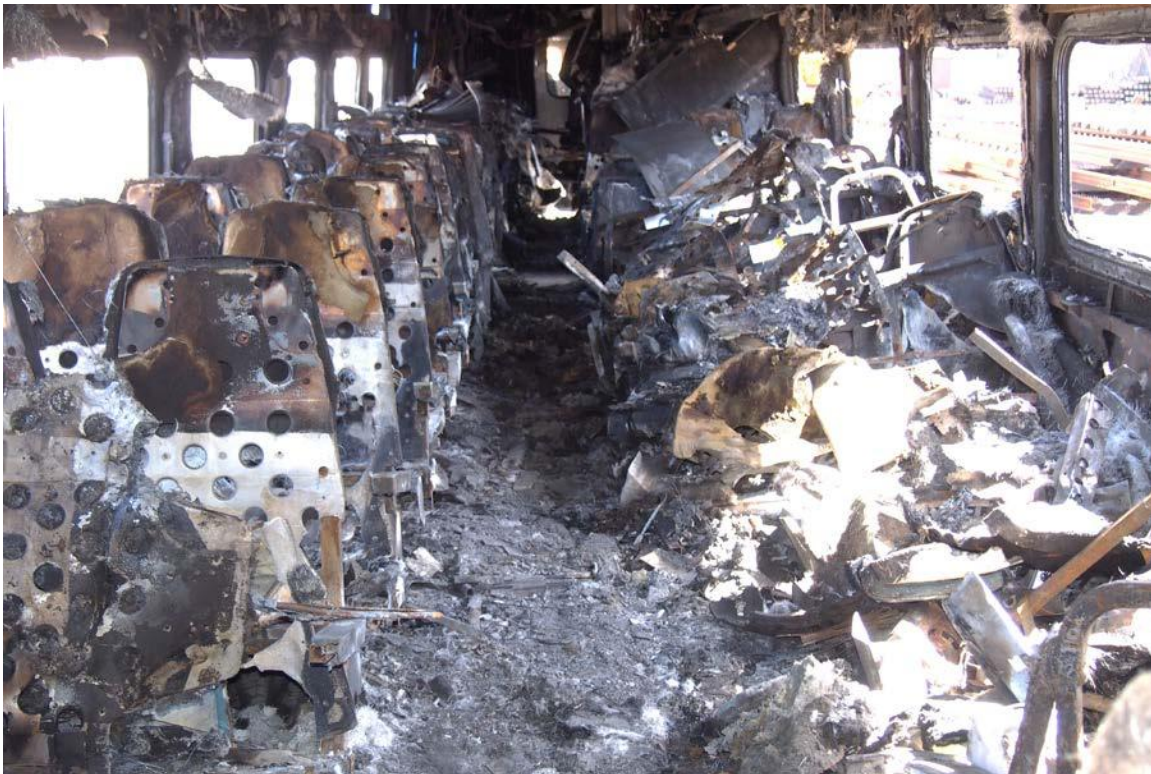
Figure 17. Passenger Compartment - Overall interior of MN 4333 after the removal of the injected rail.

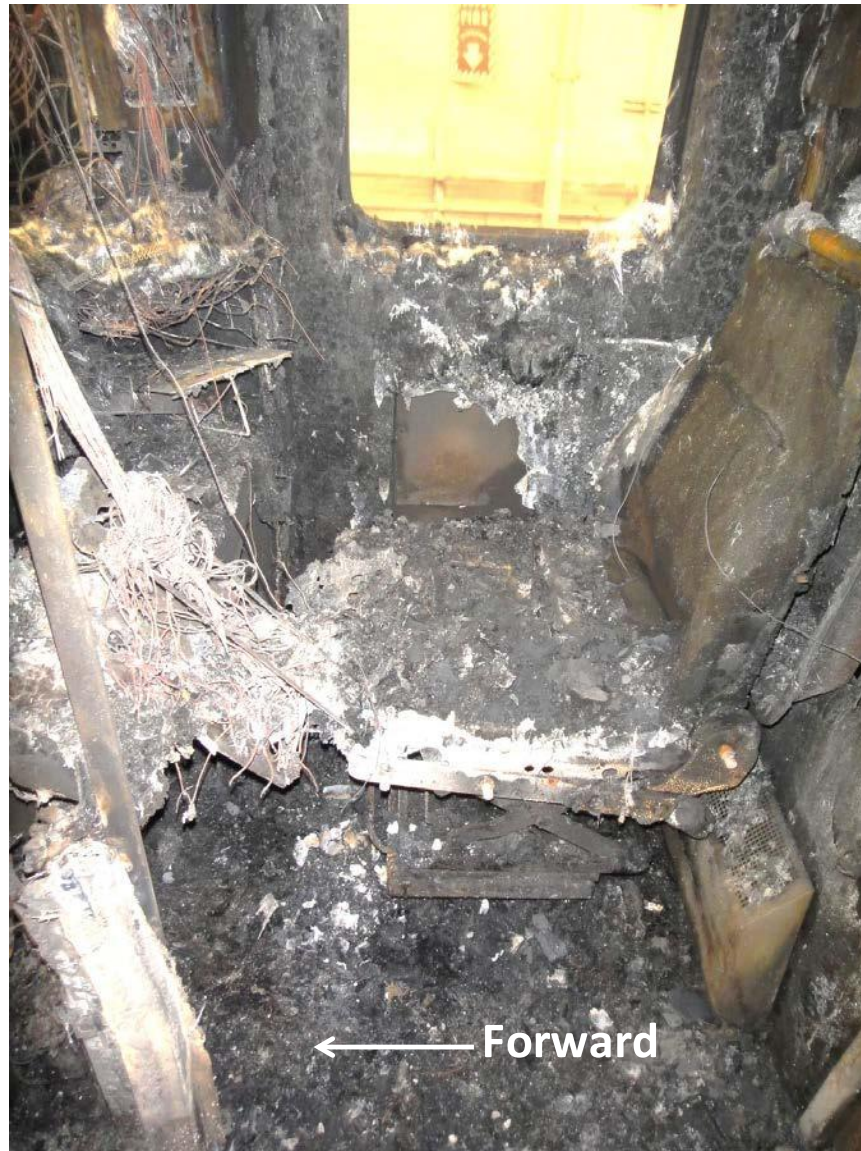
Within the Operator's compartment, most of the non-metallic, interior material was destroyed as shown in Figure 18.

Figure 18. Engineer's seat in Operator's compartment.

The engineer/operator's seat cover was destroyed⁴. Most the seat and back cushions were still present but exhibited scorching and sooting. There was no visible damage to the seat frame. For the flip-down/observer seat across the aisle, most of the cushion material had been consumed, exposing the seat frame and internal support structure as shown in Figure

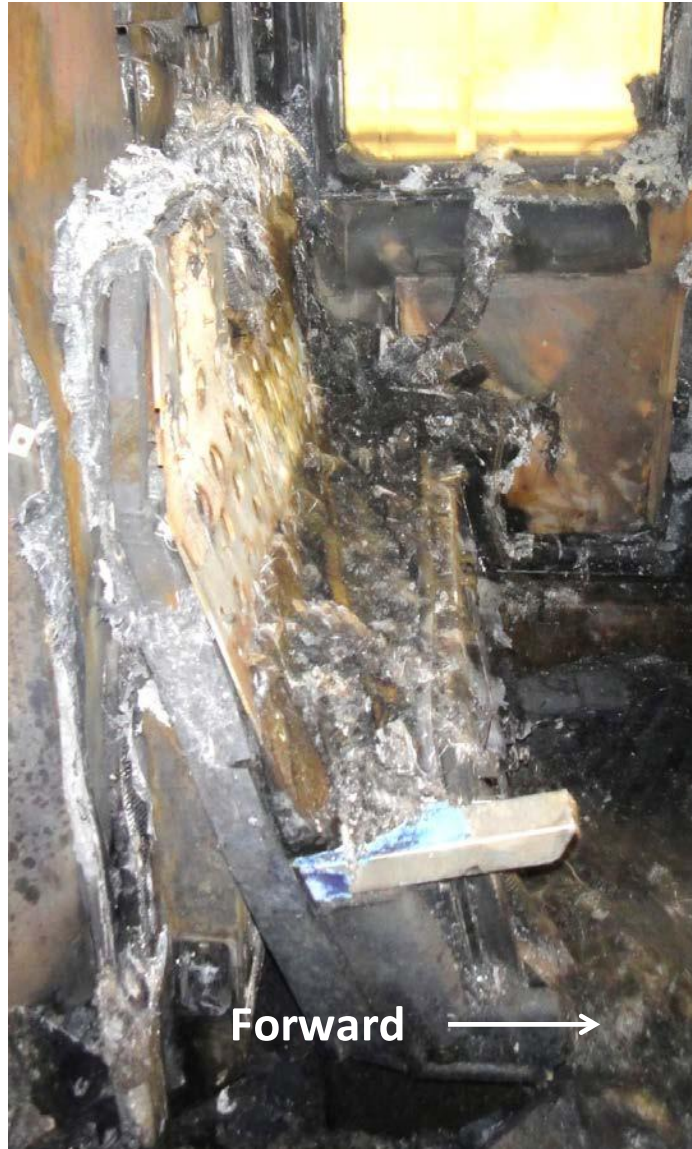
19⁵. Most of the wall and window masks and all of the ceiling panels were consumed in the fire as were the door panels for the compartment door⁶. All of the control panels were also destroyed.

Figure 19. Observer's seat in control compartment.

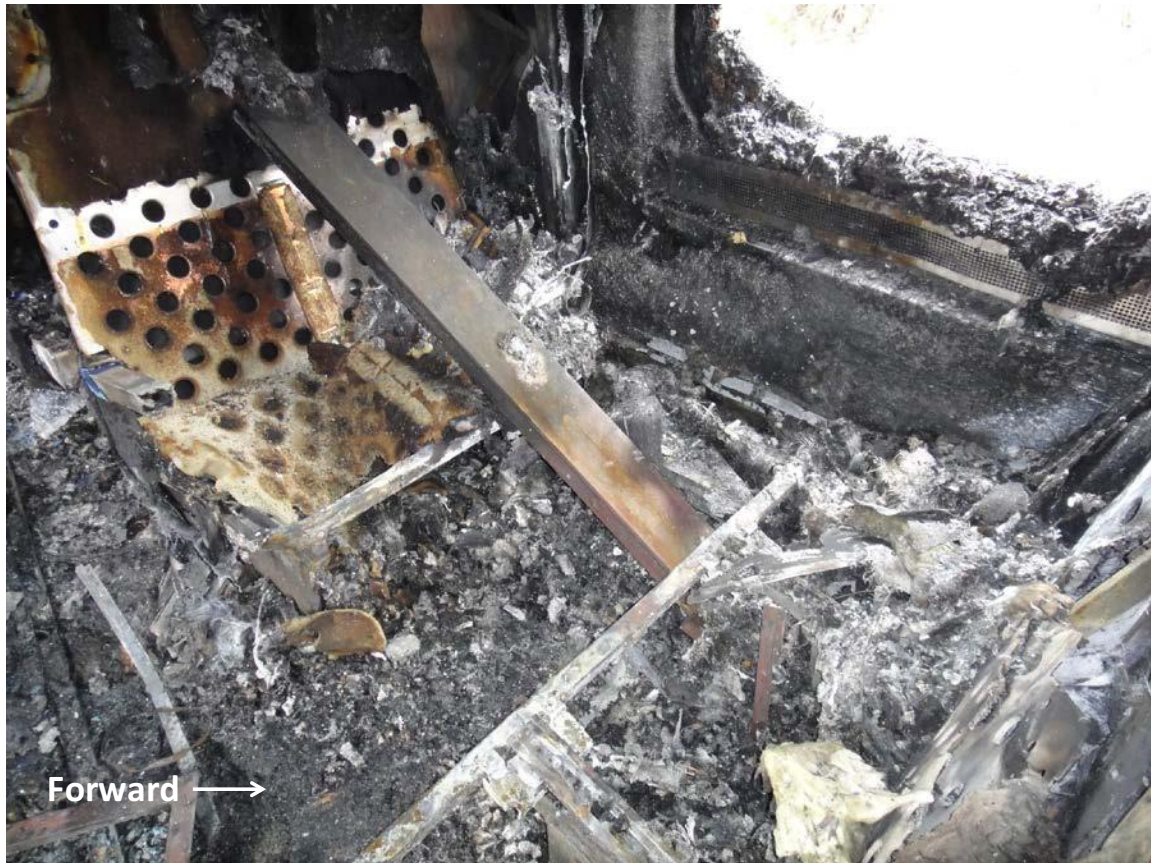
Eleven (11) sections of 3rd rail entered the first car. The approach or nose section penetrated the rail car floor between rows 1 Left (L) and 2L (located between the Operator's compartment and the F-end vestibule) as shown in Figure 20.

Figure 20. Nose piece of 3rd rail.

This section was wedged in the floor and held up by the handhold between the two passenger seat frames. The remainder of the rails entered Car MN 4333 through a penetration located in the left side, F-end vestibule in front of passenger side door. These rails came to rest in various locations inside the car. Several of the rails struck the B-end bulkhead end sheathing, leaving impact marks on the in the end sheathing. One rail penetrated the B-end end sheathing at the upper right side corner of MN 4333 and entered the B-end sheathing of car MN 4332.

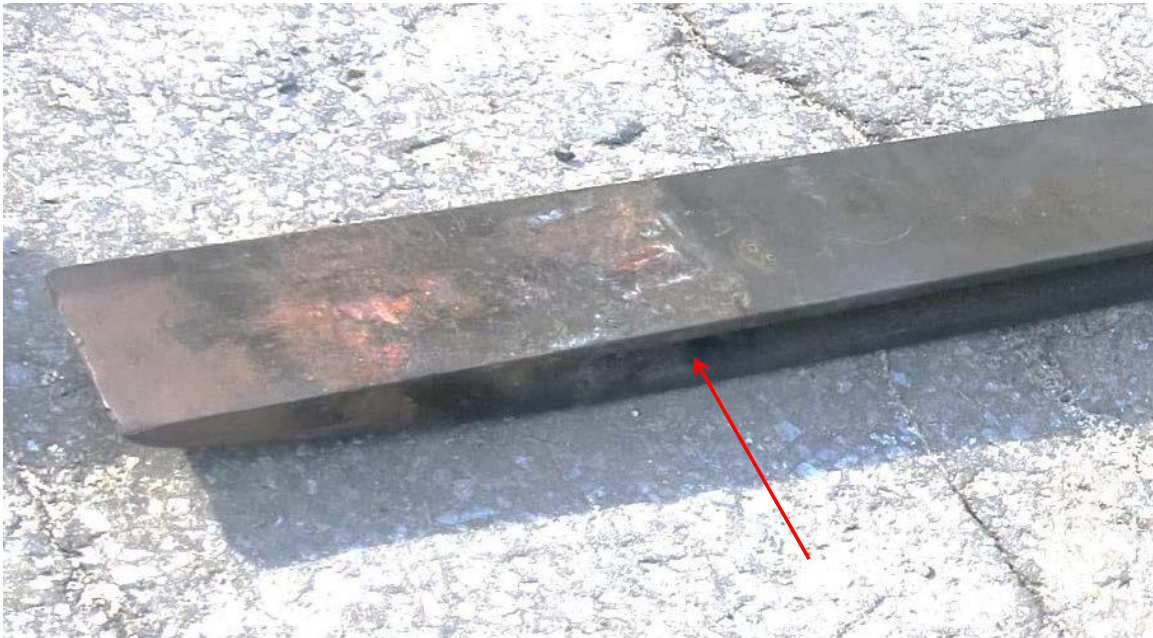
There were no obvious signs of electrical arcing/activity to the surrounding rail car structure. There were two rails that exhibited atypical, localized thermal damage on the surface of the rail. One rail was the nose piece and the damage is shown in Figure 21. The second rail was the rail removed from the SUV as shown in Figure 22.

Figure 21. Localized thermal damage (highlighted with red arrow) to surface of nose piece rail.
