NATIONAL TRANSPORTATION SAFETY BOARD

FIRE GROUP FACTUAL REPORT

Report No. 15-058

NTSB #: **DCA15MR006**

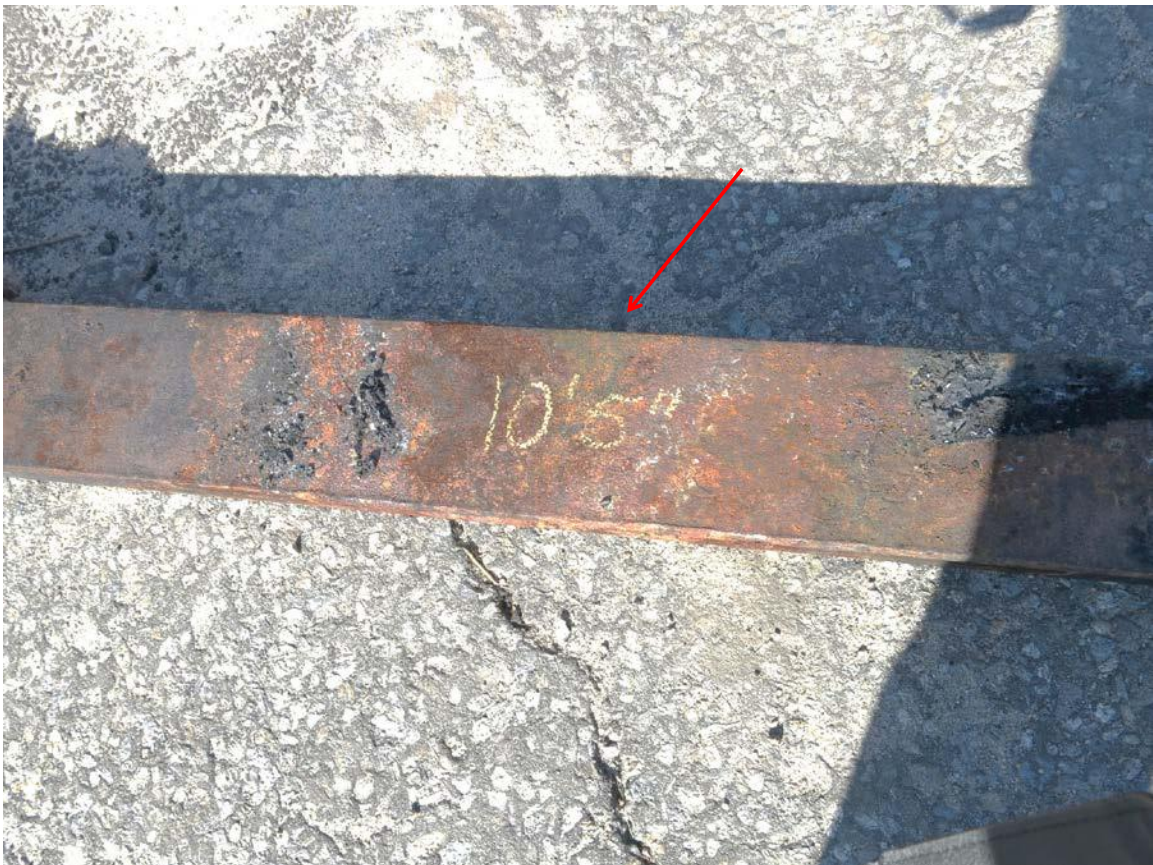
Figure 22. Localized thermal damage (highlighted with red arrow) to surface of rail removed from SUV.

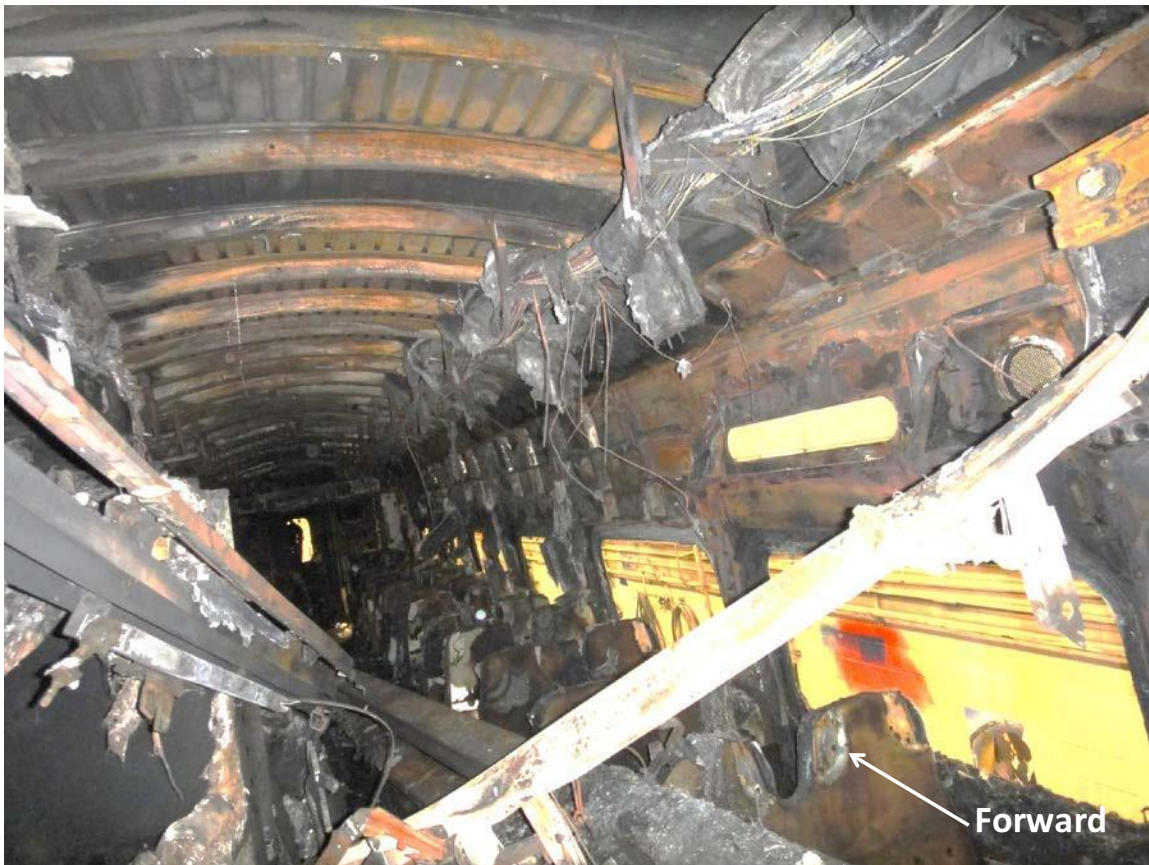
All of the cable runs in the ceiling were present. An example is shown in Figure 23.

Figure 23. Section of cable run near the right rear passenger door.

However, all of the insulation had been burned away. The conductors to the cables appeared to be mostly intact with several mechanical breaks present. These breaks were concentrated in the areas where the cables ran through the aluminum cable run hangers and in areas where 3rd rails came into contact with the ceiling and walls. There were no obvious signs of electrical arcing on any of the visible conductors. One cable run hanger was melted with a significant portion of the inboard side missing as shown in Figure 24. All other cable run hangers were intact.

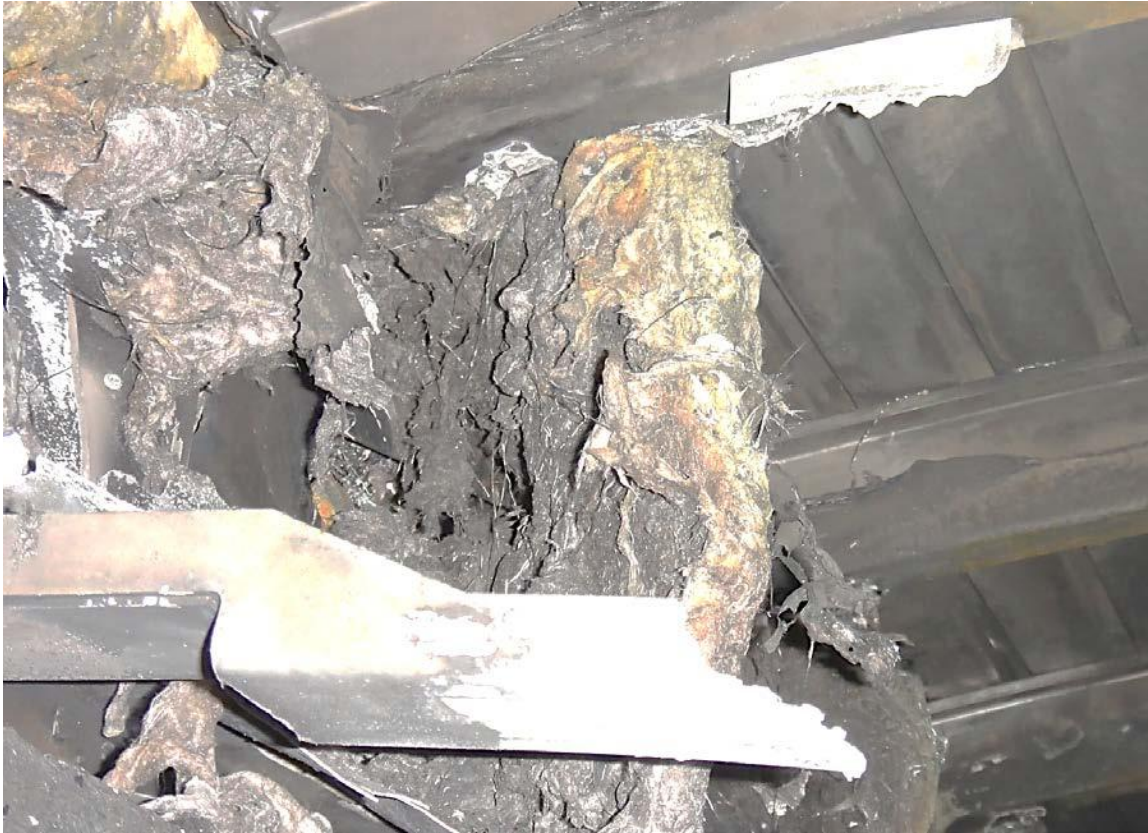
Figure 24. Damaged cable run hanger located above the toilet.

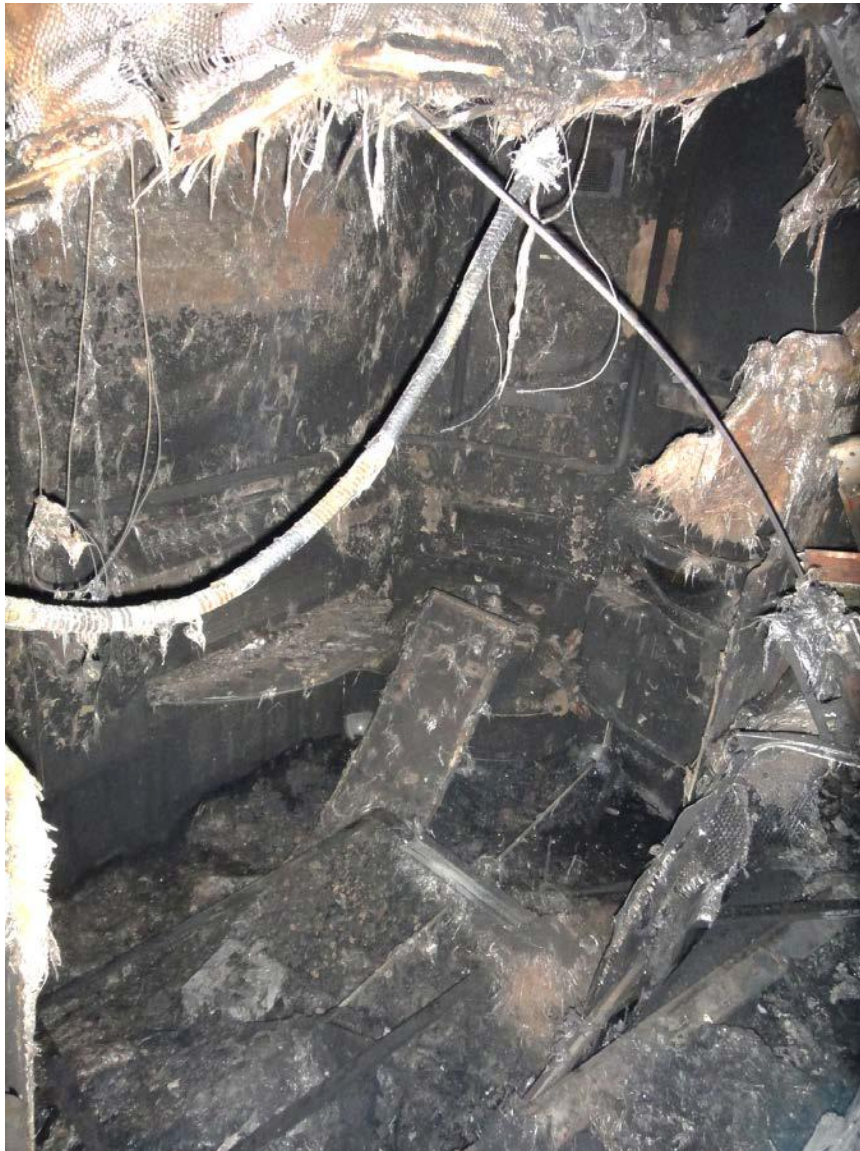
The toilet module¹⁷ was located near the left rear passenger door. The module exhibited severe fire damage. The door and most of the non-metallic components in the bathroom were destroyed as shown in Figure 25. The resin was burned out of FRP leaving behind the glass fiber mat.

Figure 25. Damaged toilet module.

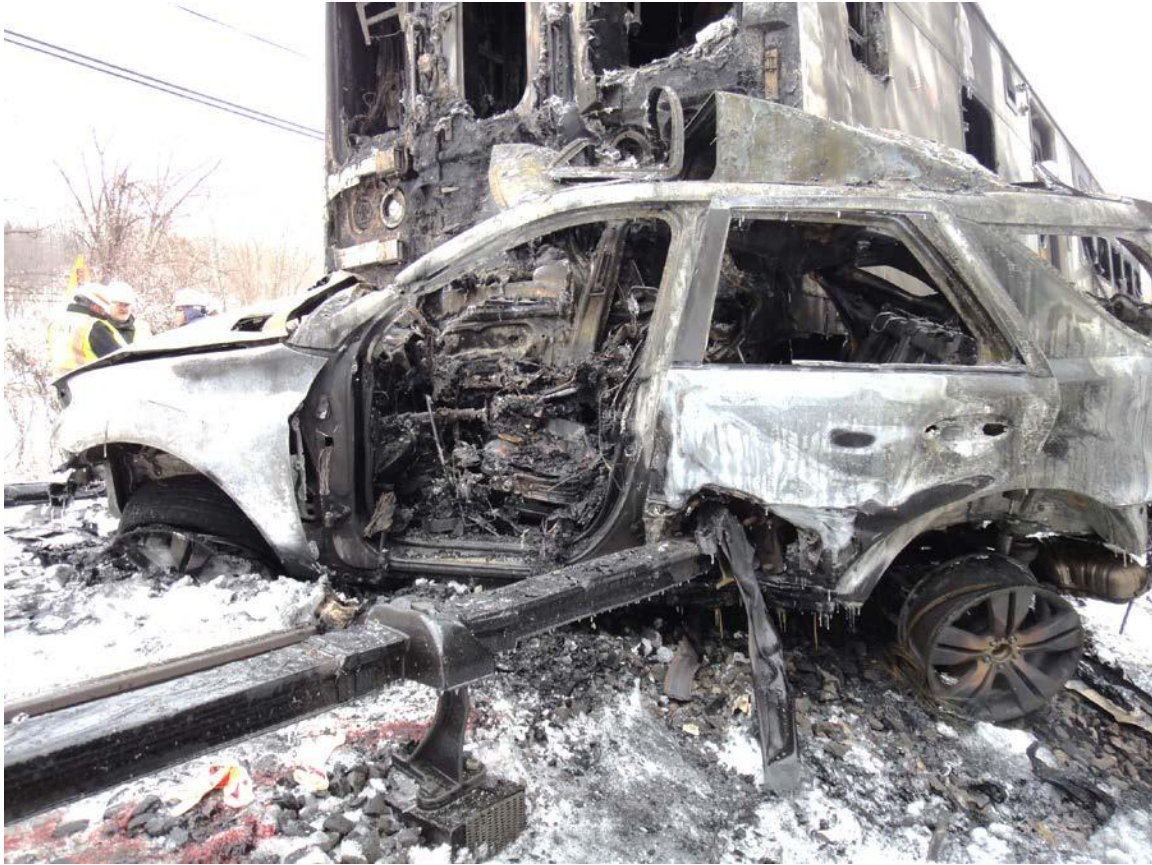
The SUV sustained heavy fire and mechanical damage over the entire structure as shown in Figure 26¹⁹.

Figure 26. Driver's side of the SUV on-scene.

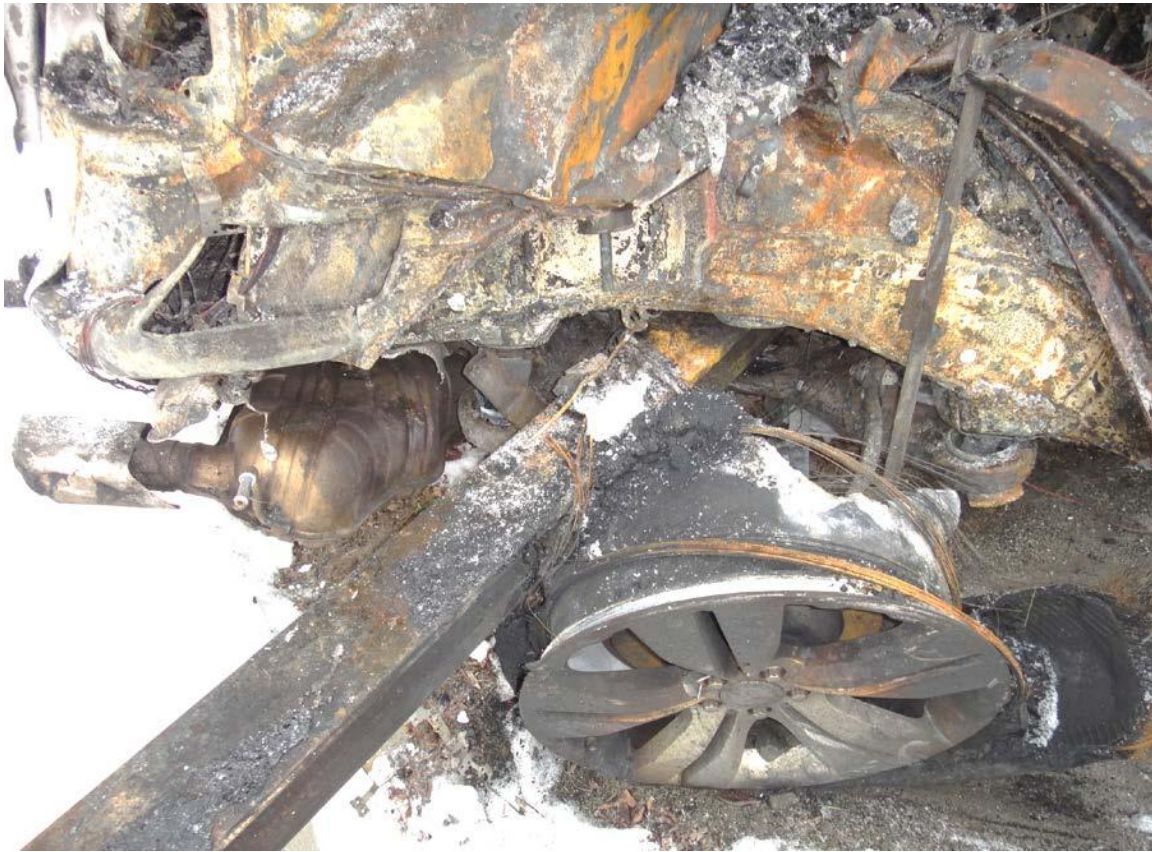
The two front tires were partially intact. The rear passenger tire was partially consumed leaving only the metal reinforcements. A portion of the interior lip of the tire rim was missing as shown in Figure 27. The rear driver's side tire was completely destroyed.

Figure 27. Rear passenger side tire with fire damaged rim.

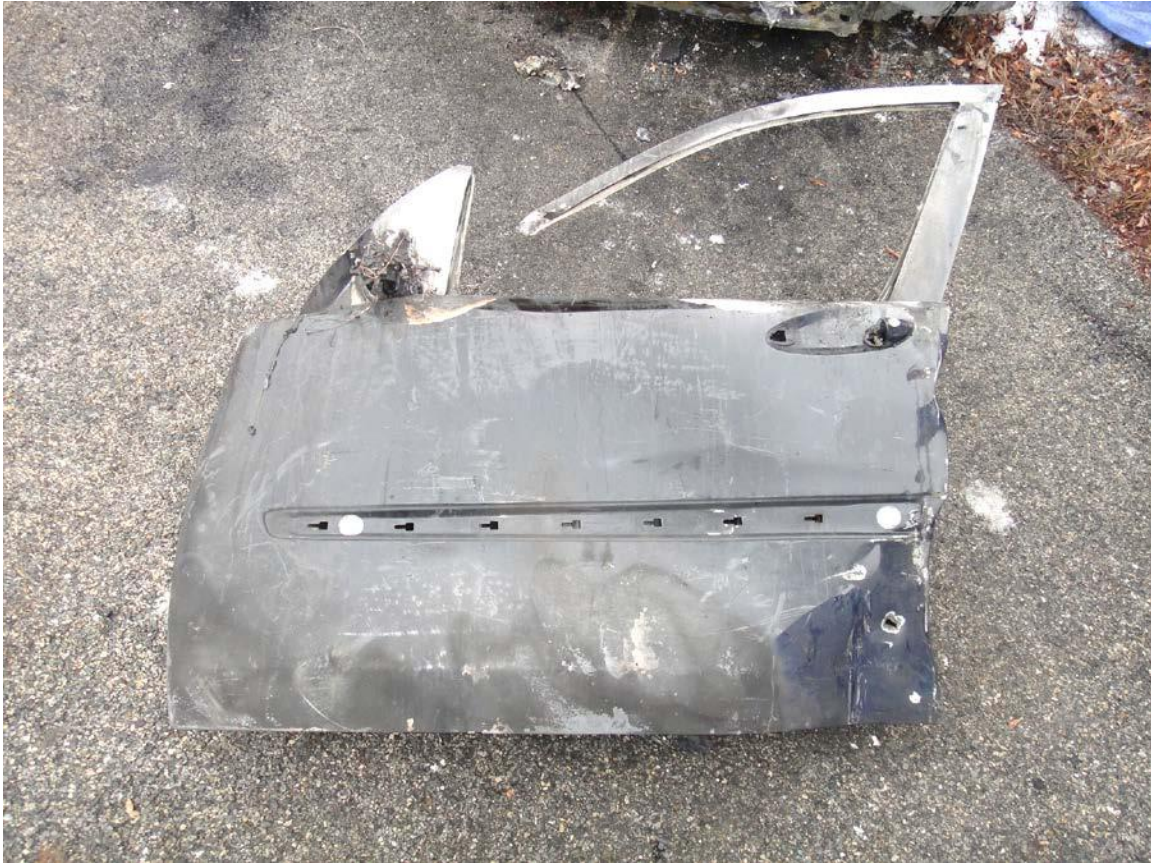
The only component to receive little or no fire damage was the driver's side door. Damage was limited to the upper window frame as shown in Figure 28. The door exhibited mechanical damage.

Figure 28. Front driver's side door.

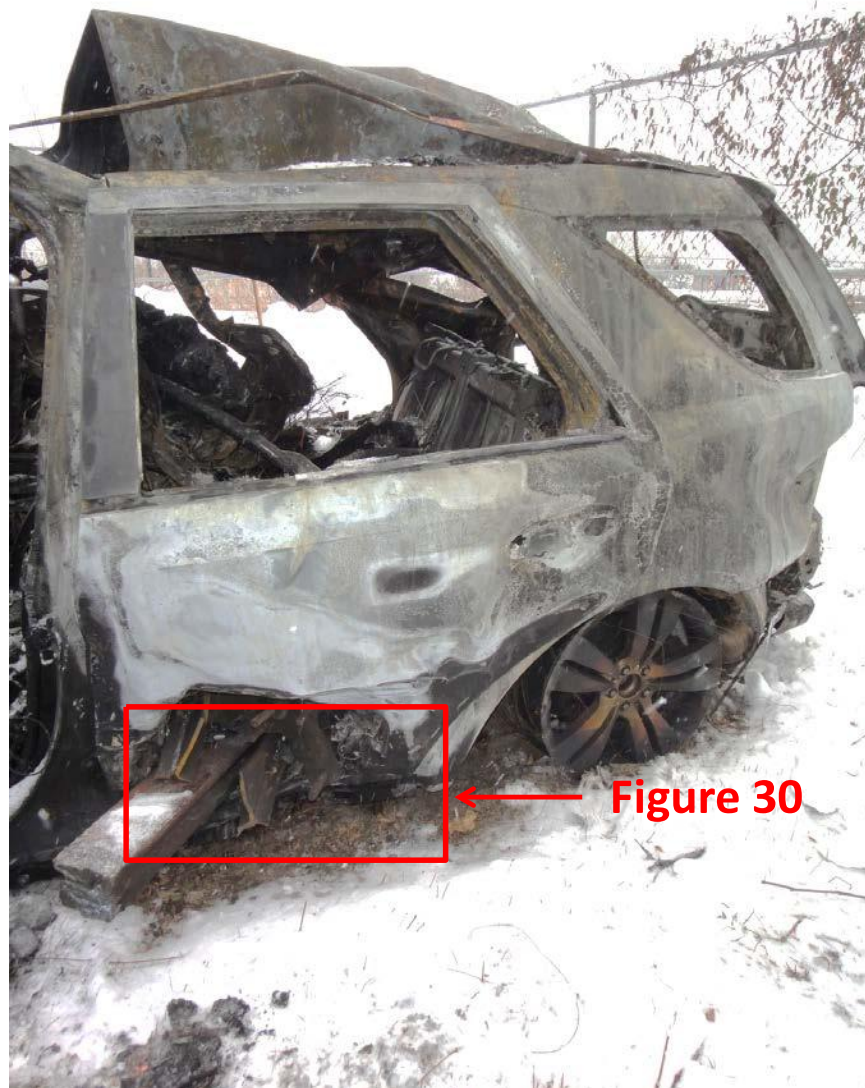
The underside of the SUV exhibited thermal discoloration on metallic components. Most non-metallic components were damaged or destroyed including the fuel tank. The 3rd rail penetrated through the entire width of the SUV, running underneath the passenger area as shown in Figure 29.

Figure 29. Entry point for 3rd rail into SUV.

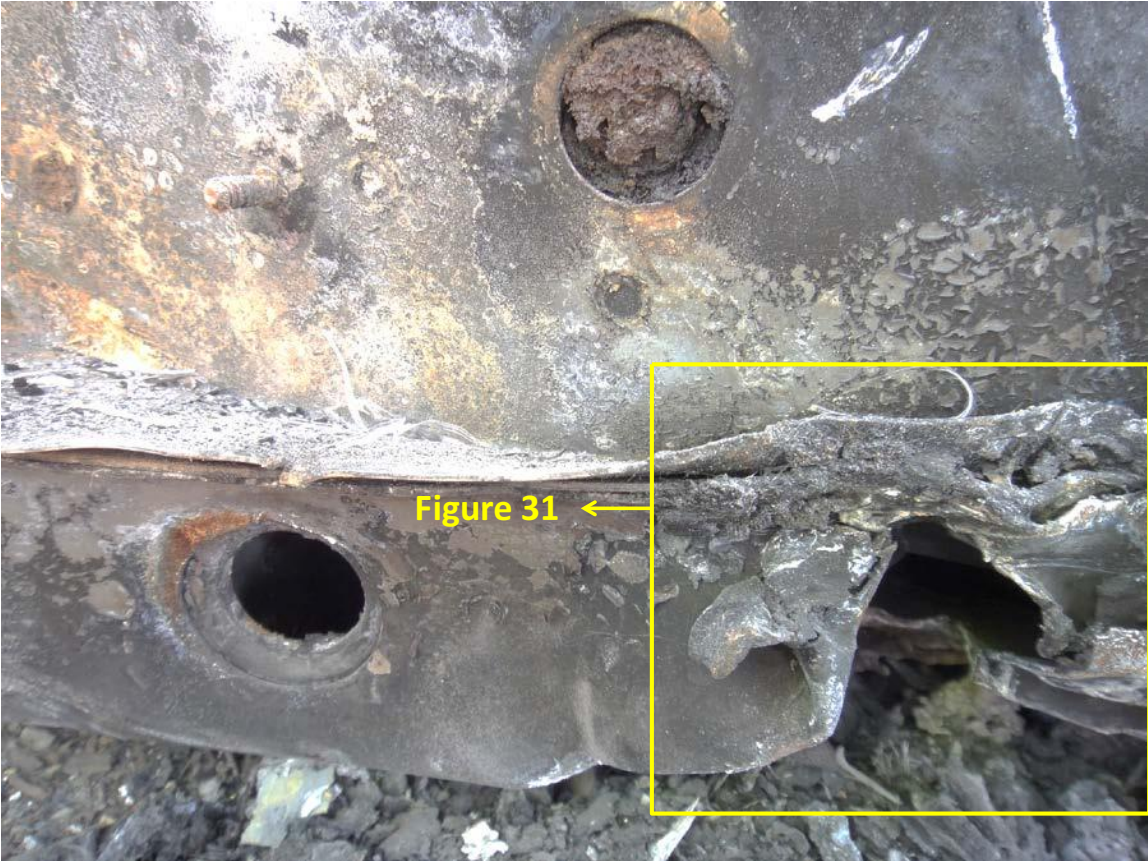
At the rail's entry point, there was an eroded area on the steel car frame underneath the left floorboard of the SUV, forward of the left rear wheel and adjacent to the left lobe of the fuel tank. The erosion pattern on the car frame was consistent with electrical arcing. A close-up of this area is shown in Figures 30-31.

Figure 30. Erosion damage to underside of SUV.

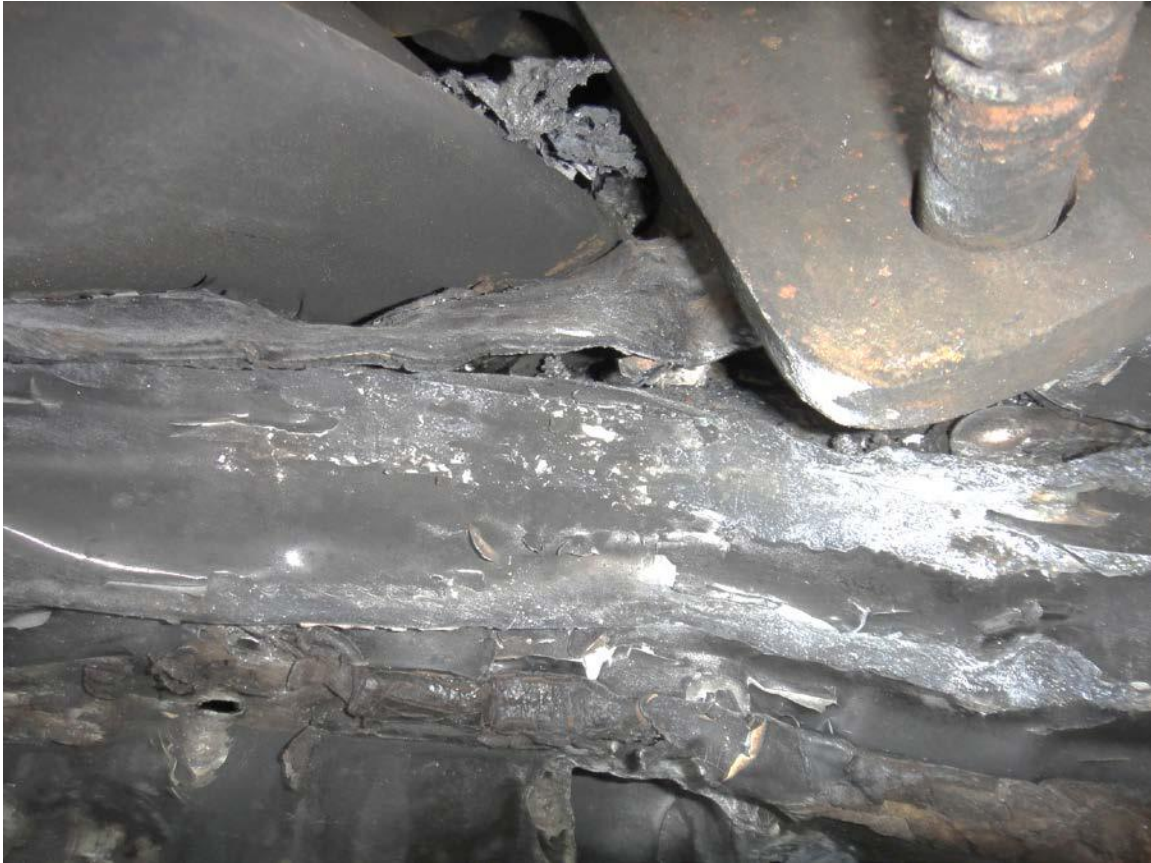
Figure 31. Close-up of erosion of SUV frame.
