NATIONAL TRANSPORTATION SAFETY BOARD

FIRE INVESTIGATION FACTUAL REPORT

Report No. 11-061

Place : Dubai, UAE
Date : 9/3/2010
Vehicle : Boeing 747-400F
NTSB No. : DCA10RA092
Investigator : Bill English

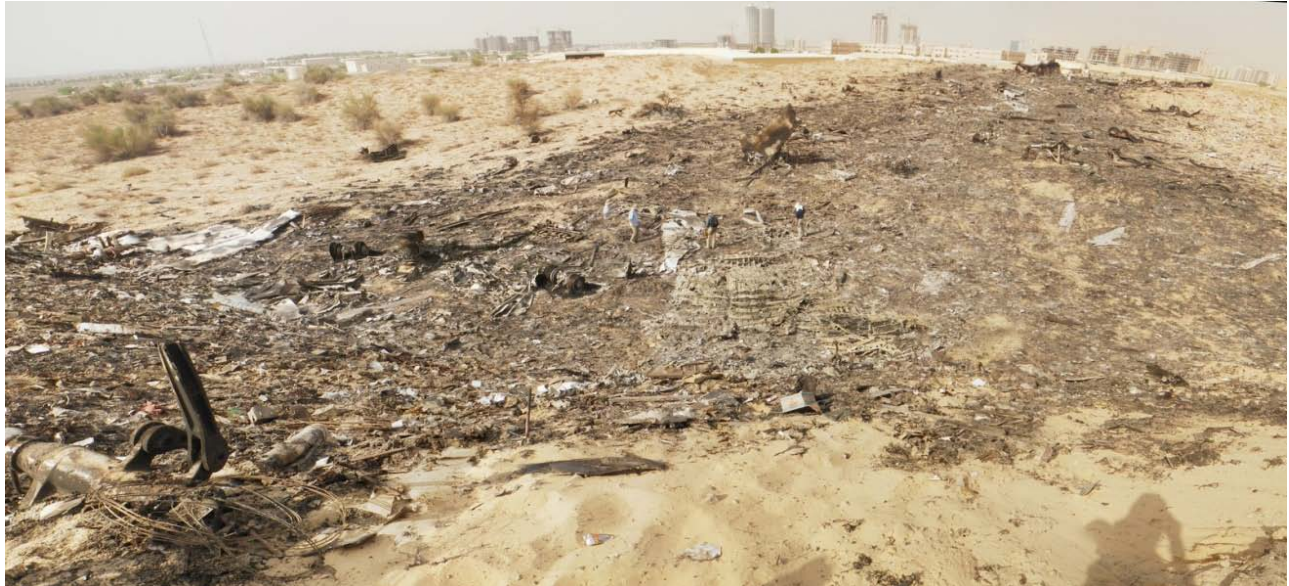
impact, the aircraft destroyed an unknown number of buildings and trucks. There was an extensive post crash fire which consumed the bulk of the aircraft and cargo (figure 1).

Figure 1: Overall view of the debris field, looking back towards the initial impact location

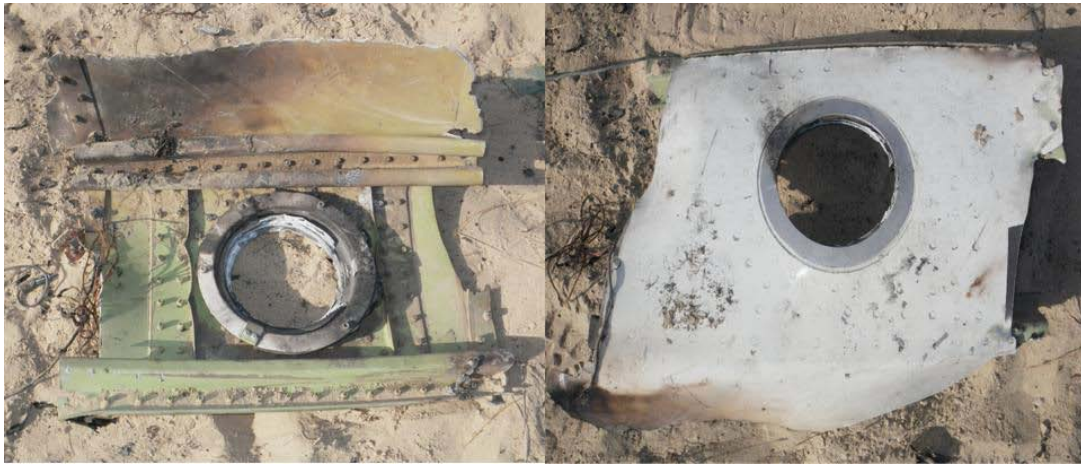
#1: Fuselage observation window (figure 6)

The piece of the fuselage observation window, or viewport, had sooting around the viewport opening and the viewport seal was charred and reduced to a white powder. An area of the green primer had evidence of thermal degradation of the primer paint. The level of damage sustained by the viewport window and seal in contrast to the level of damage to the surrounding material and primer paint is consistent with the thermal exposure having occurred while the viewport was covered by the bezel leaving only the window portion exposed to the interior of the main deck cargo compartment. This viewport was located on the right side of the aircraft at approximate station number 840, which is also cargo position 6R (figure 7).

Figure 6: Fuselage viewport

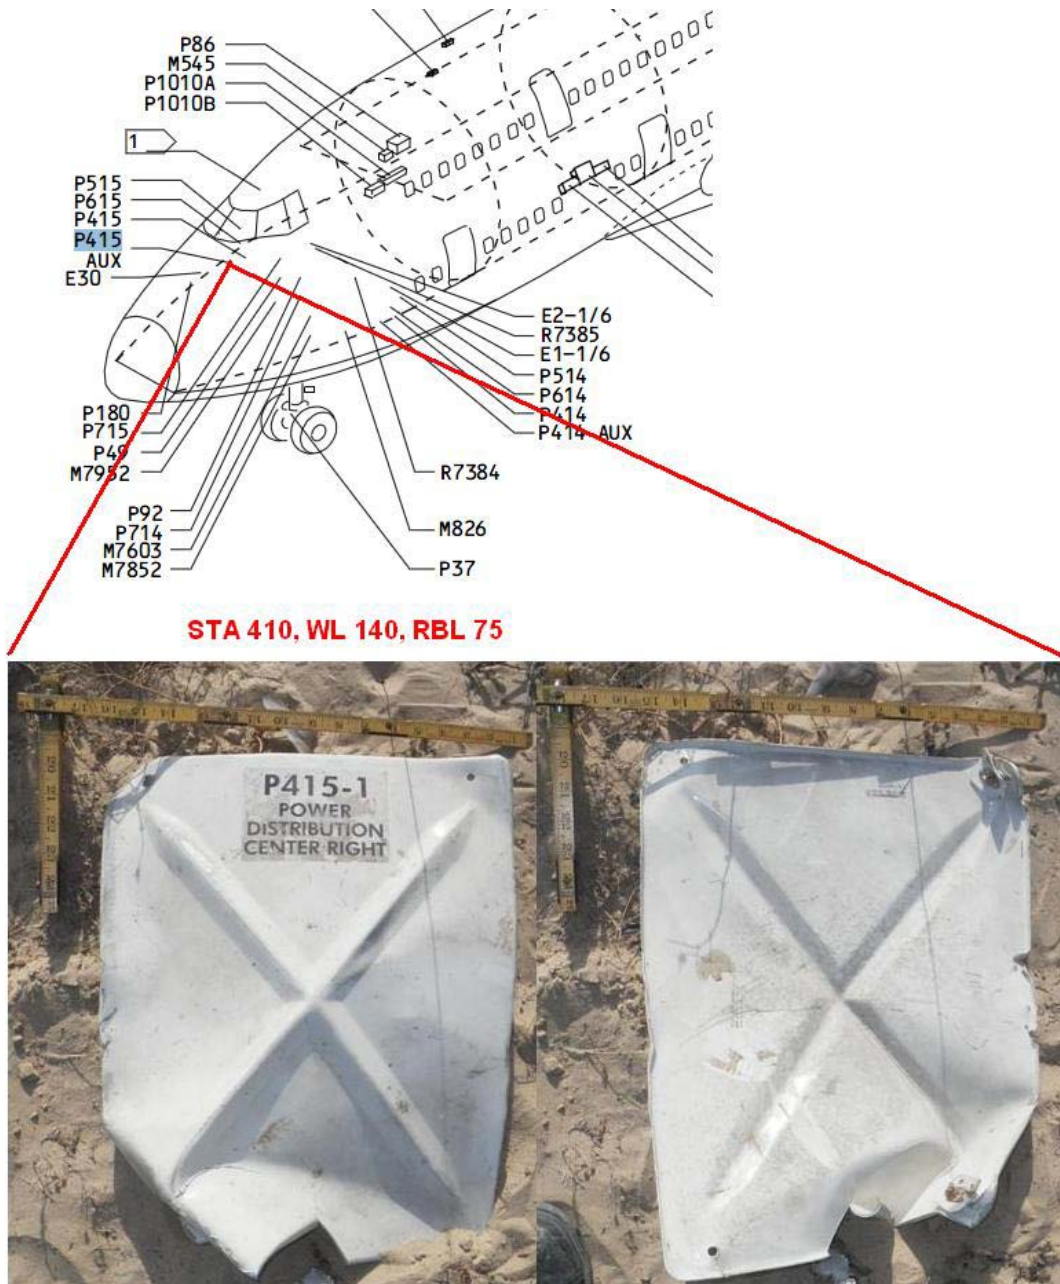
#2: Cover from power distribution center (figure 8)

The cover from the power distribution center right was found to have a light sooting on the exterior and interior surfaces. There was no thermal degradation associated with this component which would have been located at approximately body station 420 on the lower lobe.

Figure 8: Cover from power distribution center

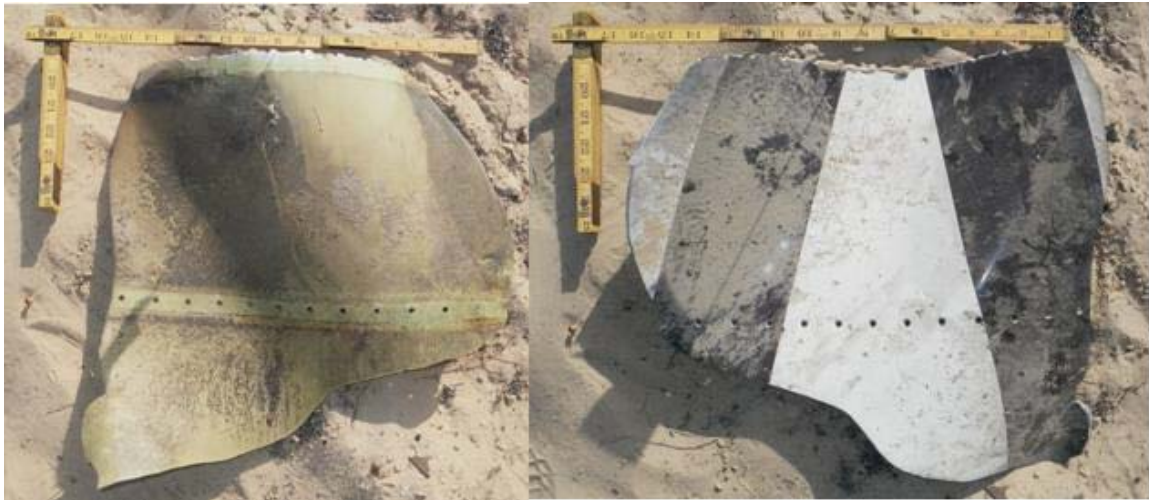
#3 Fuselage skin (figure 9)

The fuselage skin piece was a heavy gauge (~.125") skin piece from fuselage. On the interior surface there is sooted corrosion inhibiting compound (CIC) around a protected surface which became exposed after the aircraft breakup (left photo in figure 9). On the exterior surface of this part is a portion of lettering identified as belonging to the letter "V" (right photo in figure 9) from the text "Worldwide Services" displayed along the upper lobe on the left side of the aircraft (figure 10).

Figure 9: Fuselage skin piece

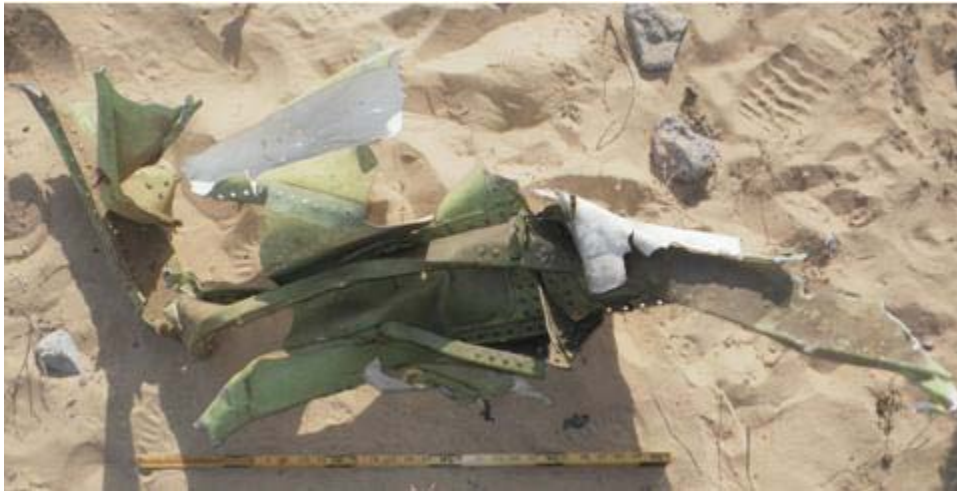
#4 Fuselage skin and structure (figure 11)

The fuselage skin and structure piece originated from the right hand side of the aircraft's fuselage skin between station 460 and 488 and somewhere between stringer 17 and 24. This item was found to have soot trapped within impact induced folds.

Figure 11: Fuselage skin and structure piece

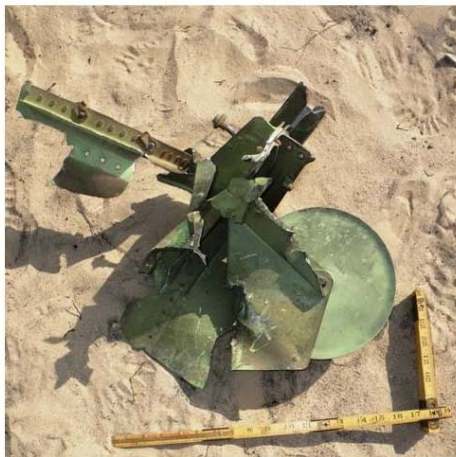
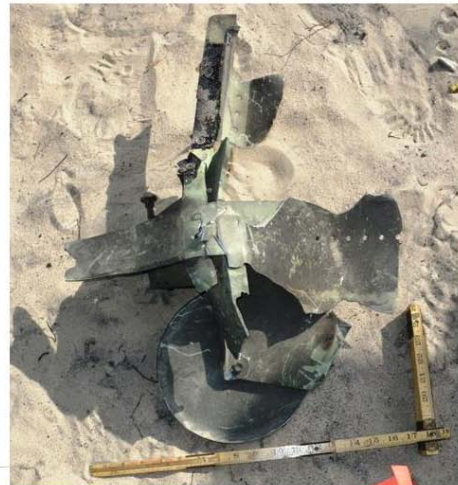
#5 Structure with pulley (figure 12)

The portion of structure with pulley was found to have heavy sooting on one side while being relatively devoid of soot on the other. This item would have been at a location described by, LBL 40, WL 302, station 287 25sv0012.

Figure 12: Structure piece with pulley (showing both sides)

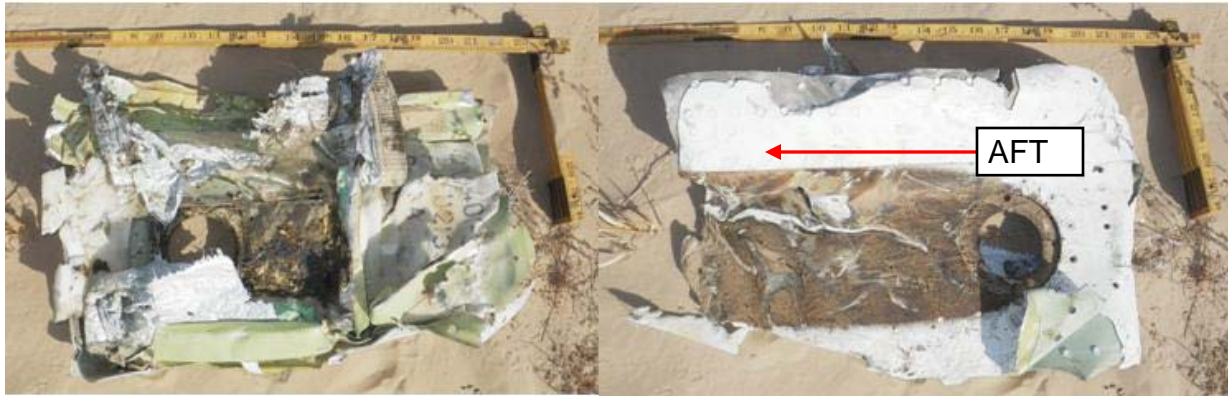
#6: Fuselage skin with smoke shutter cutout (figure 13)

The portion of fuselage skin contained the cutout for the flight deck's smoke evacuation shutter. The actual smoke shutter had separated from this portion of the fuselage. A very thick soot trail almost resembling tar extended from the cutout location aft to the end of the recovered portion of fuselage. A photo of an exemplar smoke shutter and cutout is shown in figure 14.

Figure 13: Fuselage skin piece with smoke shutter cutout (interior on the left, exterior on the right)

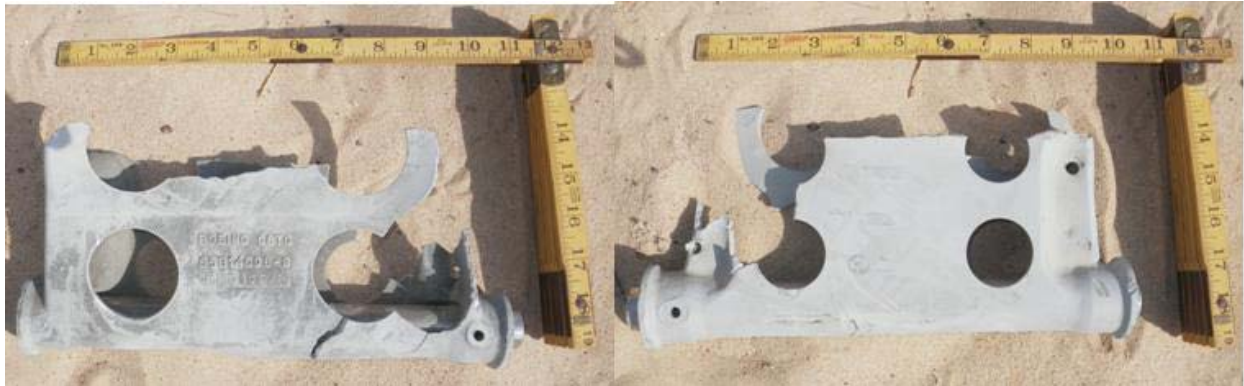
#7 Hinge casting (figure 15)

The hinge casting (PN:65b14006-3) piece was found with soot on one side and clean on the other. This item belonged to the escape slide mechanism on the right side of the upper lobe just aft of the flight deck (figure 5).

Figure 15: Hinge casting piece

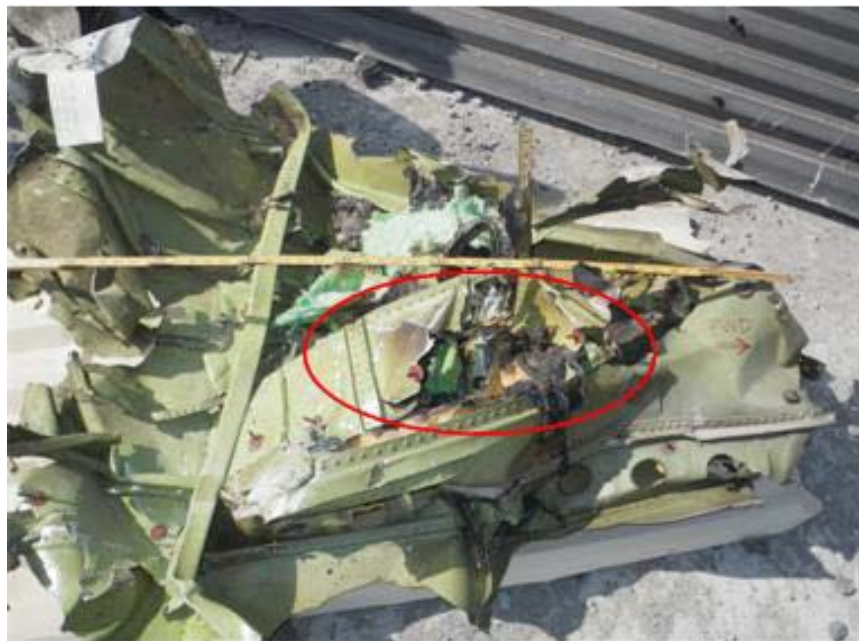
#8 Portion of nose door (lower)

This portion of the nose door (figure 16) was from the lower part of nose door on the right hand side near station 180. This item exhibited localized charring of the primer and some burnt insulation in the area shown circled in figure 16.

Figure 16: Portion of nose door (lower right hand side)

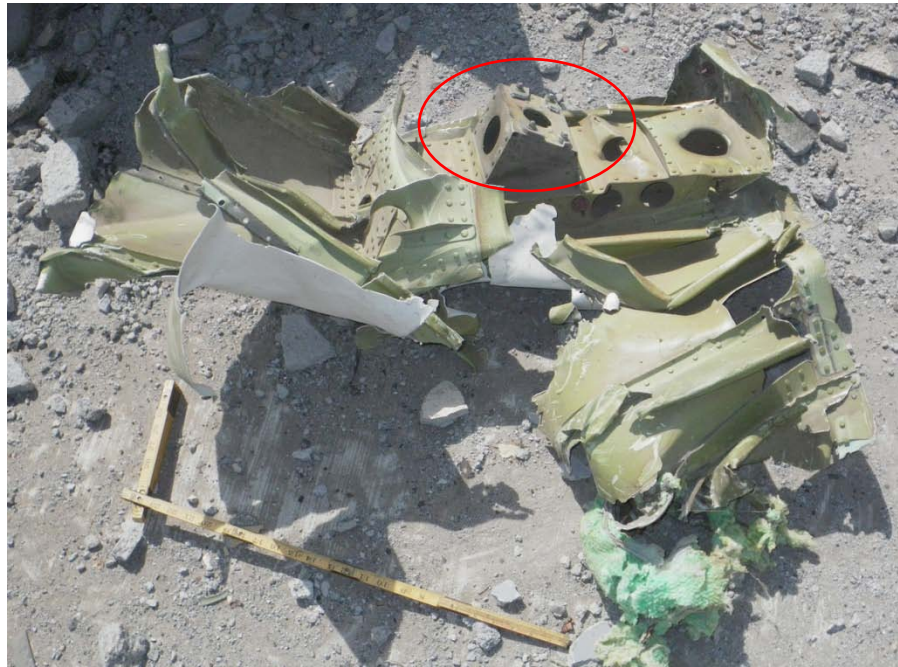
#9 Portion of nose door (upper)

This portion of nose door (figure 17) was from the upper portion of the door on the left hand side approximately between stations 160 to 200. This piece exhibited some localized discoloration of primer shown circled in figure 17.

Figure 17: Portion of nose door (upper)

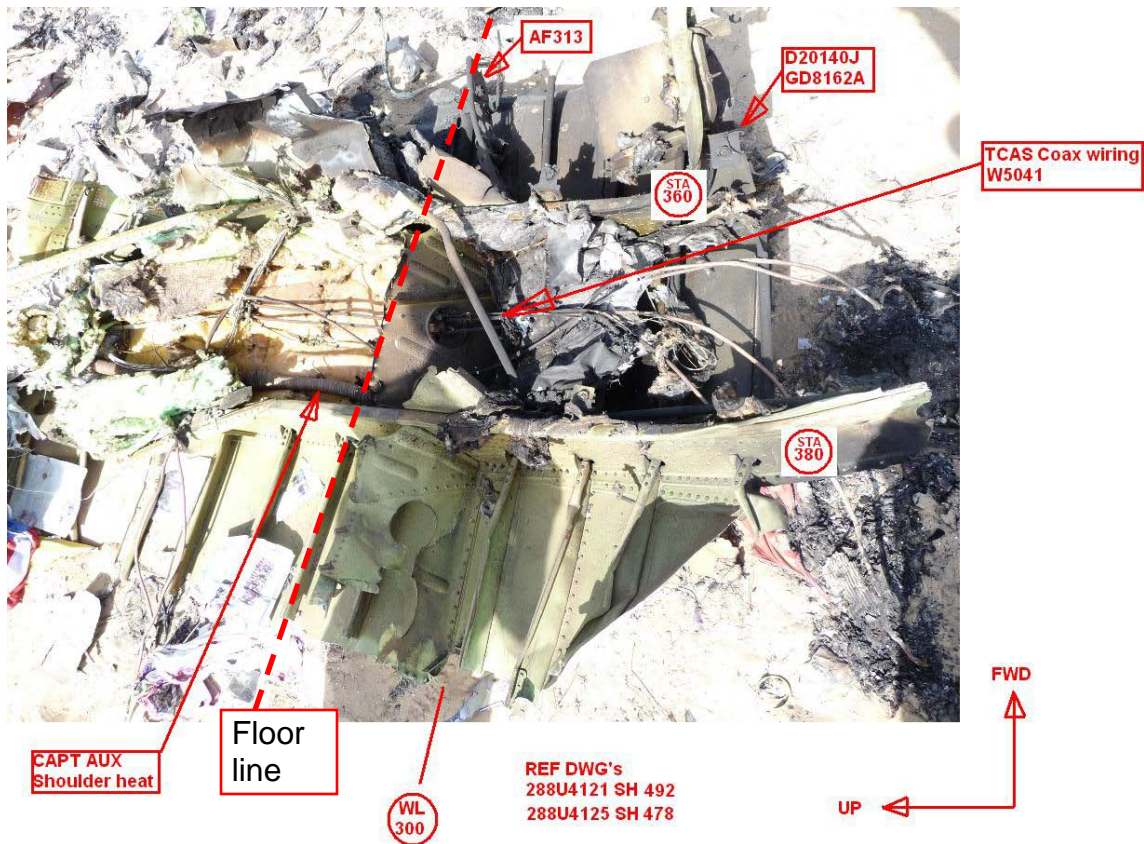
#10 Portion of structure and fuselage skin (figure 18)

This portion of structure and fuselage skin originated from the left hand side, upper section 41, Station 360 – 420. There was heavy fire damage in the form of charred insulation and primer paint between stations 360 and 380 stopping at the level of the upper deck floor (figure 18). The fire-damaged area contained TCAS coax cables and an air vent hose.

Figure 18: Portion of structure and fuselage skin

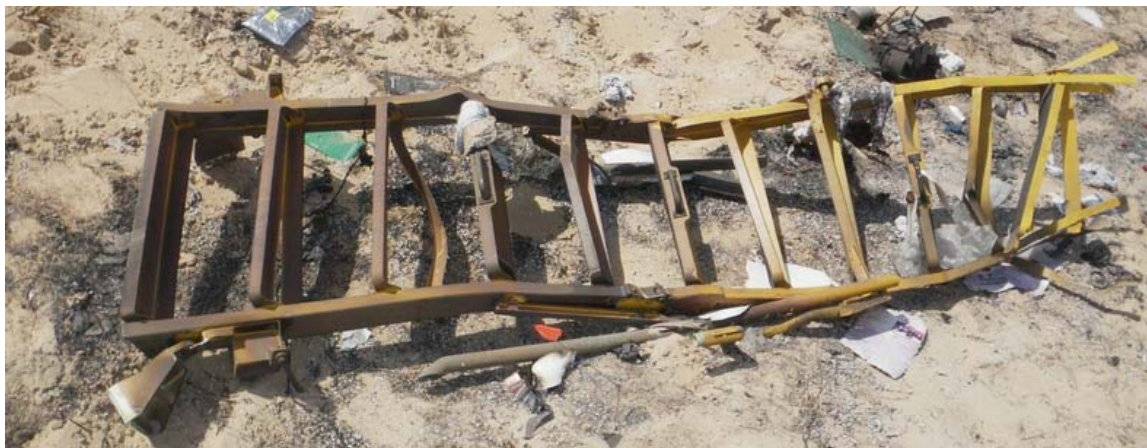
#11 Stairs to the flight deck (figure 19)

The stairs to the flight deck extend from the floor of the main cargo deck up to the upper deck. The stairs have sooting at the top portion of the stairs which then tapers off towards the bottom. This soot graduation is consistent with a stratified smoke layer existing within the main cargo deck. The demarcation of sooting on the stairs suggests a smoke layer extending to the height shown by the dotted line in figure 20.

Figure 19: Stairs to the flight deck

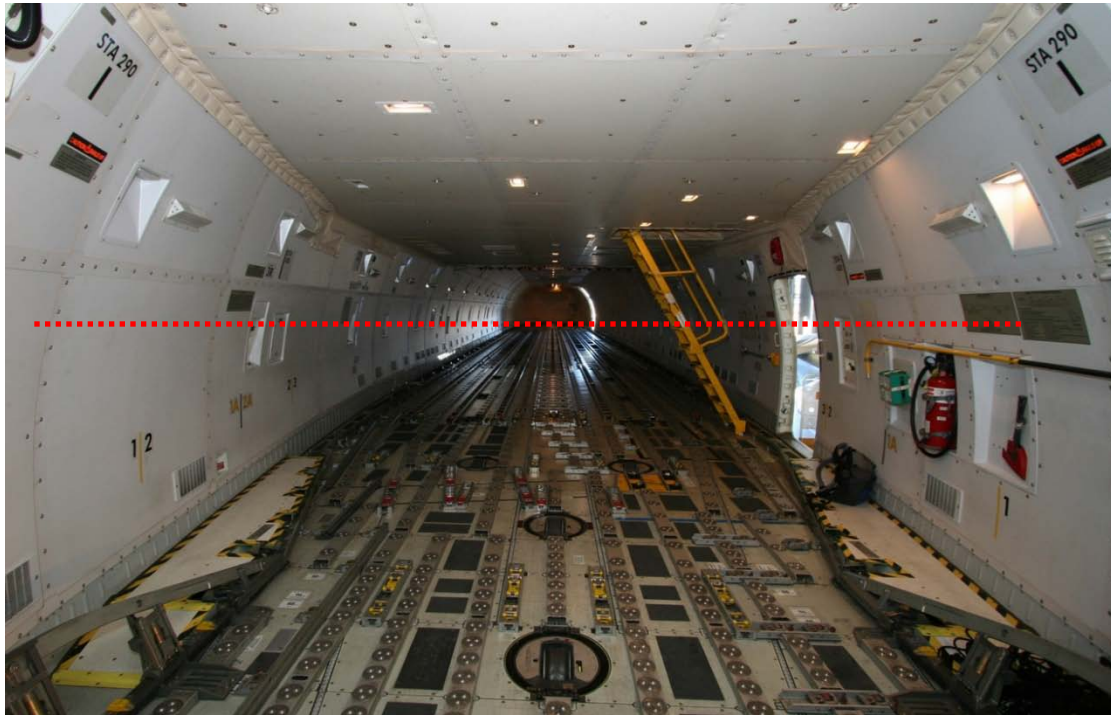
Figure 20: Exemplar interior showing stairs to the flight deck and a dotted line showing the level of the smoke layer

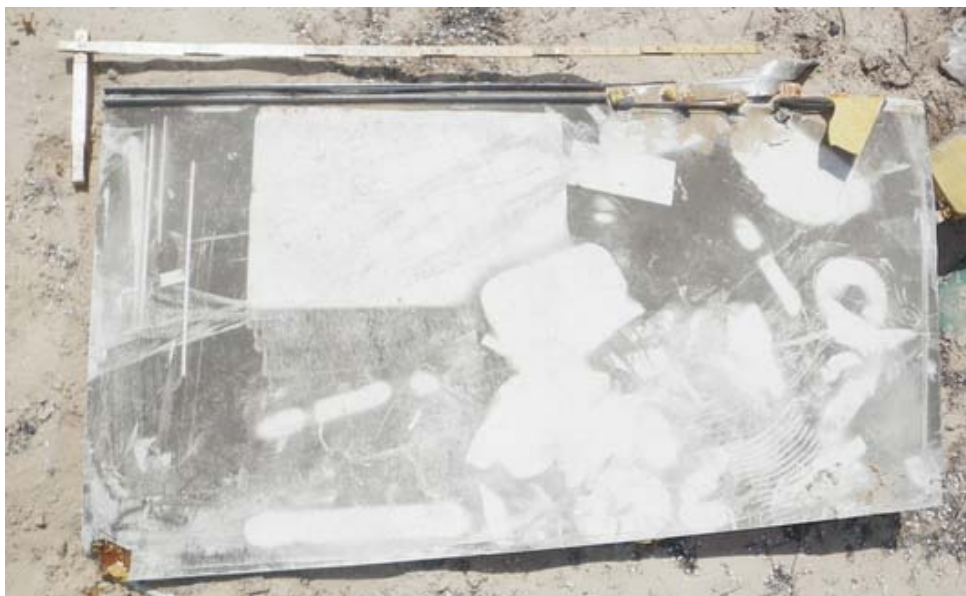
#12 Shelf from galley cabinet (figure 21)

The shelf originated from the cabinet behind flight deck bulkhead (figure 22). The shelf has heavy soot stains around outlines of items that had been sitting on the shelf during flight (figure 21).

Figure 21: Shelf from galley cabinet

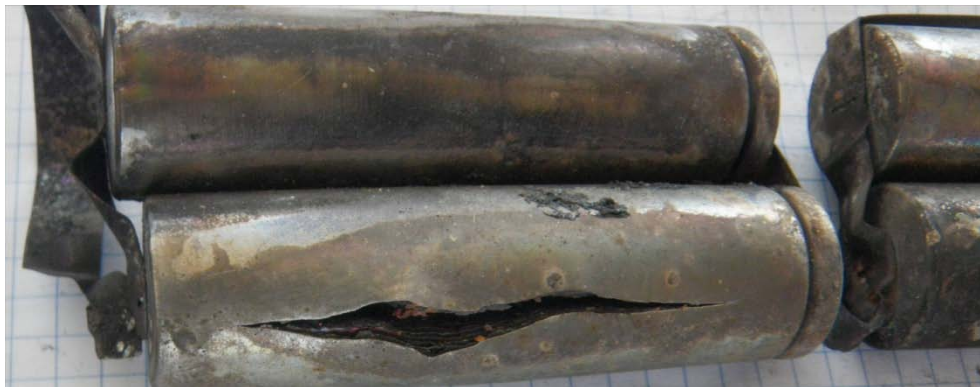
Figure 24: Fire damaged remains of battery pack with a fractured cell

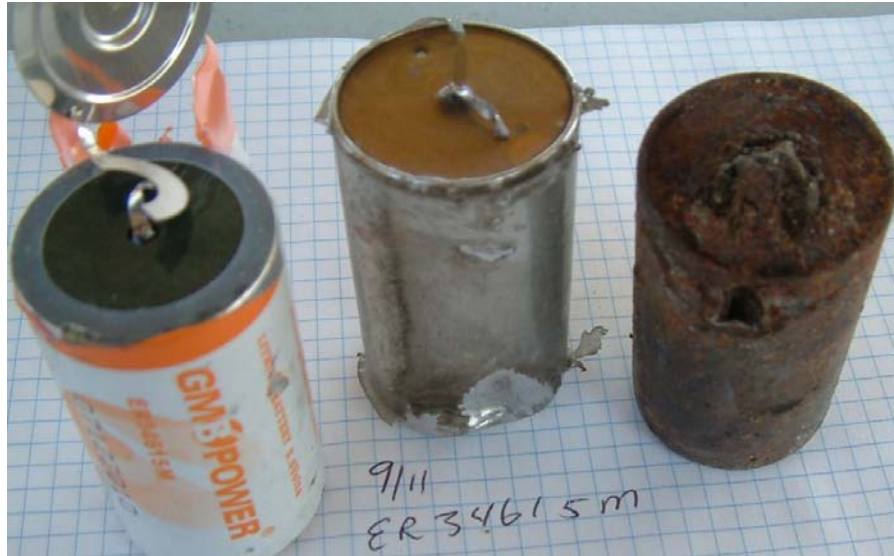
Figure 26: D-Cell size lithium primary batteries. Photo shows fire damaged and undamaged batteries

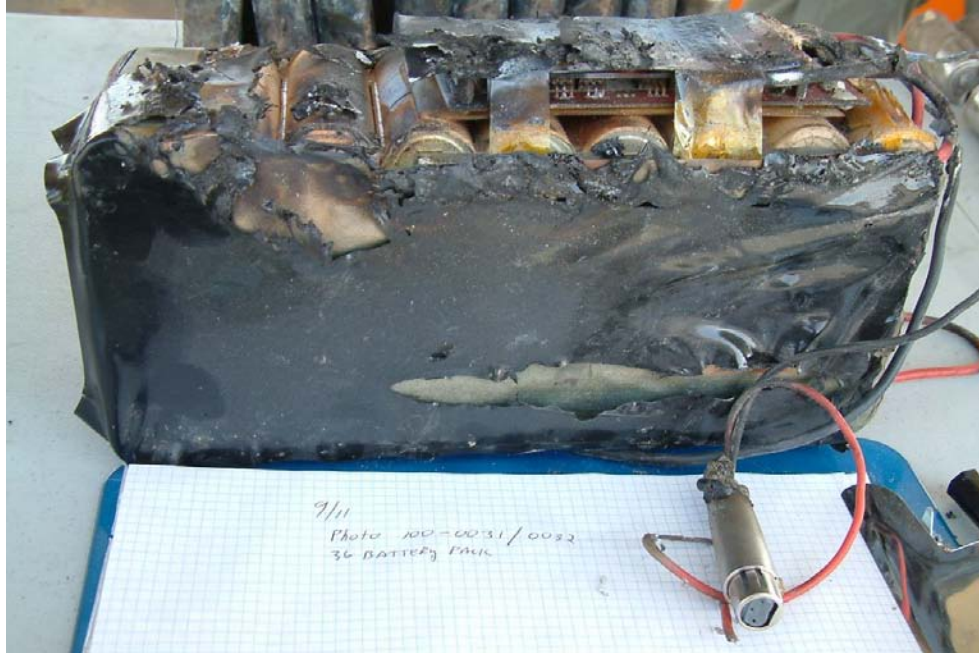
Figure 28: 36-cell lithium-ion battery pack with thermal damage.

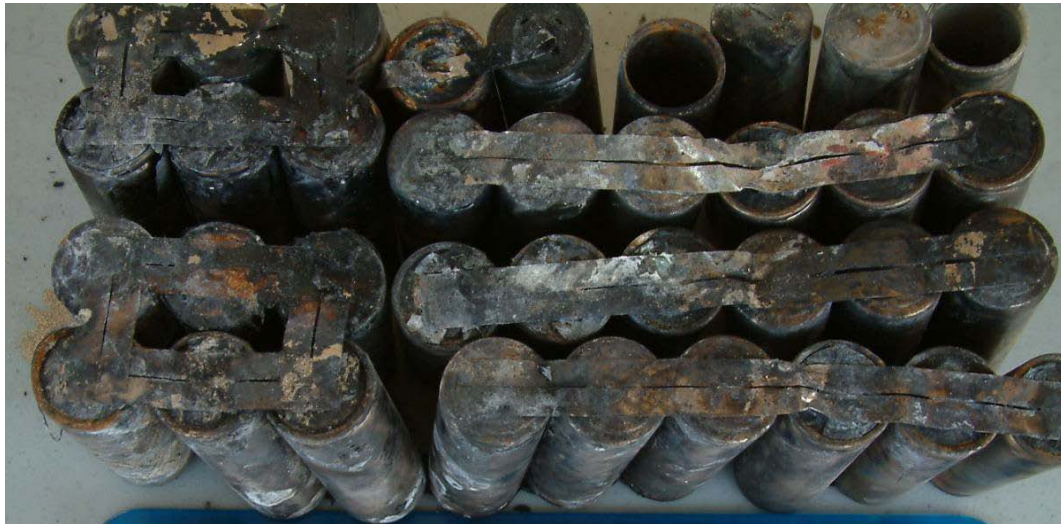
Figure 29: 36-cell lithium-ion battery pack with multiple vented cells

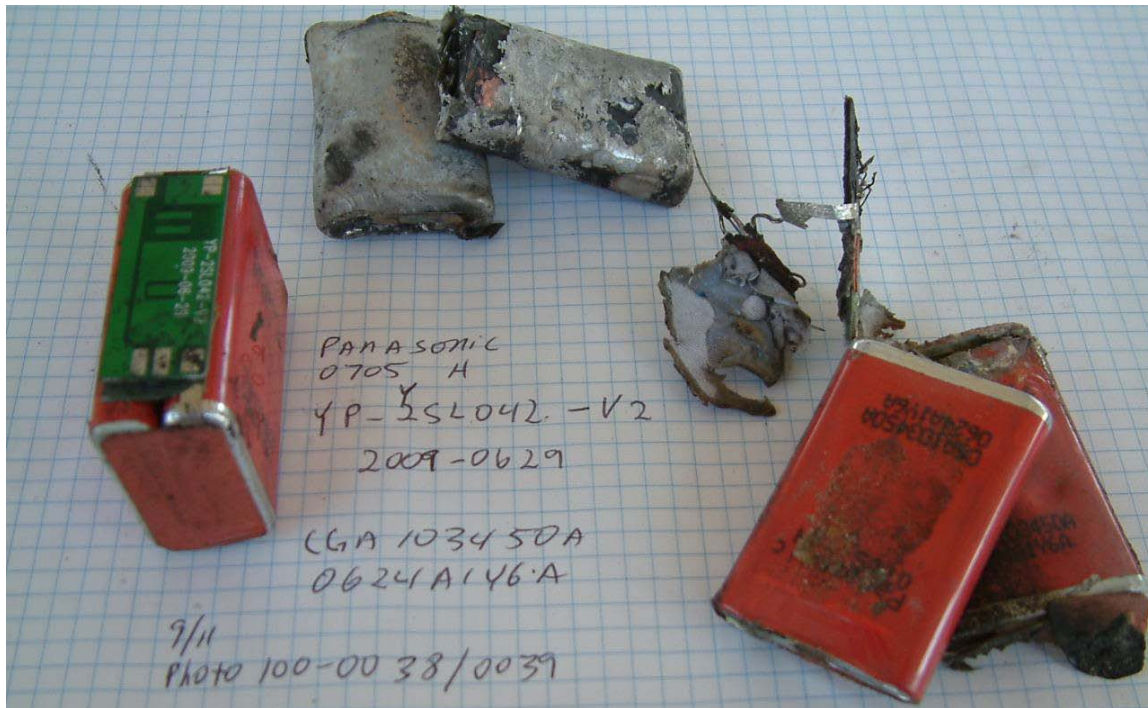
Figure 32: Intact and fire damaged Panasonic batteries (2-pack Li-ION set)

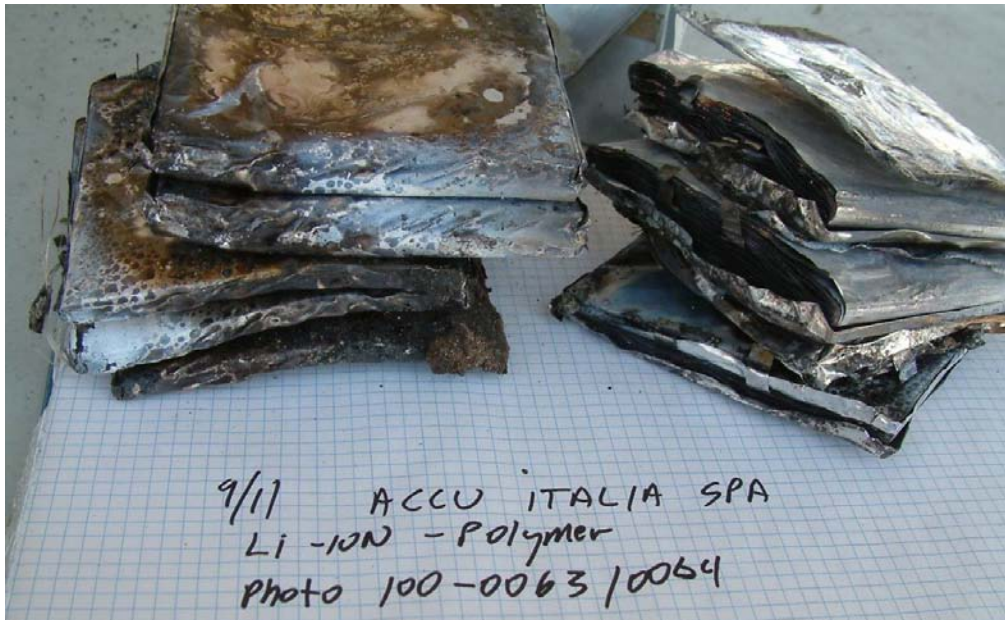
Figure 41: Lithium-ion polymer type battery pack with thermal damage
