National Transportation Safety Board

Marine Accident Brief

Fire aboard Passenger Vessel *Tahoe Queen*

Accident no.	DCA16FM054
Vessel name	<i>Tahoe Queen</i>
Accident type	Fire
Location	Zephyr Cove on Lake Tahoe, Nevada
Date	August 16, 2016
Time	0730 Pacific daylight time (coordinated universal time – 7 hours)
Injuries	Two crewmembers suffered minor injuries
Property damage	\$4.8 million
Environmental damage	None
Weather	South-southeast winds at less than 5 mph, air temperature 45°F
Waterway information	Vessel was dockside in Zephyr Cove on southeast Lake Tahoe, near the border between the states of California and Nevada.

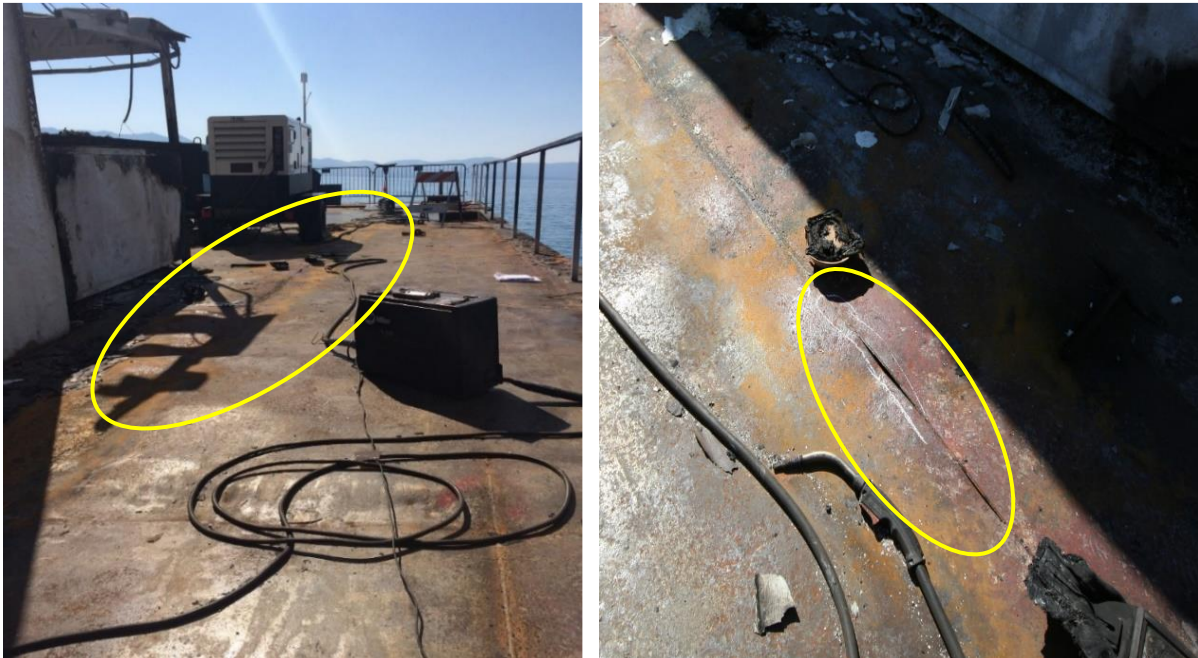
About 0725, a welder began grinding and welding a seam on a replacement steel plate that had been inserted into the deck on the port side of the hurricane deck, adjacent to the wheelhouse. The area of hot work was located directly above the Texas deck, which was a furnished passenger space with tables, a stage, a lounge, and a bar.¹ During the repair period, the painters stored supplies such as solvents (acetone, xylene, denatured alcohol, and paint thinners), marine coatings, oil-based paints, and soiled rags on the Texas deck. Divers also used the Texas deck to store their equipment, which included compressed air bottles and dive gear. Several lifejackets were stored in the overhead of the Texas deck, directly below the hot work area. The welder stated that prior to welding, he had created a “bowl” shape using fire-resistant blankets directly underneath the hot work area to catch any sparks or welding slag that might fall from the deck above. There was no power aboard the laid-up vessel and no forced ventilation in the work areas. No fire watch was assigned to the hot work area on the hurricane deck nor to the deck below in the passenger space of the Texas deck.

Left: Port side of hurricane deck where welding was being conducted. Right: Seam that was being welded when the fire started below. (Photos by Coast Guard)

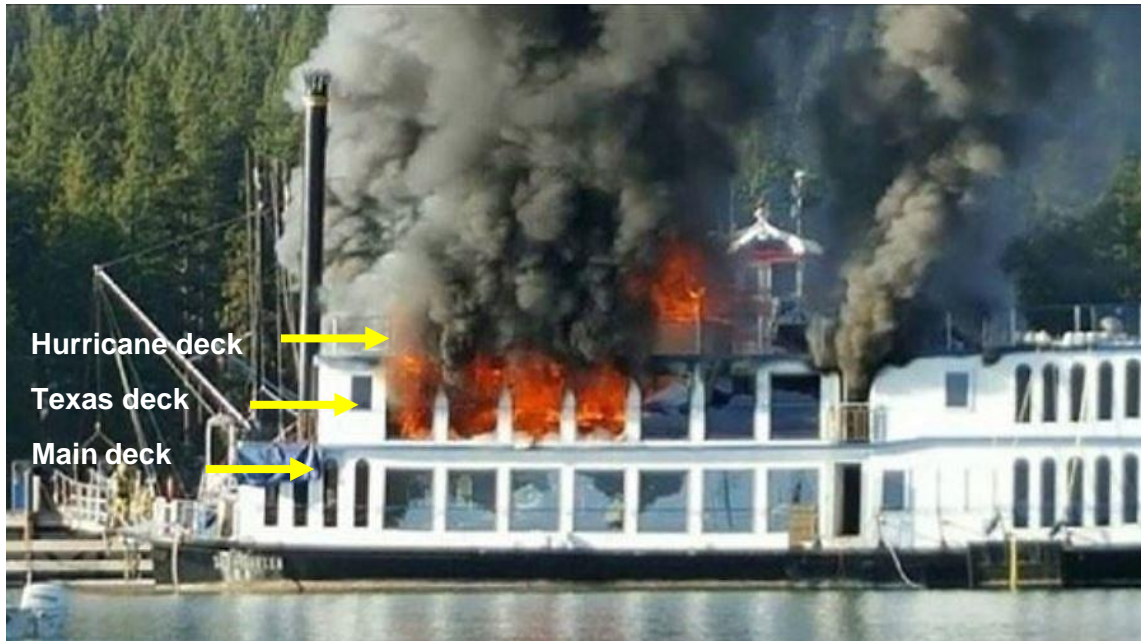
About 0730, a fire broke out on the Texas deck while the welder was welding. Thick black smoke rose from the space and into the aft ladder wells of the vessel. A painter observed the smoke on the Texas deck and alerted the welder. The welder stopped welding, located a fire extinguisher, and attempted to access the Texas deck but was unable to enter due to flames, heat, and smoke. The fire burned rapidly and engulfed the Texas deck. Flames and smoke from the Texas deck rose

Fire aboard *Tahoe Queen*. (Photo by witness)

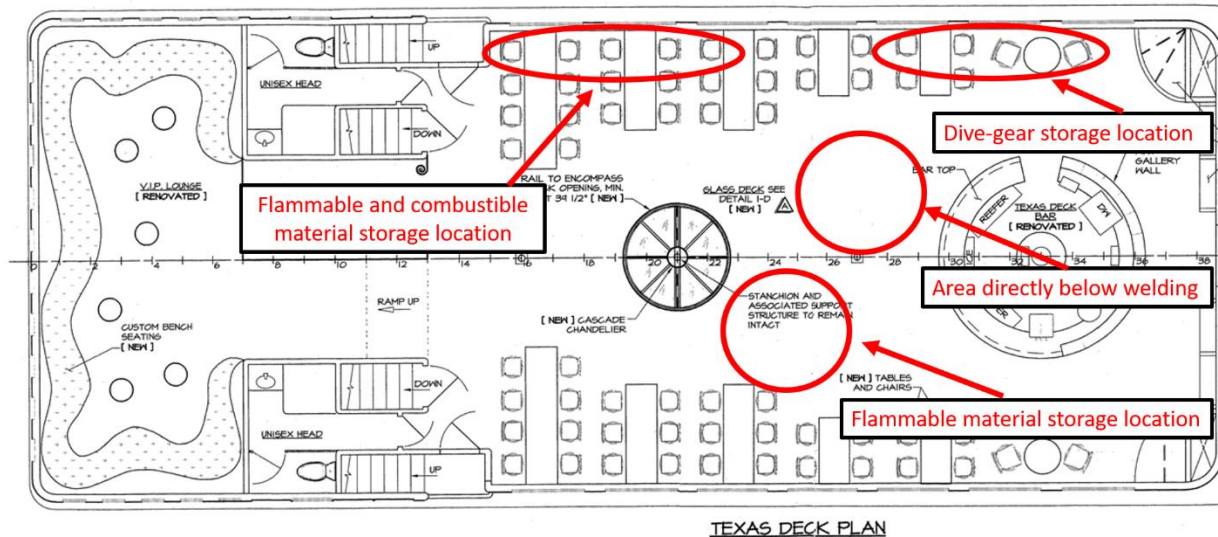
Investigators found about 15 fire-damaged storage containers for flammable liquids on the Texas deck about 10 feet below and about 5 feet outboard from the hot work area on the hurricane deck. These flammable liquids were stored below the hot work area near falling sparks and slag, which likely ignited either combustible material, a flammable vapor layer, or a combination of both within the space. According to the fire marshal, the rapidly moving conflagration inside the

Texas deck suggested the presence of flammable vapors that would have fueled and accelerated the spread of the fire throughout the space.

Texas deck, including the location of painting supplies below hot work area where welding was being conducted. (Image by Coast Guard)

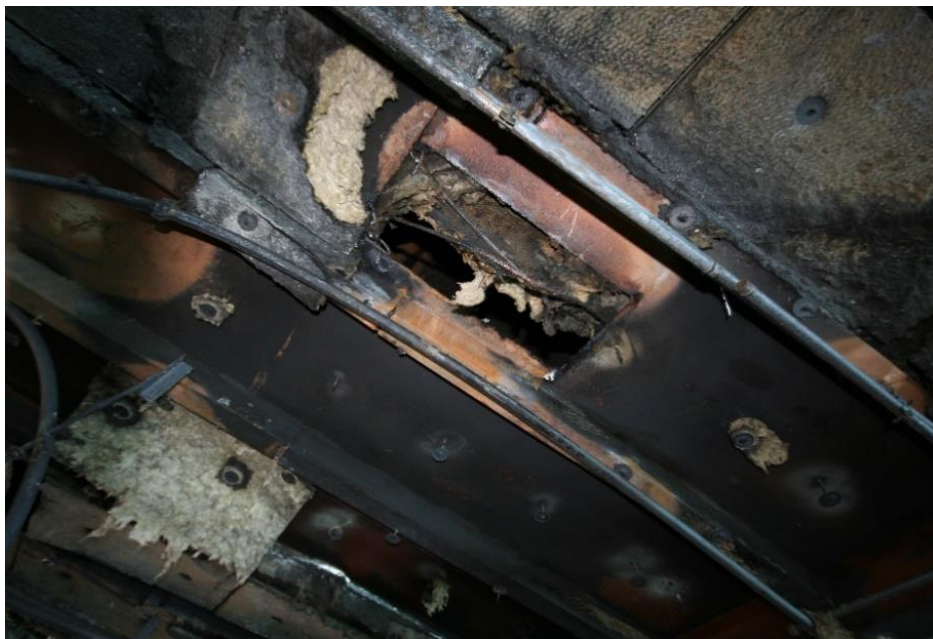
into the wheelhouse through an air-conditioning duct. The duct did not have dampers or closing devices.

While digging through debris from the fire, investigators found a 20-inch by 9-inch rectangular penetration that had been cut in the overhead of the Texas deck into the wheelhouse for installing an air-conditioning duct. According to the vessel file, this modification (cut-out) was not indicated in any of the vessel's approved plans and the Coast Guard was not advised of the modification. There were no closing devices such as dampers in the ductwork to maintain structural fire protection. The lack of dampers and closing devices allowed the fire to communicate naturally in an upward direction and toward the additional oxygen source in the wheelhouse.

Rectangular cut-out for air-conditioning duct from Texas deck into wheelhouse. (Photo by fire marshal)

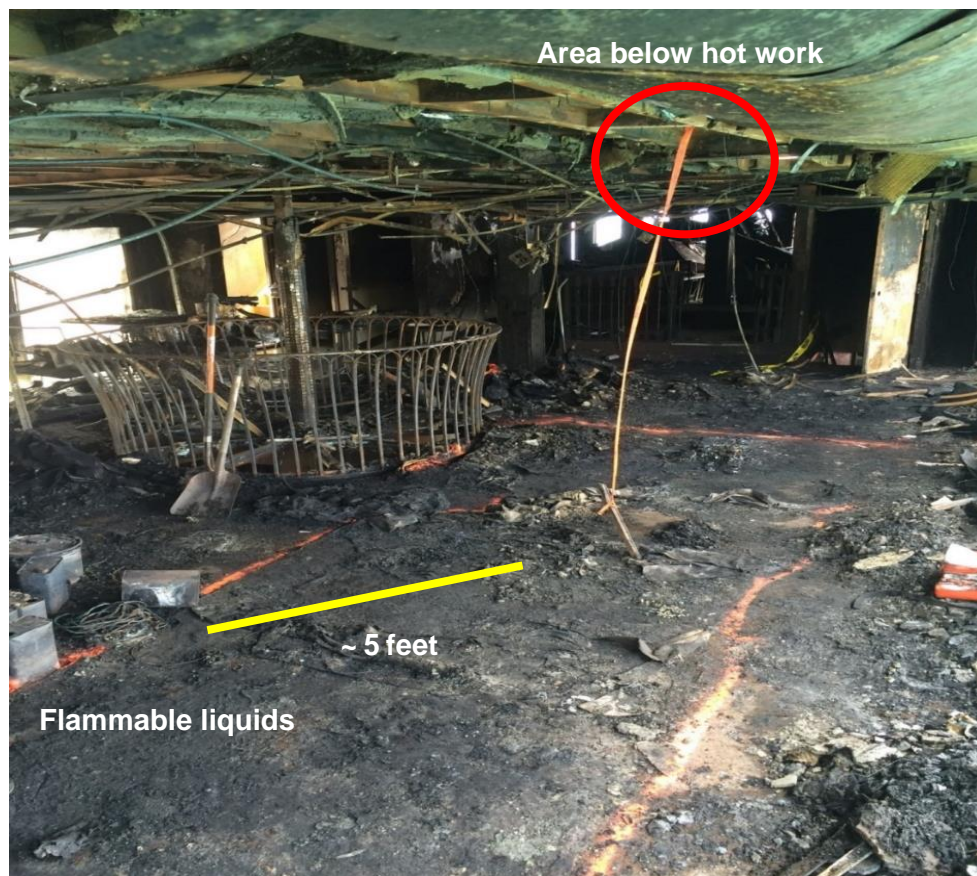
Throughout the project, contractors used the fire-resistant blankets to protect surfaces under and around hot work operations. However, both the painters and the welders stated that the painters also used these blankets as drop cloths to catch dripping paint, and, at times, the blankets were used to cover flammable liquids being stored on the Texas deck. This resulted in the fire-resistant blankets absorbing flammable solvents. On the day of the fire, the blankets had been used under the hot work area. The fire-resistant properties of these blankets were likely compromised after being permeated by the flammable liquids from the painting supplies.

Texas deck, showing the location of painting supplies below the hot work area where welding was being conducted. (Photo by Coast Guard)
