**NATIONAL TRANSPORTATION SAFETY BOARD  
WASHINGTON, D.C.**

**FIRE AND EXPLOSION GROUP FACTUAL REPORT**

**DCA-96-MA-070**

Location : East Moriches, New York  
Date : July 17, 1996  
Time : 2031 Eastern Daylight Time (EDT)  
Aircraft : Boeing 747-131, N93119,

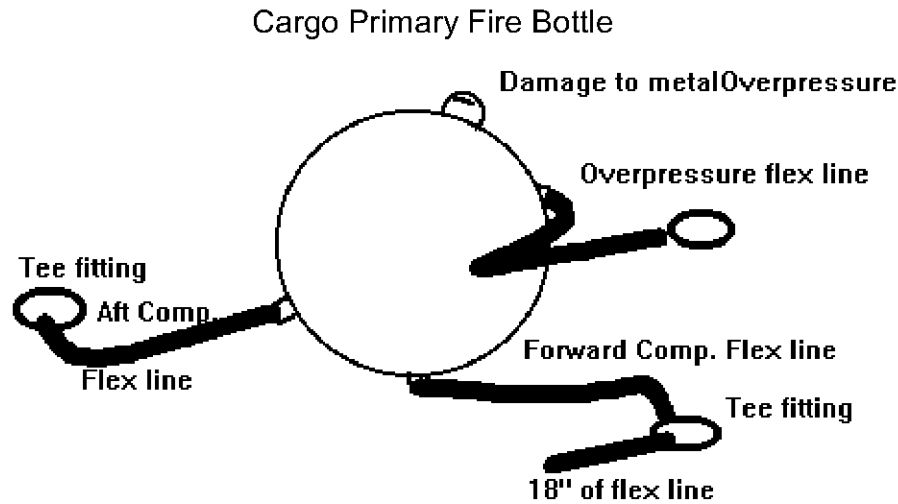
The bottle was found empty. The flex lines for the forward compartment, aft compartment, and overpressure discharge were attached. All lines were broken after the Tee fittings attached to the flex lines. The squib for the aft compartment had ~12" of the ground wire attached and ~1/2 inch of wire from the electrical plug. The squib for the forward compartment had no wire attached. There was a large (2 to 3 inch) tear in the metal dimple attached to the bottle. Other than a few dents, the bottle seemed to be free of any other damage.

The squibs were removed and inspected. They were intact and had not been fired. The frangible disks were intact and sealed to the discharge ports.
