**NATIONAL TRANSPORTATION SAFETY BOARD
WASHINGTON, D.C.**

FIRE AND EXPLOSION GROUPS FACTUAL REPORT

**Appendix III
(Tests and Study)
(81 pages)**

TWA FLIGHT 800 ACCIDENT INVESTIGATION

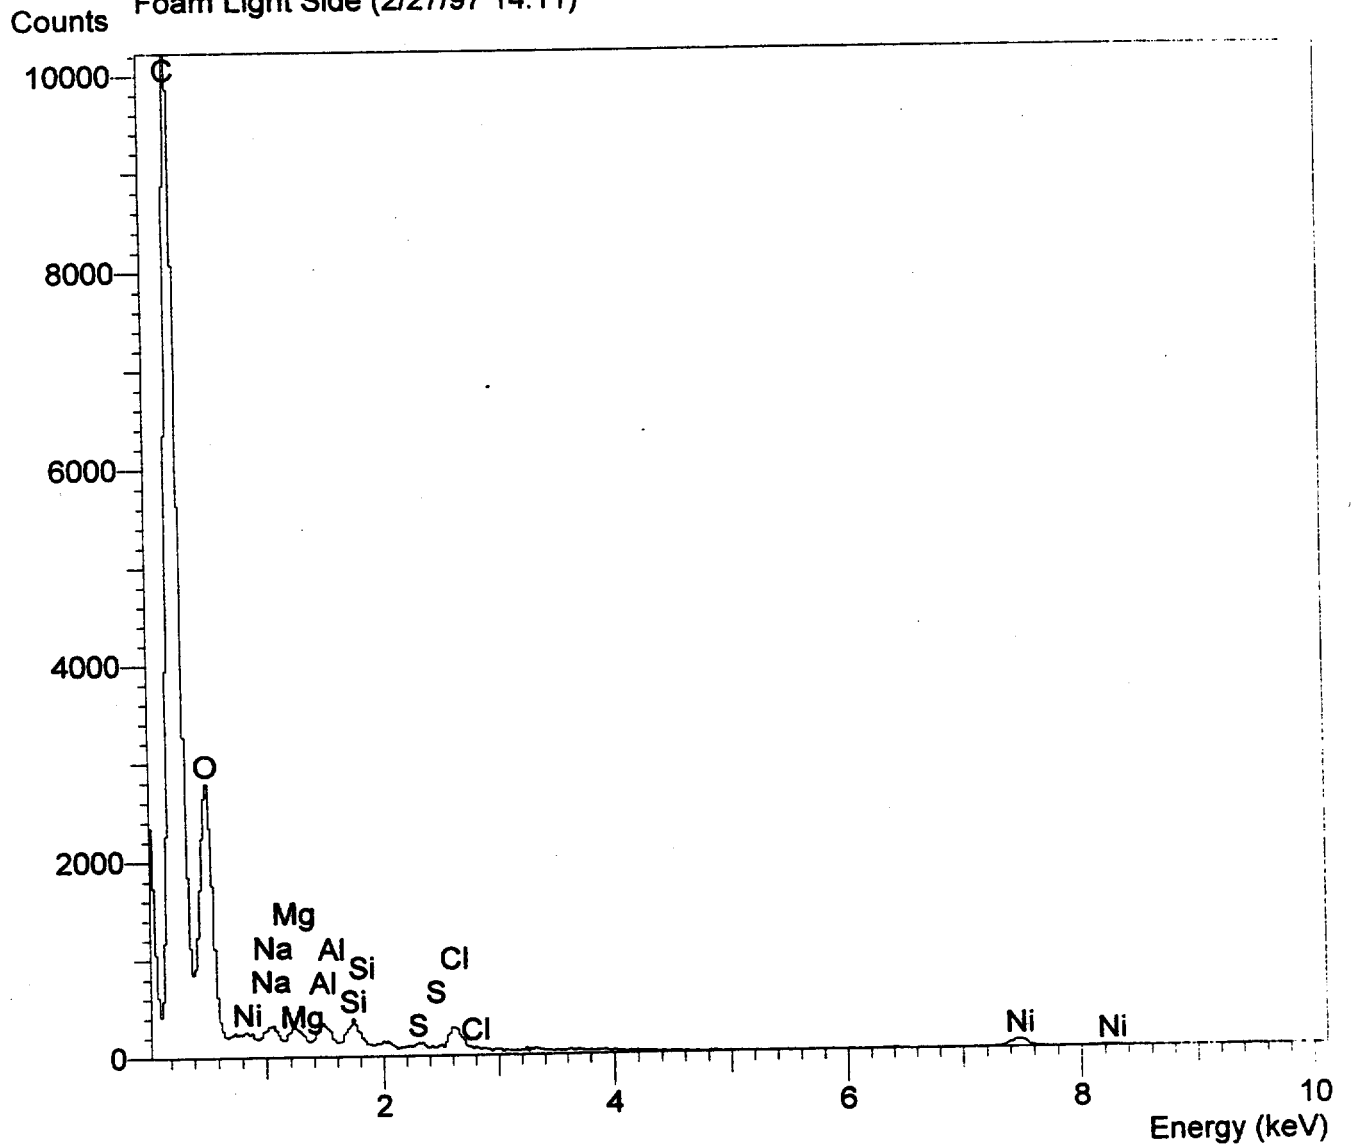
- 3.2.1 The foam material (Figure 1) was identified by FTIR as a polyurethane based substance. The spectra is shown in Figure 2. Elemental analysis by EDS of the lighter side of the foam (Figure 3) indicated the material was high in carbon and oxygen with trace amounts of sodium, magnesium, aluminum, silicon, sulfur, chlorine and nickel present. The EDS overview analysis of the darker side (Figure 4) was found to contain high concentrations of carbon and oxygen. The concentrations of sodium and chlorine (probably in the form of salts) were higher in the darker side of the foam material than in the lighter side. Finally, trace amounts of magnesium, aluminum, silicon, phosphorous and sulfur were also found.

FIGURE 3. LIGHTER SIDE

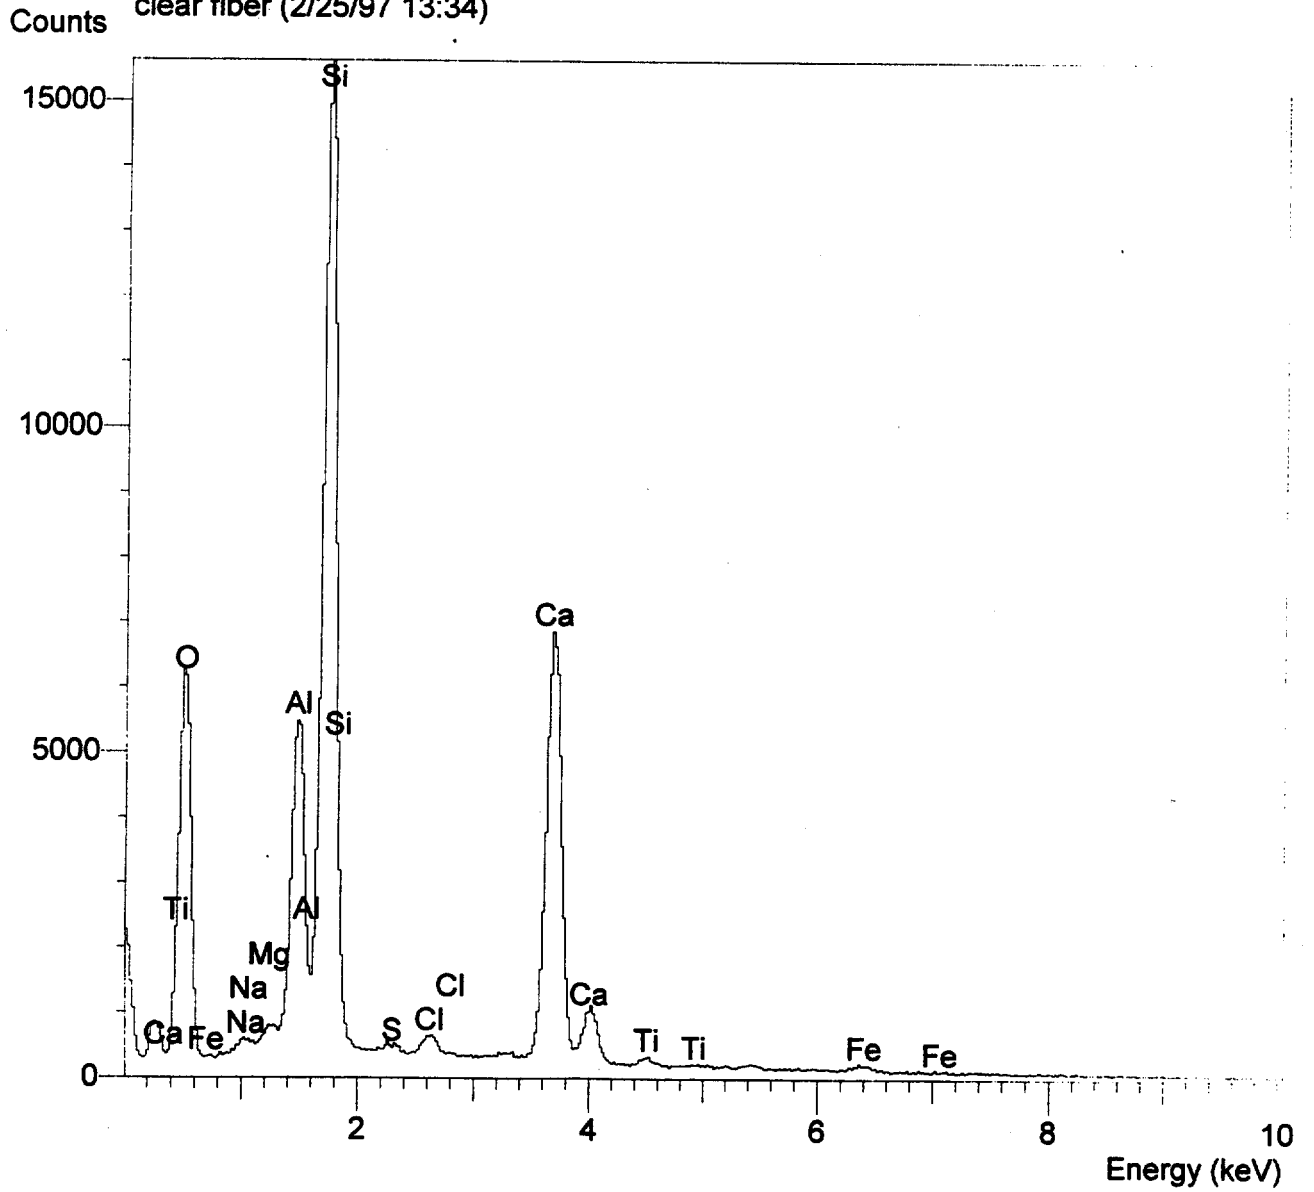
- 3.2.3 Transparent glass fibers at the ends of the fiber clusters could be clearly observed by polarized light microscopy (Figures 7 and 8). An EDS analysis (Figure 9) of the clear glass fiber shows high concentrations of oxygen, aluminum, silicon and calcium, with trace amounts of sodium, chlorine, titanium and iron present. Figure 10 shows the glass fibers as red, the binder or coating material as green, and areas of high sodium and chlorine as blue.

FIGURE 9. CLEAR FIBER

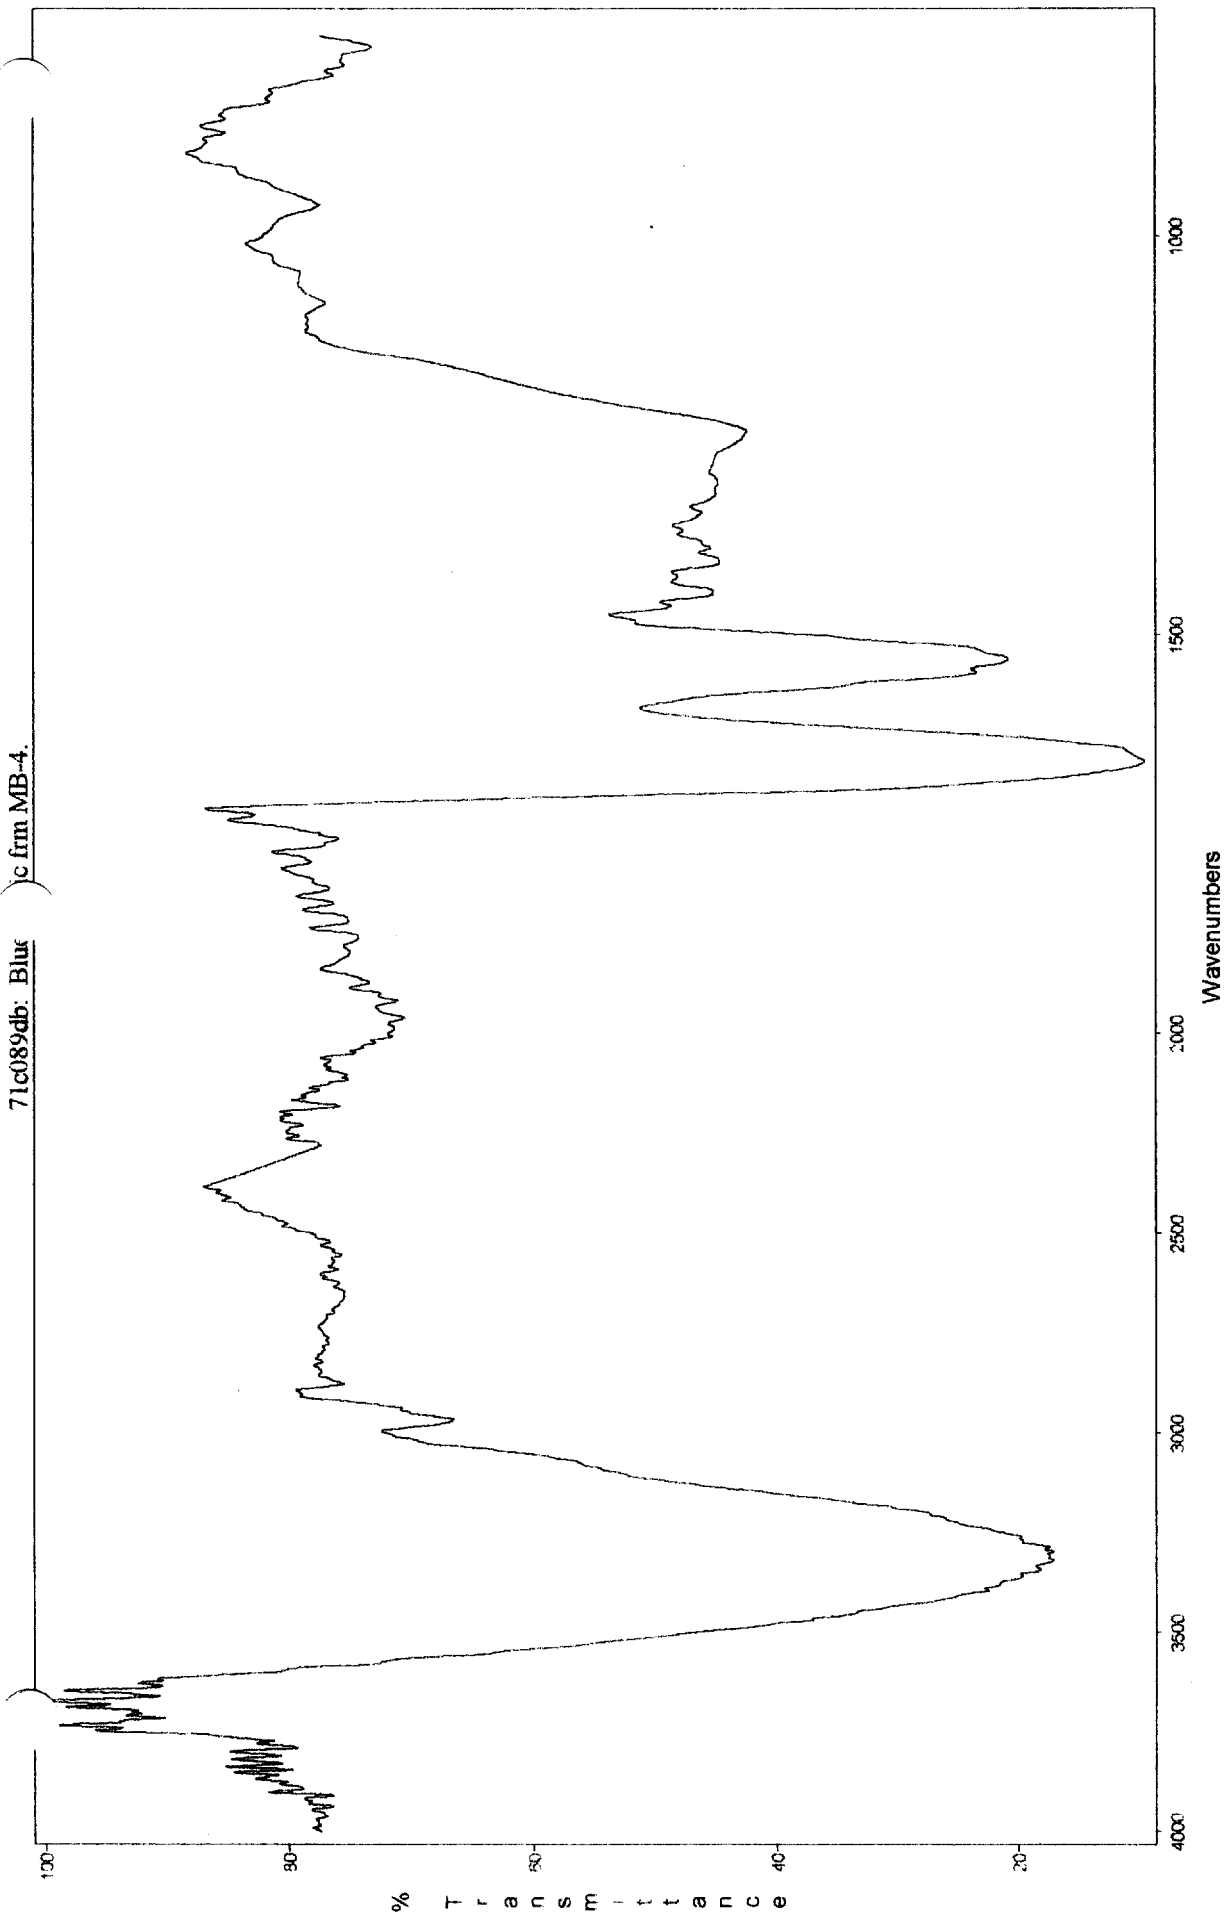
- 3.6 The blue fiber as seen in Figure 22 is from the fabric of seat #20-4 and was provided in the sample bag labeled MB-5. The blue fiber, the spectrum of which can be seen in Figure 23, is similar to Azlon.

FIGURE 23. BLUE 'AZLON' FABRIC OF SEAT #20-4.

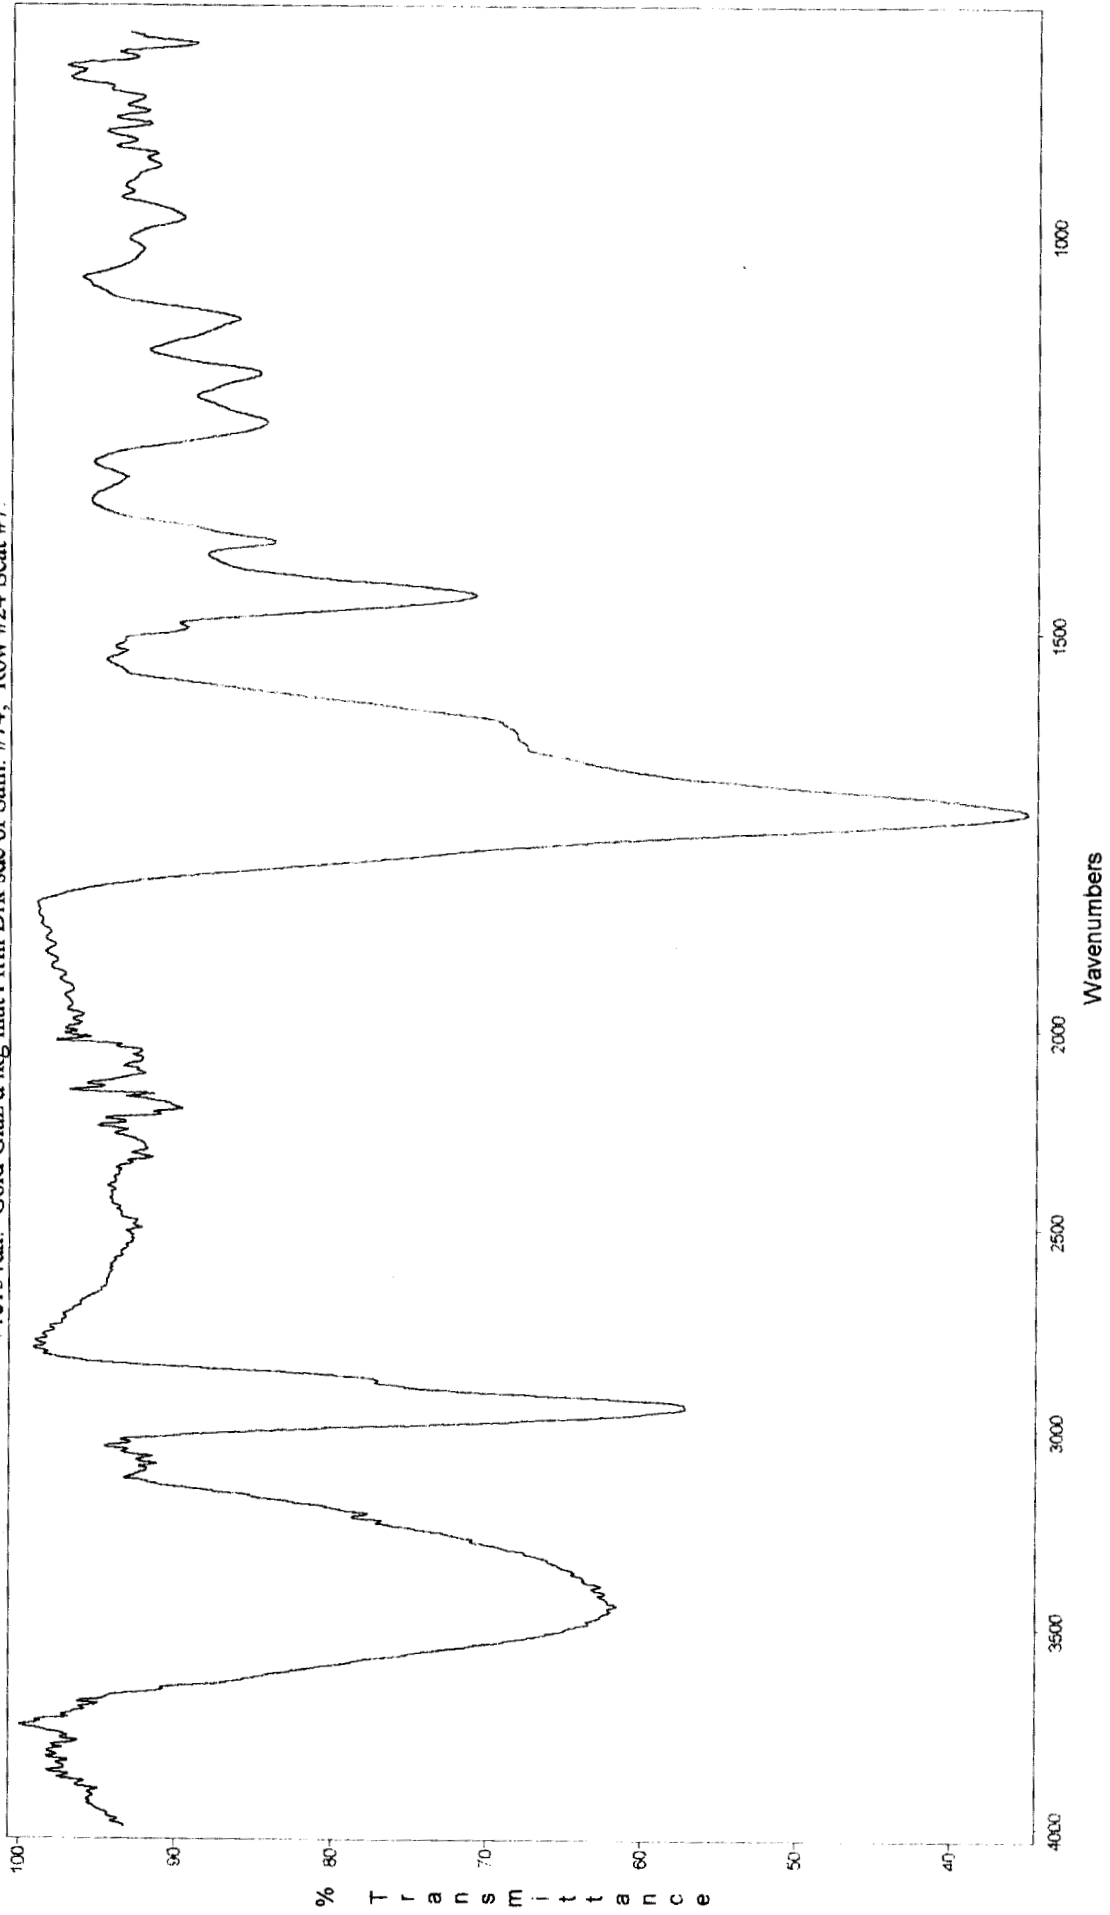
- 4.5 The gold glazed looking material removed from the darker side of sample #74, was identified as an acrylic polymer. The black looking material from the darker side of the metal was identified as a phthalate resin product, probably a Dacron™ filler. The presence of an anti-static agent was also detected. The same organic presence was observed on the lighter side of the metal sample although it was much less abundant. Since it is plausible to expect similar results from these materials, they were not examined further. There was a "soot" like substance present on this side that was not found on the previous side. This soot material was extracted, concentrated to dryness and analyzed. The IR data indicates that the major component of the "sooty" material is a zinc oxide which could be the oxidized phase of a zinc based polyvinyl chloride stabilizer.

Figure 18. Glazed looking material from darkest side of sample #74.

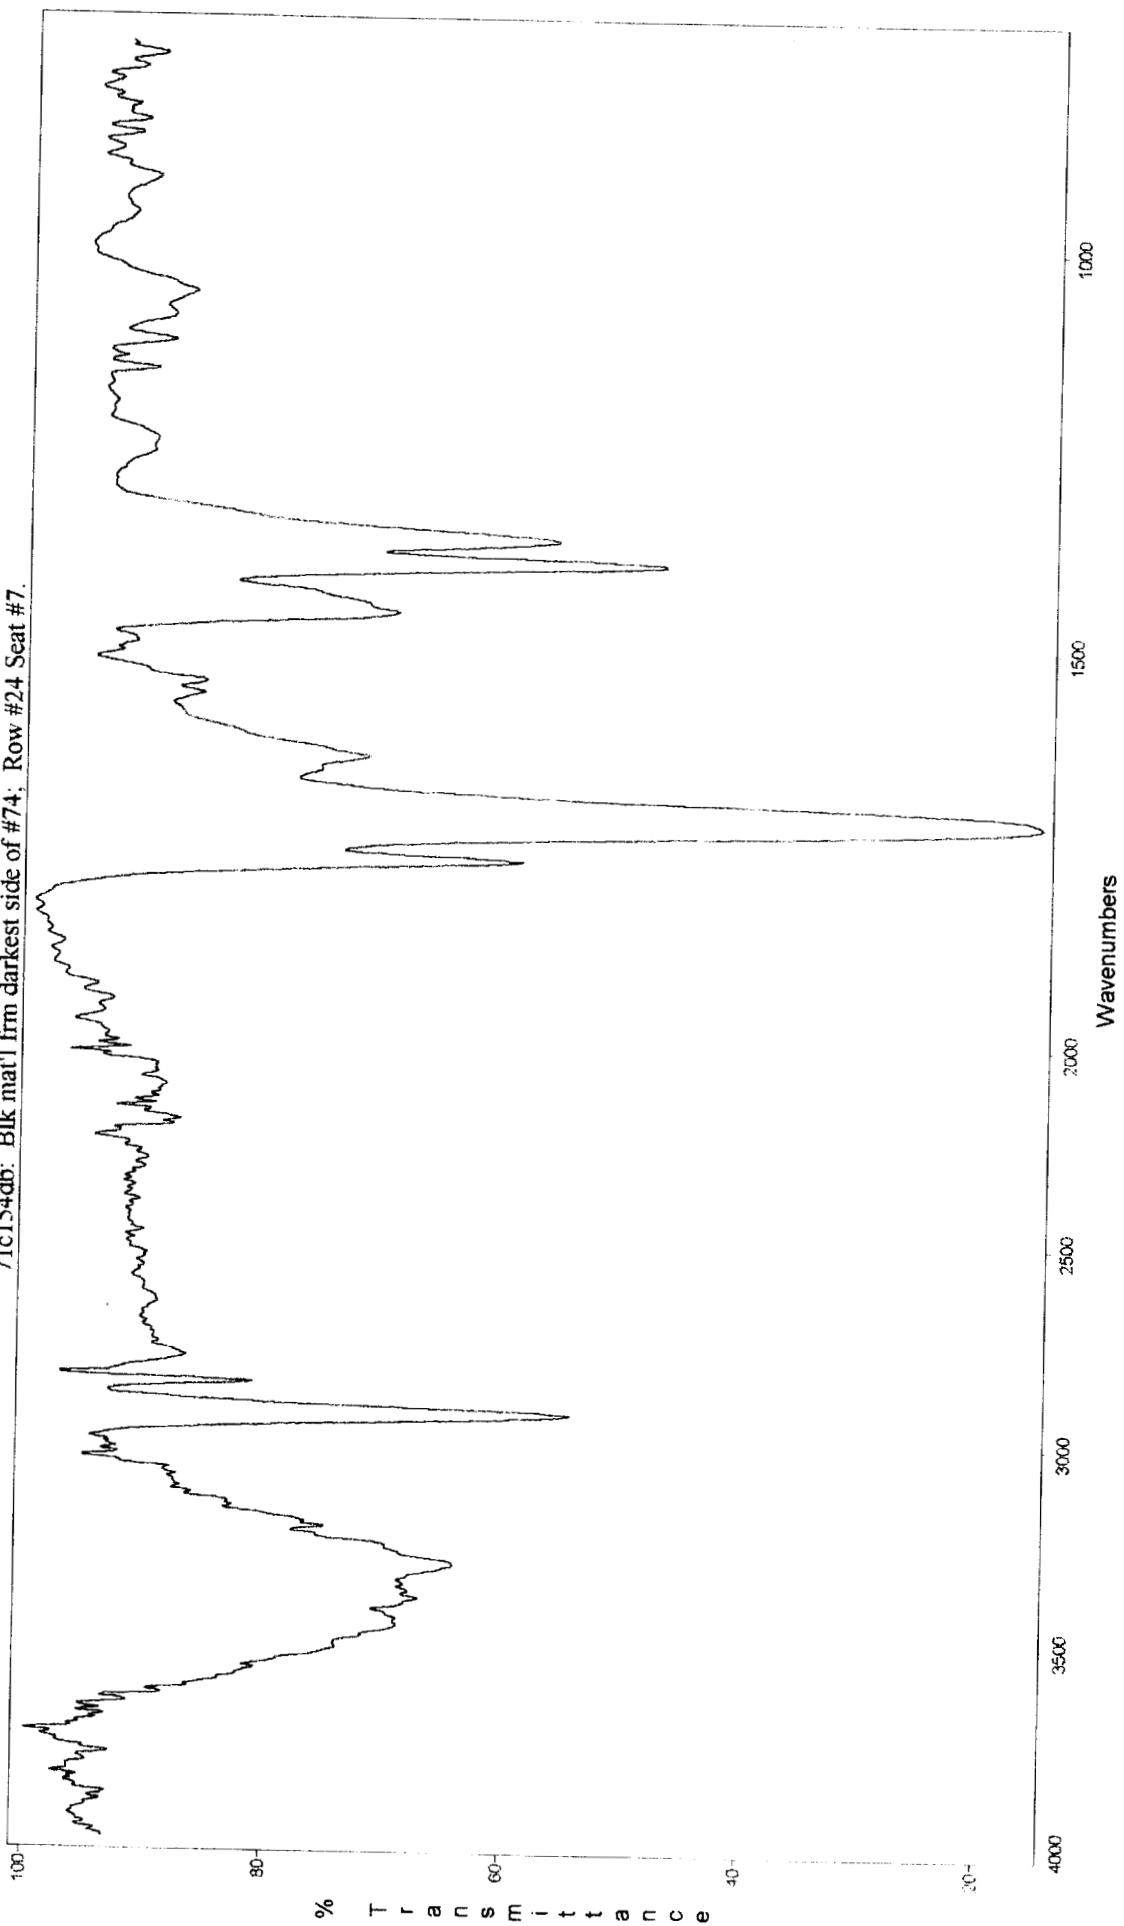
Figure 19. Black material from darkest side of sample #74.
