**NATIONAL TRANSPORTATION SAFETY BOARD
WASHINGTON, D.C**

FQIS Compensator Probe Testing

Summary Data Report

Investigation of the Effects of Combustion on a
Fuel Quantity Indicating System Fuel Compensator Probe

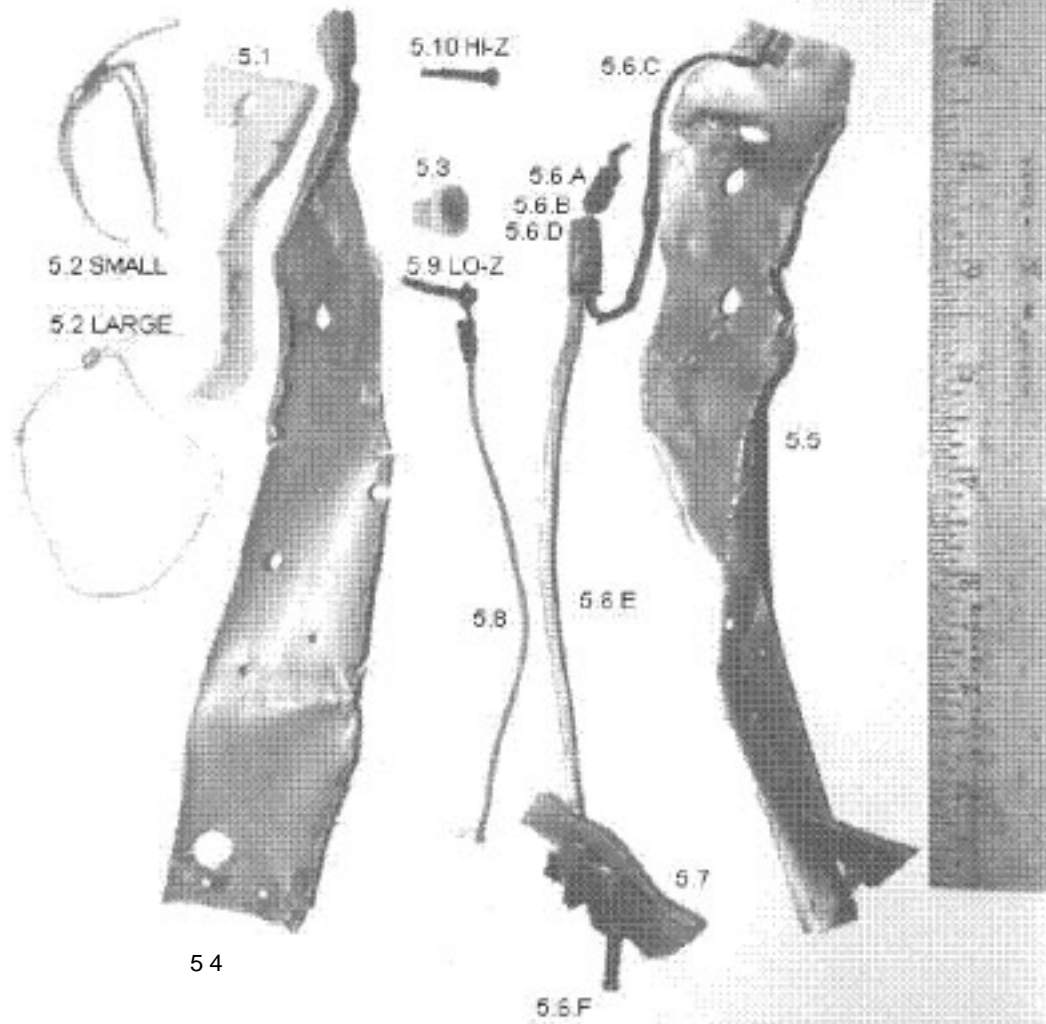
Figure 3. Exploded view of recovered compensator.

Figure 3 shows an exploded view of the compensator recovered from the TWA800 wreckage. Of particular note are the items identified as parts 5.6A, 5.6D, 5.9 LO-Z, and 5.7. These items exhibited thermal damage.
