ARTECH TESTING L.L.C.
FINAL REPORT

TWA FLIGHT 800 WRECKAGE EXAMINATION

**Prepared for
PERKINS COIE LLP,
KREINDLER & KREINDLER,
and
NATIONAL TRANSPORTATION SAFETY BOARD**

**ARTECH Testing, LLC
Project No. M90127
December 22, 1999**

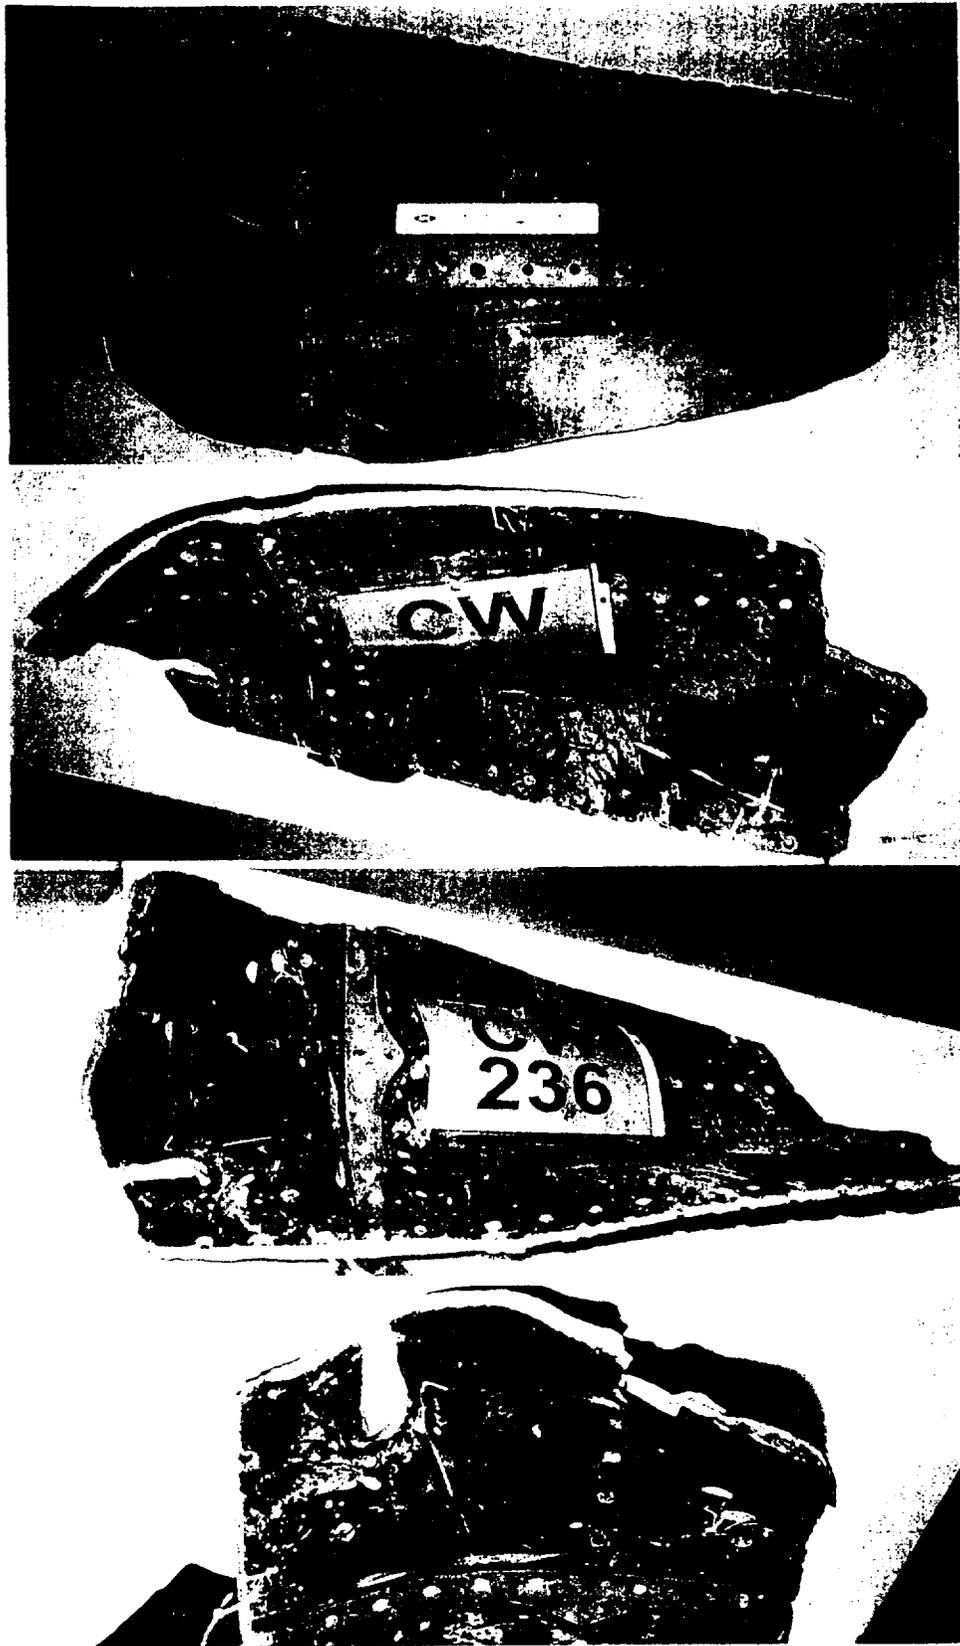
Two sections of the tank are shown in figures 1 and 2 in the as-received condition. The approximate dimensions of Sections CW236 and CW238 were 30x15 inches and 10x8 inches respectively. Both sections were deformed as shown in the photographs. The fracture plane along which these sections had fractured is shown in figure 3.

Figure 1 Photographs of the tank section CW236 in the as received condition. Figure A shows the inside surface and figures B - D are views of the outside surface. Note a general deformation (curling) of the section.

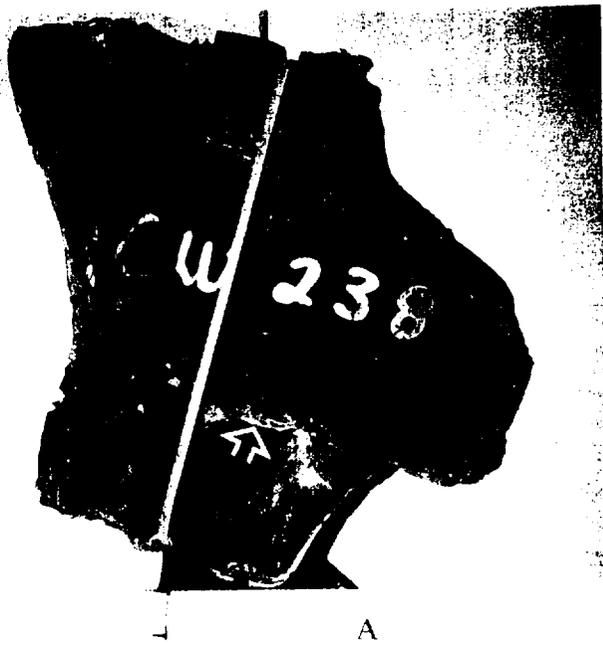
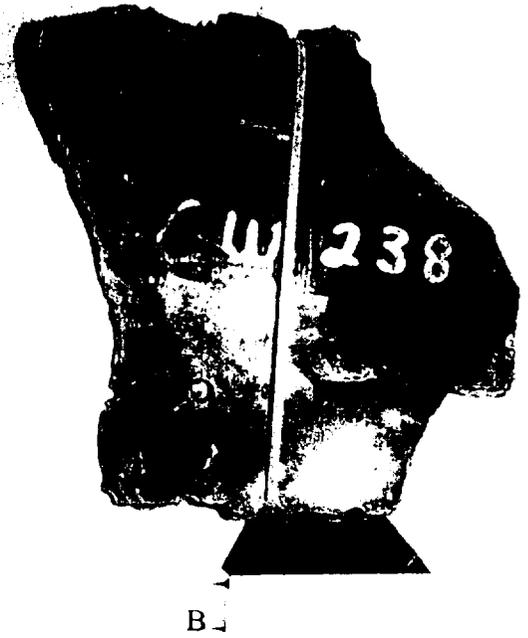
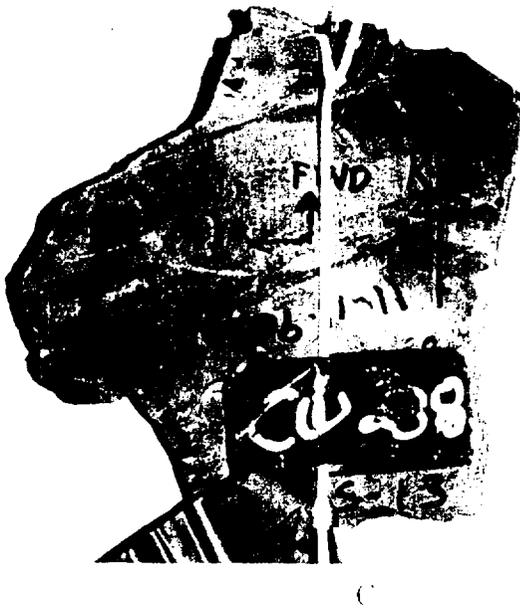
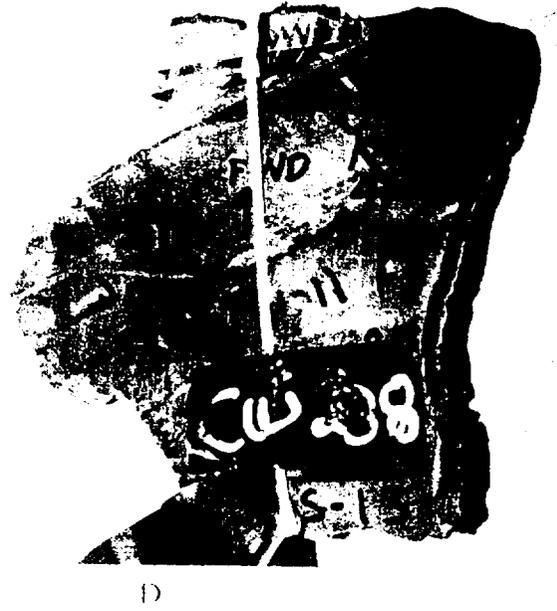
Enlarged views of the fracture surface of the Section CW238 adjacent to the hole are shown in figures 6A and 6B. Note the flattening damage at the lip of the fracture surface on the inside surface of the tank; a light brown stain was also observed on the fracture surface in that area. A deep gouge/dent mark, about 1.5 inches long, was noticed on the inside surface of the tank; its location in reference to the hole is indicated in figure 2A. It appeared as if a foreign object had penetrated the tank material inside out.

Figure 2 Photographs of the rank section CW 238 in the as-received condition. Figures A & B show the outside surface and figures C & D are views of the inside surface. Note a general deformation of the section. Location of a deep gouge mark is indicated by an arrow in figure A (see figure 1B for details).

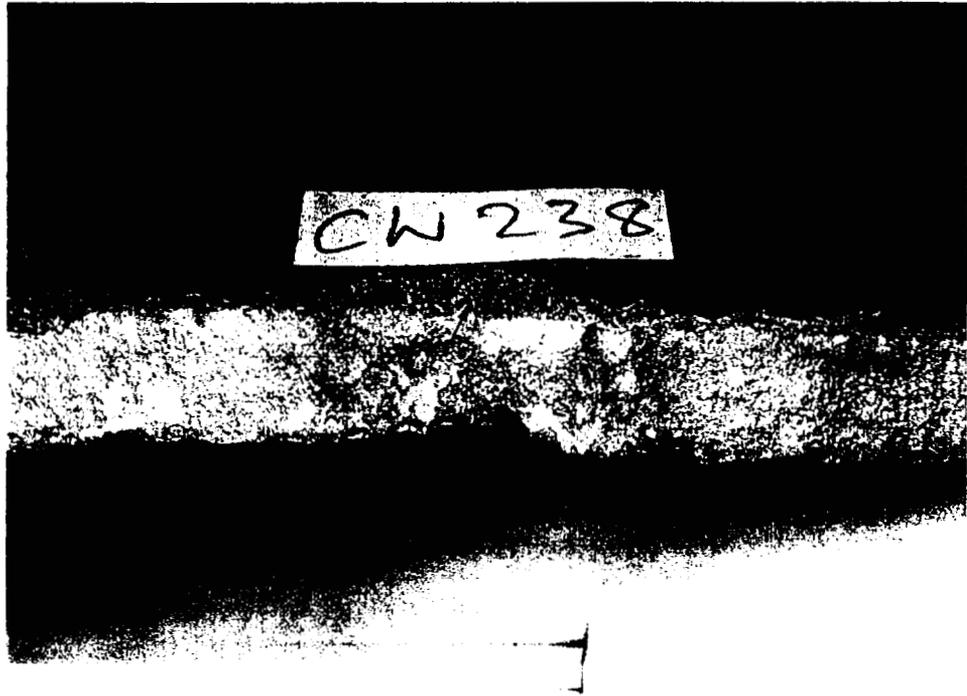
(shown in figure 6B) were analyzed by EDS. Two EDS spectra collected from the stained area indicated major peaks of Al, Cu, Cl, and S. Minor presence of K, Ca, Fe, and Phosphorus (P) was also detected. Similar results were obtained from the unstained area. See the EDS spectra in Appendix 3. These results are similar to what was found in Section CW236 analysis.

Figure 6A: Photograph of the part of the fracture surface (adjacent to the hole in Section CW236) on Section CW238 shows light brown staining in that area. Note the flattening at the lip of the fracture surface (arrow).

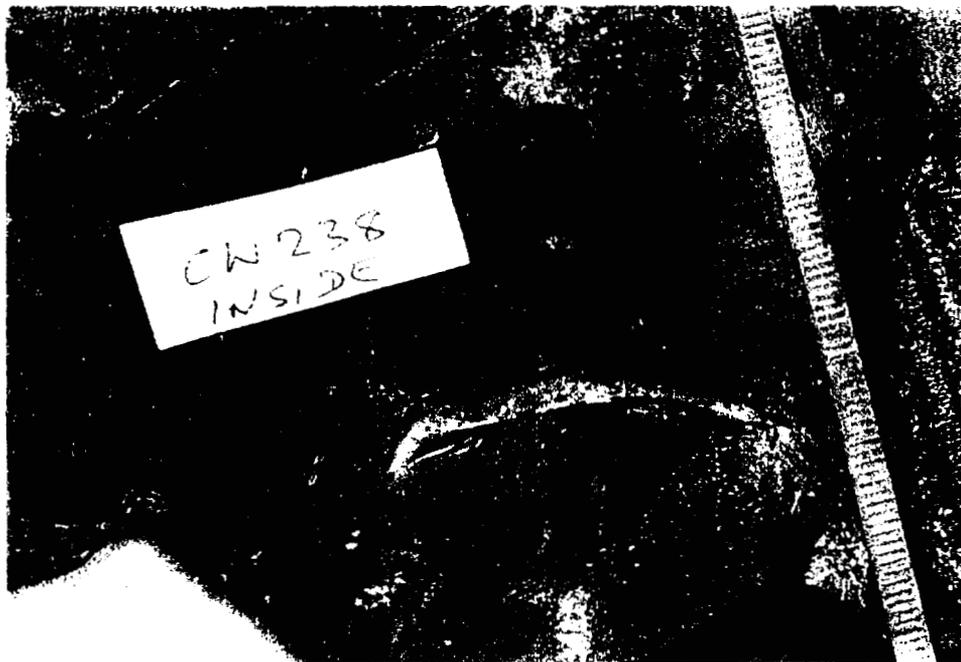
Figure 6B: Photograph of the inside surface of Section CW238 shows a deep gouge mark, about 1.5 inches long.

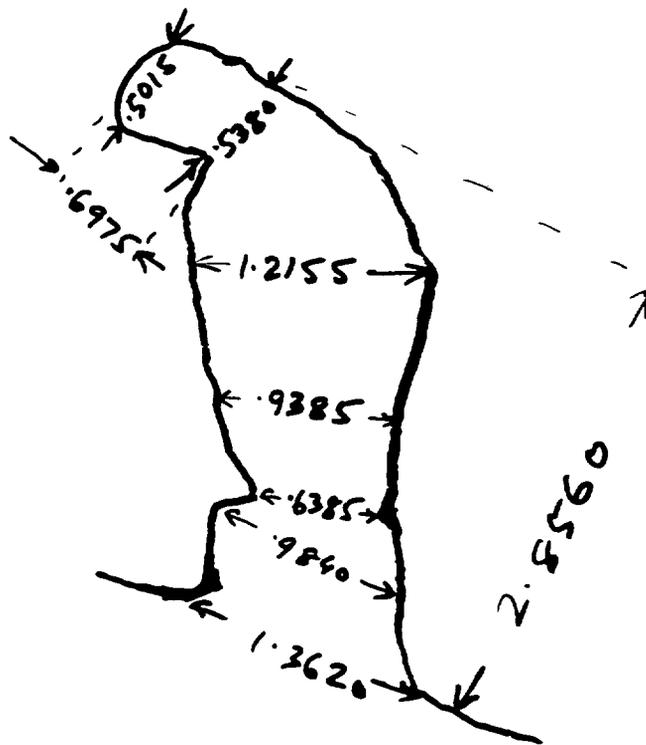
CW-236
INSIDE

Profile of the hole in reference to the inside and outside surfaces of the tank was traced on a transparent paper. Measurements at different locations were taken using a calibrated digital caliper. See figure 7 for details. Thickness of the tank material near the fracture surface was in the range of 0.2965-0.3080 inches and that remote from the fracture surface was 0.3060-0.3088 inches. All measurements were taken without removing the paint.

Figure 7A: Profile of the hole in the plane of the inside surface.

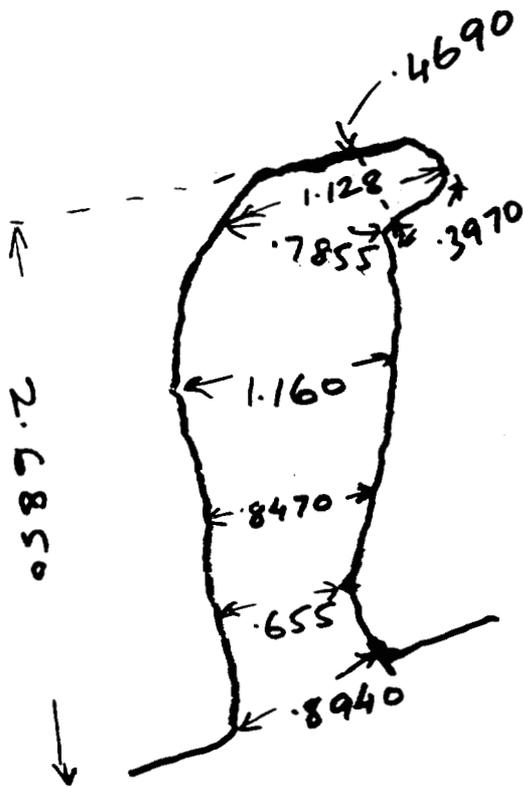
CW-236
OUTSIDE

Figure 7B: Profile of the hole in the plane of the outside surface.

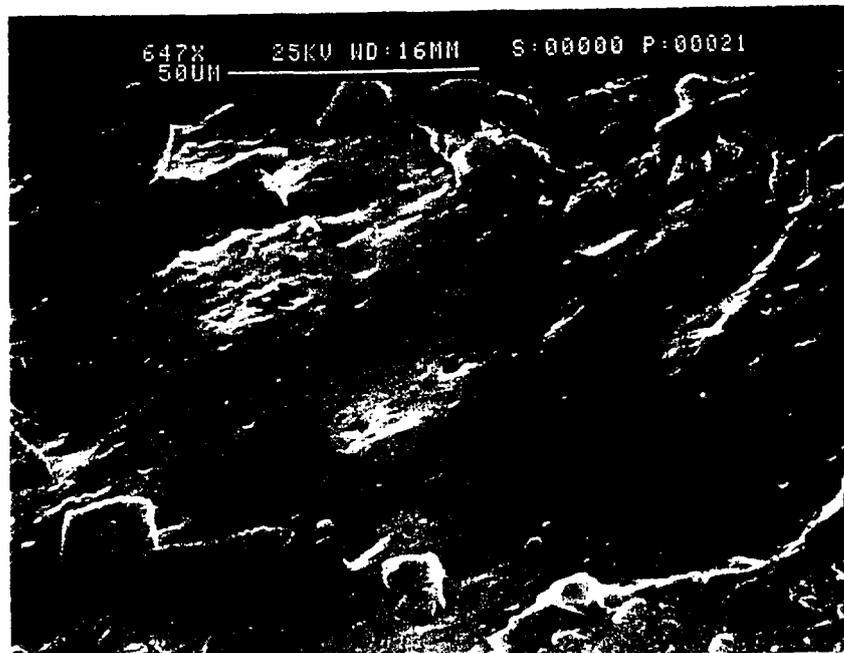
Figure 13: SEM fractograph shows featureless characteristics of the partially cleaned fracture surface. Bottom of the fractograph is toward the inside surface of the tank, X925.

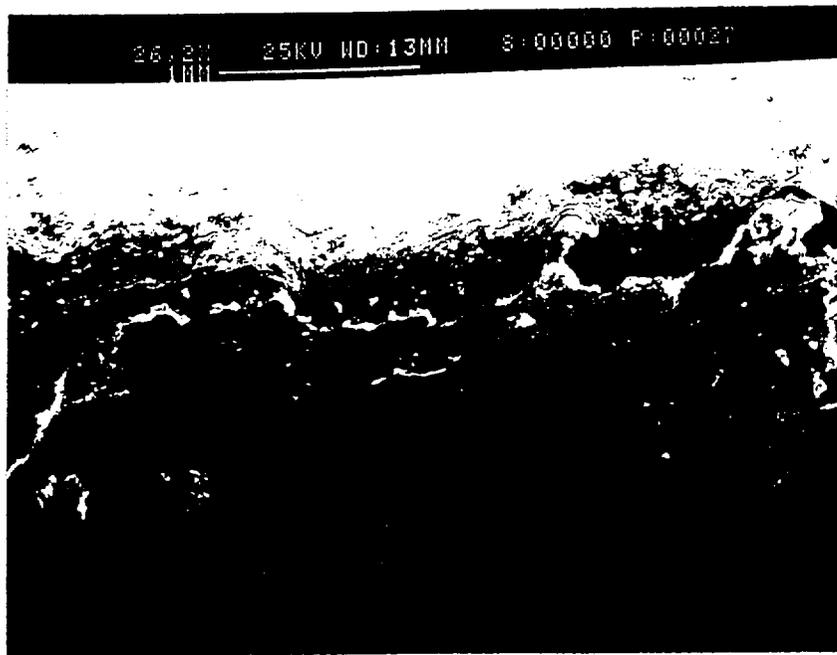
Figure 14: SEM micrograph shows cracking of the paint layer under a tensile load. Top of the fractograph is toward the outside surface of the tank, X26.

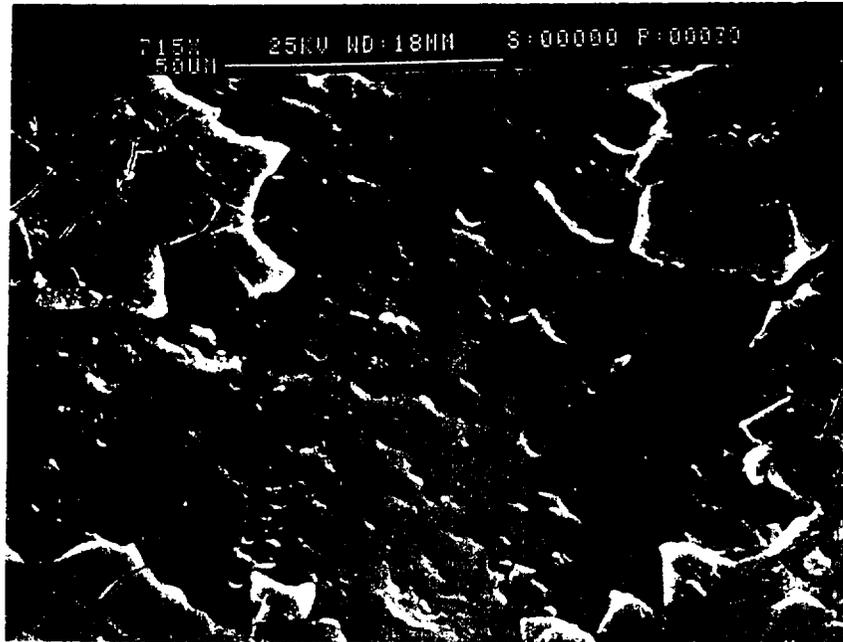
Figure 15: SEM fractograph shows similar features as in figure 14. Bottom of the fractograph is toward the inside surface of the tank, X715.

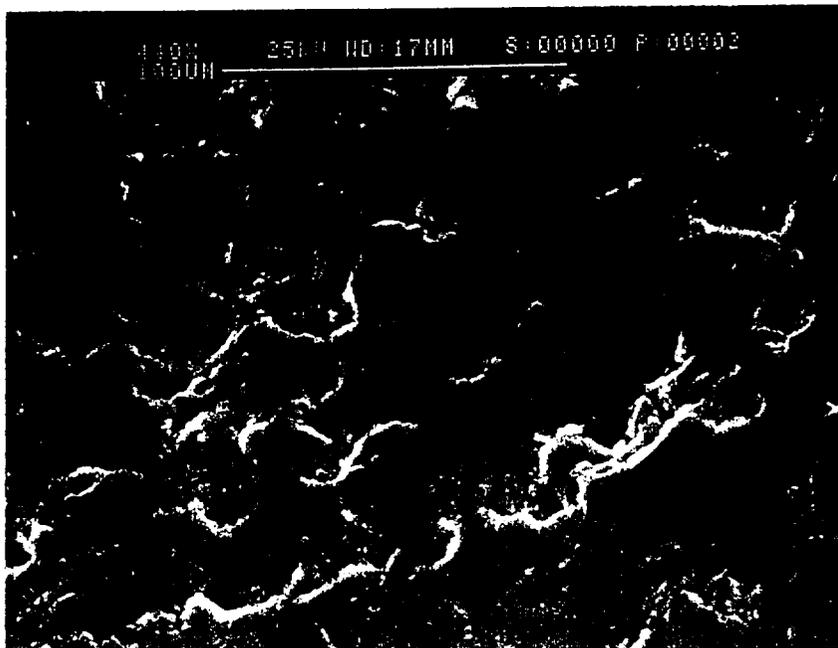
The fracture surface of Section CW238 revealed the presence of extensive amounts of corrosion product, which made it impossible to characterize the fracture surface; see figure 17.

Figure 17: SEM fractograph shows similar features as in figure 12. Bottom of the fractograph is toward the inside surface of the tank, X447.

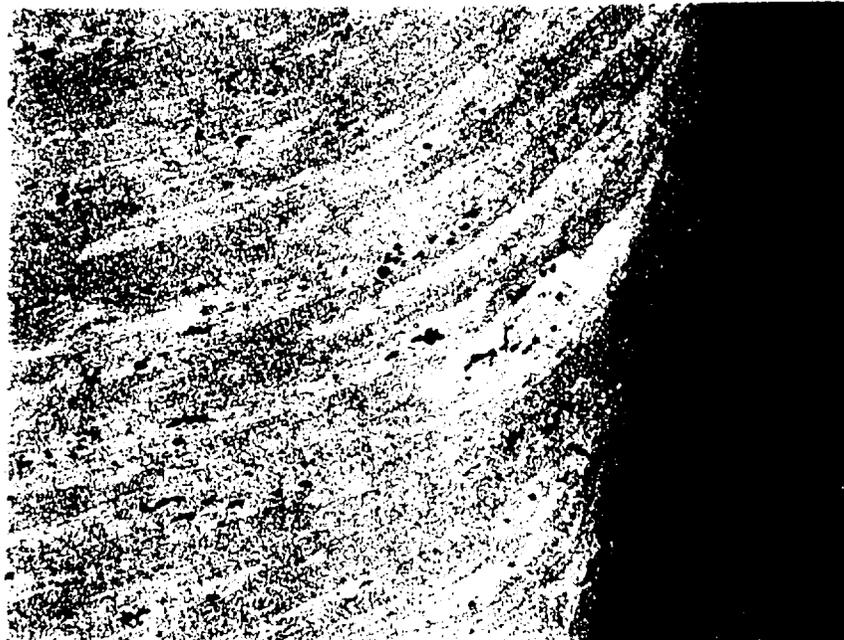
One transverse section through the fracture face was cut from each of Sections CW236 - 1, CW236 - 2, CW236 - 3A, CW236 - 3B, and CW238. The section locations are shown in figures 18 and 19. These sections were prepared for metallographic analysis. The fracture faces of the polished and etched sections were examined at various magnifications to characterize the direction of grain flow. Photomicrographs of the sections are presented in figures 20-24. Grain flow in these photomicrographs clearly indicates stretching of grains from the inside surface of the tank to the outside surface.

This feature suggests that the damage to the tank initiated on the inside surface and propagated outwardly. No evidence of recrystallized grains and/or incipient melting at the fracture surfaces was observed which precludes high strain rate impact preceding formation of the hole. Some areas on the inside and the outside surfaces of the tank exhibited features typical of intergranular corrosion; see figures 20A, 22A, 23A, and 24A.

The results of metallographic analysis suggest that a slowly applied load on the inside surface created the hole in the tank.

Figure 20. Photomicrographs of the polished and etched section CW236-1 show grain flow from the inside surface (bottom of the micrographs) to the outside surface (top of the micrographs). The outside surface in Figure A exhibits evidence of intergranular corrosion, Kojima's etch.
