**DOCKET NO. SA-516**

**FACTUAL REPORT ON SPLATTER DEPOSITS  
JULY 20, 2000  
(18 pages)**

**FACTUAL REPORT ON SPLATTER DEPOSITS**

**A. ACCIDENT: DCA96MA070**

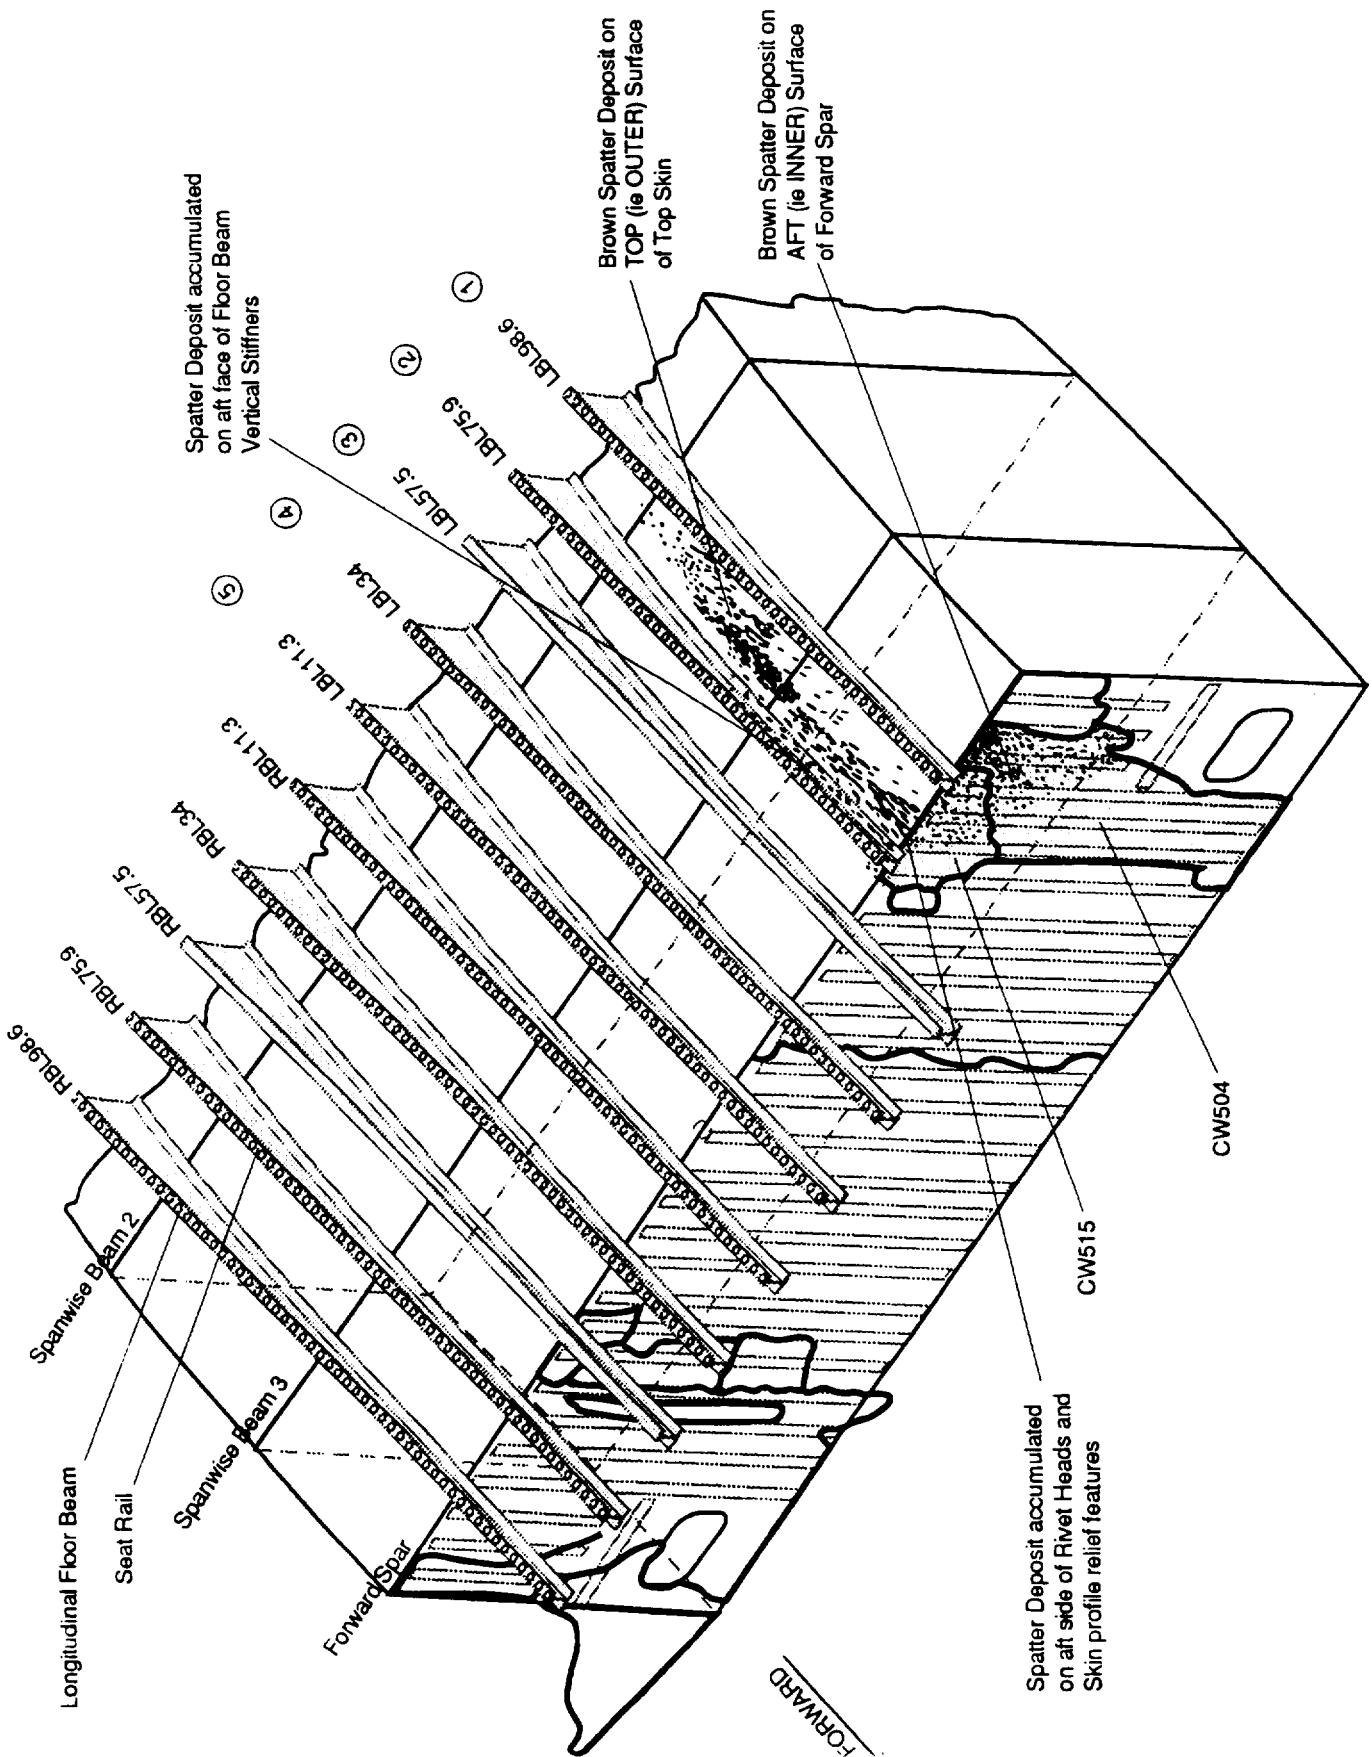
Figure 1

The deposits were generally found around the left, forward upper region of the WCS (Figure 1), on the following surfaces:

- Deposit 1 Top surface of the upper WCS skin (WCS exterior), including floor beams attached to the WCS skin (CW 114).
- Deposit 2 Aft surface of the WCS Front Spar (WCS interior, CW 504).
- Deposit 3 Area of left fuselage frames and floor beams just forward of the WCS.
- Deposit 4 Passenger seats, particularly the left side of the left armrest of Seat 23-4.
- Deposit 5 Left side ECS duct from above and forward of the WCS.
- Deposit 6 Floor board and floor board support at station 960.

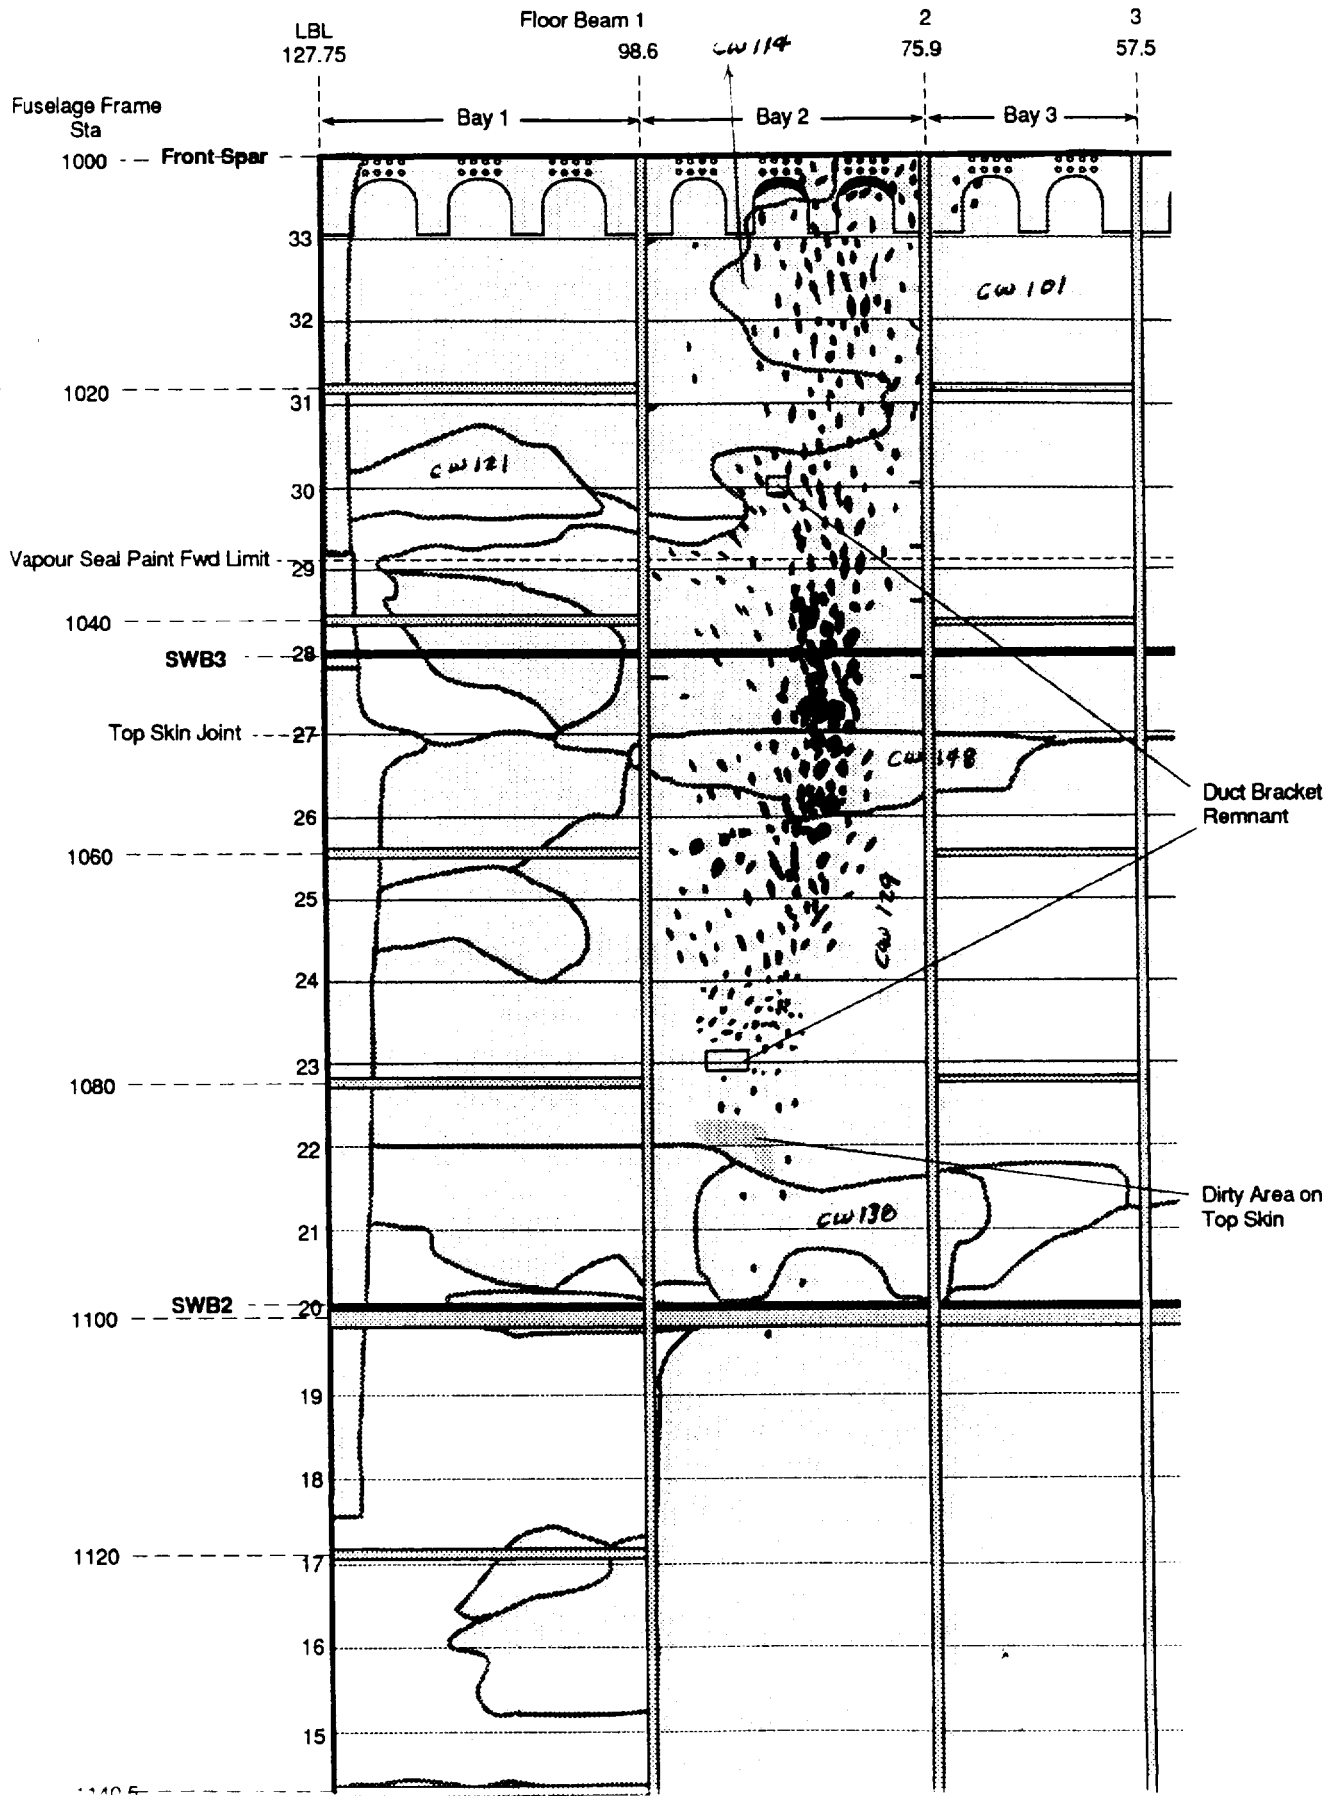
Figure 2 shows a schematic of the location, density and nature of Deposit 1. The main deck longitudinal floor beams over the WCS and the bays between them are numbered left to right (see also figures 5 and 6).

**Longitudinal Extent:** The deposit extended from just aft of SWB2 to the FS, a distance of approximately 100 inches.

**Lateral Extent:** The deposit was between main deck longitudinal Floor Beams 1-2 (left buttock line LBL 98.6-LBL 75.9), plus a few spots between Floor Beams 2-3 near the intersection of Floor Beam 2 and the Front Spar (within around 3 inches of both).

**Concentration:** The area of the deposit on the WCS top skin between Floor Beams 1-2 was generally biased somewhat left of center over its aft portion (between stringers 20 and 26) and right of center between Stringer 26 and the FS (approximately between LBL 76-87). The left side of the top surface between SWB3-FS where the flight deck conditioned air duct runs (LBL 89-97) had some deposit between stringers 23-26 but generally only isolated spots further forwards. In the forward region the left edge of the deposit area was fairly sharply, albeit incompletely, demarcated at approximately the position of the right side of the duct.

**Nature:** The deposit was generally of moderate density, medium sized streaks between stringers 20-25; of high density, large blobs (lacking direction) between stringers 25-29; and of moderate density, smaller sized streaks between Stringer 29-FS.

**DEPOSIT 1 ON TOP SURFACE OF WING CENTRE SECTION TOP SKIN**

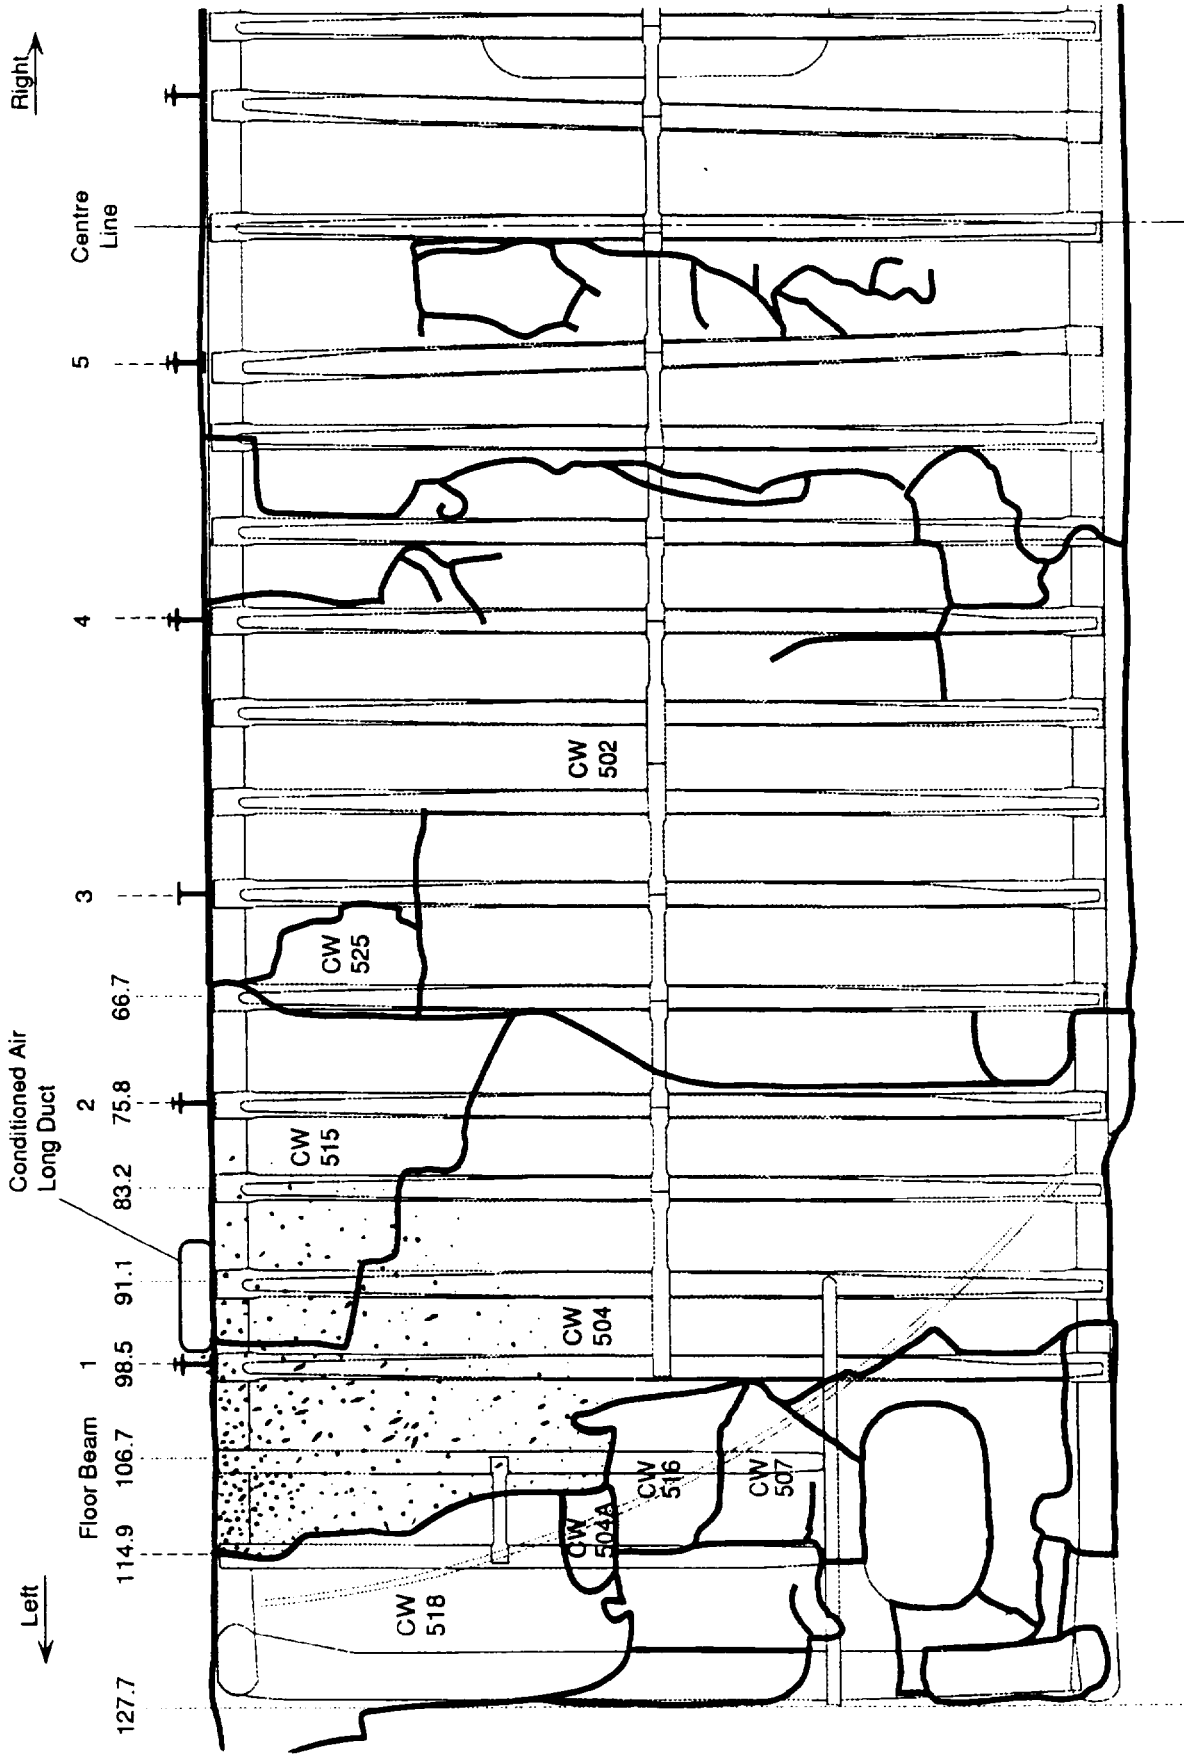
Figure 3

**Longitudinal Extent:** The deposit was found on the aft face of part of the FS formed by CW504 and CW515, on both the spar web and on the vertical stiffeners (Figure 3). The top edge of the FS (CW504) has splatter material between LBL100 to 104.

**Lateral Extent:** The deposit was found on the whole width of the upper part of CW504 and on the left one half of CW515. The total width was approximately 32 inch at the top of the FS (LBL 83-114).

**Vertical Extent:** The deposit area extended from the top of the FS down to a depth of approximately 36 inch on the left side and 14 inch on the right side.

**Concentration:** The deposit was most dense over the upper few inches of CW504, particularly in the top left corner of CW504 (estimated coverage in the order of 10%), becoming progressively sparser with distance from this point to fade out at the extremities of the area. FS stiffeners had been deformed in a number of places in the area; in some cases the deformation appeared to have resulted in blanking (an absence of the deposit) of the forward facing part of the deformed stiffener and of the part of the FS web aft surface covered by it, but not in others. No pattern was discerned in these features.

**Continuity:** The deposit was totally discontinuous across the fractures between the left side of CW504 and the adjoining FS fragments CW518, CW504A and CW516. No deposit was found on the latter three fragments. The deposit was continuous across the fracture between CW504 and CW515. There was splatter on the left top of the 504 web where the web is normally masked by the pickle fork fitting.

DEPOSIT 2 ON CENTRE WING BOX FRONT SPAR

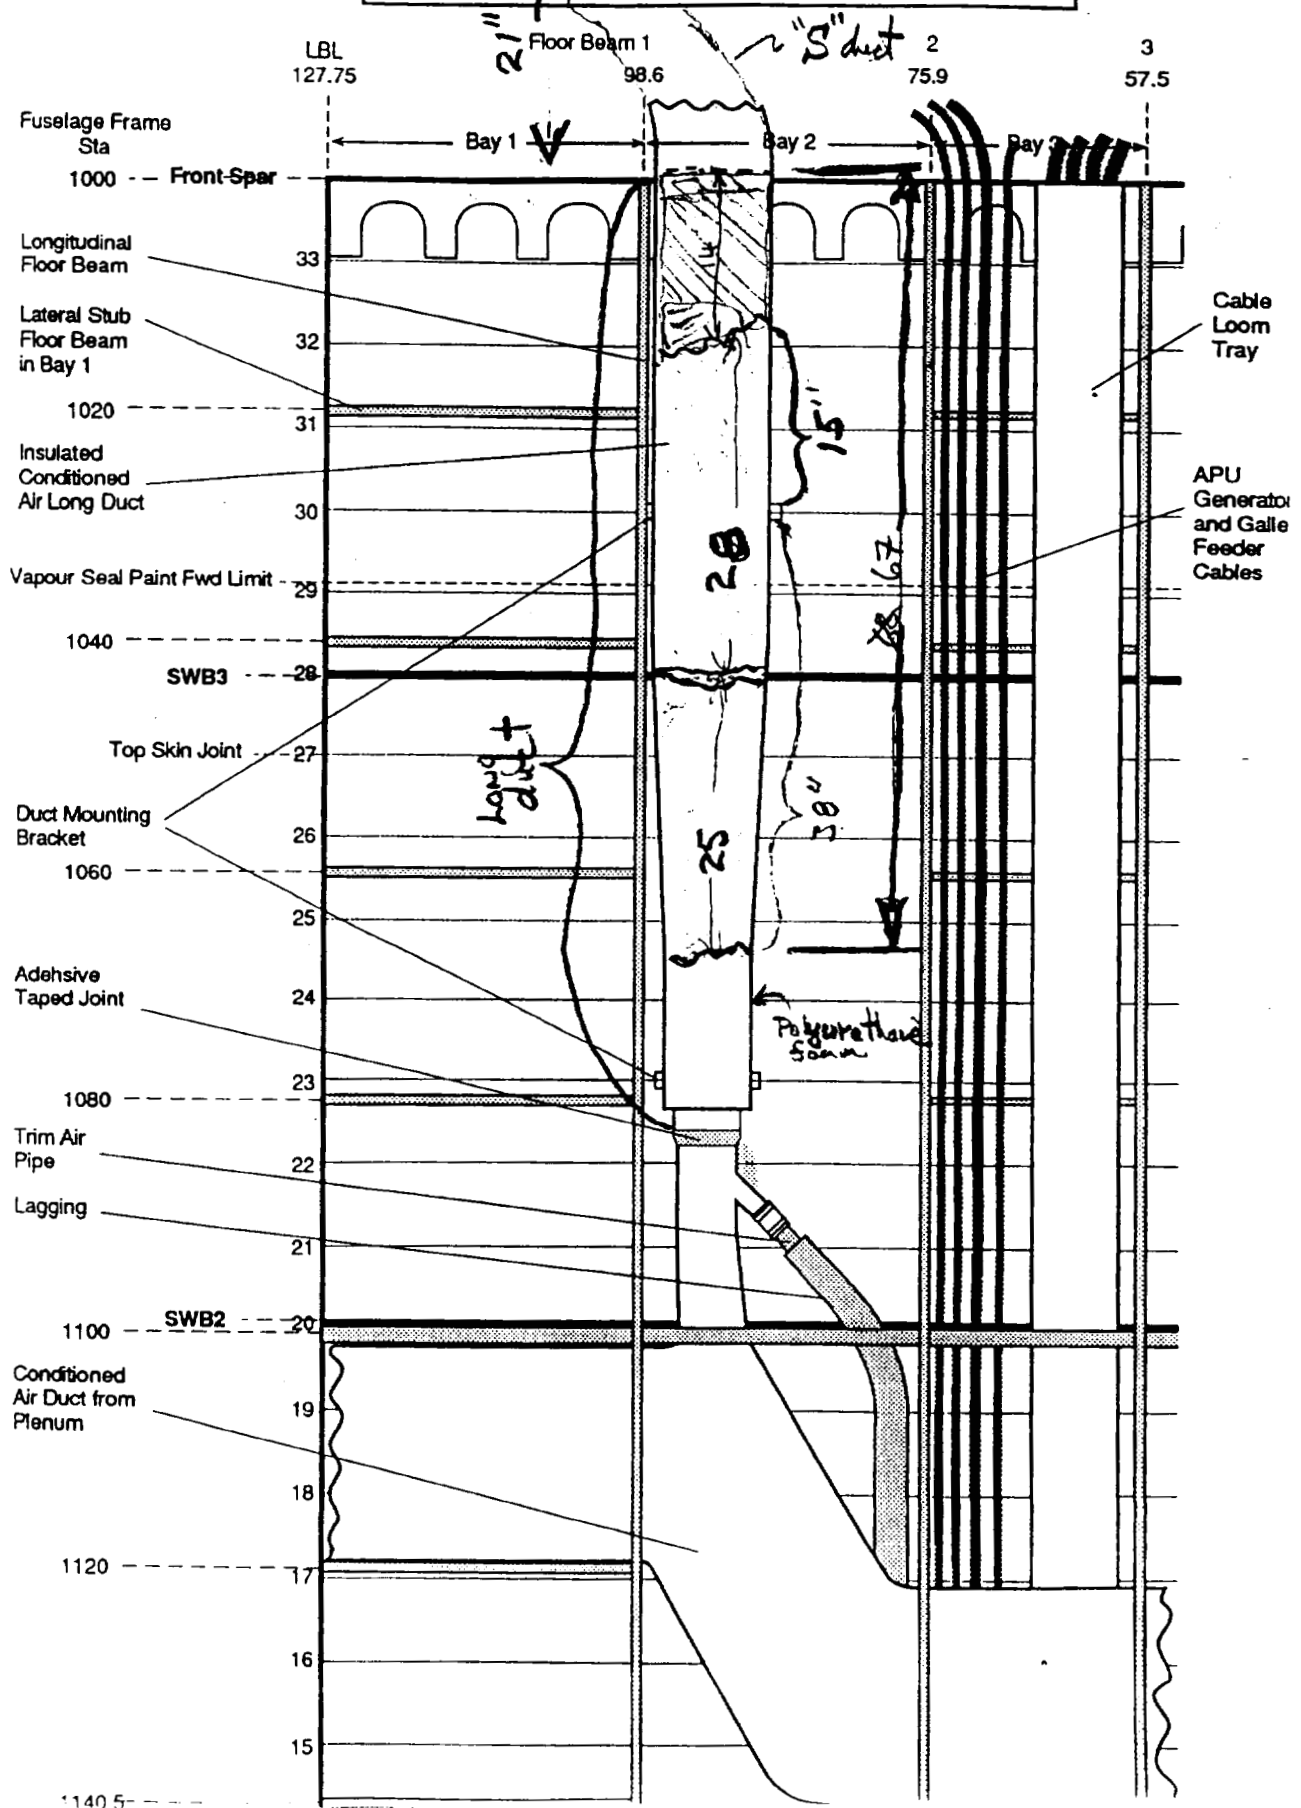
Figure 5

Three pieces of the air conditioning long duct were identified (P/N 69B42220) which were located between the cabin floor and the WCS top surface. The three pieces had an aggregate length of about 67 inches of a total of length of about 85 inches (figure 5). The aft section of the "S" duct was located. This section curves down and outboard and attaches to the long duct. This "S" duct piece had mechanical damage to the

The second piece of straight long duct identified (intermediate section) was about 28 inches long, had essentially no insulation left on it, and was darkened from fire (figure 5). There was a color discontinuity across the fracture line between this duct piece and the forward duct piece. The forward fractured end corresponded in location to about a position 2 inches forward of Stringer 32 (fuselage station 1015) with the aft end at about SWB3. This piece had part of the duct inboard mounting bracket attached to it for exact positioning relative to the WCS top skin. Splatter like material extended about 1 foot into the duct along the inside bottom surface on the forward end. On the inside inboard surface the splatter material starts at the forward end and goes back about 6 inches. On the inside outboard surface the splatter material starts at the forward end and goes back about 16 inches, although it is intermittent (figure 5).

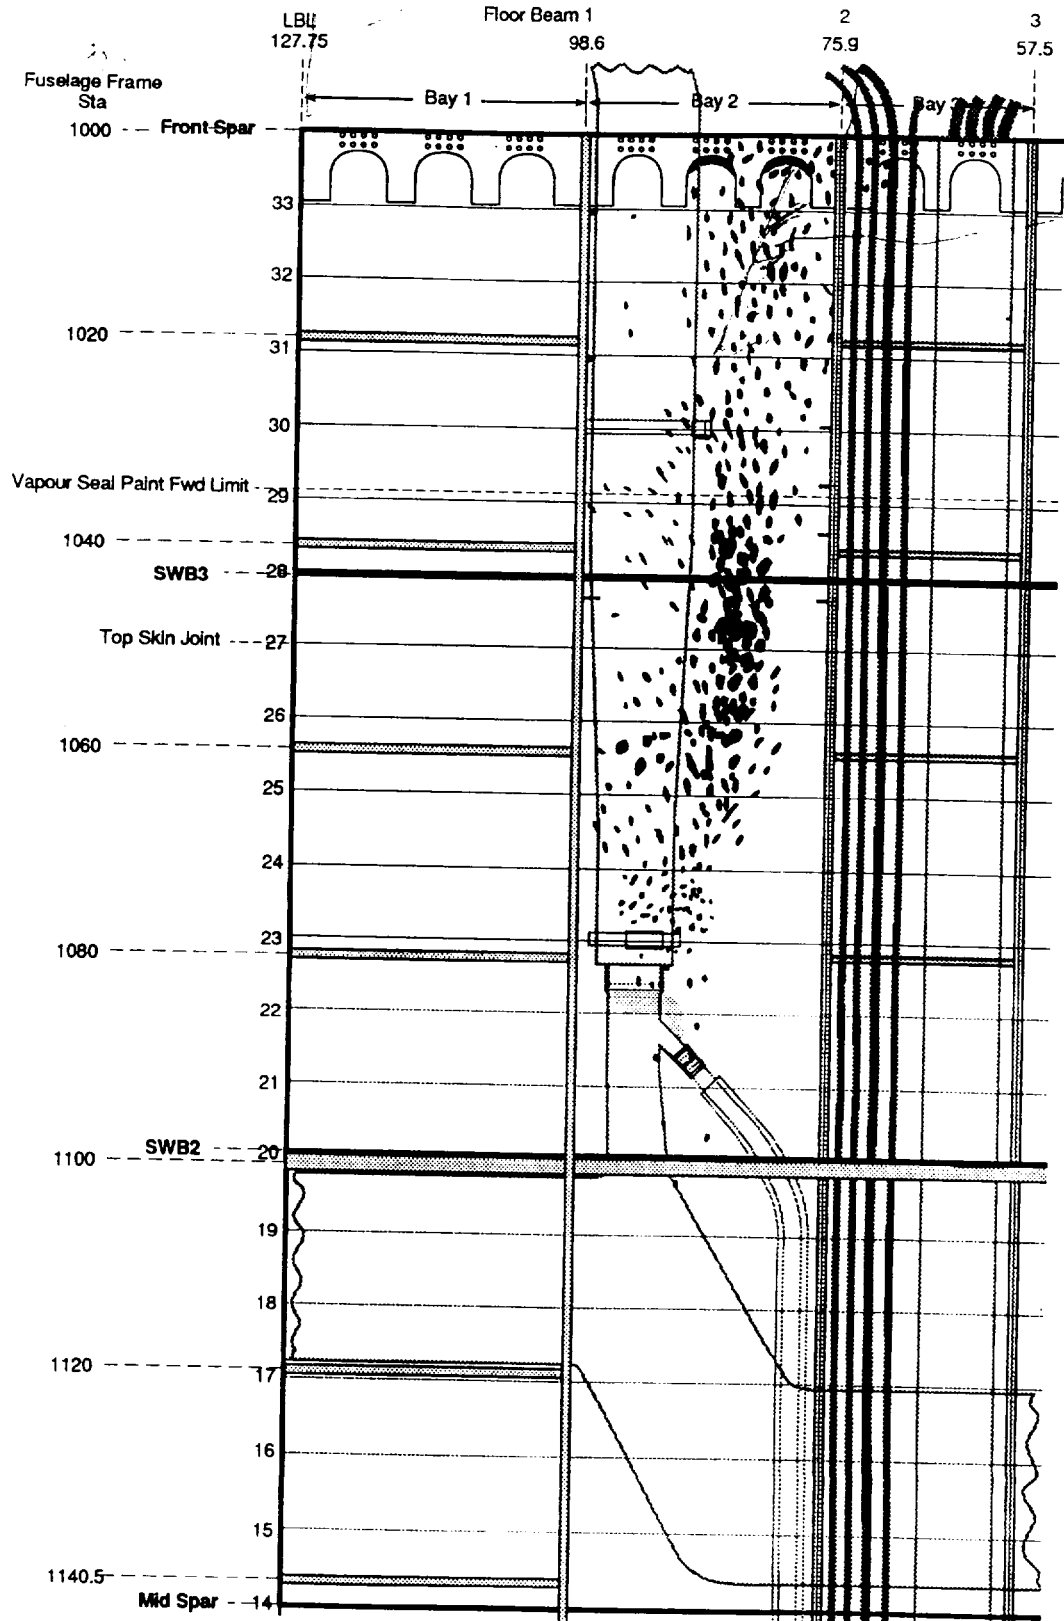
Figure 6

4. There had been a generally forward airflow through the region for at least part of the time during which Deposits 1, 2 & 3 had accumulated. This was clearly evident from the location of the deposits on aft facing surfaces in all three areas (Fig 6).

**DEPOSIT 1 AND SYSTEMS ON TOP OF WING CENTRE SECTION**

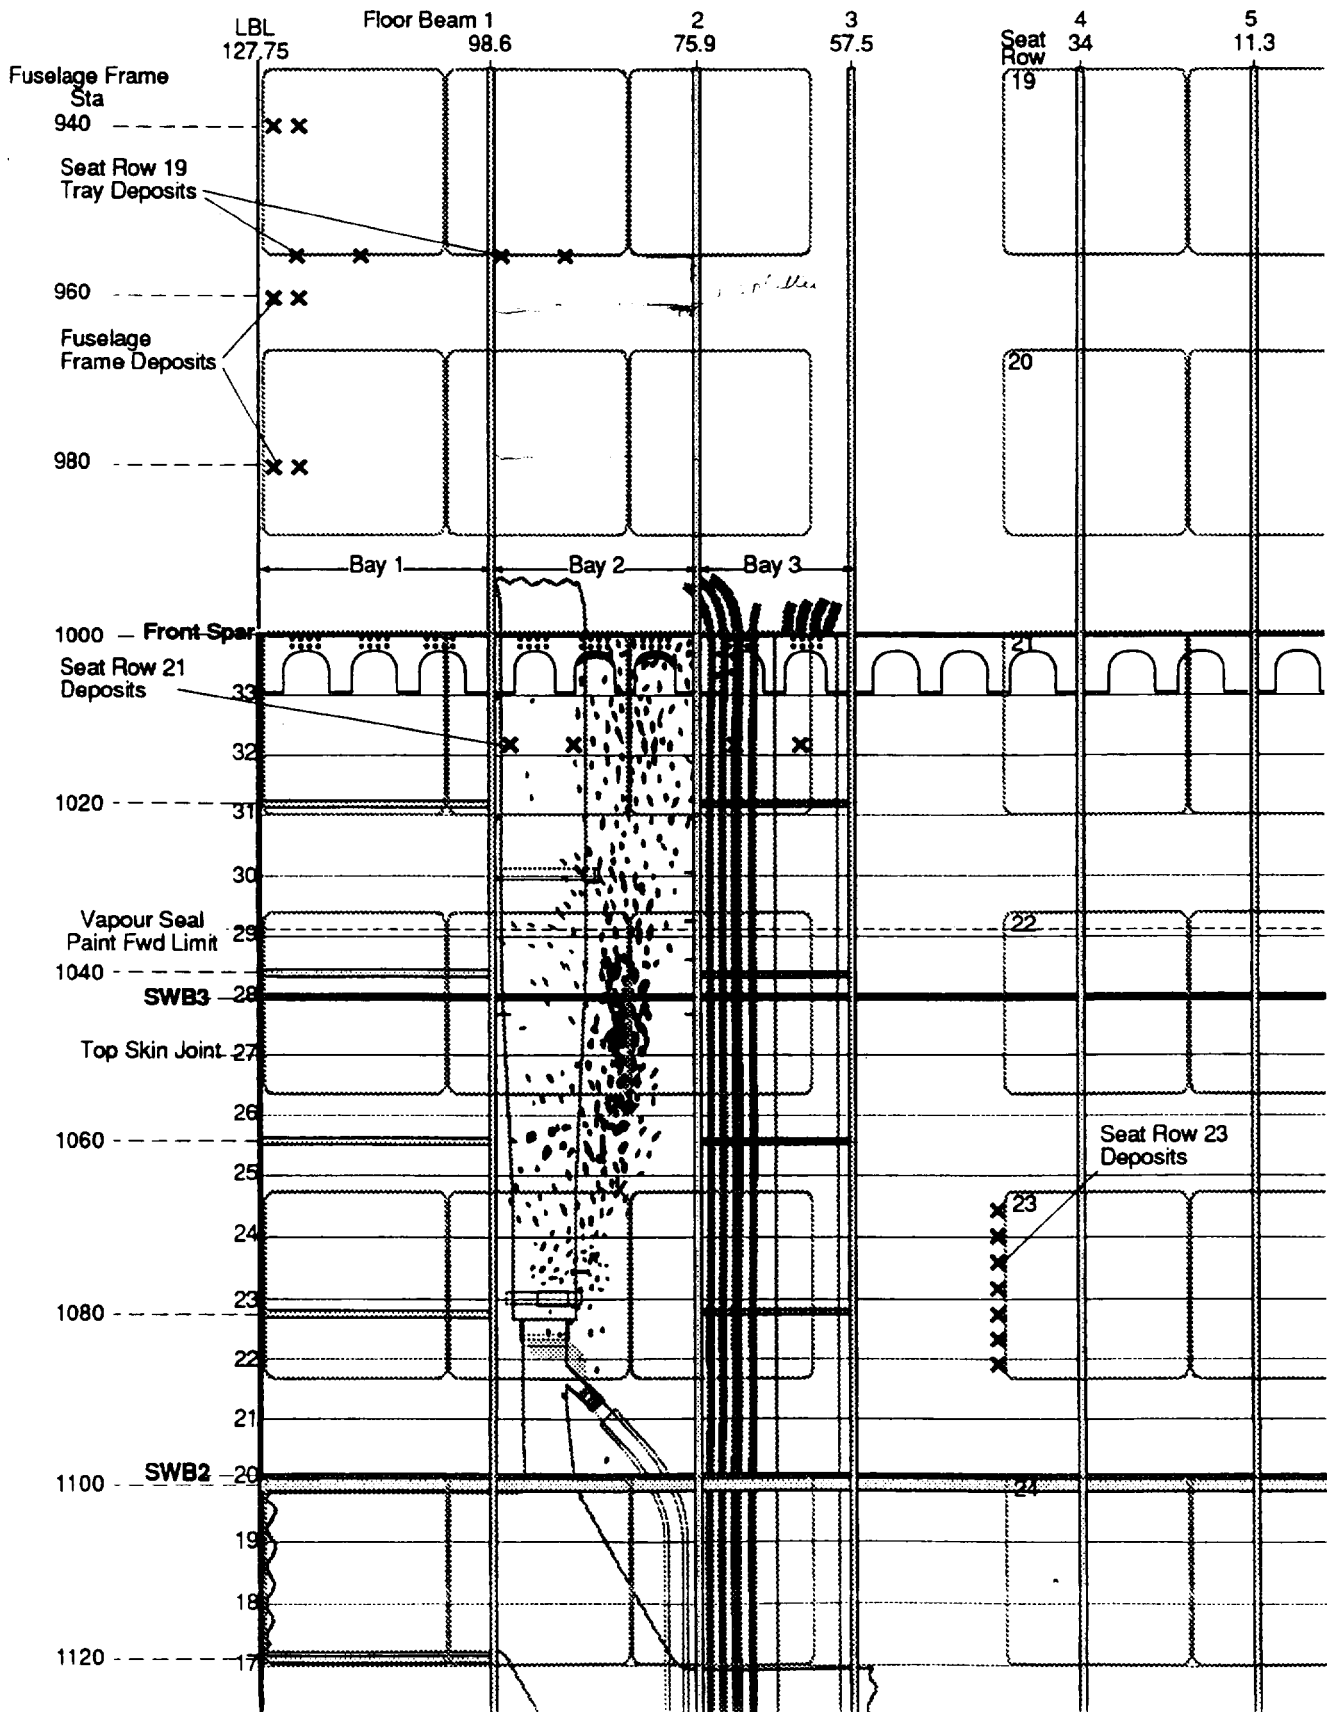
Figure 7

Location: Deposit on left side of the left armrest of Passenger Seat 23-4, located approximately relative to the WCS (see figure 7):

Features: The deposit consisted of a series of fairly sparsely spread, generally horizontal streaks of moderate size, apparently similar to the WCS deposit material. A similar effect was not present on any other identified seats in the center or forward cabin.

**DEPOSITS AROUND WING CENTRE SECTION, SYSTEMS AND SEATS**
