**NATIONAL TRANSPORTATION SAFETY BOARD
WASHINGTON, DC**

**FACTUAL REPORT ON RED/BROWN SHADED SUBSTANCE
FOUND IN PASSENGER SEATS**

DCA96MA070

Airplane: Boeing 747-131, N93119
Operated as Trans World Airlines (TWA) flight 800

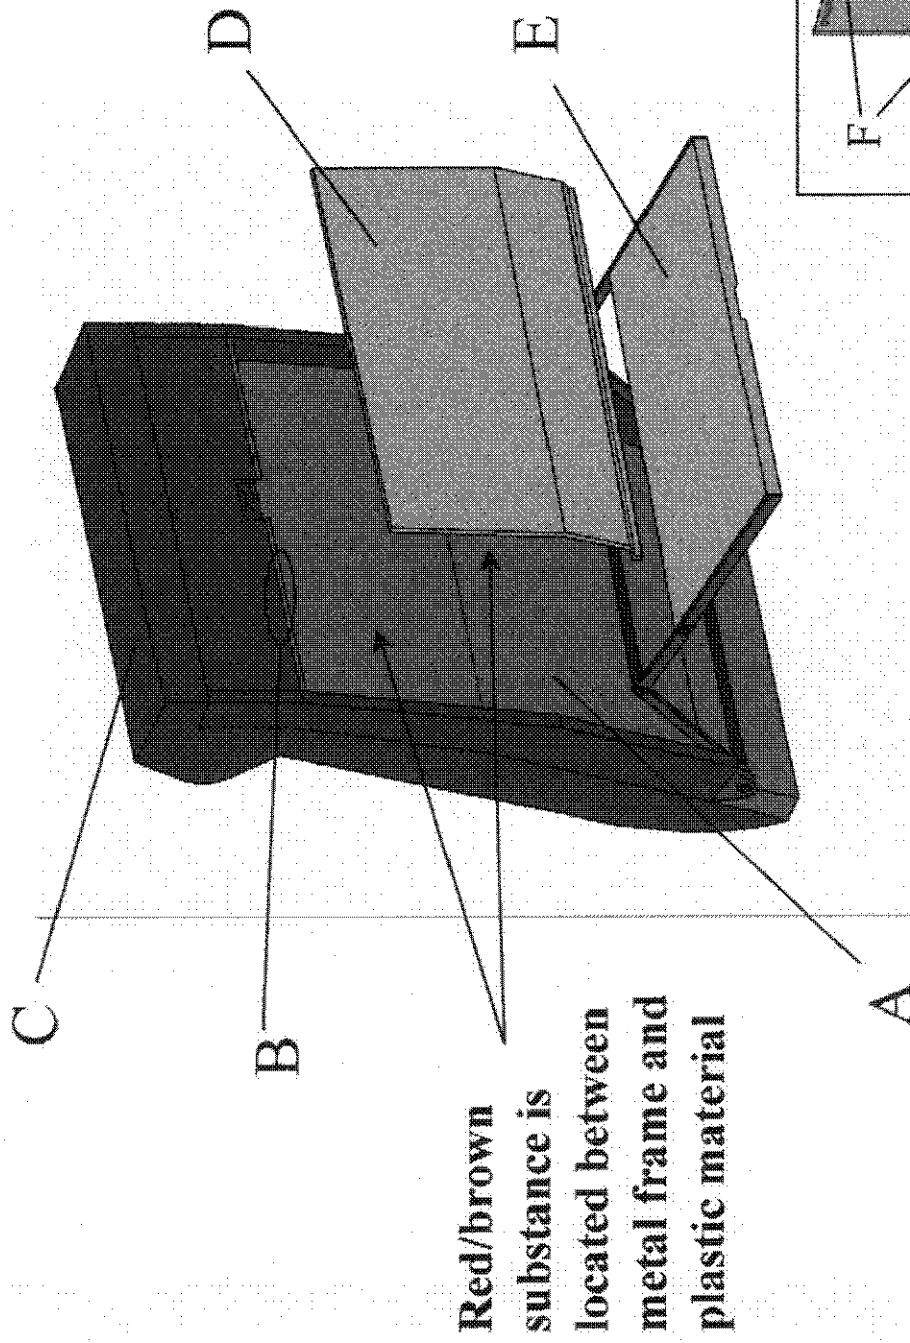
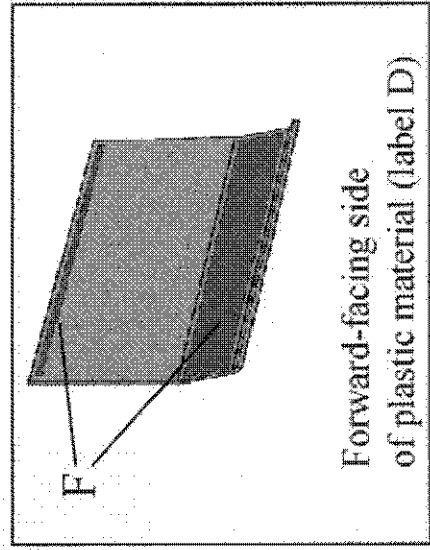
Figure 1. Seatback structures (not to scale).

The internal seatback frame is made of aluminum (Figure 1, label A). Different types of cushioning material and filler material cover the internal seatback frame including a polyvinyl chloride (PVC) foam and a polyethylene foam. These materials are bonded to the internal seatback frame with adhesives. An upholstered cover (which is typically made of a blend of wool and nylon² fabric) is attached to the cushioning materials and the internal seatback frame with adhesive and Velcro® tape.

In the aft side of the seat headrest, sections of foam (Figure 1, label B) are bonded with adhesive to the internal seatback frame. The padded cushioning materials are placed over this foam, and the upholstered cover is placed over the cushioning materials (Figure 1, label C). The Weber Aircraft representative told Safety Board investigators that this foam material in the seats of the accident airplane appeared to be Ethafoam™ (a polyethylene foam) which is manufactured by Dow Chemical Company. These foam sections are bonded to the internal seatback frame with an adhesive.

A rectangular-shaped rigid plastic sheet that forms the external surface of the seatback (Figure 1, label D) is bonded with adhesive to the aft side of the seatback. A pull-down food table (Figure 1, label E) when stowed fits against this plastic material on

the seatback. This plastic material is an acrylonitrile butadiene styrene (ABS) plastic sheet. Flexible foam strips (Figure 1, label F) are bonded with adhesive to this plastic sheet, and these materials are bonded together with adhesive to the internal seatback frame. These strips are used to strengthen the plastic to metal adhesive bond. The Weber Aircraft representative told Safety Board investigators that this foam in the seats of the accident airplane appeared to be a foam material which is manufactured by Rubatex® Corporation. According to the corporation's literature, this material is polyvinyl chloride/acrylonitrile butadiene rubber (PVC/NBR) foam.
