NATIONAL TRANSPORTATION SAFETY BOARD
Office of Research and Engineering
Washington, D.C.

Flight Data Recorder

Specialist's Factual Report of Investigation by Erin M. Gormley

Location: Anchorage, AK
Date: October 9, 2002
Aircraft: B-747-400, N661US
Operator: Northwest Airlines Inc.
NTSB Number: ANC03IA001

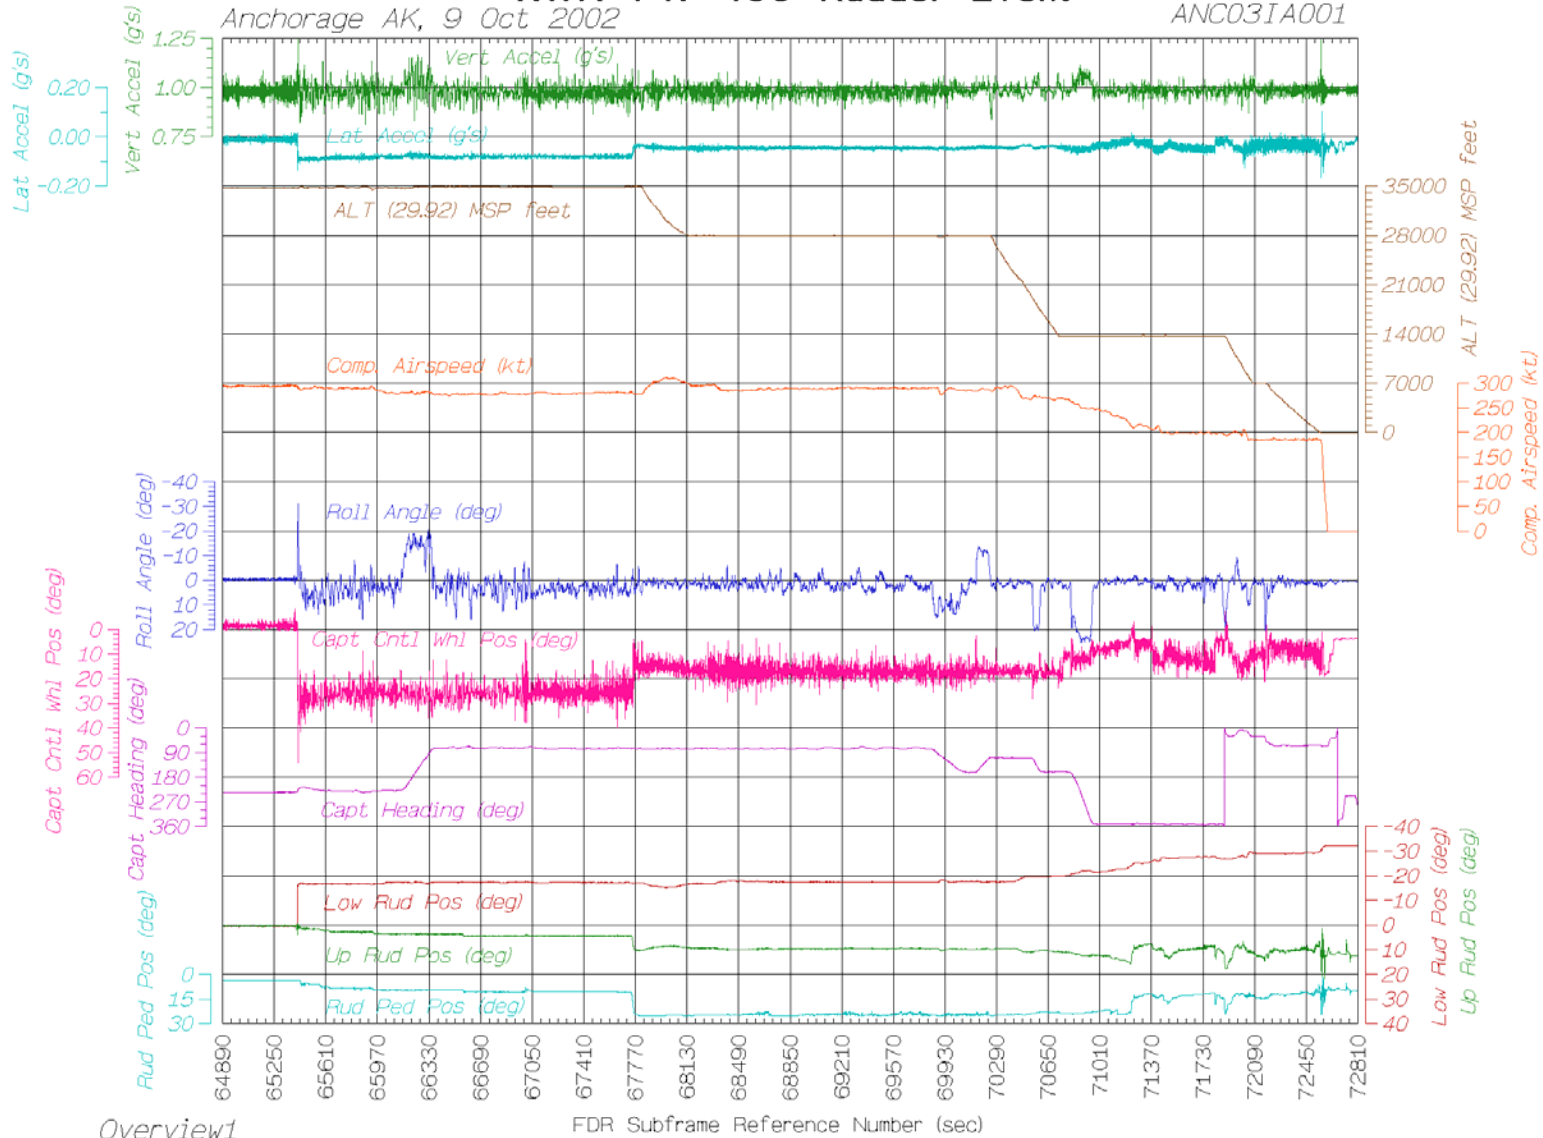
Overview1

The FDR data indicate that the aircraft took off around SRN 40636. At SRN 65410, as the aircraft was cruising at a pressure altitude of about 35000 feet and an airspeed of 293 knots, the lower rudder position parameter started deflecting from 0 degrees to the left. One second later, the yaw damper module lower parameter registered a fault and the aircraft began to roll to the left. At SRN 65416, the aircraft reached -31 degrees left roll, the captain control wheel position parameter showed a value to the right of +54 degrees. The data recorded during the next second show that the upper rudder parameter began to deflect to the right and the A/P command L parameter had moved to not engaged. At SRN 65418, the lower rudder position reached -17 degrees and remained near that value.

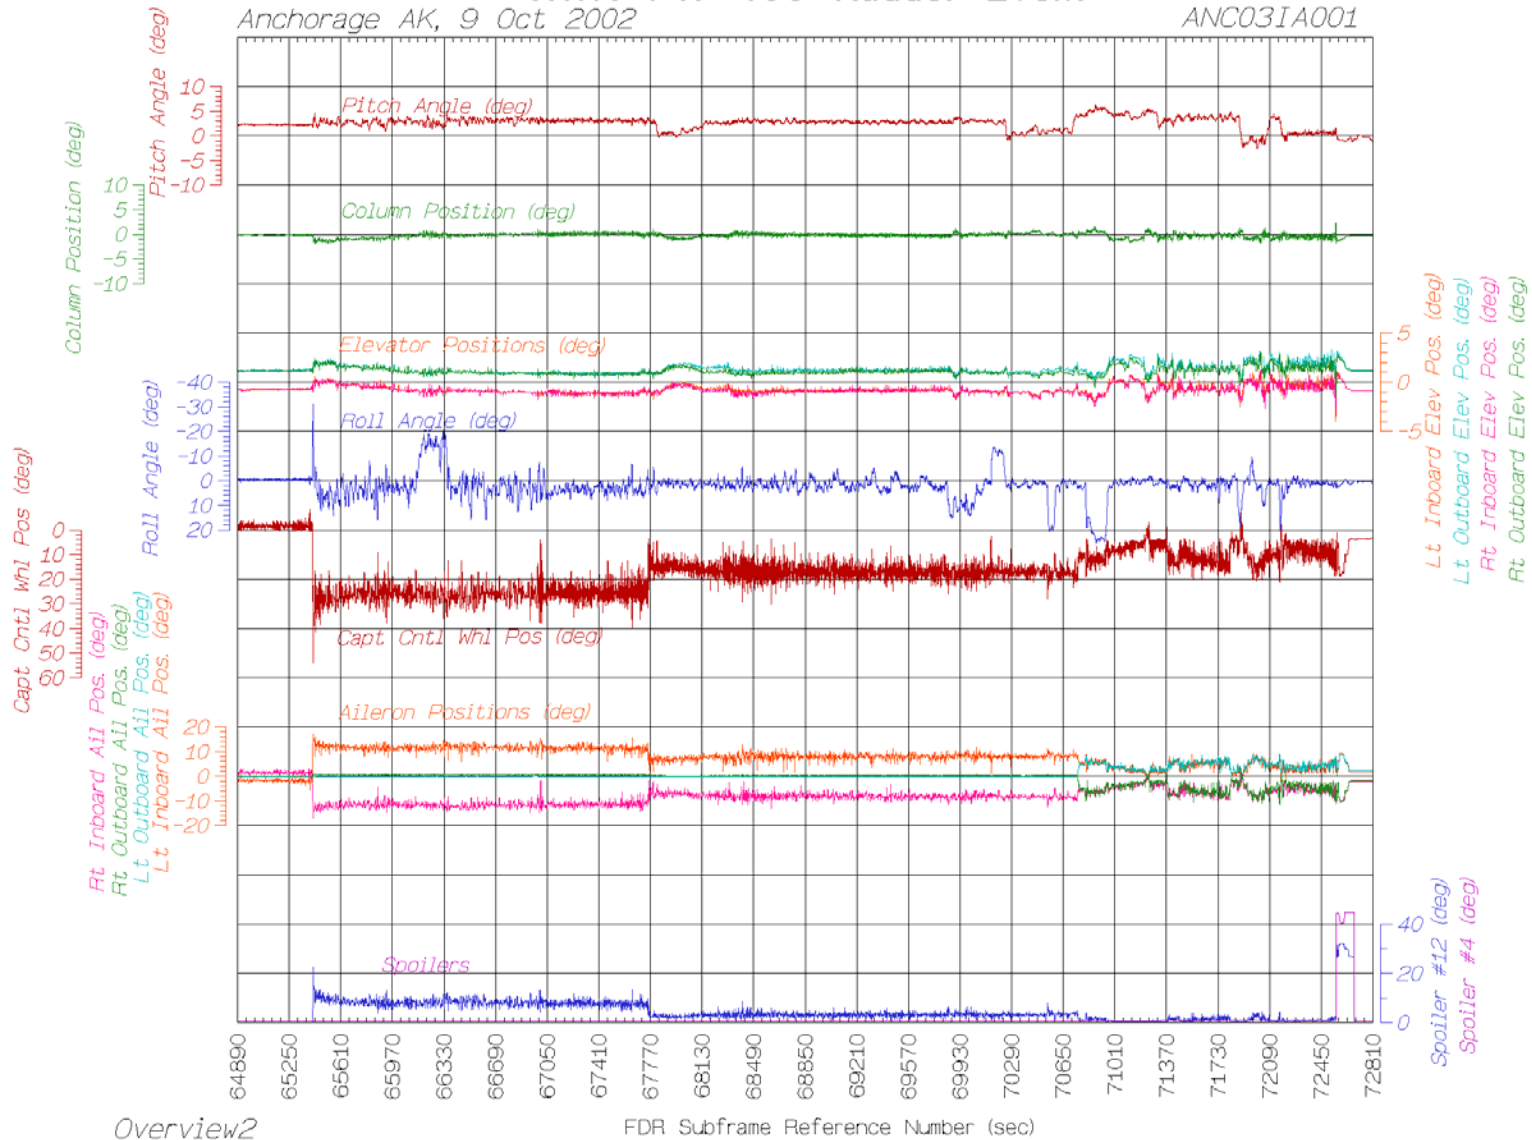
Overview2

After SRN 67745, the upper rudder parameter moved further to the right and the recorded pressure altitude began to decrease. After SRN 70420, as the aircraft began descending from about 22400 feet, the airspeed began to decrease and the lower rudder parameter started moving further to the left. The lower rudder position parameter moved continually to the left as the aircraft descended and slowed and recorded over -30 degrees when the aircraft landed at SRN 72553.
