Waterman Peak Site Exam
N530RL, S/N 0602FF

WATERMAN PEAK SITE EXAM 3-8-2011
N530RL, S/N 0602 FF

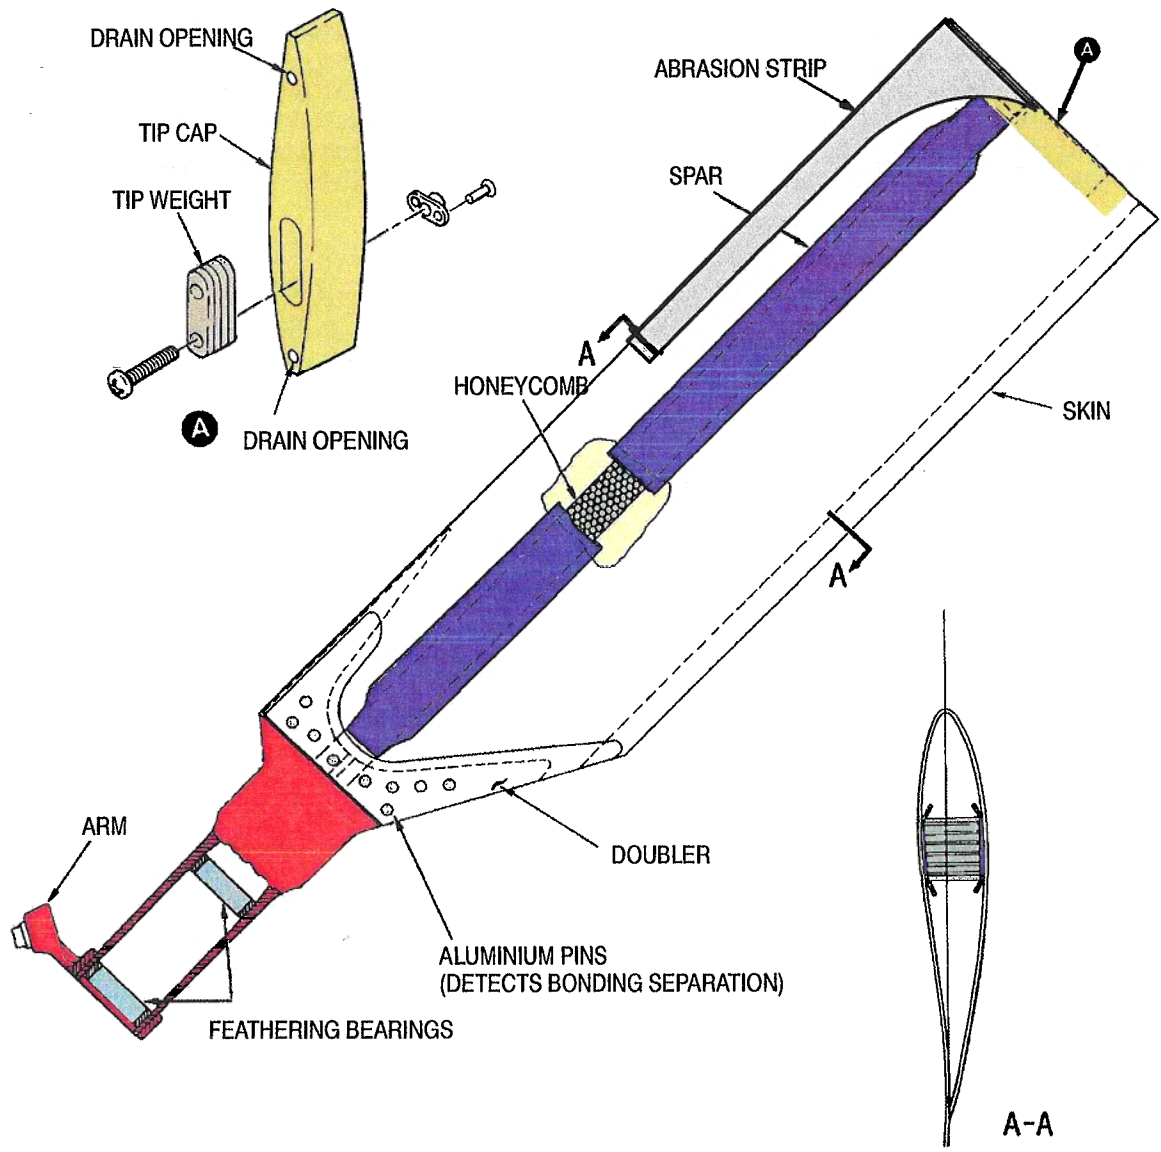
Figure 4-2. Tail Rotor Blade

Both tail rotor blades were substantially damaged at the tip ends with 3 to 6 inches of the blades tips missing and rough abrasive scoring in the cord wise direction on the tail rotor blades. Two pieces of tail rotor blades skin were recovered by the Pinal County Sheriff's department during a secondary parts search after the helicopter wreckage was removed. The two tail rotor blades pieces found were reportedly located in the same canyon as the wreckage. During the wreckage exam at the recovery yard, the tailboom was found to have a torsion twist at approximately station 257 and damage to the stingers left side. This tail boom twist is consistent with an impact to the lower vertical while the helicopter is in a right hand rotation.

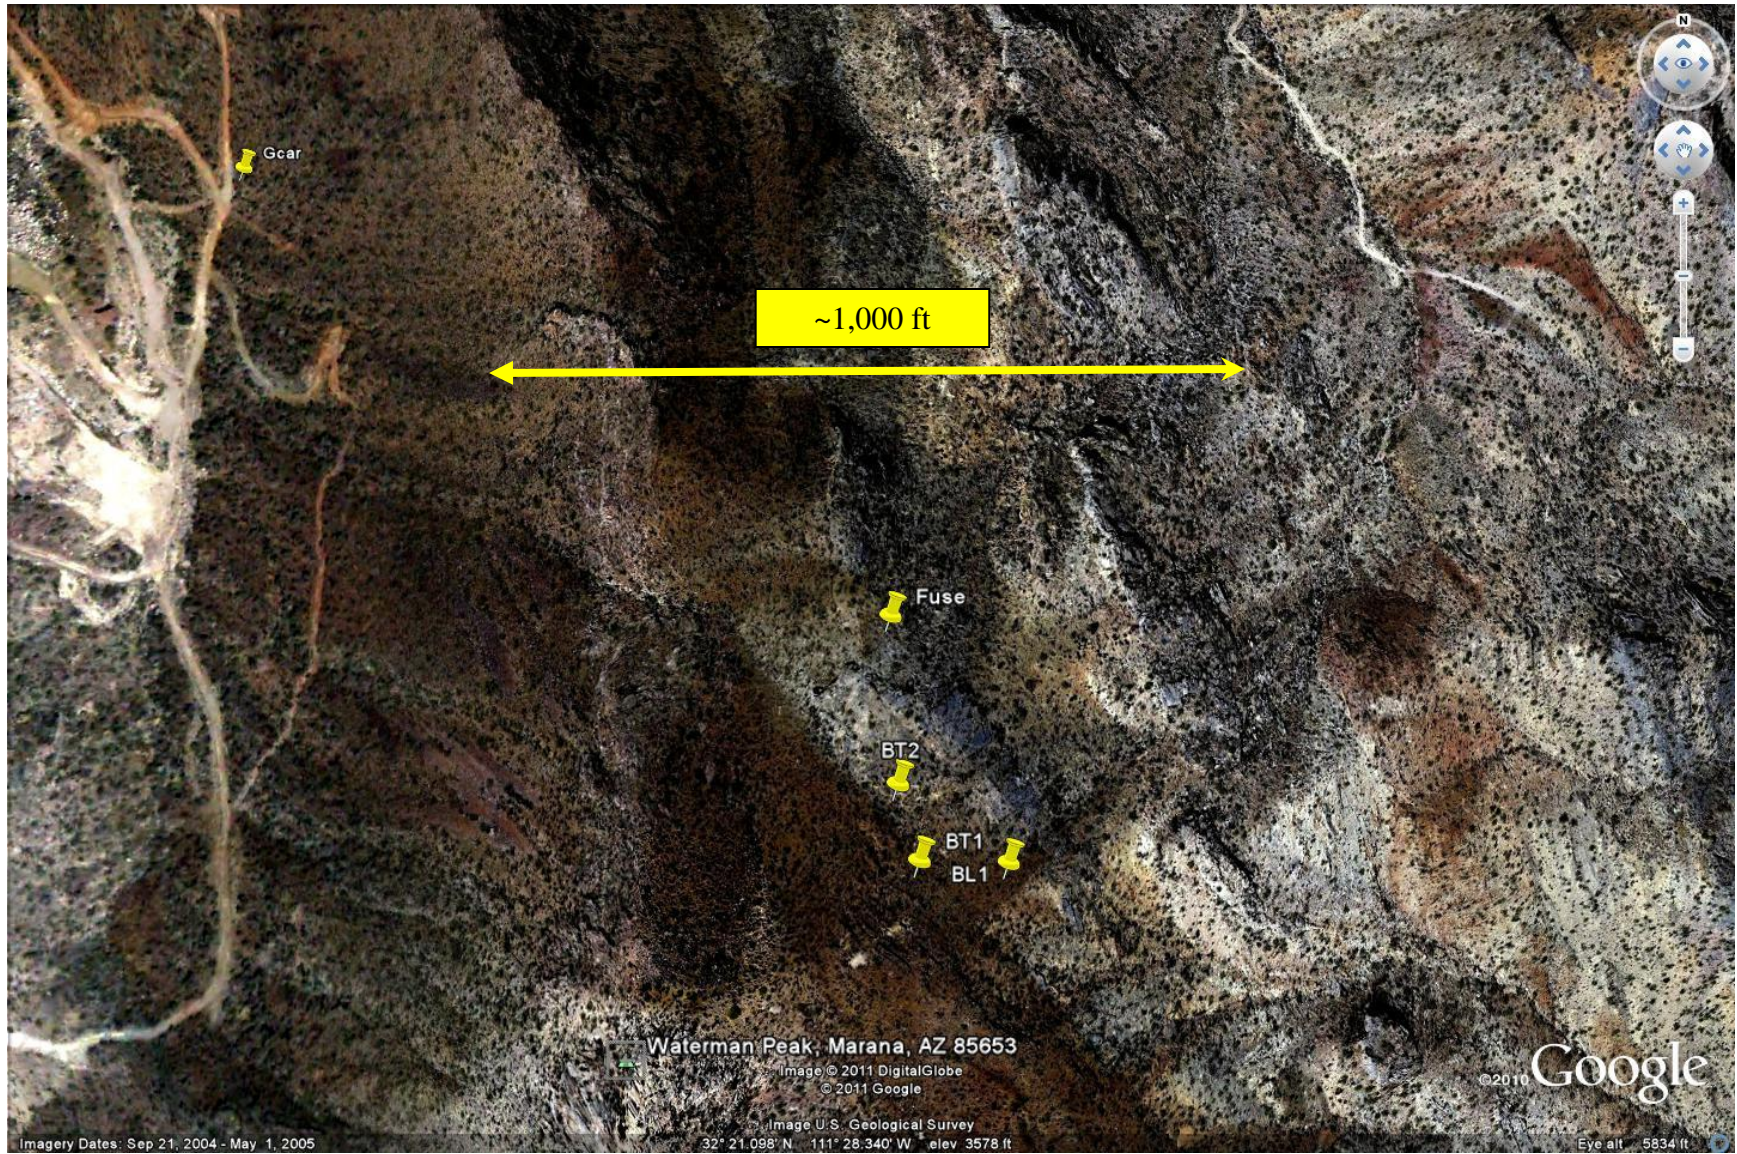
WPR11GA115
From FAA

The accident site exam found pieces from the tail rotor blades on the pinnacle landing area in one general debris field. The pieces found were identified and numbered and the relative locations are shown on the attached map. The ground is rocky providing little evidence of ground scarring as verified by the limited rock scarring where known main rotor blade strikes occurred. A location on the ground or rocks where a tail rotor strike occurred was not determined. Pieces from the tail rotor blades are hi-lighted in yellow. A blue colored adhesive is used in the tail rotor blade bonded skin joints and red colored adhesive is used in the main rotor blade bonded skin joints (except for the tip weight). The red paint pieces are consistent with the paint stripes on the tail rotor blades. Since both the main and tail rotor utilize honeycomb, no determination of origin was made to these pieces. The parts recovered were retained by the FAA, Ken Fenning.

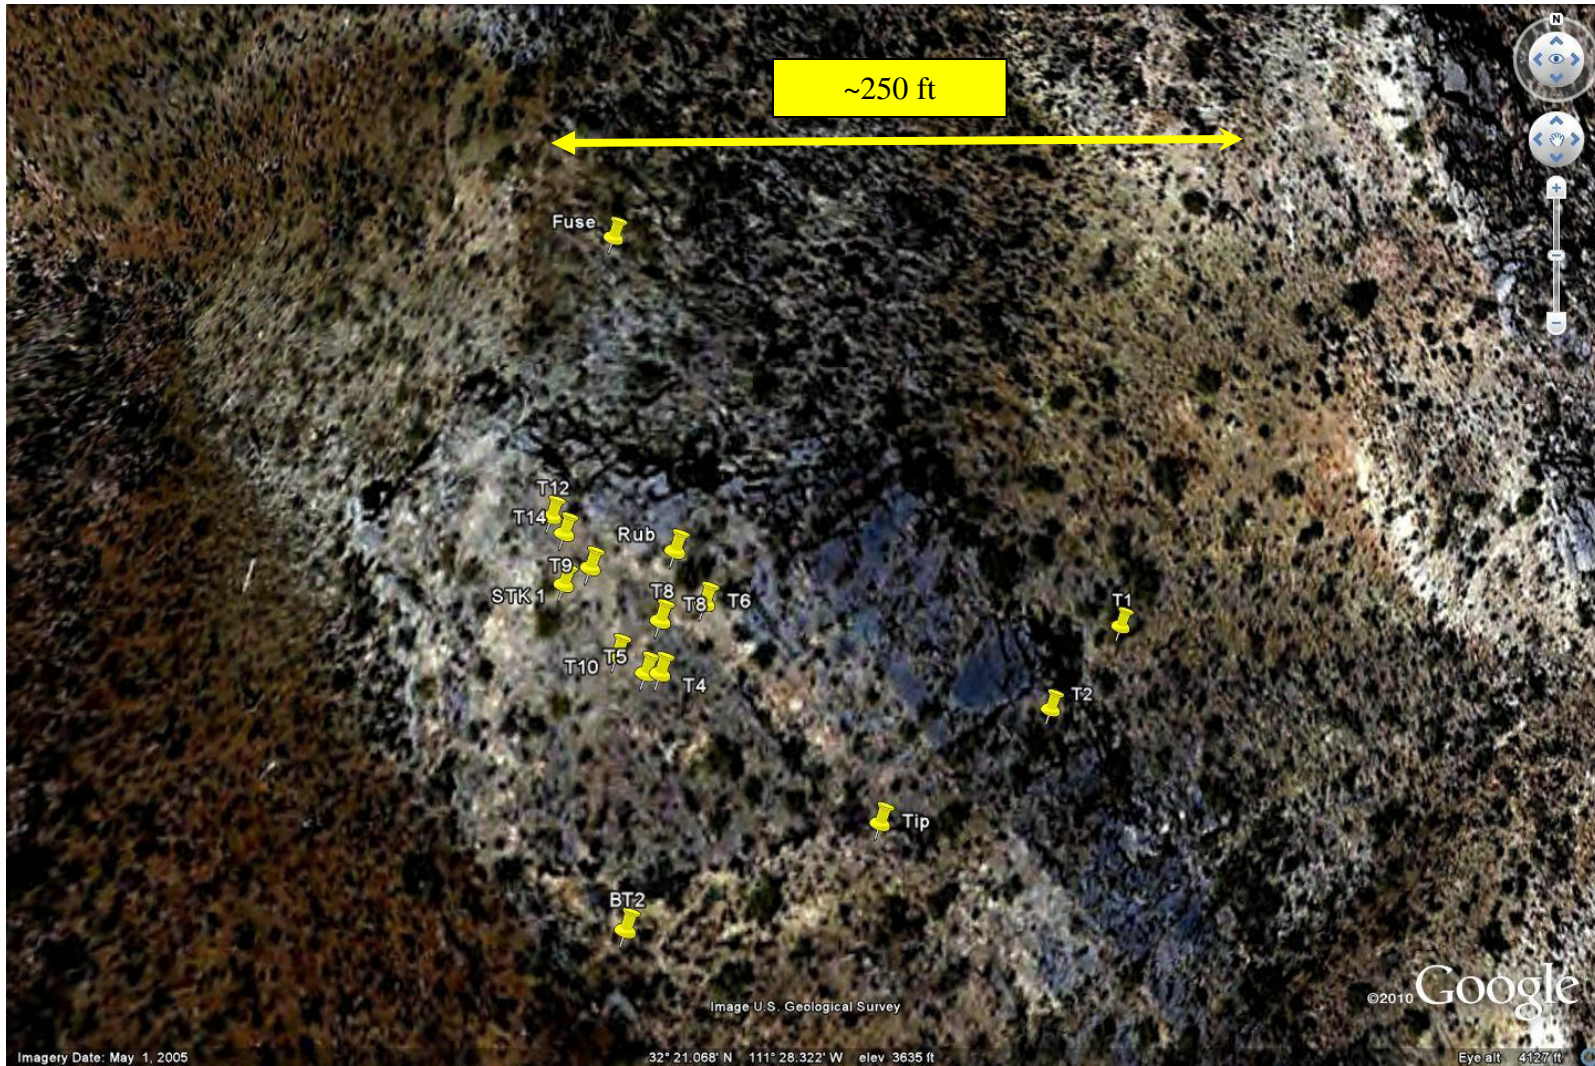
WPR11GA115
From FAA

We visited the crash site one last time. We found numerous tail rotor blade pieces that gave us a definitive plane that the tail rotor was on when it came apart. It was not a mechanical failure. We could not definitively locate what the tail rotor hit however, but it did hit something. I've attached another google earth j peg to give you a rough idea of what we found. Ignore the pins labeled BT2, Ruc and STK 1. Those are not T/R parts. The pin labeled Tip is a piece of one of the T/R blade tips.
