**FORENSIC EVIDENCE AND RESEARCH DOCUMENTATION (MAPPING)
FACTUAL REPORT**

DCA14FR008

**NATIONAL TRANSPORTATION SAFETY BOARD
OFFICE OF RESEARCH AND ENGINEERING
WASHINGTON, D.C.**

Location: Lynchburg, Virginia
Date: April 30, 2014
Vehicle: CSX train KO8227
NTSB #: DCA14FR008

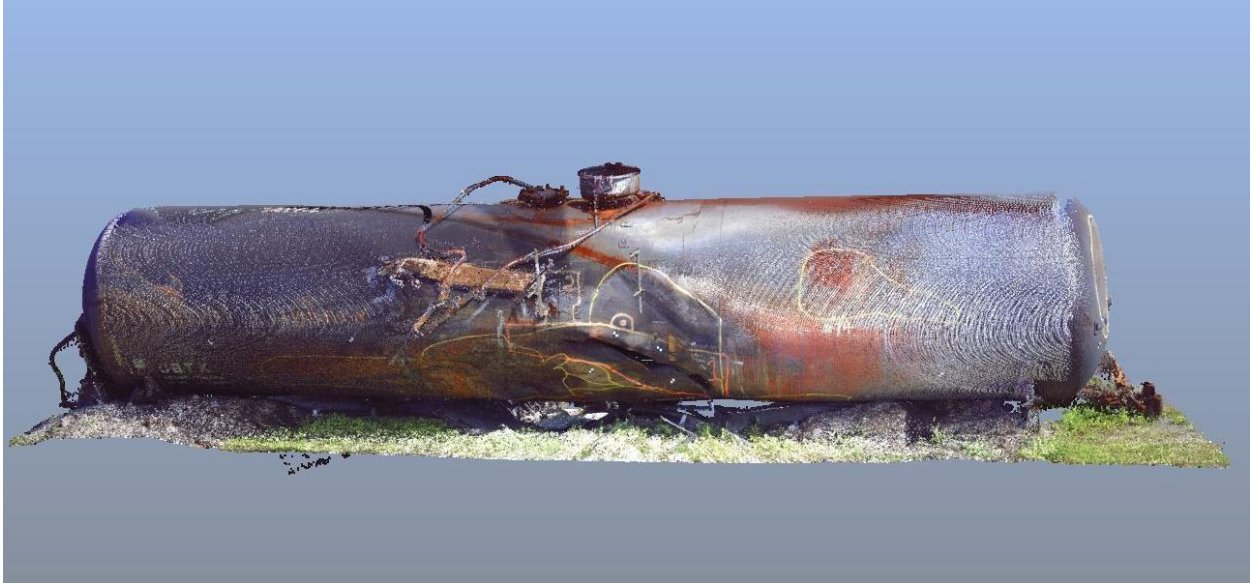
Figure 1: An image from the 3D laser scanner point cloud showing the left side of tank car CBTX 74712. The A-end of the car is shown on the right in the image. Prior to the accident the tank car was traveling B-end leading.

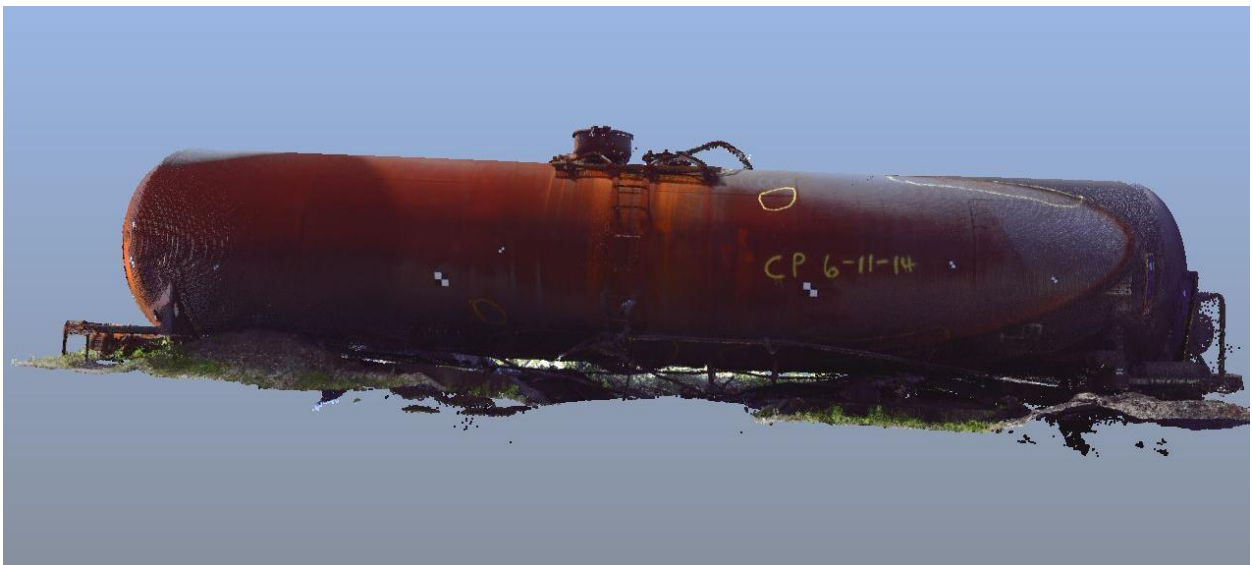
Figure 2: An image from the 3D laser scanner point cloud showing the right side of tank car CBTX 74712. The A-end of the car is shown on the left in the image. Prior to the accident the tank car was traveling B-end leading.

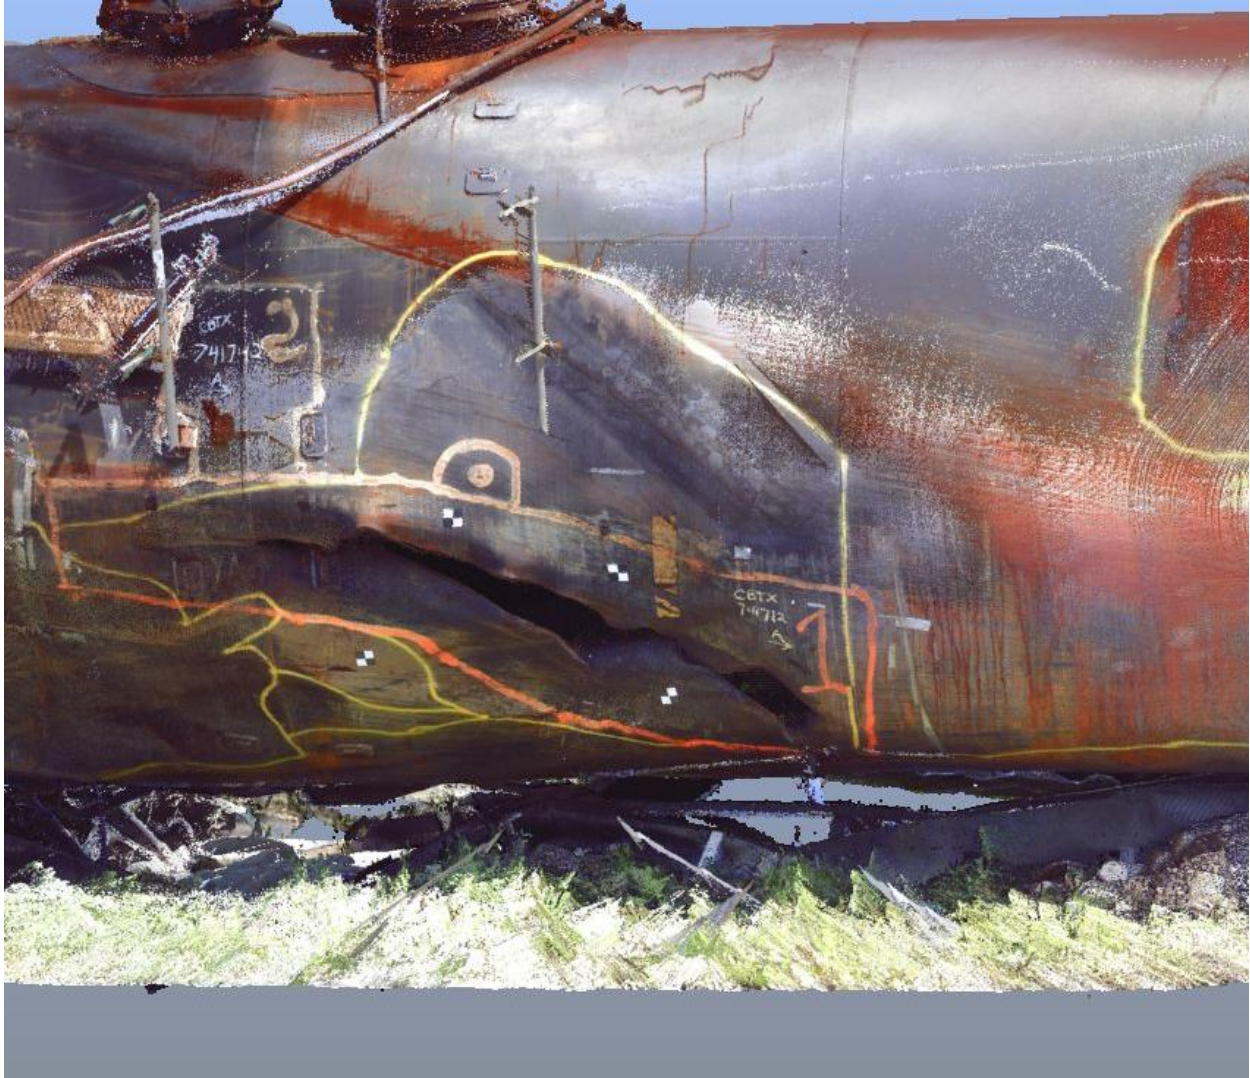
The exterior of the tank car was documented with a total of 16 scans. Two of the 16 scans were performed from an elevated position to capture the data from the top of the tank car. Four scans were used to document a large gash in the side to the tank car. Images from the point cloud created by the scanner documenting the tank car are shown in Figure 1 and Figure 2. A close-up image of scan data documenting the large gash found on the left side of the tank car is shown in Figure 3.

Figure 3: An image from the 3D laser scanner point cloud showing a close-up of the gash in the found on the left side of tank car CBTX 741712. Prior to the accident the tank car was traveling B-end leading.

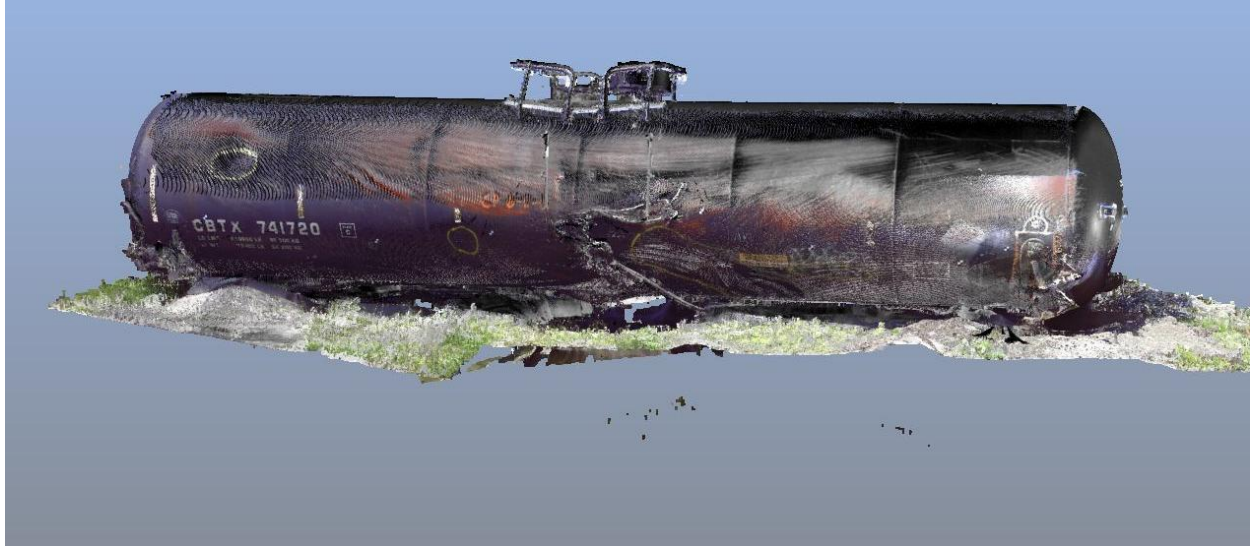
Figure 4: An image from the 3D laser scanner point cloud showing the left side of tank car CBTX 741720. The A-end of the car is shown on the right in the image. Prior to the accident the tank car was traveling B-end leading.

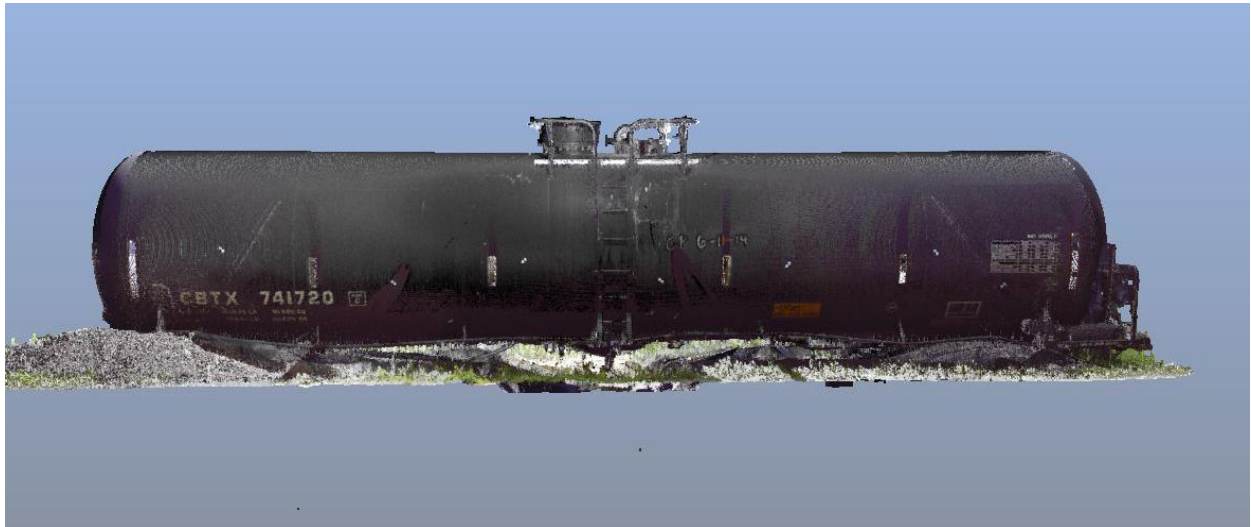
Figure 5: An image from the 3D laser scanner point cloud showing the right side of tank car CBTX 741720. The A-end of the car is shown on the left in the image. Prior to the accident the tank car was traveling B-end leading.

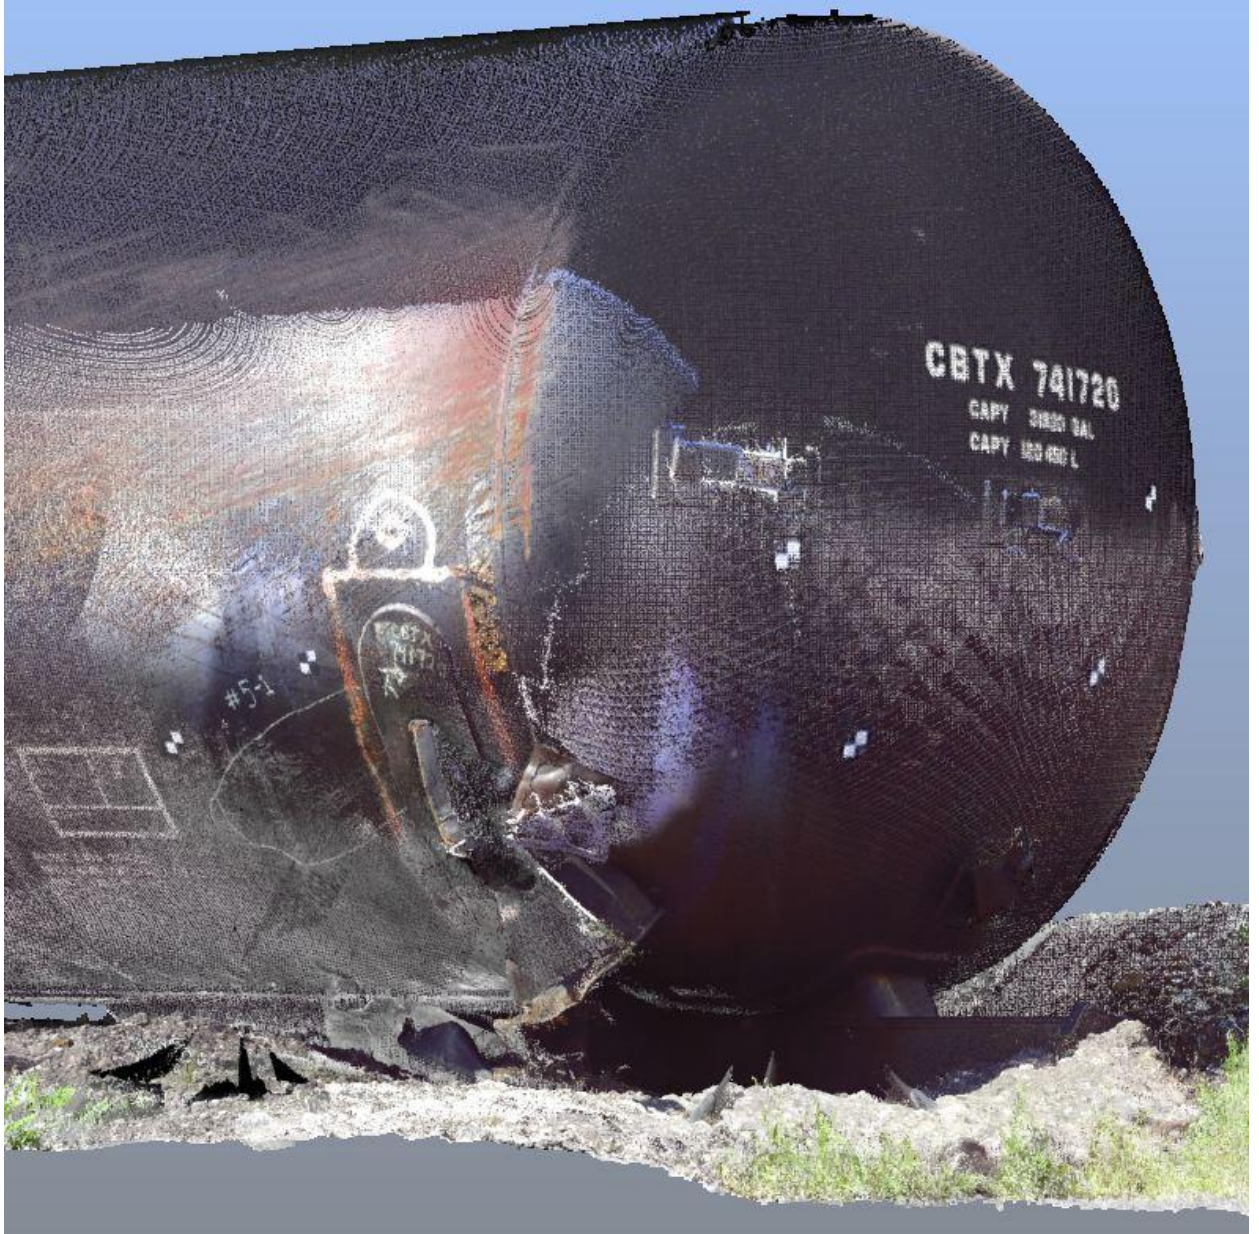
The exterior of the tank car was documented with a total of 16 scans. Four of the 16 scans were performed from an elevated position to capture the data from the top of the car. Four scans were used to document damage to the right side bolster on the A-end of the car. Images from the point cloud created by the scanner documenting the tank car are shown in Figure 4 and Figure 5. A close up of the damaged left side bolster on the A-end of the car is shown in Figure 6.

Figure 6: An image from the 3D laser scanner point cloud showing a close-up image of the A-end of car CBTX 74720 and the damage to left side bolster. Prior to the accident the tank car was traveling B-end leading.
