FORENSIC RESEARCH AND EVIDENCE DOCUMENTATION GROUP
Factual Report

CHESTERFIED TWP, NJ

HWY-12-MH-007
(13 Pages)

**NATIONAL TRANSPORTATION SAFETY BOARD
OFFICE OF HIGHWAY SAFETY
WASHINGTON, D.C. 20594**

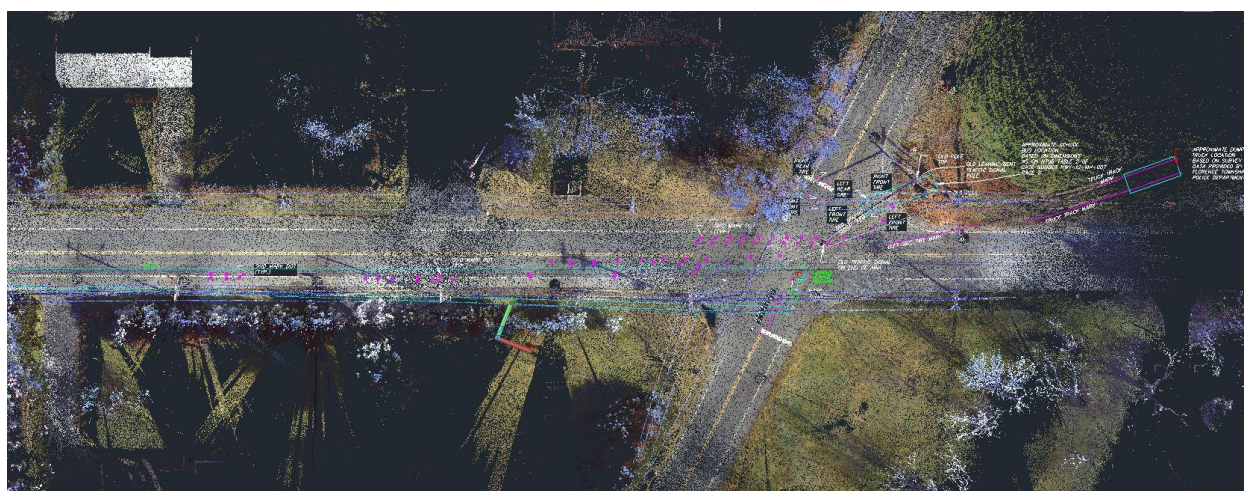
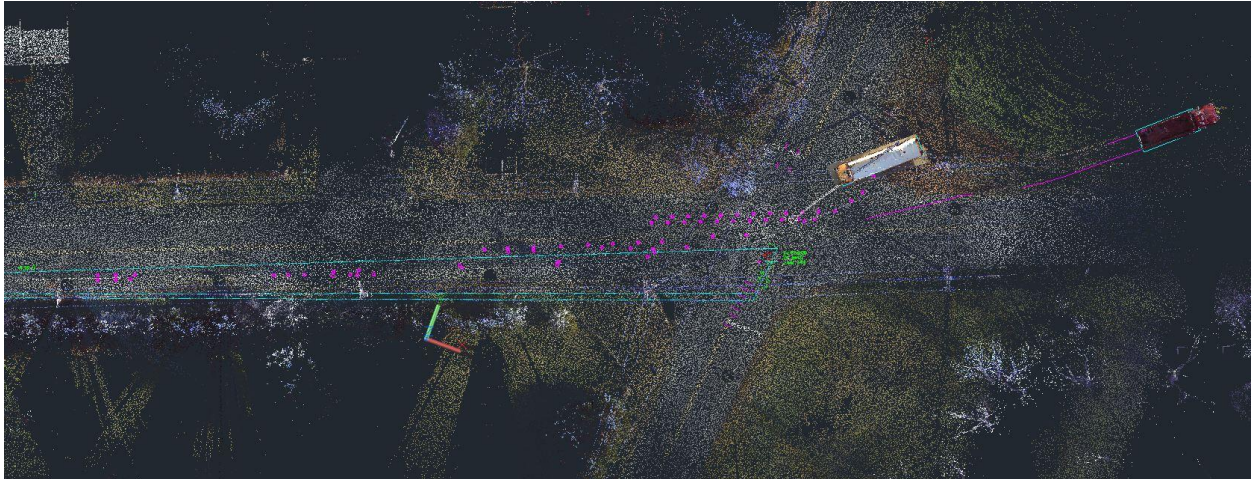
Figure 3: An overlay of the police survey of the accident scene and vehicle positions onto the 3D scan. The 3D scans of the school bus and truck are also shown in the final rest positions.

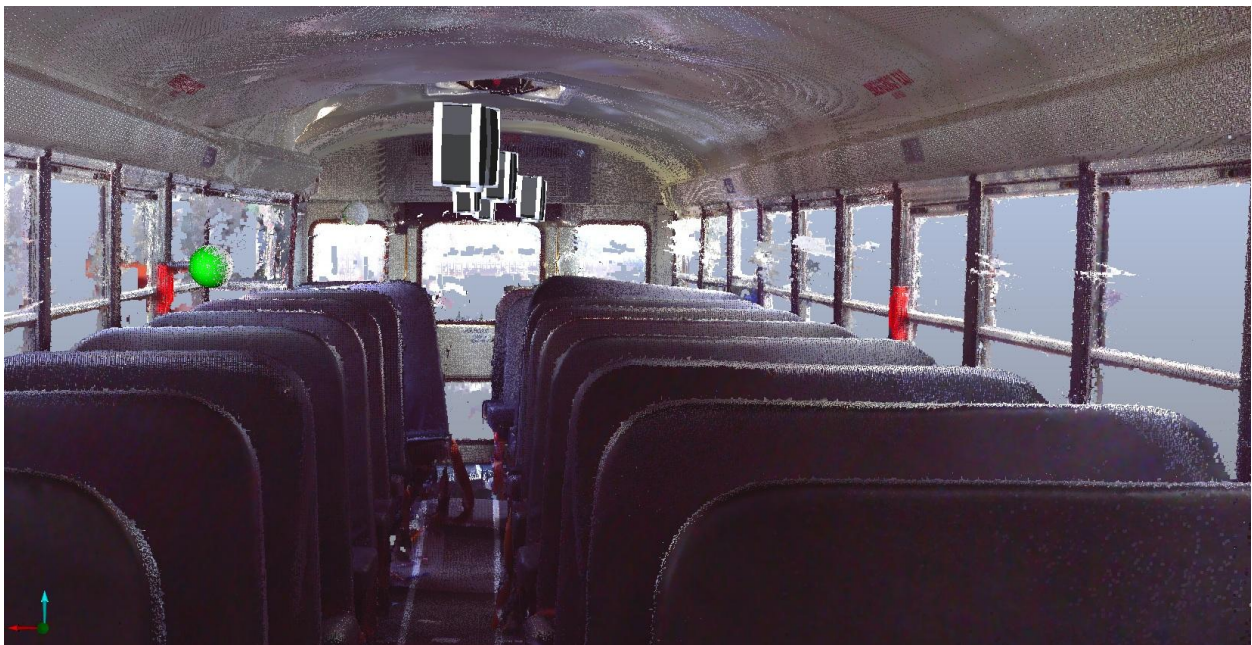
Figure 4: An image of the school bus interior from the combined 3D scan.

Interior dimensions¹ were measured from the scanned data. The width of the seats on the driver's and passenger's sides of the bus was 45" and 30", respectively. The vertical distance from the floor to the top of the seat pan was approximately 16.8" and to the top of the seat back was approximately 42.3". The maximum vertical deformation of the floor in the area of intrusion was approximately 10". The damaged floor began approximately 45.5" forward of the rear emergency exit door and continued forward for about 71". The roof also showed damage that started approximately 37" forward of the rear emergency exit door and continued forward for about 95". The roof displacement vertically measured approximately 5.7". Some seats were also shifted both laterally into the aisle and vertically upwards. Seat 8 on the passenger side was shifted about 8.7" into the aisle. Seat 9 on the driver's side was shifted 3.7" into the aisle and 4.4" vertically upward compared to the undeformed seats at the front of the bus.

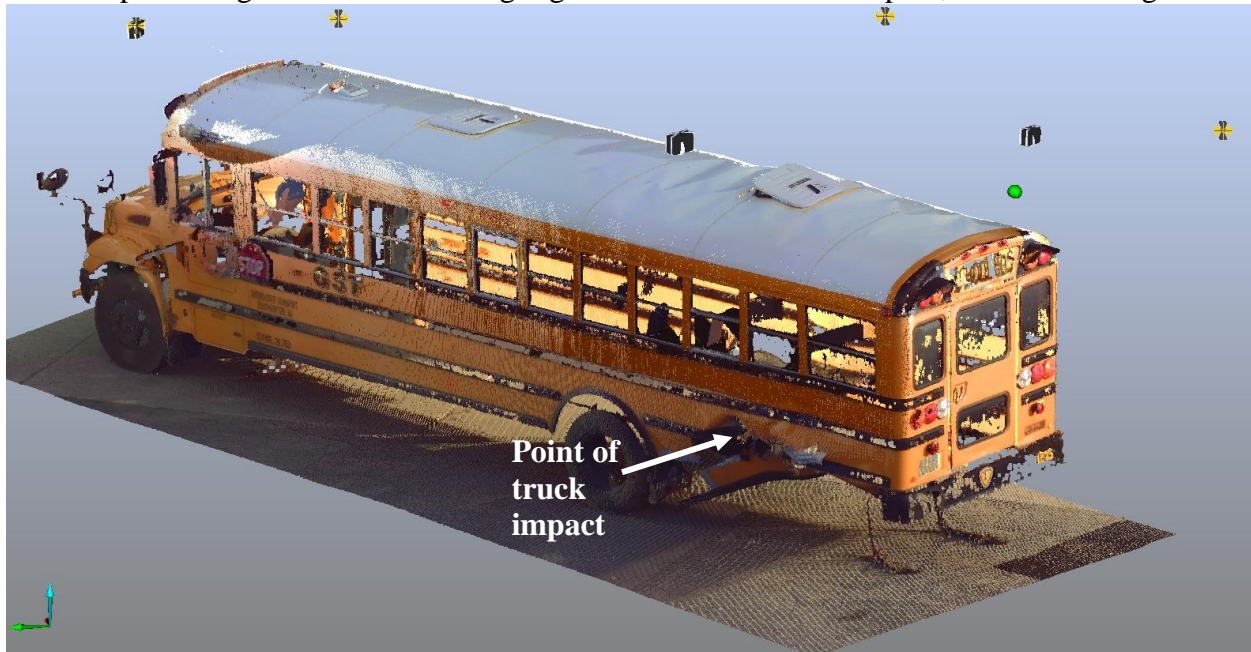
Figure 5: An image from the combined 3D scan of the driver's side of the accident school bus.

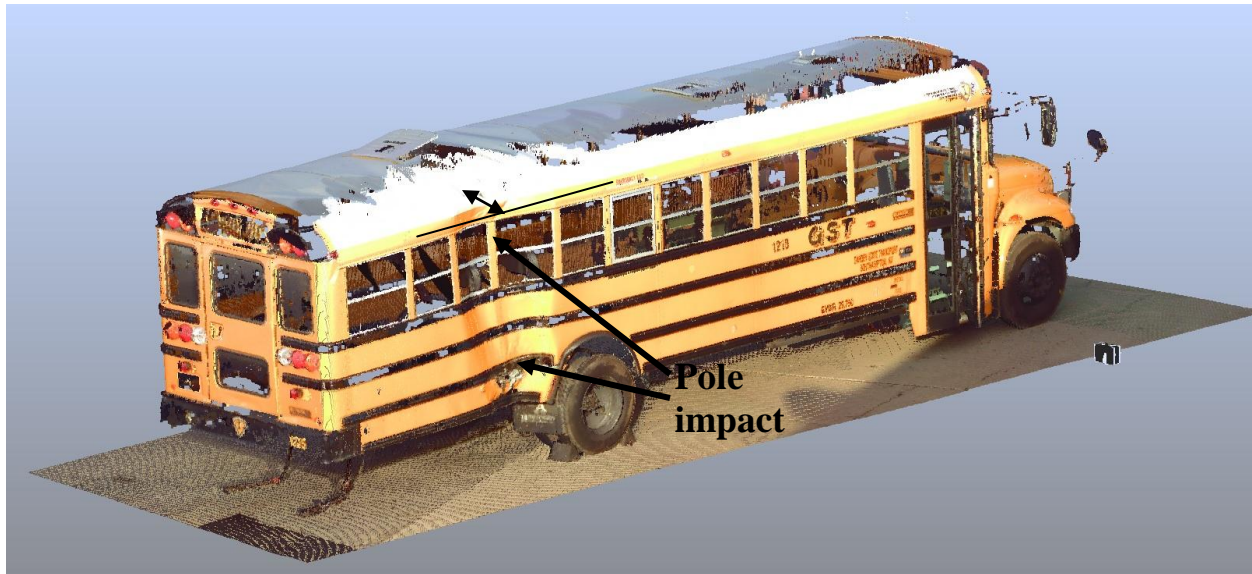
Figure 6: An image from the combined 3D scan of the passenger side of the accident school bus.

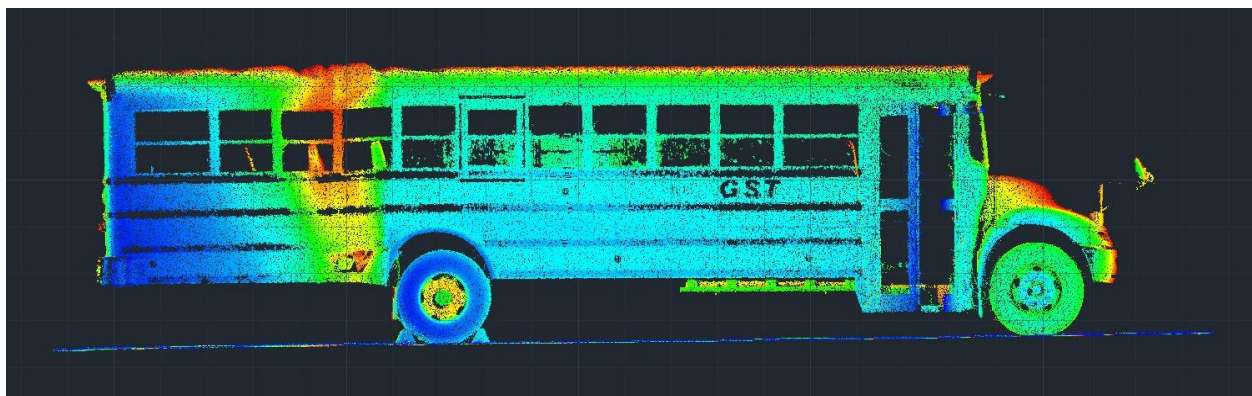
Figure 8: Color coded deformation at the intrusion from the pole impact.

In order to measure the intrusion into the bus as a result of the pole impact at various vertical locations, five slices were taken at elevations representing a position below the occupant compartment (slice A), at approximately floor level (slice B), at hip level (slice C), at head level (slice D) and above head level (slice E). See Figure 9. Nine measurements were taken at consistent horizontal locations from the front of the bus at each vertical level (shown in Table 1 and Figure 10). Images of the measurements are shown in Figure 11 through Figure 15. Table 2 summarizes the measurements. The scanning equipment measures points in meters but for reference, the measurements were converted to English units in Table 3. The maximum intrusion was 10.38” seen above head level in the center of the pole impact. Generally, the crush depth was greater as the vertical slice height increased.

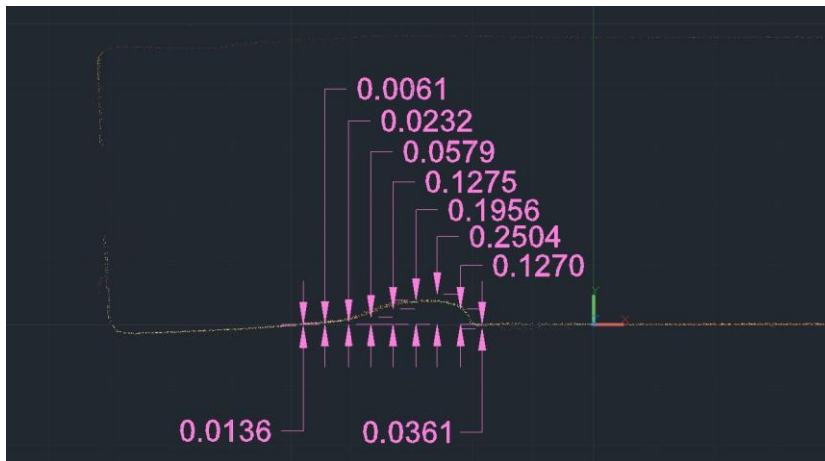
Figure 11: Crush measurements at slice A (below occupant compartment) on the accident school bus. (meters)

Slice Name	Distance from Ground (m)	Crush Measurement from front to back (m)								
		1	2	3	4	5	6	7	8	9
A	0.9007	-0.0361	0.127	0.2504	0.1956	0.1275	0.0579	0.0232	0.0061	-0.0136
B	1.1091	-0.0073	0.1433	0.1938	0.1844	0.1666	0.1083	0.0417	0.0157	0.0018
C	1.5114	0.0109	0.1185	0.2073	0.2223	0.2275	0.1868	0.0939	0.0425	0.0238
D	2.0042	0.0205	0.108	0.1863	0.2624	0.2635	0.2205	0.155	0.0888	0.0757
E	2.5583	0.0309	0.1176	0.2172	0.2468	0.2636	0.238	0.1707	0.1001	0.0693

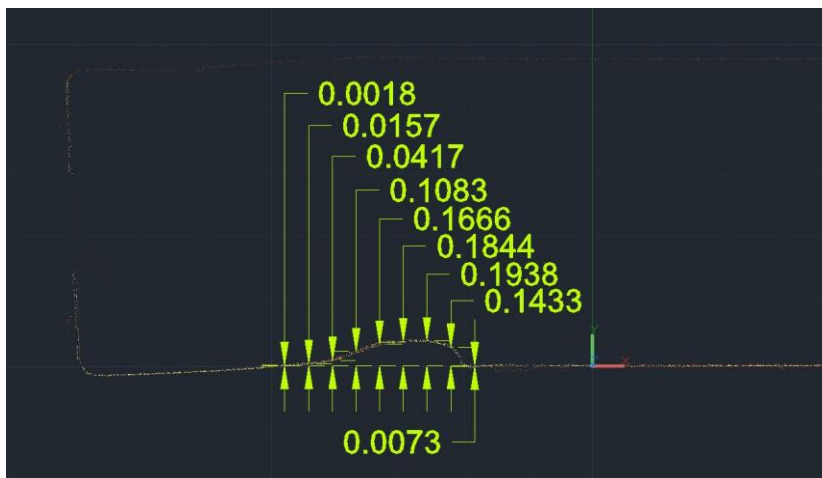
Figure 12: Crush measurements at slice B (floor level) on the accident school bus. (meters)

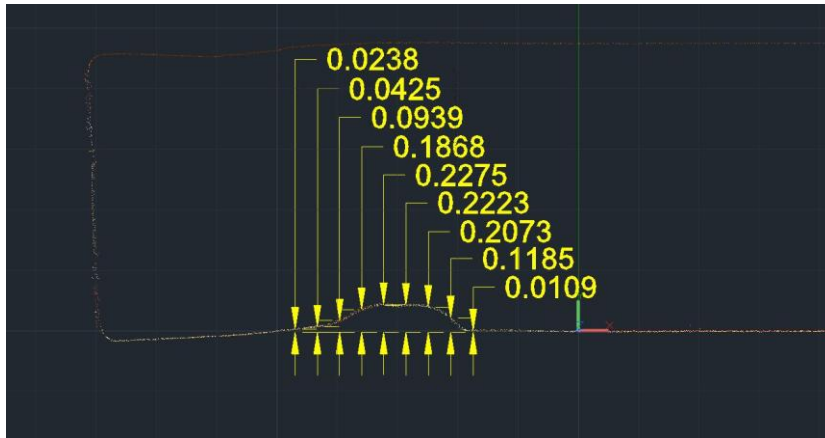
Figure 13: Crush measurements at slice C (hip level) on the accident school bus. (meters)

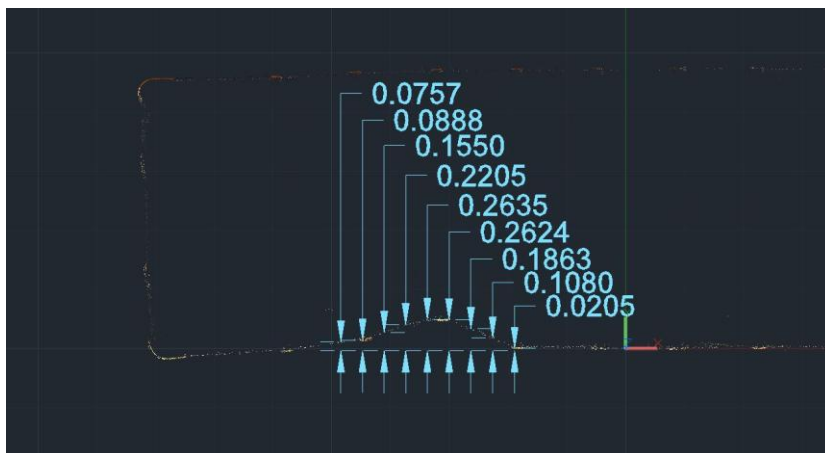
Figure 14: Crush measurements at slice D (head level) on the accident school bus. (meters)

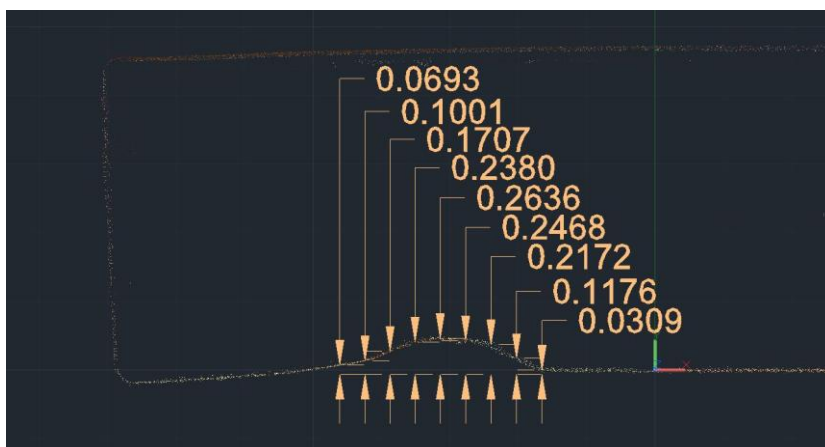
Figure 15: Crush measurements at slice E (above head level) on the accident school bus. (meters)

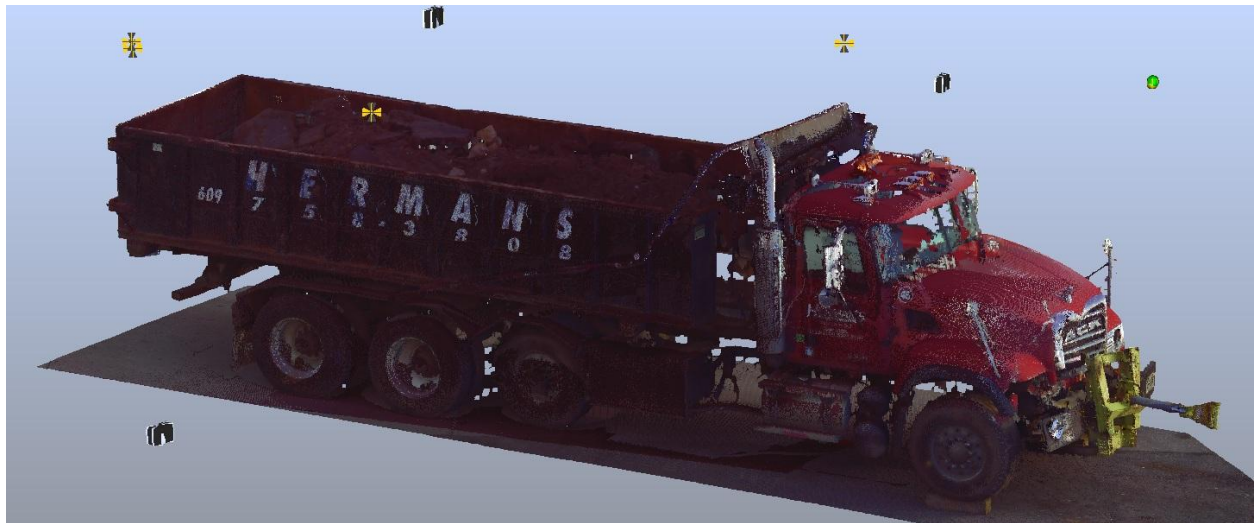
**Figure 16: An image from the combined 3D scan of the accident truck.**
