## NATIONAL TRANSPORTATION SAFETY BOARD

### ENGINE-DRIVEN FUEL PUMP EXAMINATION FIELD NOTES

**Location:** West Milford, NJ  
**Date:** May 2, 2018  
**Time:** 1410 EDT  
**Aircraft:** N4153R, Piper PA-32-300

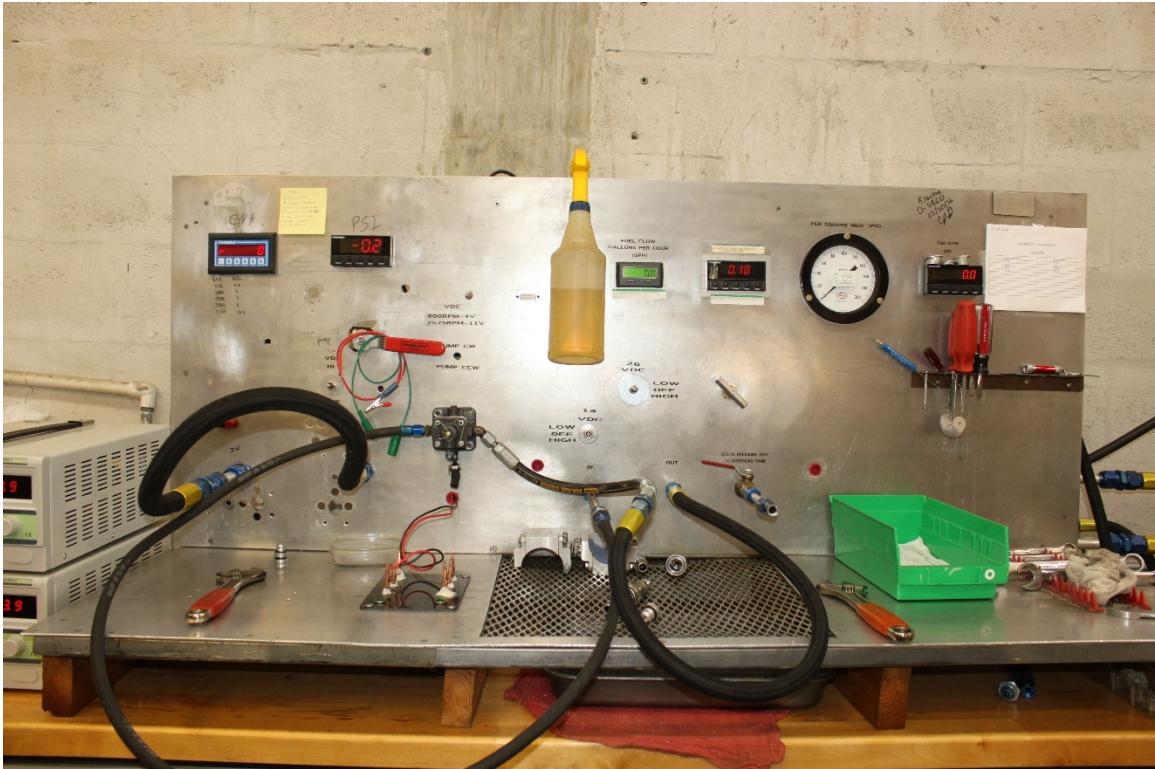
The pump was placed as received on a test bench with motor voltage calibrated for 2,575 rpm and the fluid coming out of the pump was directed into a clean white plastic bucket. A few black specs of material were noted discharged from the pump. The outlet hose was then connected to the test bench (normal to return fluid to the holding tank) and normal self-priming occurred. At 11.0 volts, 2,575 rpm, the unit flowed 72.8 gallons-per-hour (gph) at 5.1 psi, or 436.8 pounds-per-hour (PPH). At 11.6 volts, 2,575 rpm, and 22 psid, the unit flowed 60.8 gph, or 364.8 PPH<sup>3</sup>. At 5.0 volts, 600 rpm, and 16 psid, the unit flowed 7.0 gph, or 42 PPH<sup>4</sup>.

Figure 1: Engine-Driven Fuel pump on Test Bench with Outlet Hose Attached

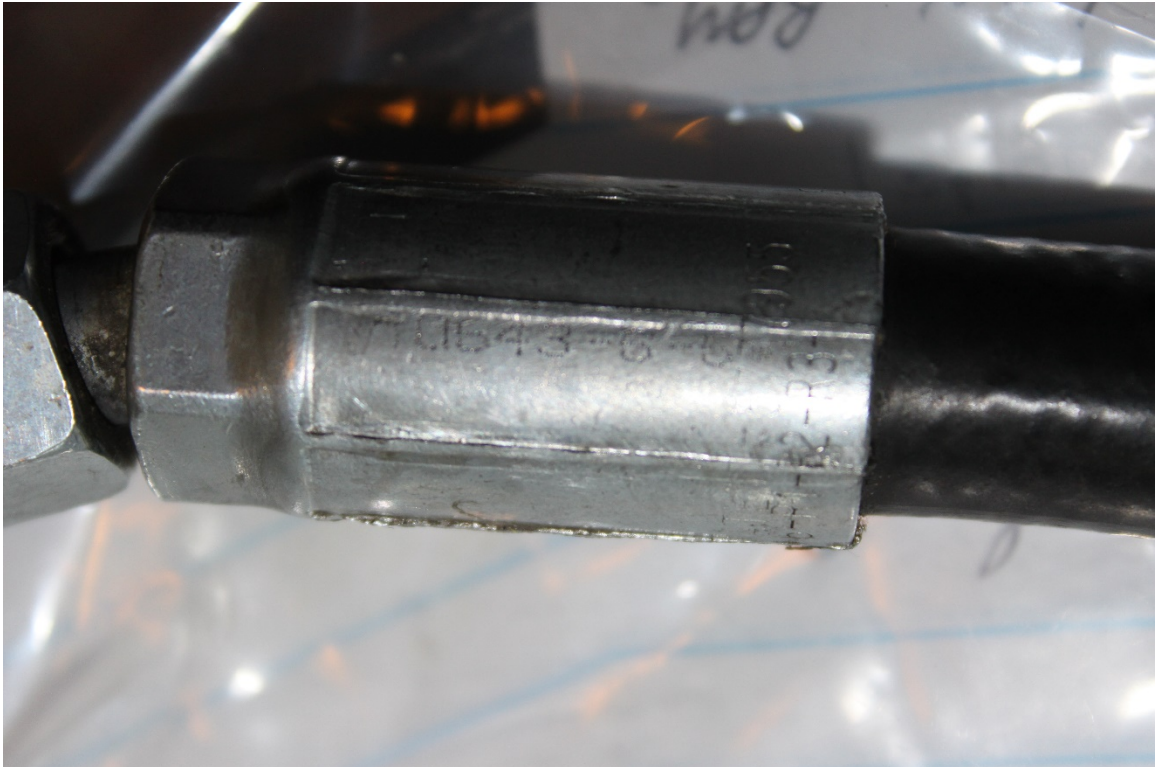
<sup>2</sup> According to [www.parker.com](http://www.parker.com), P/N 10643-6-6 is a crimp style hydraulic female JIC 37° swivel steel fitting with a straight shape for a -6 size hose.

Figure 2: View of the Ferrule/Sleeve at the Outlet Hose End that Would Connect with the Fuel Injection Servo. Note the marking 10643-6-6.

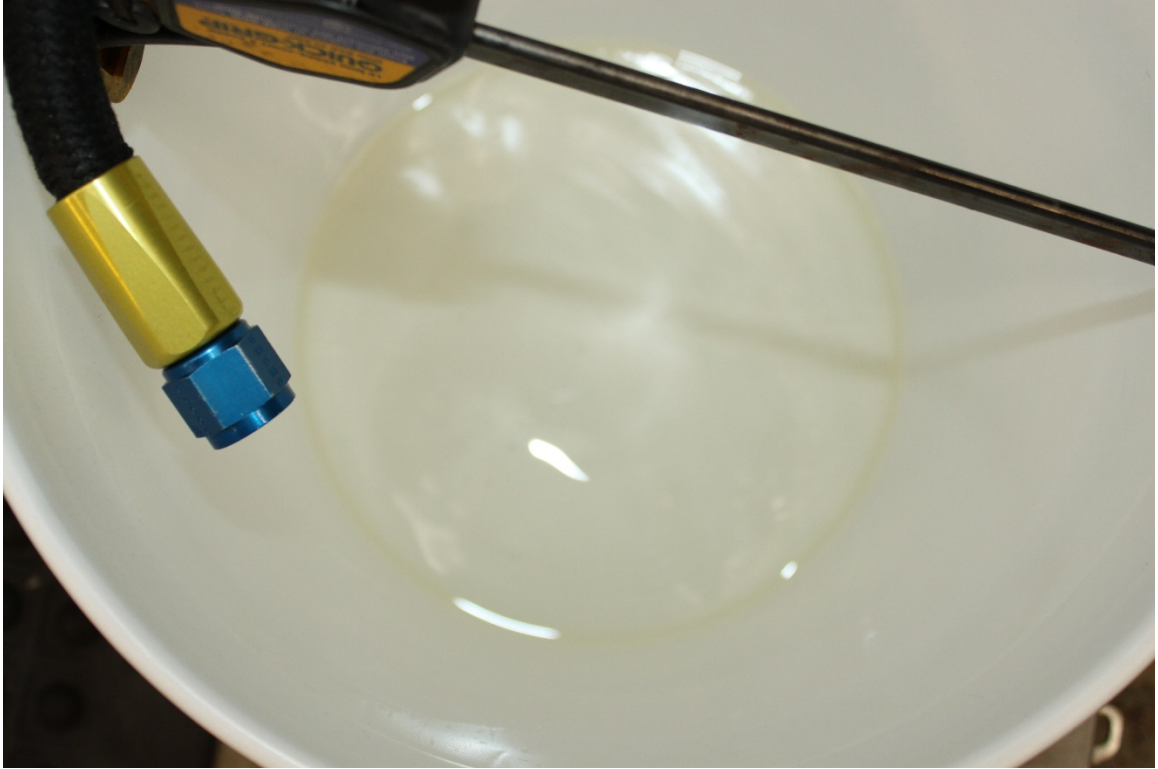
Figure 3: View of the Clean White Bucket Used to Capture the Fluid First Exiting the Pump.

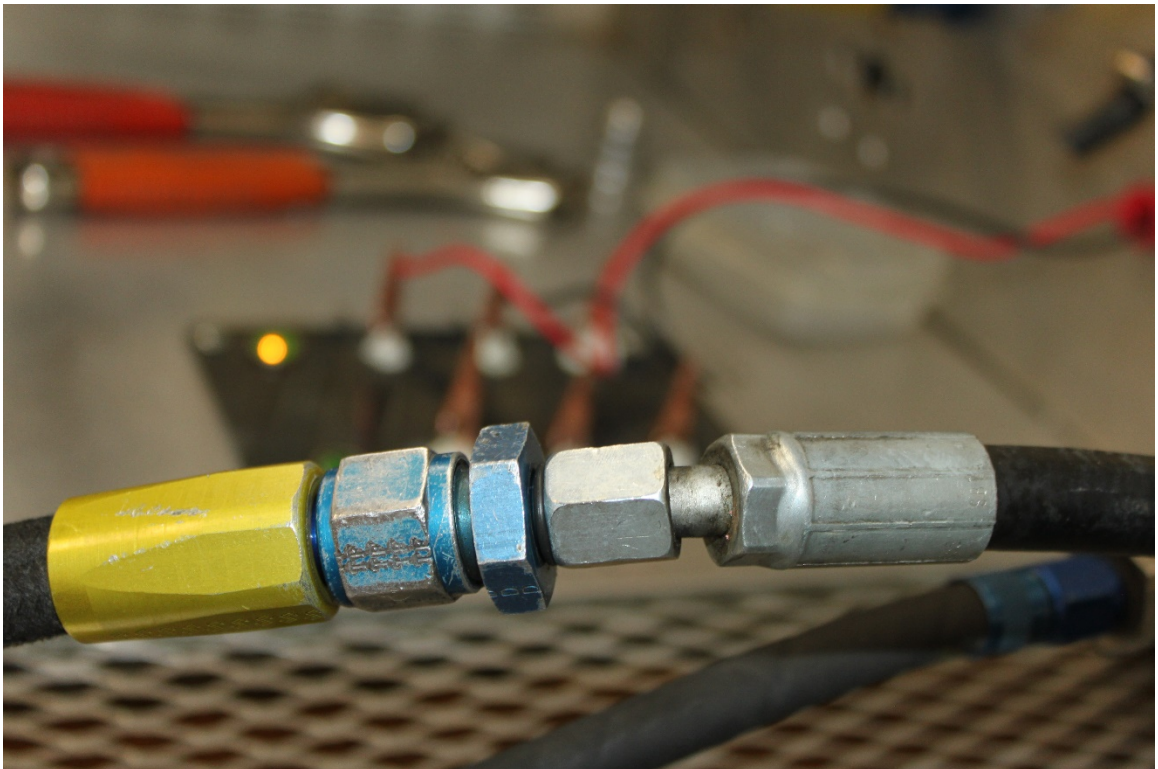
During testing, no leaks were noted on the exterior of the pump or from the drain line, but slight leakage was noted from the end of the outlet hose fitting that would connect to the fuel injection servo. The pump was retained by NTSB.

Figure 4: View of the Outlet Hose and the End That Would Connect to the Fuel Injection Servo. Slight Seepage was noted at the Area of the Sleeve/Ferrule.

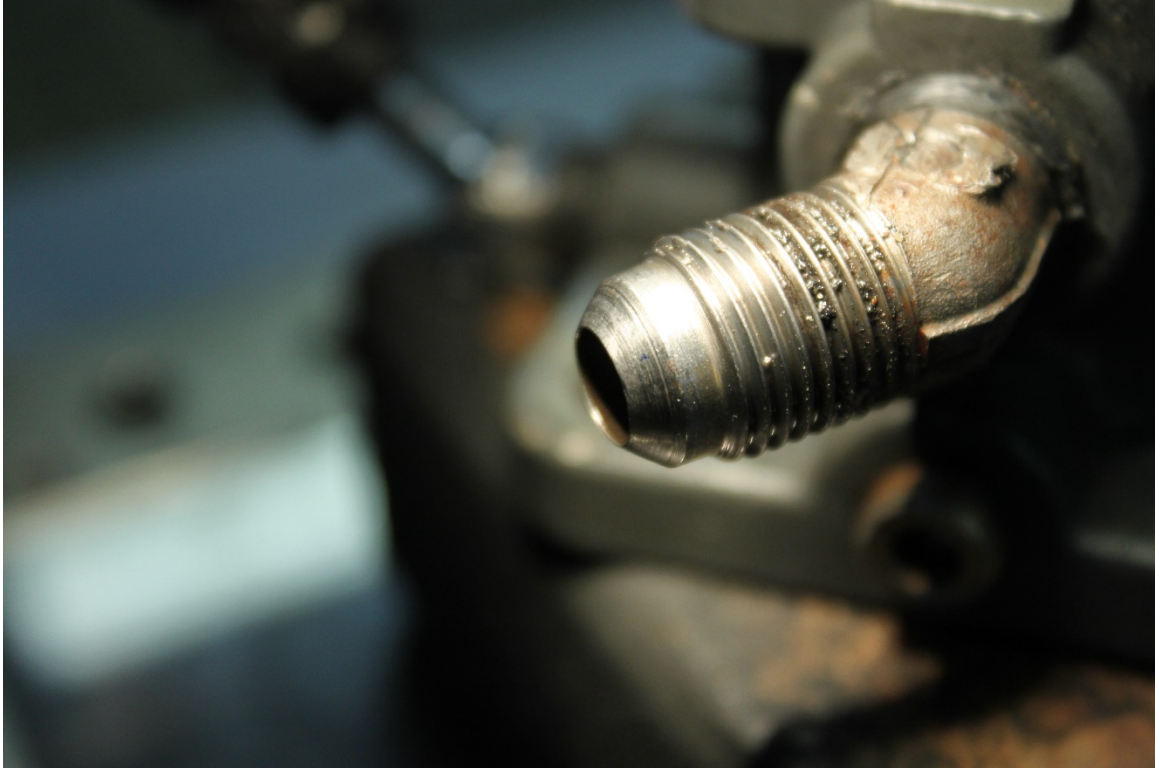
The pump was brought back to CJ Aviation on July 3, 2018, for testing at 2,650 rpm. The pump was installed/connected onto a 3-phase motor with attached coupling that mated with the engine-driven fuel pump; the motor rpm was calibrated and presented on a digital gauge along with motor load or torque. For testing, the pump discharge was directed into a plastic container that had been previously calibrated in gallon increments, and was timed using a calibrated stopwatch. The pump was operated at 2,650 rpm, and 22 psid, and flowed 1 gallon in 45.31 seconds, which calculated to be 79.45 gph, or 476.7 PPH. The pump was then operated at 600 rpm and 16 psid, and flowed 0.25 gallon in 1 minute 01.25 seconds, which calculated to be 14.69 gph, or 88.15 PPH. The pump was removed from the motor and the hose attached to the outlet fitting was removed for examination. A circumferential gouge was noted on the flare of the outlet fitting (Figure 5), which was marked with “MS.” The outlet fitting of the pump was examined with a video comparator and the flare angle was determined to be about 41°. The inlet fitting of the pump was examined and marked with “AN.” It was also examined with the video comparator and the flare was about 39.1°.

Figure 5: View of the Outlet Fitting. Note the circumferential gouge in the flare.
