NATIONAL TRANSPORTATION SAFETY BOARD
Office of Aviation Safety-Eastern Region
Ashburn, Virginia 20147
June 24, 2015

ENGINE FUEL COMPONENT EXAMINATION FIELD NOTES

Location: Chamblee, Georgia
Date: May 8, 2015
Time: 1010 EDT
Aircraft: N5802V, Piper PA-32R-300

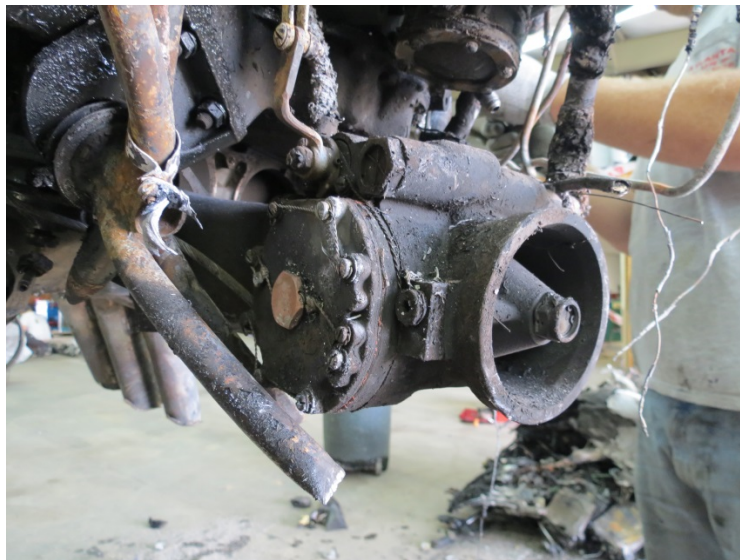
Figure 1: View of the fuel injection servo

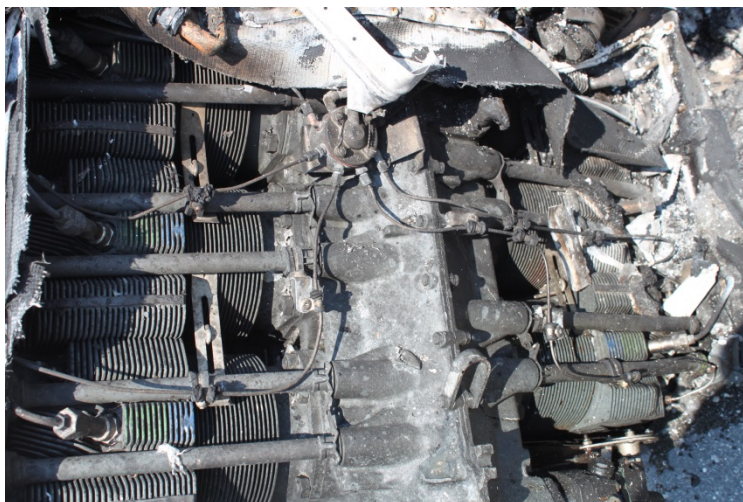
Figure 2: View of the flow divider.

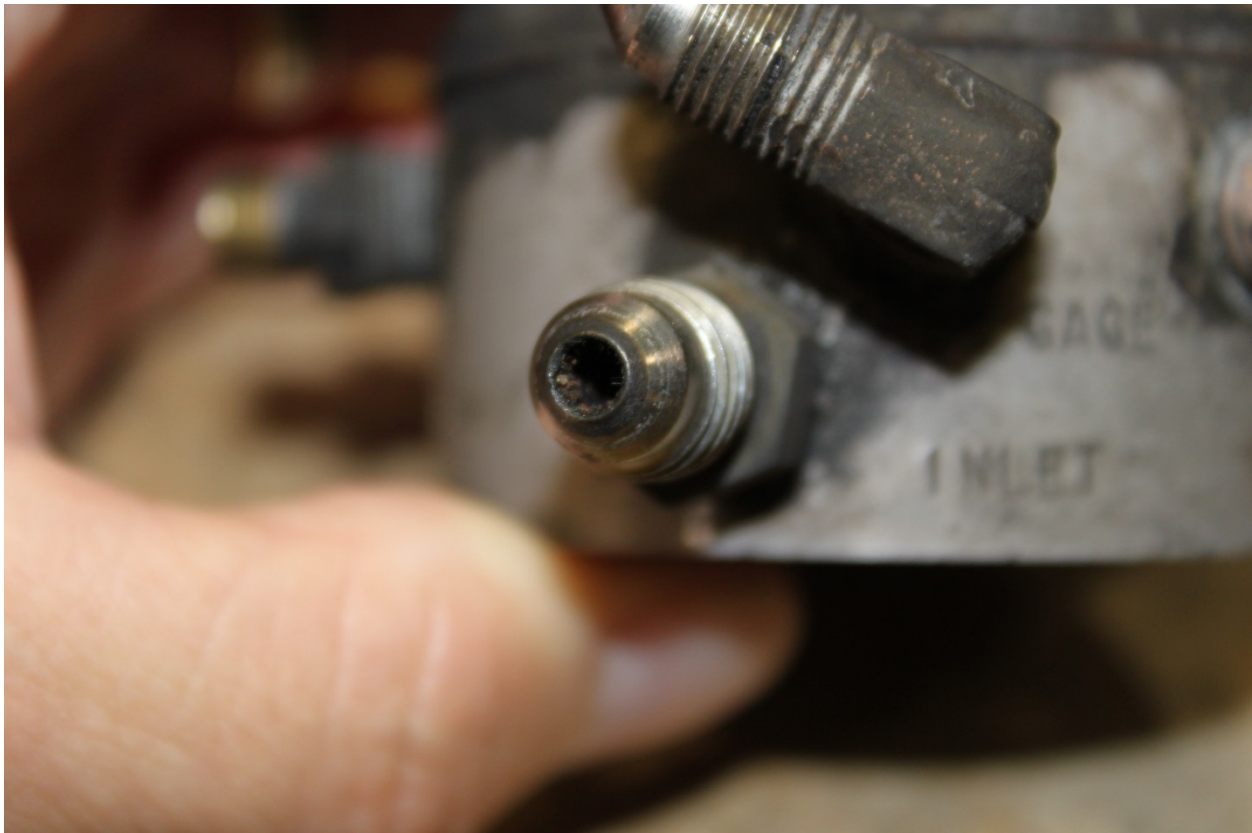
The flow divider was removed from the plastic bag and there were no caps on any of the fittings. Visual inspection revealed some small debris inside the inlet fitting and evidence of black discoloration; the inlet fitting was removed for bench testing (see Figure 3). The unit was placed on a test bench and did not flow when tested up to 7 psi (normal test pressure is 4.5 psi). The unit was removed from the test bench and the bottom cover was removed. Following removal of the bottom cover, the gasket did not exhibit heat damage. The bottom portion of the movable portion of the body assembly was measured and found to be positioned 0.032 inch below the spool of the body assembly (normal closed position). The bottom of the movable portion of the body assembly was pushed by hand and some resistance was noted at first but it then moved. The bottom cover was reinstalled, and the 4 screws were torqued to the proper setting. The flow divider was placed on the test bench and debris was noted coming from the ports during initial flow (see Figure 4). The unit was flowed at 4.5 psi (normal) and it was found to flow equally from all ports at 132 pounds-per-hour (PPH); the minimum specification is 135 PPH. The flow divider was removed from the test bench, and the top cover which was safety wired was removed. Test bench fluid was noted on the top side of the diaphragm (air side) and some slivers of material were noted. The movable portion of the body assembly was removed and contamination/debris was noted (see Figure 5). Re-insertion of the movable portion of the body assembly into the body revealed slight binding. A 2 psi spring was installed (normal).

Figure 3: View of the slight debris inside the inlet fitting of the flow divider

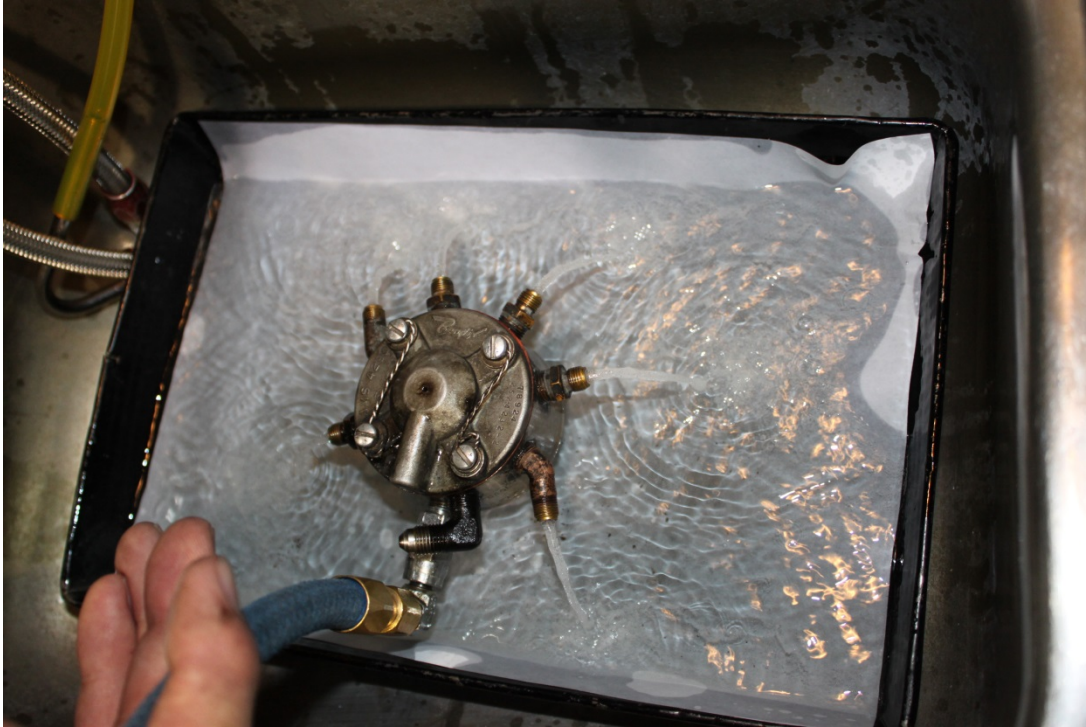
Figure 4: Bench Test at 4.5 psi of Flow Divider

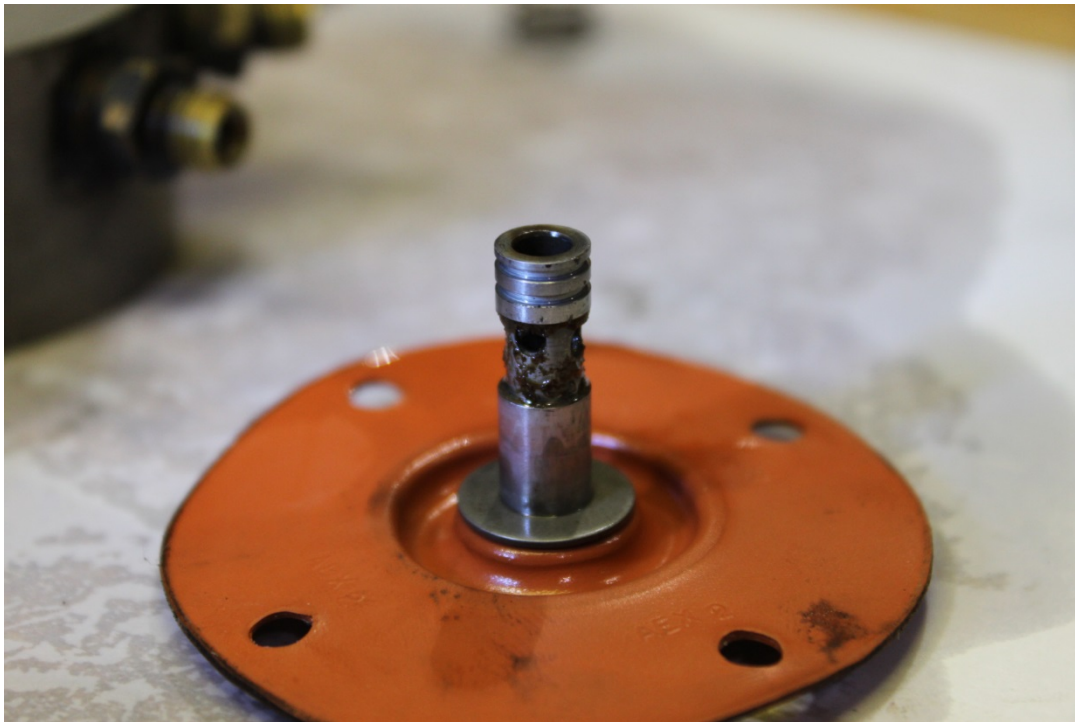
Figure 5: View of the contamination/debris on the movable portion of the Body Assembly.

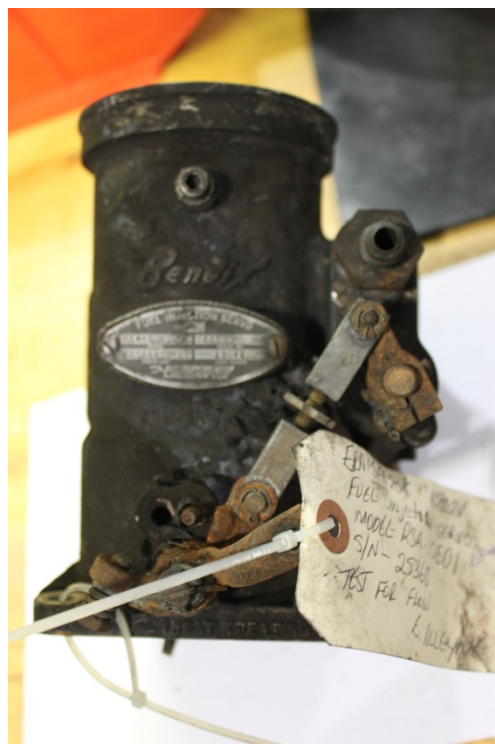
The fuel injection servo was removed from the plastic bag and inspected; the exterior surface was noted to be black consistent with heat damage (see Figure 6). The body of the Precision Airmotive LLC dataplate was black in color. Visual inspection revealed the spacer was missing

Figure 6: Fuel Injection Servo

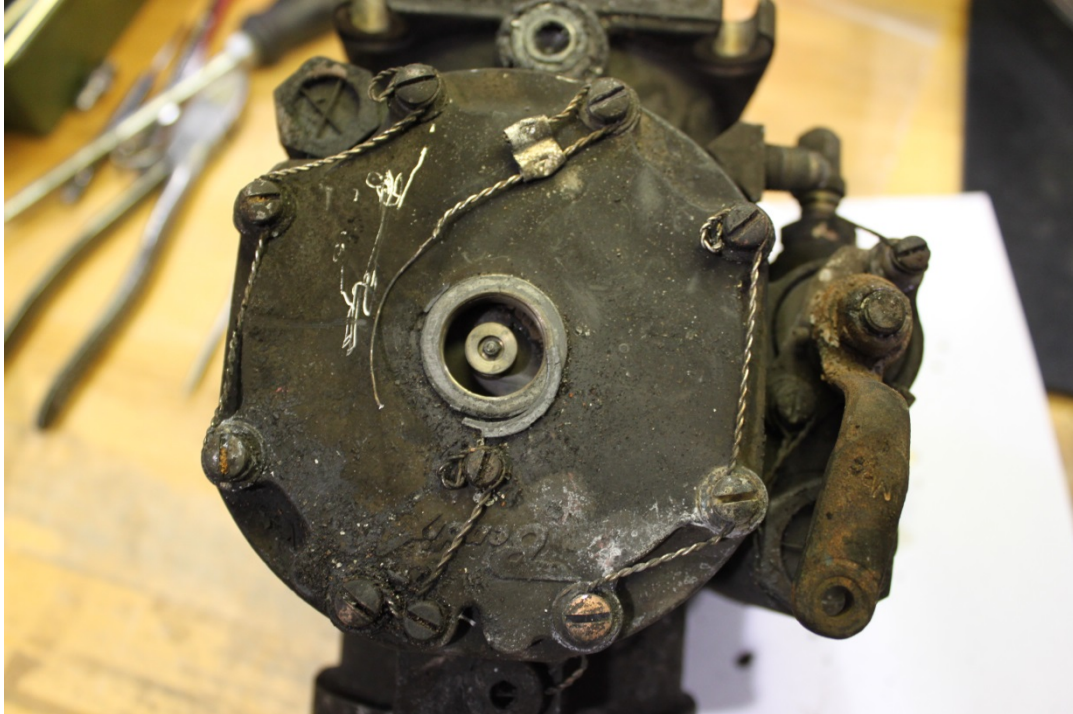
Figure 7: View of gasket material following removal of hex plug.

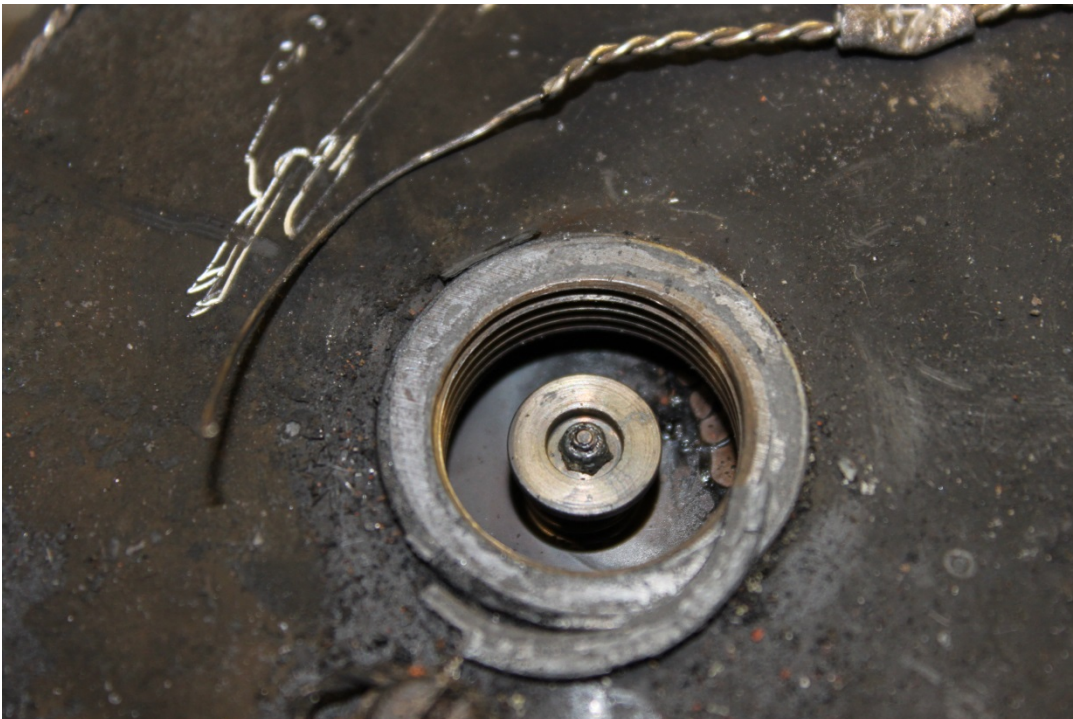
Figure 8: View showing nut installed on end of fuel diaphragm stem.

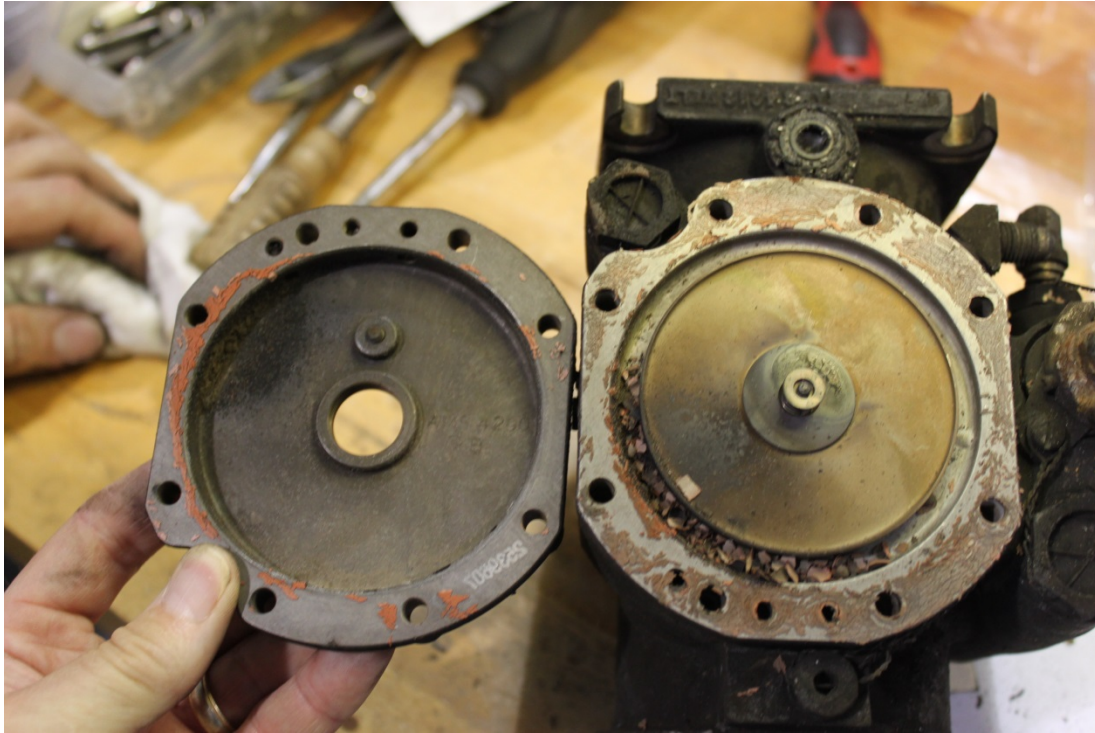
Figure 9: View of the remains of the diaphragm assembly.

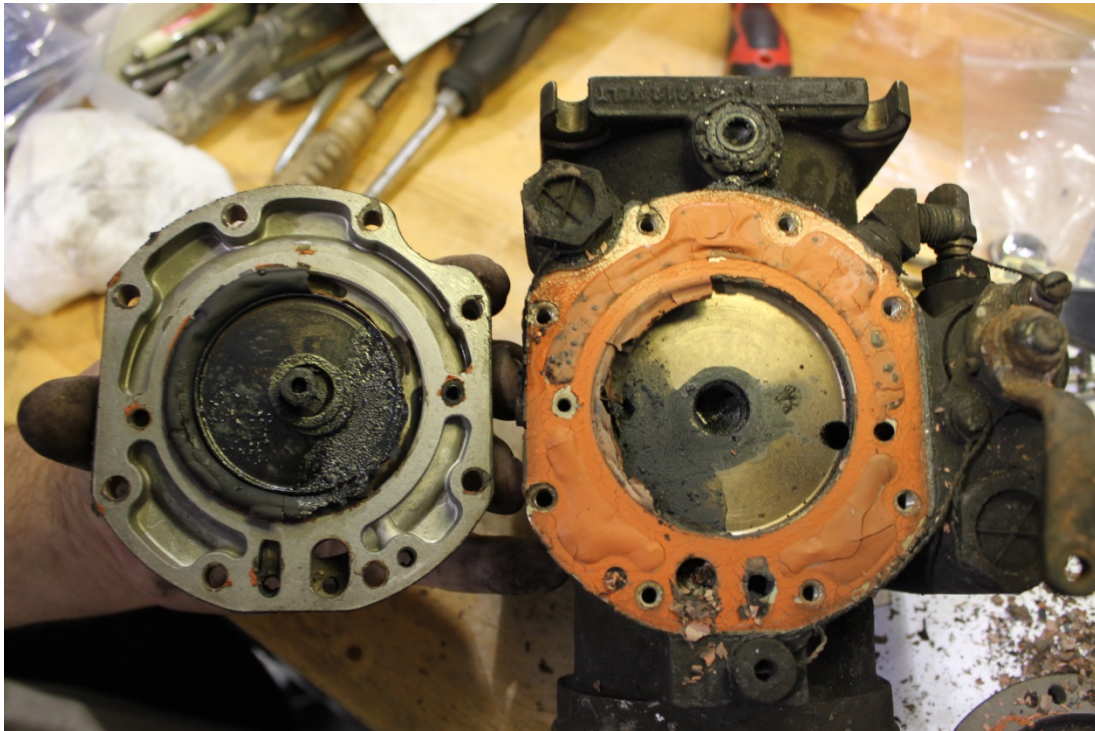
Figure 10: View of the regulator body and fuel diaphragm assembly.

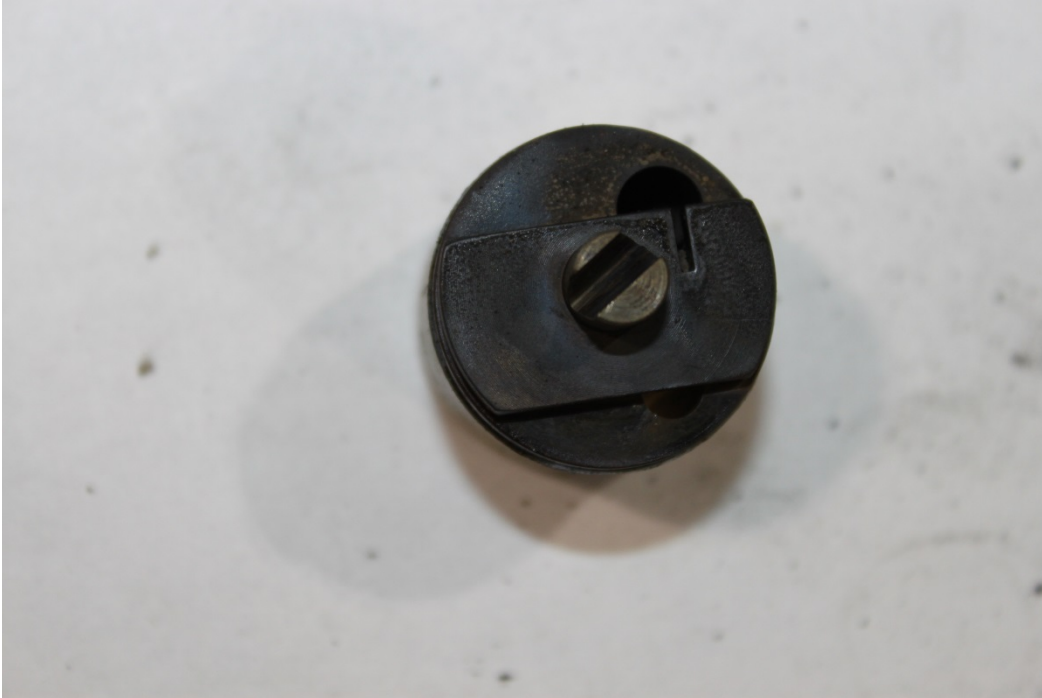
Figure 11: View showing the position of the mixture control (nearly full rich).

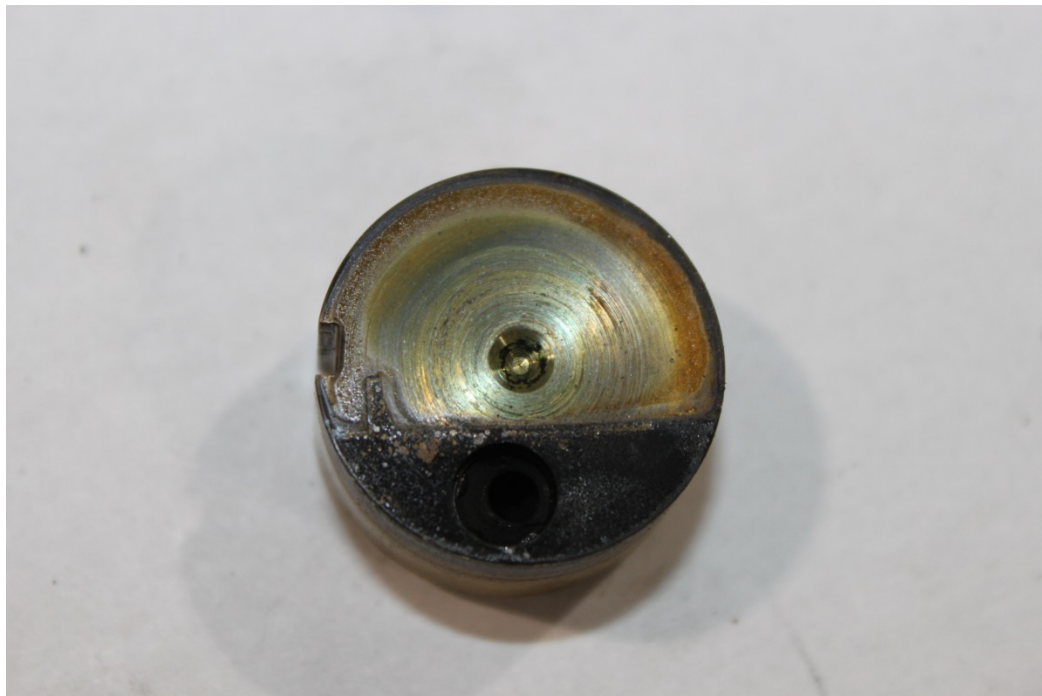
from the mixture stop but the stop screw was safety wired. The mixture control as received was near the full rich position, and the serrated lever was tightly secured to the mixture control lever assembly. The throttle was also near the full open position and the serrated throttle stop was tightly secured to the throttle lever. The regulator cover was safety wired, but it could be moved with slight hand pressure. The regulator hex plug was safety wired to one of the regulator cover screws, and a lead seal with “4” impression was noted on the hex plug safety wire. The hex plug could also be moved by slight hand pressure. Because of the obvious heat damage to the diaphragms, the decision was made by NTSB not to flow test the unit. The hex plug was removed and inspected and it was not marked with ‘G’. Following removal of the hex plug, pieces of burned gasket material were noted on the machined surface of the regulator cover (see Figure 7). Inspection of the remains of the burned gasket material revealed it crumbled easily and did not appear to have any portion of aluminum construction. The nut on the end of the fuel diaphragm assembly was in-place (see Figure 8). The threads of the hex plug were measured with a calibrated dial caliper and the pitch of the threads measured 0.746 inch (per service bulletin specification is 0.7400 to 0.7500 inch). Inspection of the threads of the regulator cover and hex plug revealed no abnormal wear. The regulator cover was removed, and the air diaphragm assembly was destroyed (see Figure 9). The regulator body assembly was removed and the fuel diaphragm stem was not fractured and the fuel diaphragm exhibited extensive heat damage (see Figure 10). The regulator seat was also heat damaged; spacer rings were in-place. The fuel side of the regulator body was relatively clean. The fuel inlet screen was clean, but evidence of re-solidified solder was noted and melted packing was noted. The mixture control assembly was removed, and based on ghost signatures, was positioned to full rich (see Figure 11). The idle valve assembly was also removed and based on ghost signatures, was positioned in the wide open position (see Figure 12).

Figure 12: View showing the position of the throttle based on the idle valve.
