**GCI Communication Corp's**  
**Submission to the**  
**National Transportation Safety Board**  
**in the investigation of**  
**de Havilland Canada DHC-3T Otter, N455A**  
**Aleknagik, Alaska, August 9, 2010**  
**NTSB Number ANC10MA068**

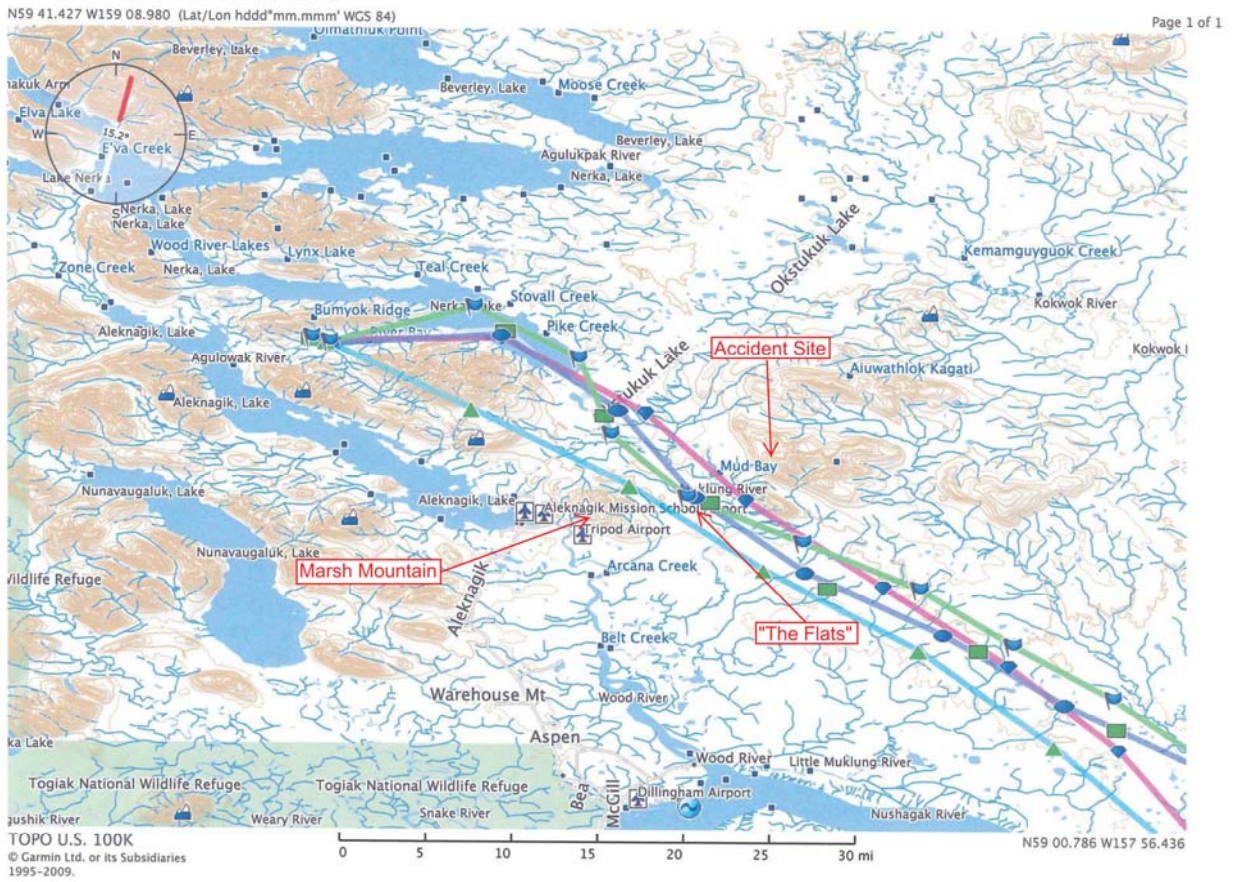
GCI MAP 1B – Captain Smith’s Recent Flights from the GCI Lodge to HRM Fish Camp

On each prior trip from the GCI Lodge to the HRM fishing camp, except when ceilings and visibility were unrestricted, Captain Smith flew through the Flats, a wide valley between the Muklung Hills and Marsh Mountain that is just over three miles wide. GCI Map 1B, below. This is confirmed by SkyConnect Satellite Tracking data for Captain Smith’s previous flights to the HRM fishing camp. Those data show that he would typically travel down River Bay and over Lake Nerka until the end of the lake, then turn south/southeast toward the Flats. SkyConnect Data; GCI Map 1B, below.

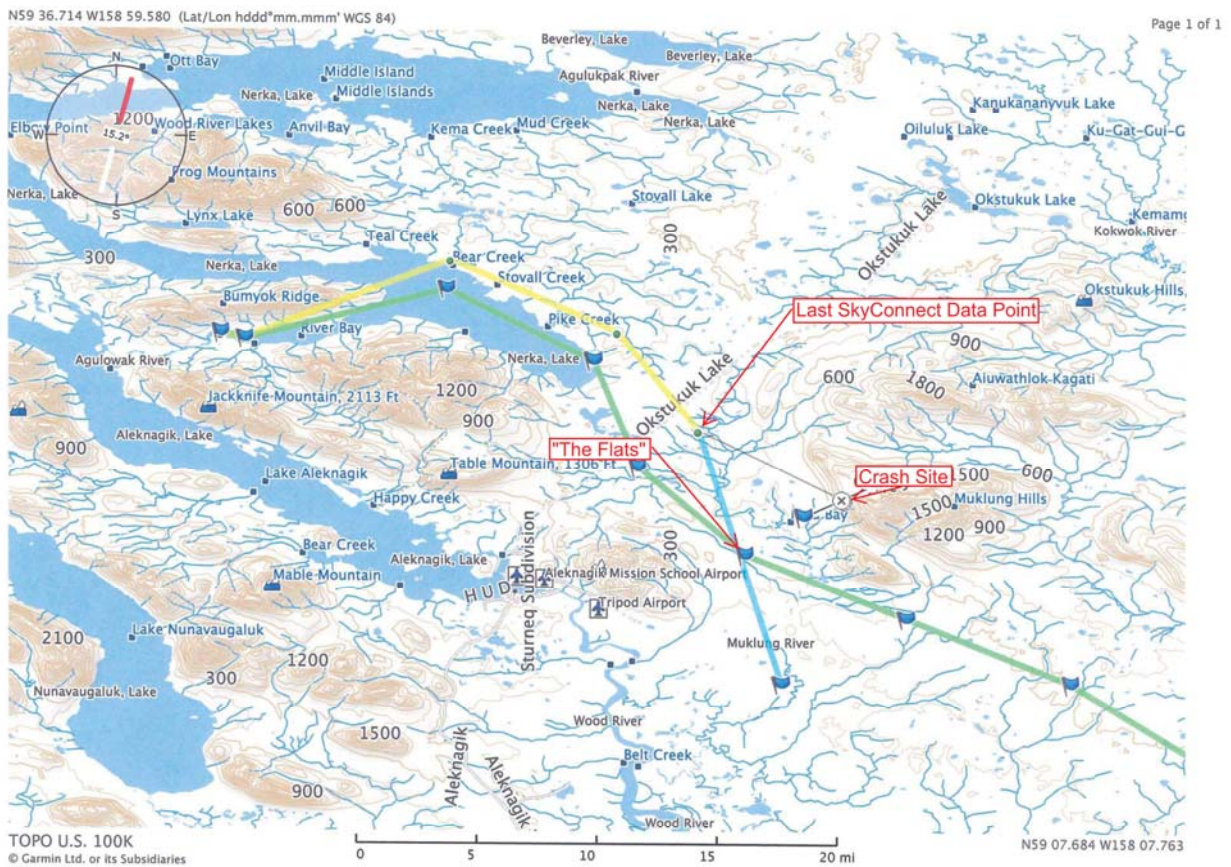
GCI Map 2B - Accident flight path in yellow, last known heading (as reported by SkyConnect) in blue, direct line from last SkyConnect data point to crash site in black, Earlier flight from GCI Lodge to HRM fish camp in green.

Captain Smith then picked up his typical route and turned south/southeast towards the center of the Flats. The last SkyConnect data point collected before the accident indicates that Captain Smith was on a 168 degree course, heading directly for a spot midway between the Muklung Hills and Marsh Mountain, almost exactly through the middle of the Flats. See blue course-line in GCI Map2B; SkyConnect Data; Oper. Fact. Attach. 6. Additionally, when the Garmin 530 installed in the accident aircraft was powered up by the NTSB after the accident, it displayed the “Muklung” waypoint, located near the middle of the Flats. Air. Fact., p. 52. Thus, had Captain Smith flown to the displayed waypoint, he would have traveled through the middle of the Flats.

The wreckage was found on the western slope of the Muklung Hills. A straight line from the last SkyConnect data point to the accident site shows a course of 127 degrees true (112 degrees magnetic), a deviation of 41 degrees to the left of the course at the time of the last SkyConnect data point. The aircraft heading at the time of impact was 85.1 degrees, a change of over 80 degrees to the left of the aircraft's course at the time of the last SkyConnect data point. See Aircraft Performance Study, p. 6.

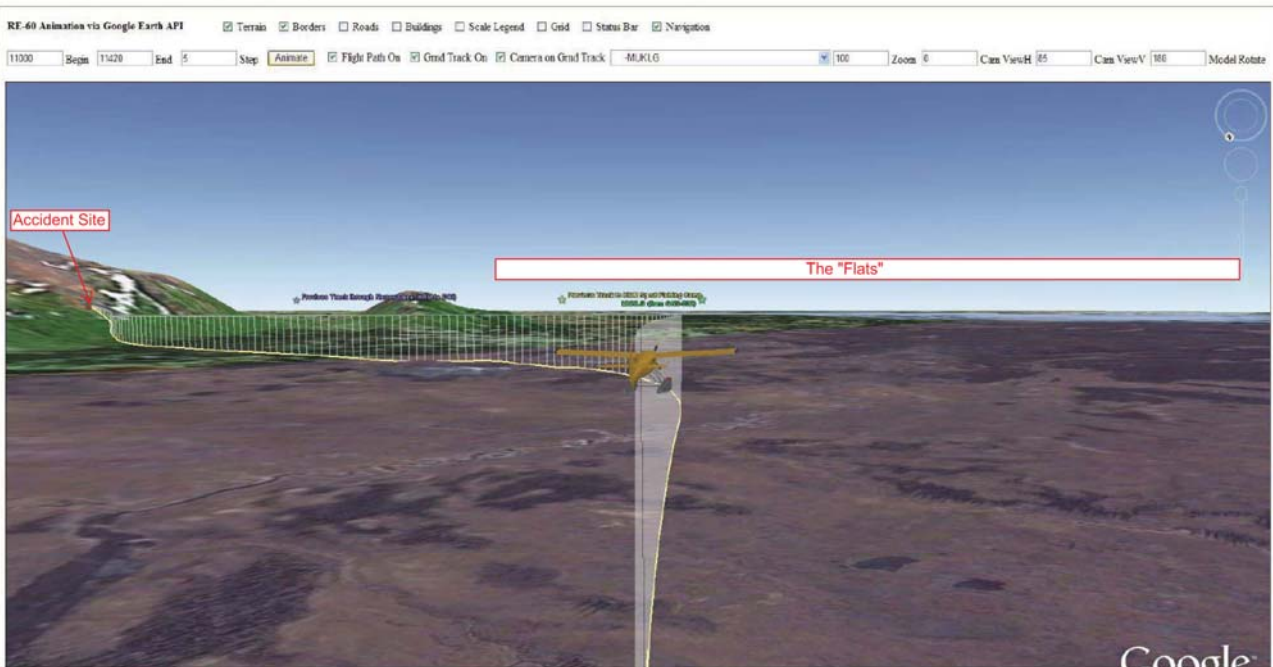
Figure A9.2 from Aircraft Performance Study (annotations added)

Figure A9.2 from the NTSB Aircraft Performance Study provides a "pilot's eye view" of the aircraft heading at the last SkyConnect data point as well as the locations of the accident site and Captain Smith's prior routes to the HRM fishing camp:

The accident site was at an elevation of approximately 900 feet MSL, just over 700 feet above the elevations of the Flats. Oper. Fact., p. 4. This would be an expected altitude at which to fly through the Flats given the reported cloud ceilings near the accident site.
