NATIONAL TRANSPORTATION SAFETY BOARD

GPS Factual Report

Location: Guntersville, Alabama
Date: September 8, 2013
Aircraft: Piper PA-28R-300
Registration: N8362C
Operator: Private
NTSB Number: ERA13LA407

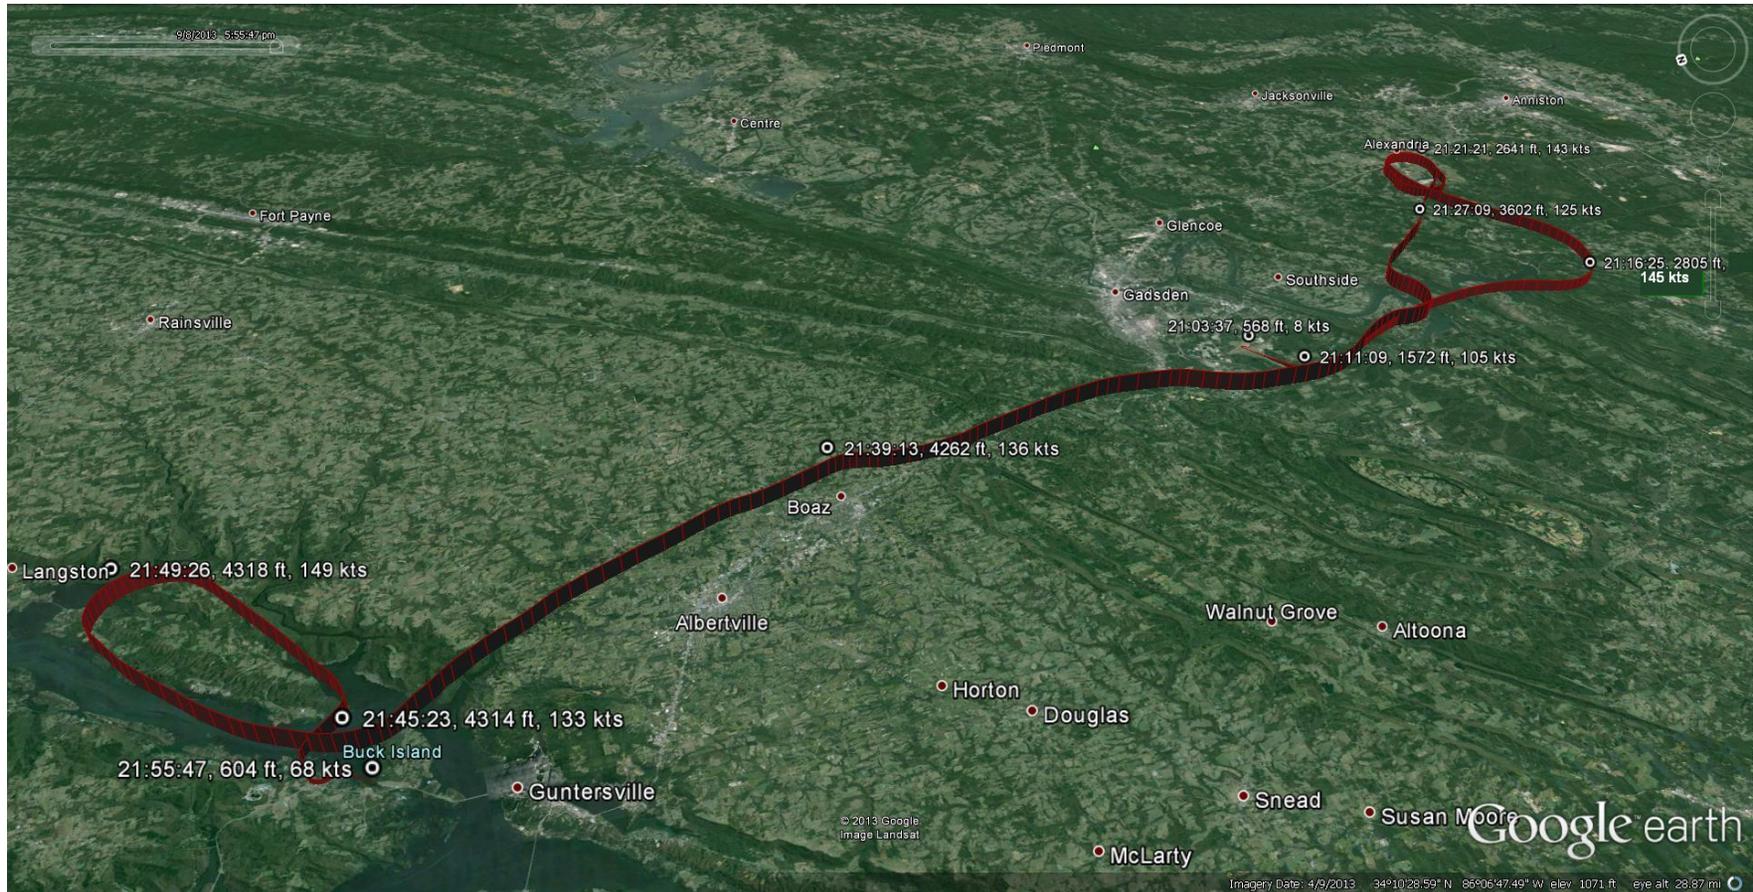
Figure 1. Google Earth overlay of the entire accident flight recording.

Figure 1 provides an overview of the accident flight. The recording began at 2103:37 UTC at the GAD airport. By 2111:09 UTC, the aircraft had departed runway 24, was climbing through 1,572 feet, and was turning southbound. After maneuvering south/southeast of GAD, the aircraft proceeded north and passed 8A1 at about 2145 UTC at about 4,300 feet.

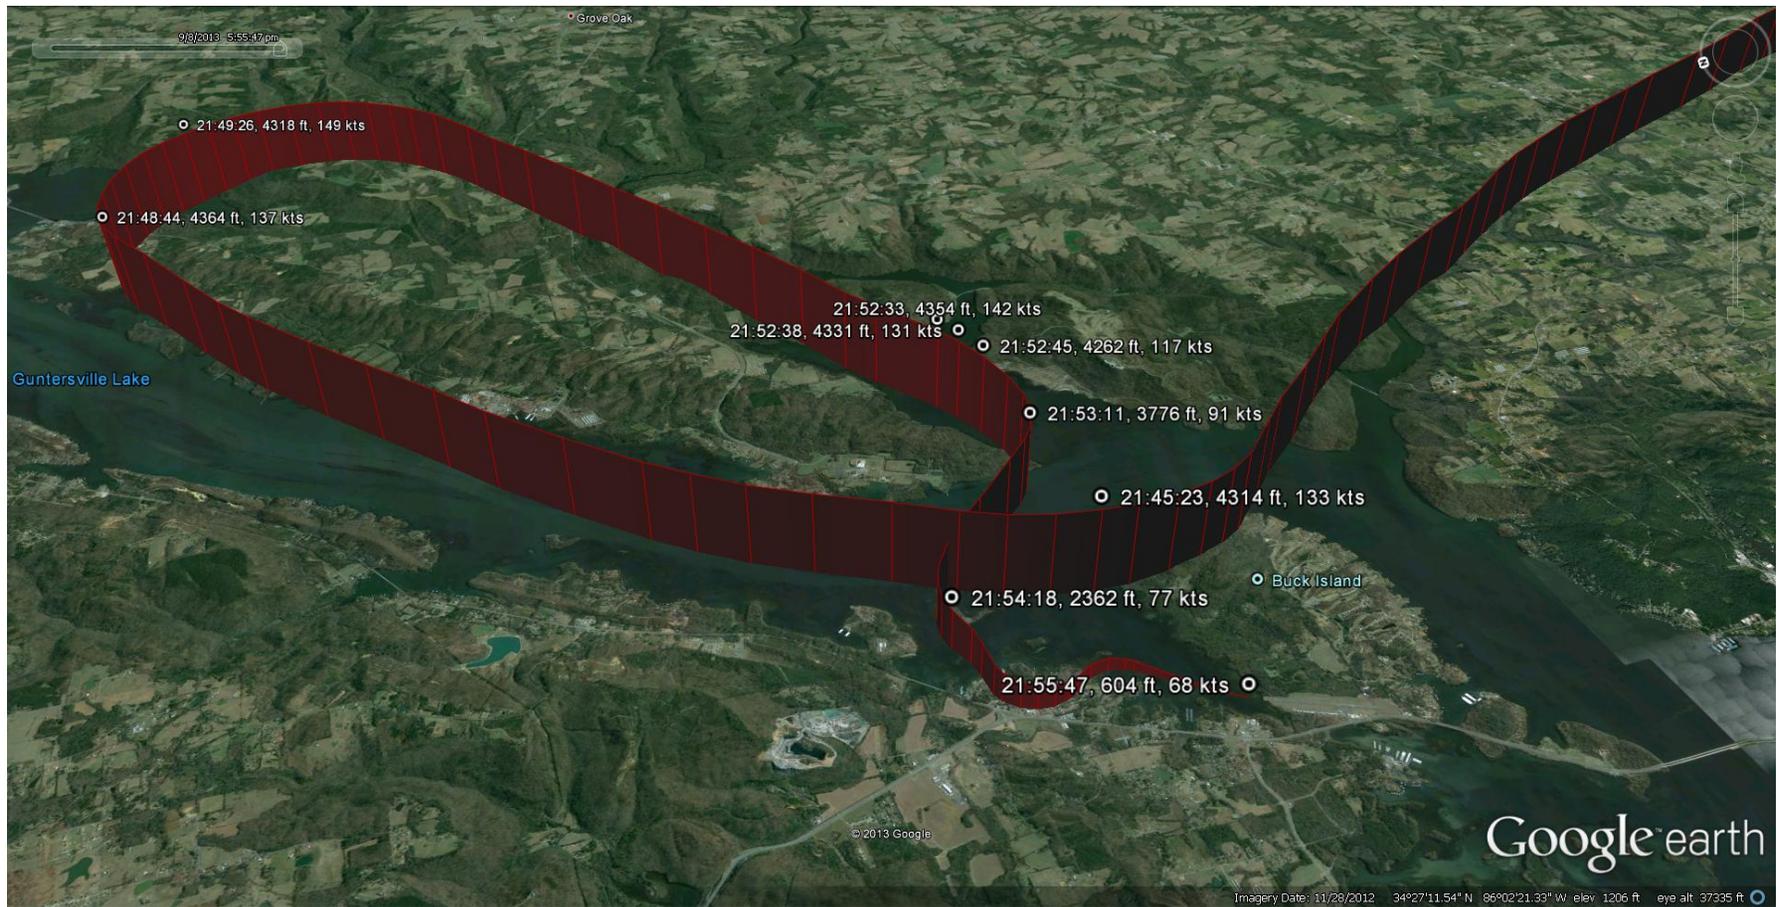
Figure 2. Google Earth overlay near 8A1 airport.

Figure 2 shows flight path details north of 8A1. After passing 8A1 northbound, the aircraft paralleled Guntersville Lake northeast bound. At about 2148 UTC, the aircraft turned towards the southwest, still at an altitude of about 4,300 feet, flying parallel and east of Guntersville Lake.

Between 2152:33 UTC and 2152:45 UTC, the groundspeed slowed from 142 knots to 117 knots, and the aircraft altitude decreased from 4,354 feet to 4,262 feet.

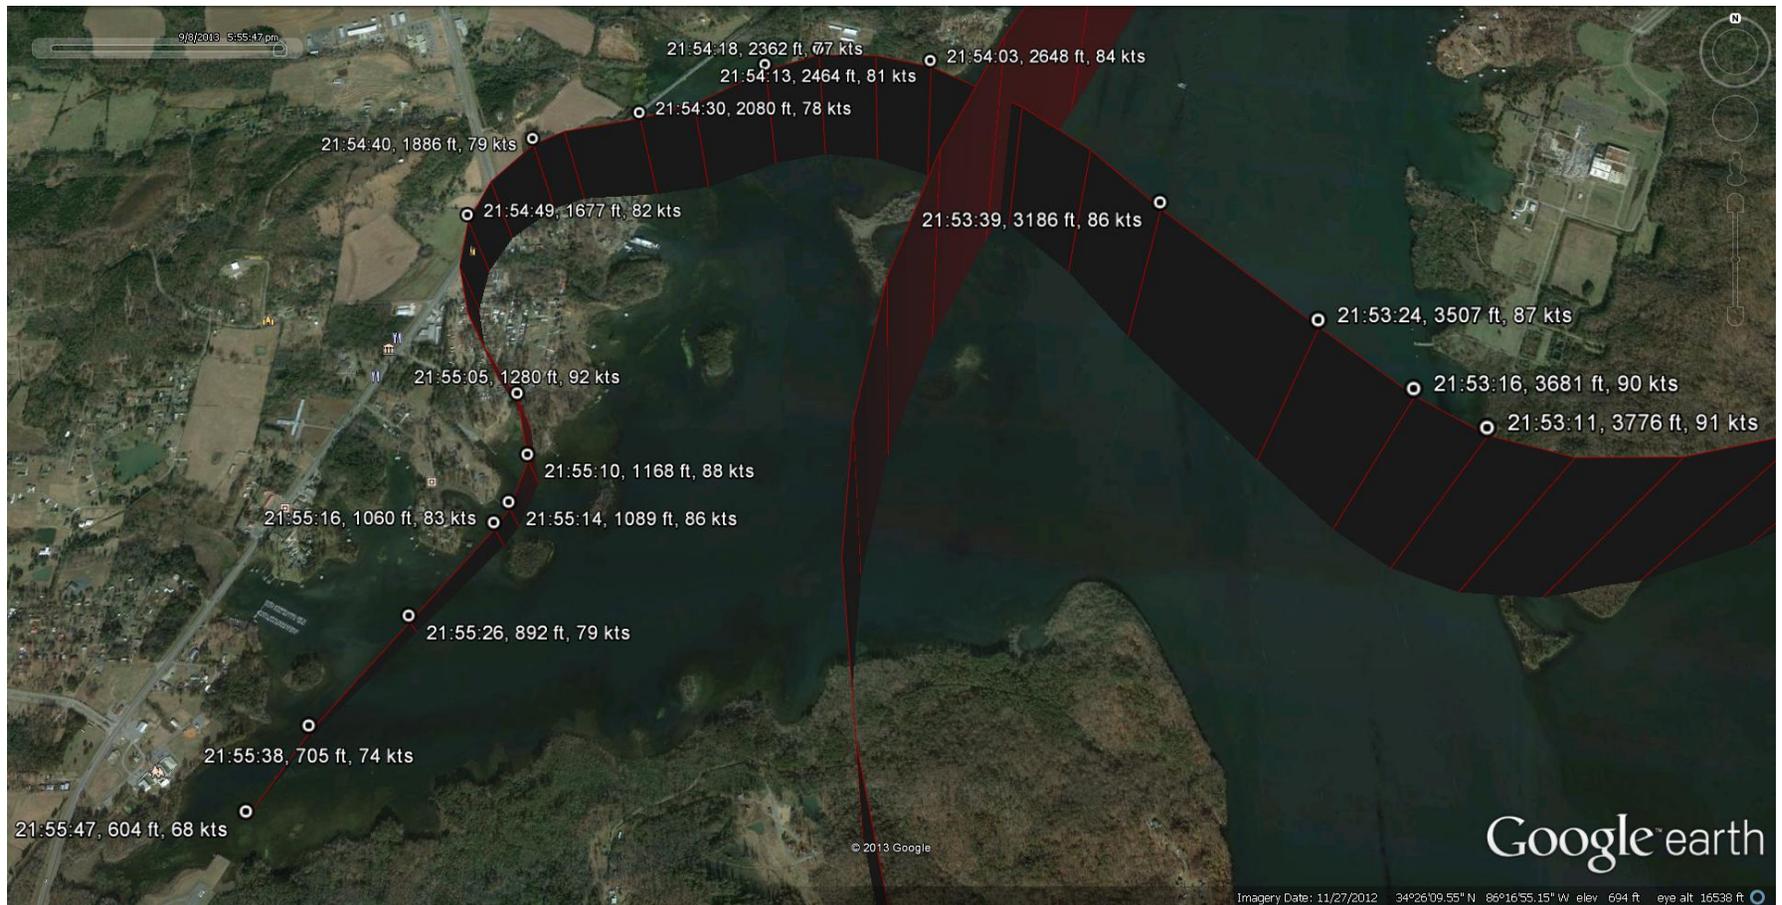
Figure 3. Google Earth overlay of the end of the accident recording.

Figure 3 shows flight path details for the end of the recording. At 2153:11 UTC, as the aircraft was descending through 3,776 feet at about 91 knots groundspeed, it turned towards the northwest; at this point the aircraft was about 2.2 nautical miles (nm) northeast of the runway 21 threshold at 8A1.

At 2154:03 UTC, as the aircraft was descending through 2,648 feet at about 84 knots groundspeed, it turned towards the west; at this point the aircraft was about 1.7 nm north-northeast of the runway 21 threshold at 8A1.

At about 2154:30 UTC, the aircraft was travelling westerly as it passed through the extended centerline of runway 21 at 2,080 feet; at this point the aircraft was about 1.6 nm north-northeast of the runway 21 threshold at 8A1.

At about 2154:49 UTC, as the aircraft was descending through 1,677 feet at about 82 knots groundspeed, it turned towards the southeast; at this point the aircraft was about 1.3 nm north of the runway 21 threshold at 8A1.

At about 2155:05 UTC, the aircraft was travelling southeasterly as it passed through the extended centerline of runway 21 at 1,280 feet and turned towards the southwest; at this point the aircraft was about 1.1 nm north-northeast of the runway 21 threshold at 8A1.

From 2155:05 UTC until the end of the recording at 2155:47 UTC, the groundspeed slowed from 92 knots to 68 knots and the altitude decreased from 1,280 feet to 604 feet.

The last recorded point was about 0.1 nm north-north east of the runway 21 threshold at 8A1 approximately aligned with the extended centerline of the runway.
