NATIONAL TRANSPORTATION SAFETY BOARD

17 - GPS Factual Report

Location: Pueblo, Colorado
Date: February 2, 2012, 1915 Mountain Standard Time (MST)
Aircraft: Lear 35
Registration: N31WS
Operator: Extrapoint LLC
NTSB Number: CEN12FA151

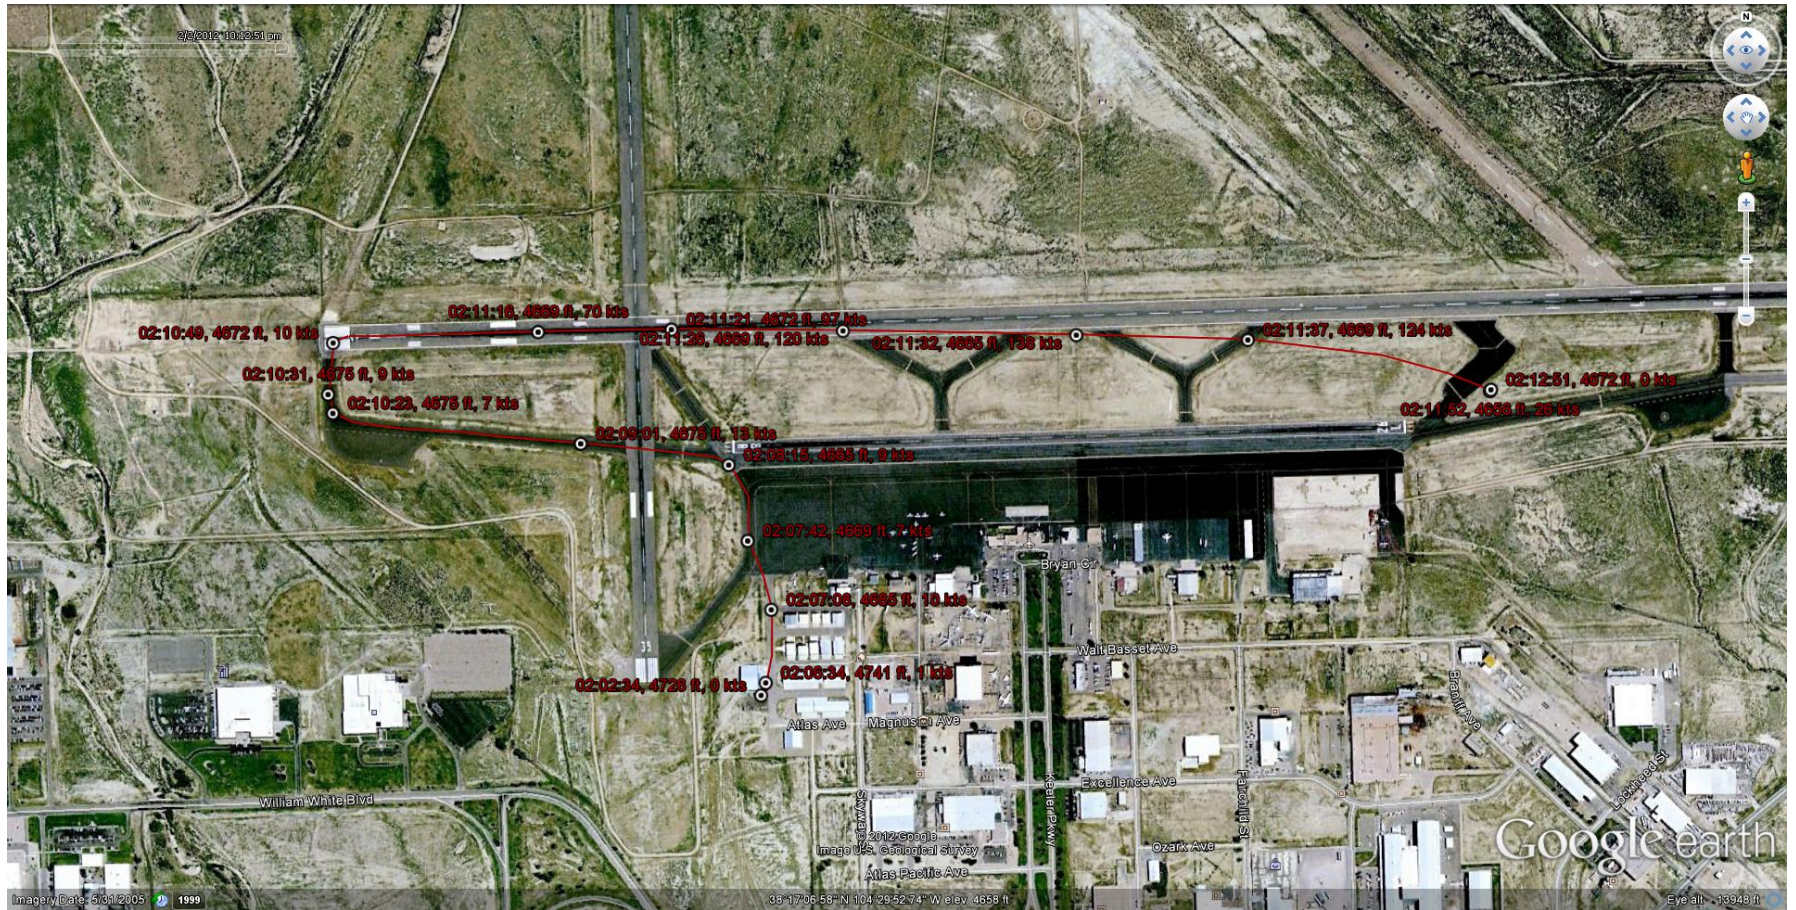
Figure 1 is a graphical overlay for select recorded points of the accident flight. The first recorded point is at 02:02:34 UTC, followed about 4 minutes later at 02:06:34 by the next point. The overlay shows the aircraft taxied to runway 8L and enter the runway at about 02:10:49. The aircraft then accelerated and departed the runway. It came to a stop at about 02:12.

Figure 1. Google Earth overlay showing select points from taxi-out, take-off roll, and aircraft coming to rest.

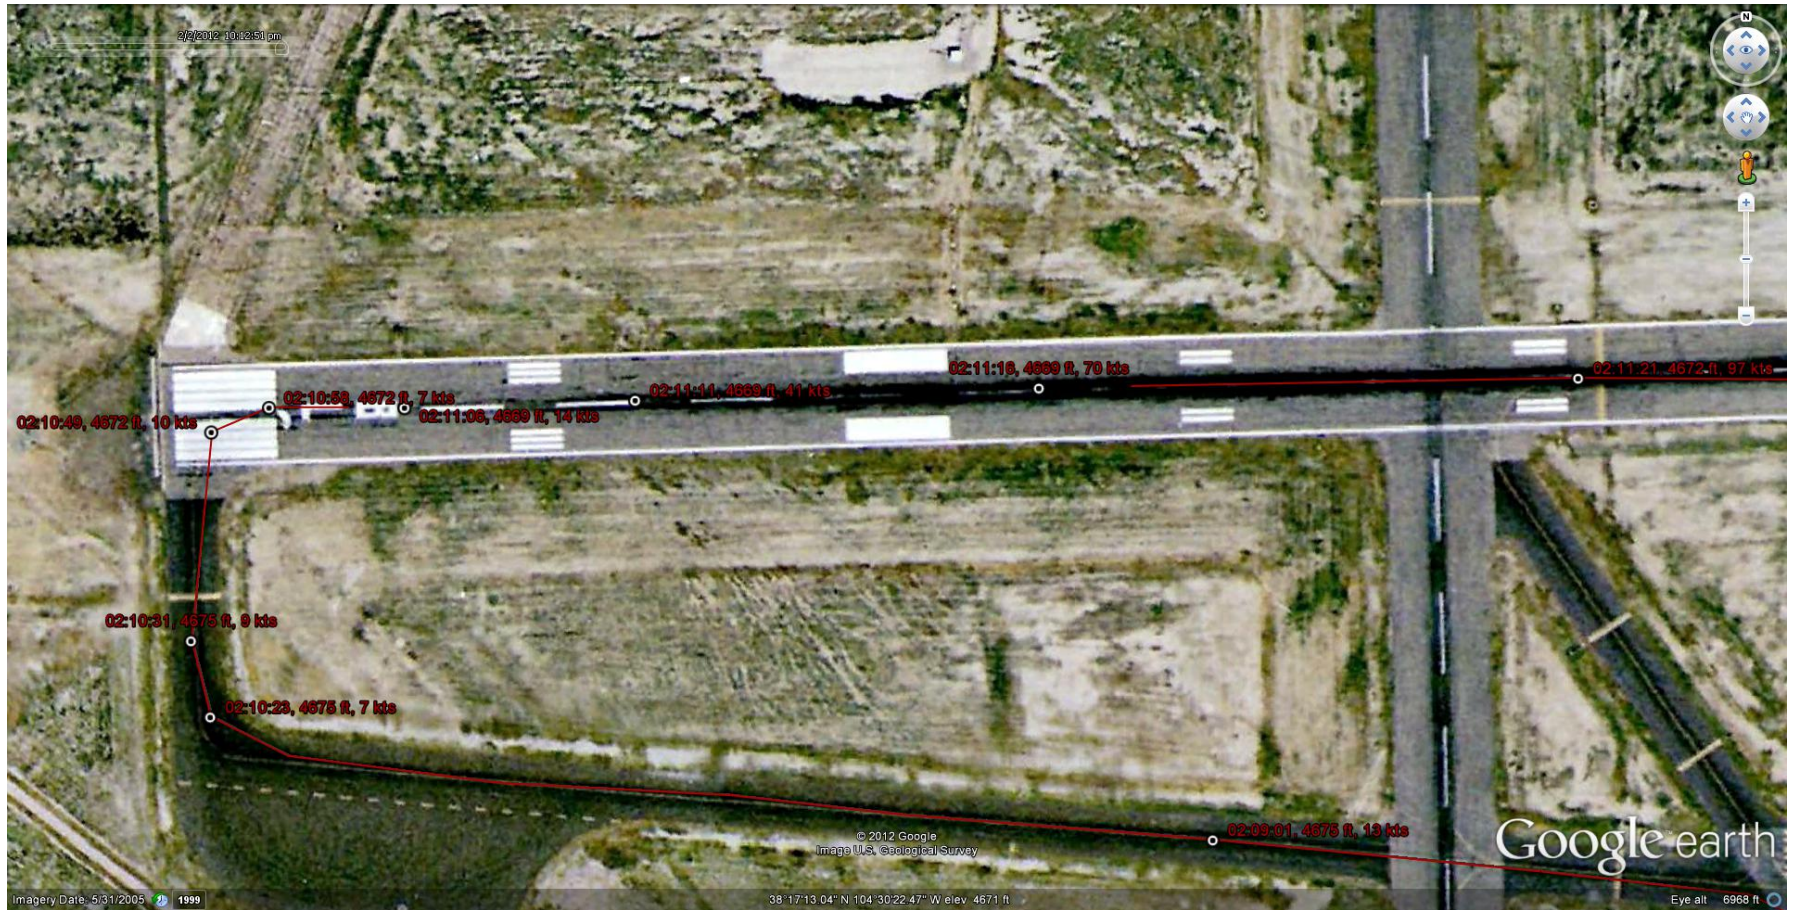
Figure 2 is a graphical overlay of all points for the first part of the take-off roll. The aircraft began the take-off at about 02:10:58 and achieved an average speed of 97 knots at about 02:11:21, just after crossing the intersecting runway 17/35.

Figure 2. Google Earth overlay showing all points, start of take-off roll.

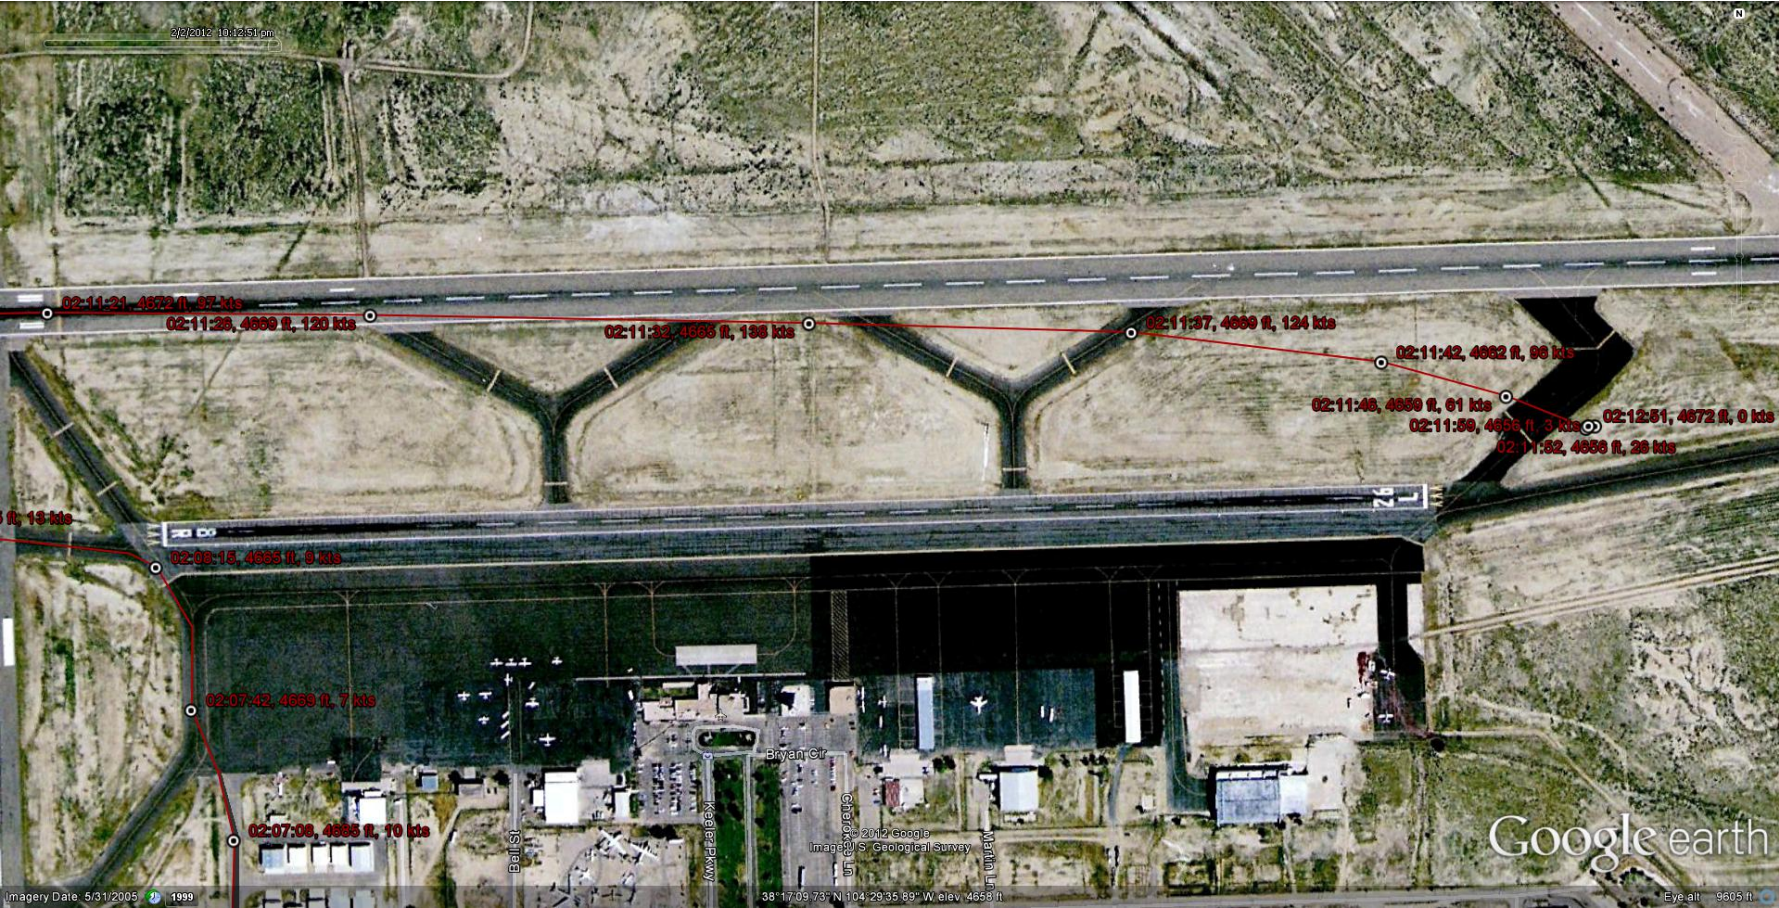
Figure 3 is a graphical overlay for all points in the latter part of the take-off roll until the aircraft came to rest. The point recorded at 02:11:26, at an average speed of 120 knots, shows the aircraft first departing the centerline. The aircraft departed the south side of the runway at about 02:11:32, at an average speed of 138 knots. The aircraft came to a stop at about 02:11:59. The last point recorded was at 02:12:51.

diverged from runway track; the overlay in figure 3 shows the aircraft had exited the south side of the runway by this time.

Figure 3. Google Earth overlay showing all points, take-off roll, and aircraft coming to rest.

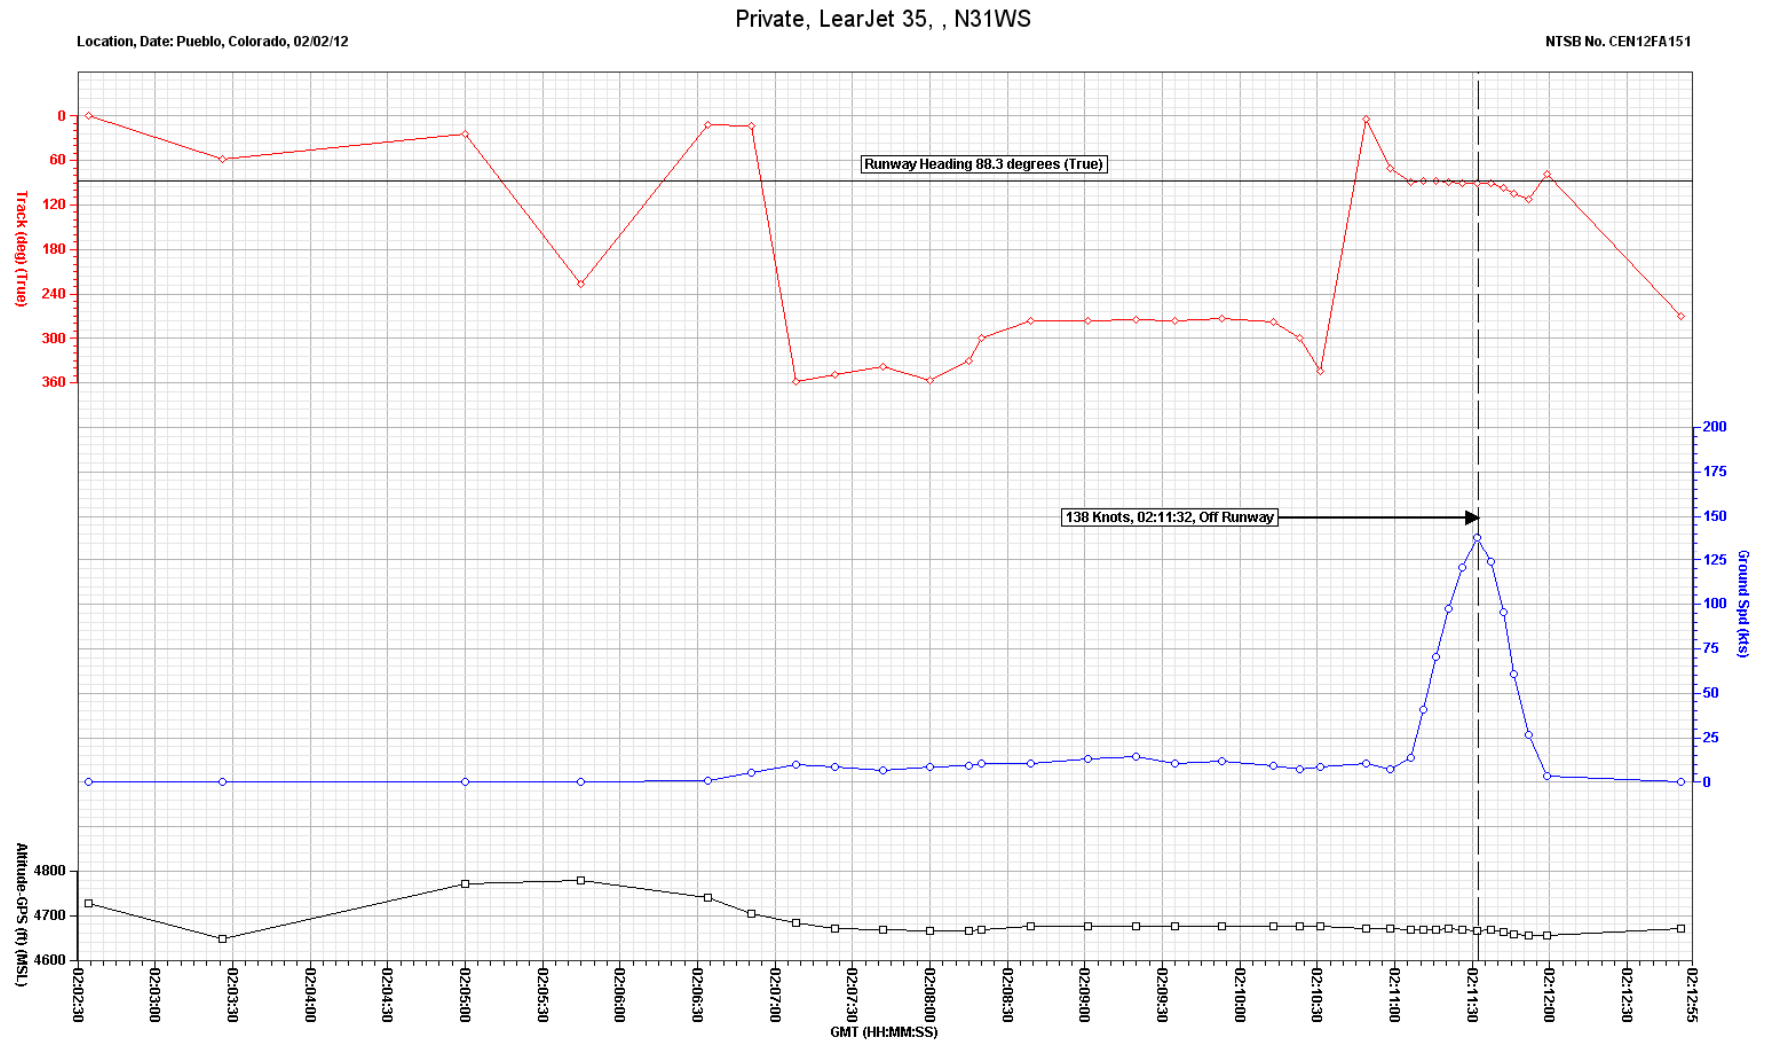
Figure 4. Plot of all recorded points.

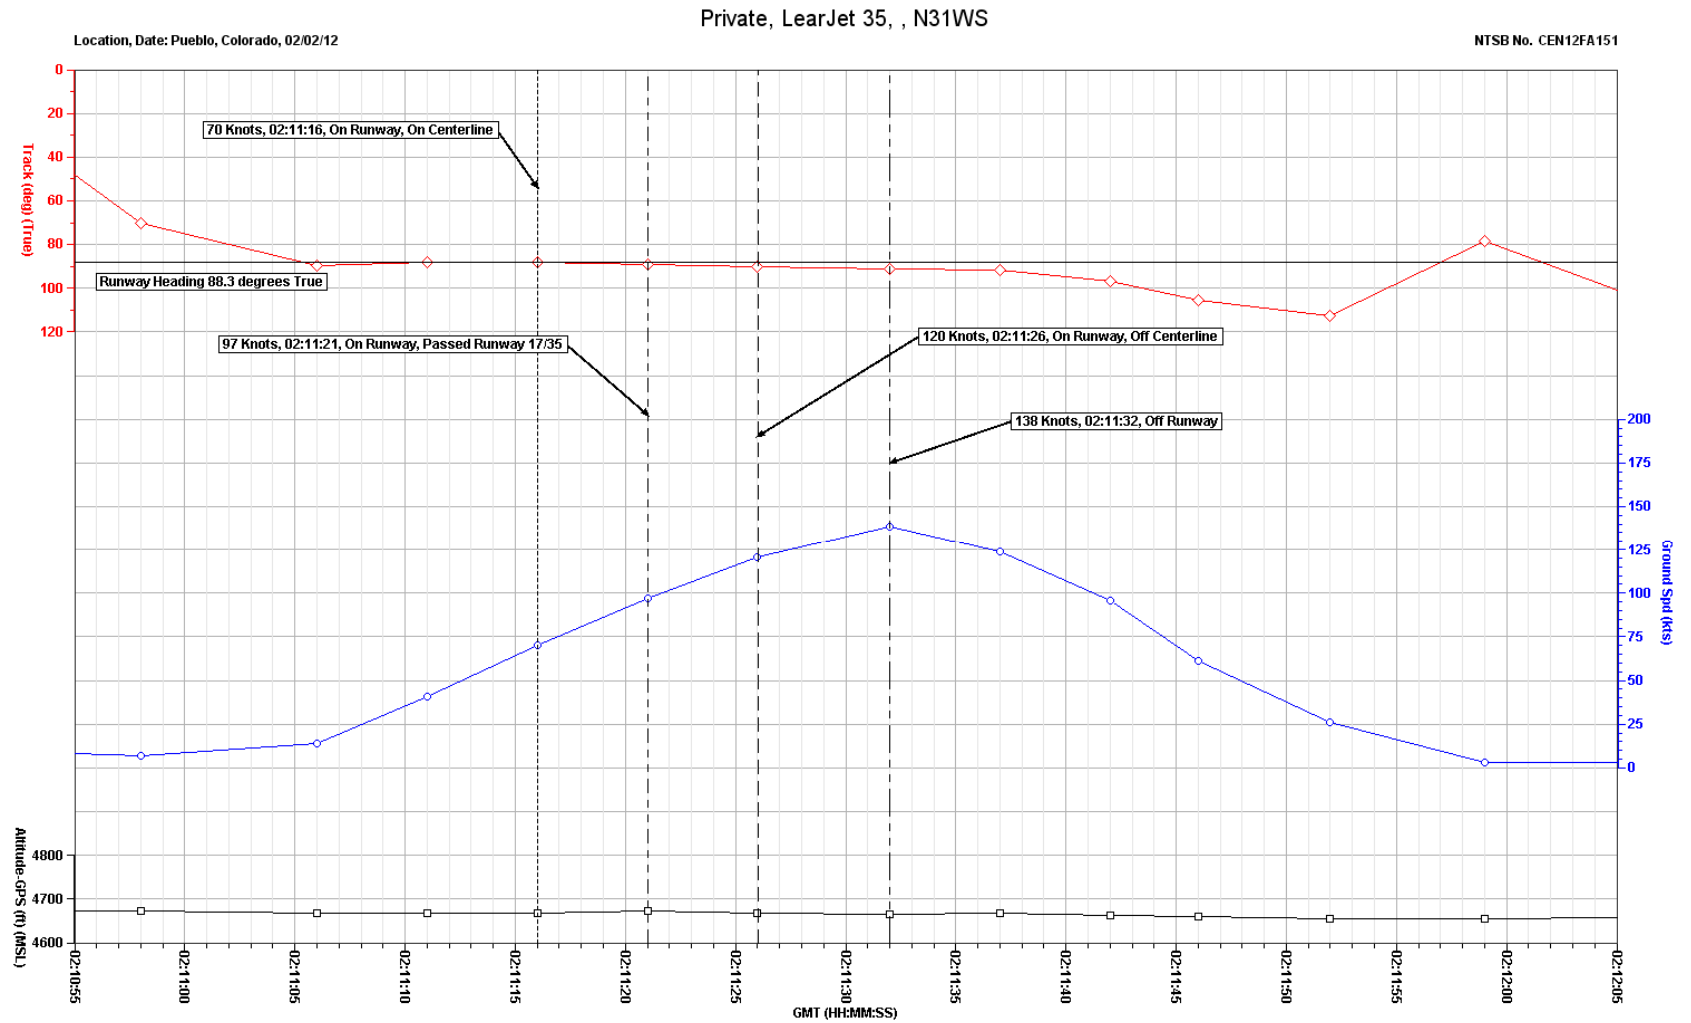
Figure 4 is a plot of altitude, calculated average true track, and calculated ground speed for all recorded points. Figure 5 shows only those points related to the take-off roll and the aircraft coming to rest. Figure 5 includes a reference line for the runway true direction⁴. Select recorded points are annotated with captions identical to those on the Google Earth overlays in figures 1 through 3. The plot shows the aircraft achieving a maximum average speed of about 138 knots at 02:11:32 when the aircraft track had

Figure 5. Plot of take-off roll and aircraft coming to rest.
