NATIONAL TRANSPORTATION SAFETY BOARD
Vehicle Recorder Division
Washington, D.C. 20594

Garmin Integrated Avionics (GIA) Units

Specialist's Factual Report
by Bill Tuccio, Ph.D.

Location: Gaithersburg, Maryland
Date: December 8, 2014
Aircraft: Embraer S.A. EMB-500
Registration: N100EQ
Operator: Sage Aviation LLC.
NTSB Number: DCA15MA029

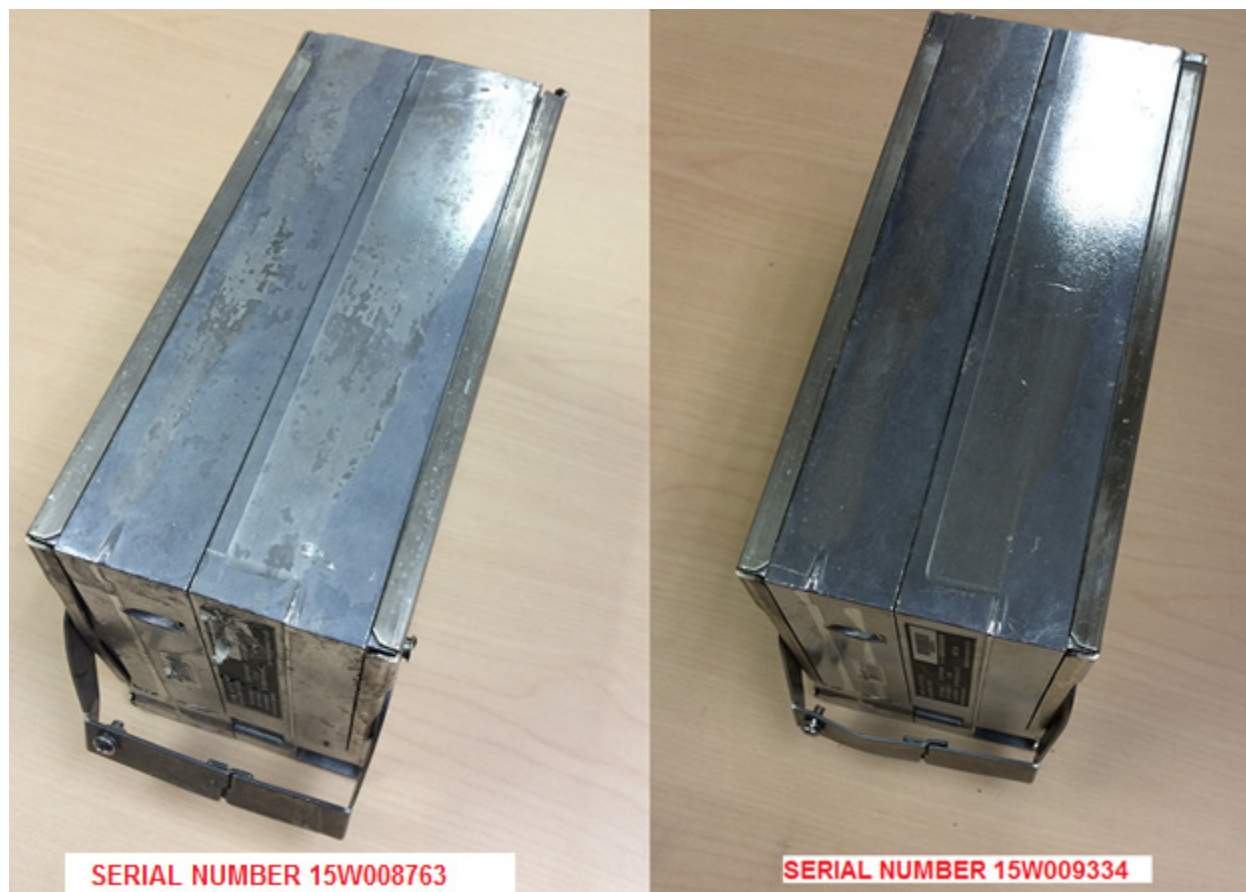
Upon arrival at the Vehicle Recorder Division, an exterior examination revealed the units had sustained minor damage, as shown in figure 1. With assistance from the manufacturer, the information was downloaded using custom cables and software.

Figure 1. GIA 63W units.
