NATIONAL TRANSPORTATION SAFETY BOARD
Vehicle Recorder Division
Washington, DC 20594

Ground Observer Videos

Specialist's Factual Report
By George Haralampopoulos

Location: Cameron, Missouri
Date: June 27, 2015
Aircraft: Pitts S-2B
Registration: N877UP
NTSB Number: CEN15FA282

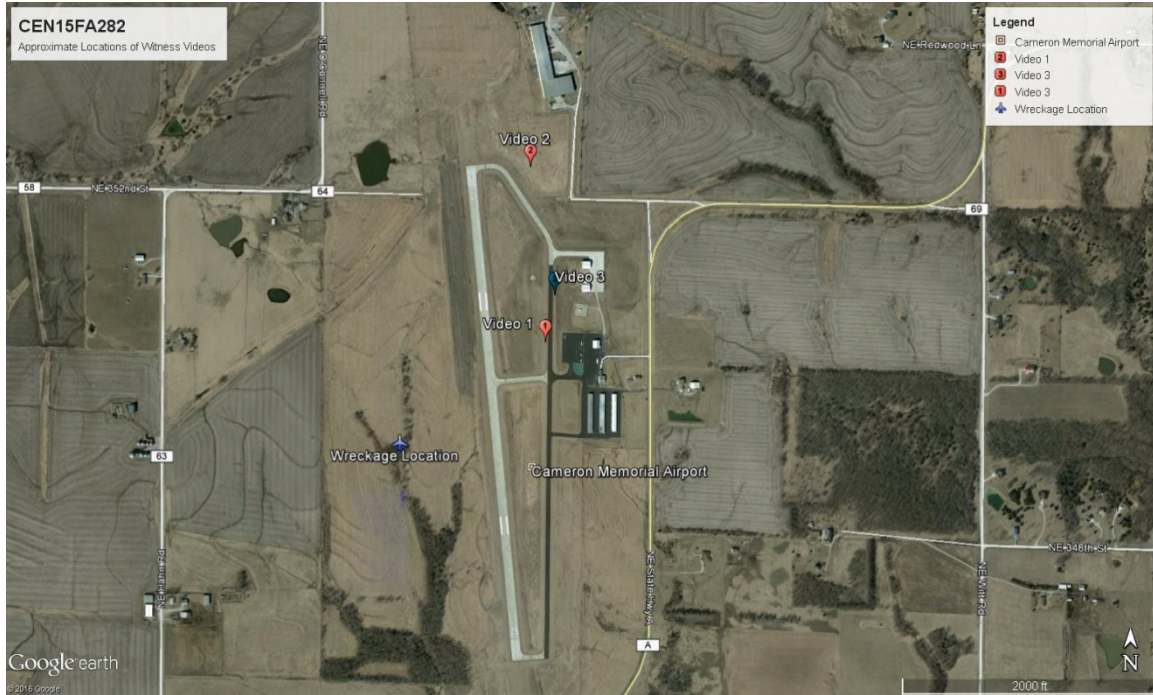
Each file was captured from their respective ground observer. Figure 1 is a google earth overlay that shows the approximate location of each ground observer. Video 3 was considered to contain redundant information at

Figure 1. Approximate impact and observer's location.

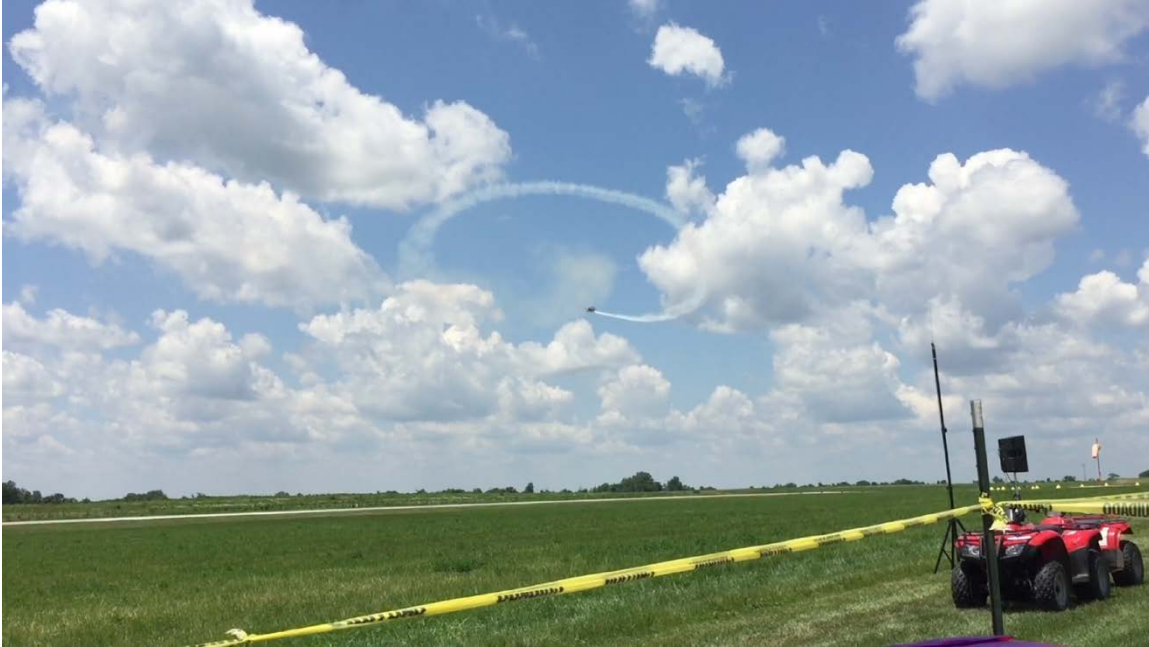
Throughout the recording the camera tracked the aircraft's movement with the sky mostly in the background with ground references occasionally appearing in few frames. Figure 2 shows a frame containing ground references with the runway wind sock visible. The sound of the airshow announcer was predominately heard along with the aircraft's engine throughout the recording. The impact occurred at approximately 47 seconds video elapsed time. Video 1 is included as attachment 1 to this report.

Figure 2. A frame from Video-1 showing wind sock and smoke oil trail.
