NATIONAL TRANSPORTATION SAFETY BOARD
Vehicle Recorder Division
Washington, D.C. 20594

17 – Ground Video Factual Report

Location: Plant City, Florida
Date: April 1, 2012
Aircraft: Powrachute LLC AirWolf 912ULS
Registration: N415BA
Operator: Private
NTSB Number: ERA12LA264

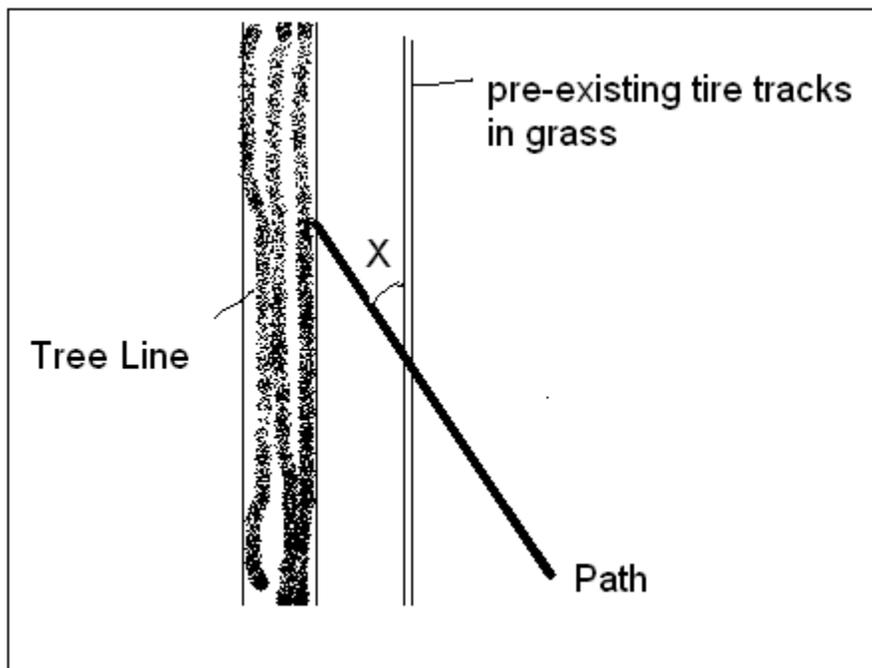
Figure 1. Approximate aircraft path schematic.

By about 5 seconds, the wing was fully inflated. The aircraft direction after 5 seconds was essentially straight, towards the tree line, as shown in figure 1. The angle of convergence with the tree line, X in figure 1, was about 20-30 degrees.

By about 11 seconds, the engine sound began to increase and the aircraft accelerated. At about 14 seconds, the cart began to rotate for take-off and was just about over tire tracks worn into the grass, as shown in figure 1. The engine sound was louder than the initial part of the video and remained so until the end of the recording.

By about 17 seconds, the aircraft had left the ground and had achieved a height of about half that of the tree line it was approaching. The angle of convergence, X in figure 1, remained roughly the same, about 20-30 degrees.
