National Transportation Safety Board

Marine Accident Brief

Grounding of Bulk Carrier *Nenita*

Accident no.	DCA17FM003
Vessel name	<i>Nenita</i>
Accident type	Grounding
Location	Columbia River at navigation marker "23," Three Tree Point, in the Welch Island Reach near Skamokawa, Washington, 46° 16.0' N, 123° 31.2' W
Date	November 19, 2016
Time	0246 Pacific standard time (coordinated universal time – 8 hours)
Injuries	None
Property damage	\$4 million est.
Environmental damage	None
Weather	Clear visibility, calm winds, air temperature 45°F
Waterway information	The Columbia River is the largest river in the US Pacific Northwest. Near the accident site, the main channel of the river follows the north (Washington State) shore and has a current velocity of about 1 knot. ¹

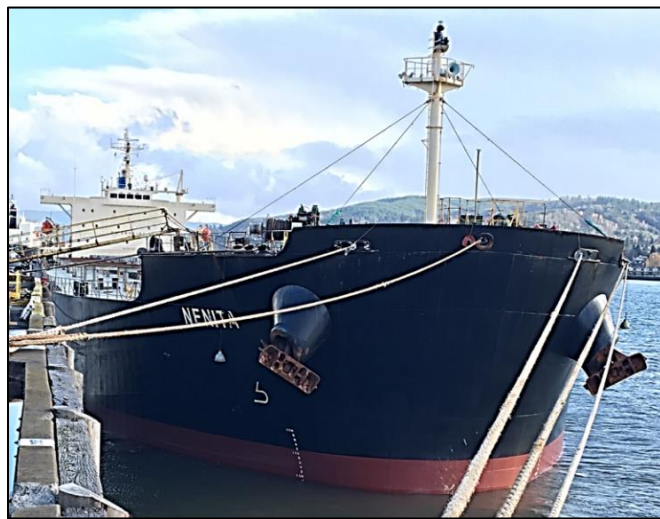
Nenita undergoing temporary repairs at Longview, Washington, following the accident.

The vessel was towed to Longview, Washington, for temporary repairs, where seventy cubic yards of cement were added to the bulbous bow void space. As a

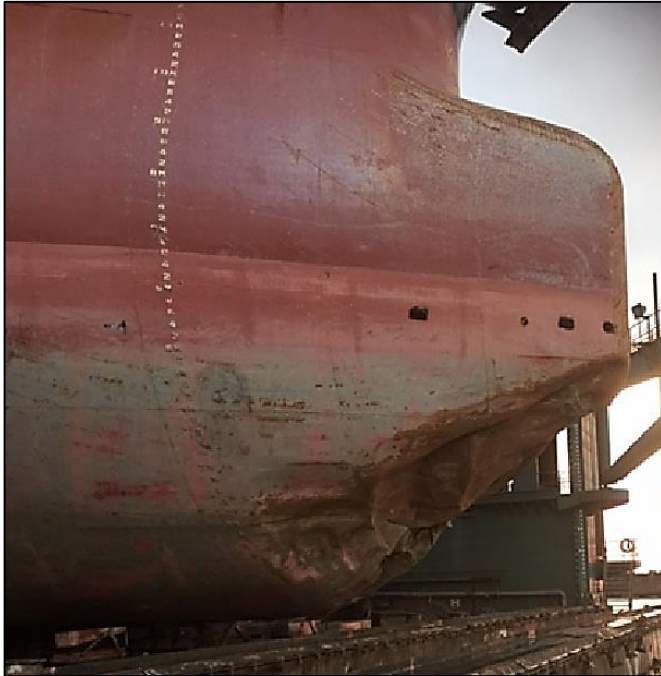
Damage to *Nenita's* bulbous bow starboard side.
(Photo by Spring Marine Bulk, S.A.)

During the grounding, the *Nenita's* forepeak flooded when the vessel's bulbous bow was breached. Web frames were damaged in the bow and shell plating was torn, folded, or fractured. The forward end of the bilge keel exhibited no signs of damage.

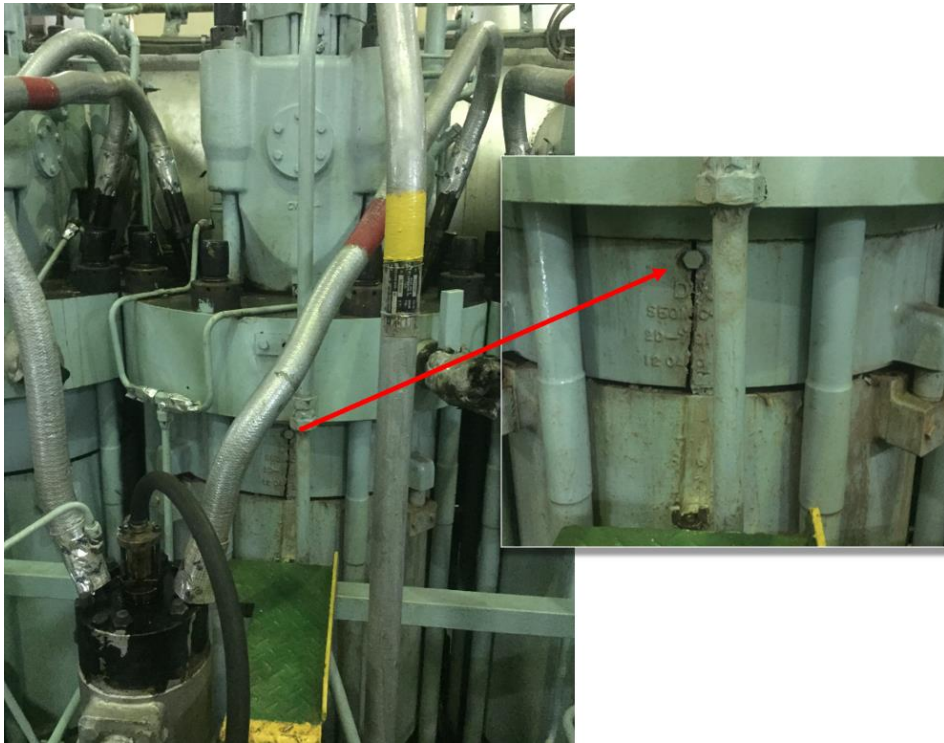
Investigators documented the fractured no. 3 cylinder cover cooling jacket and the condition of the other six cylinders cooling jackets. No. 1 and no. 2 cylinders also showed signs of cooling water weeping from the cooling jacket o-rings and connections, and investigators observed potential hairline cracks in the area of the bolts securing the cooling jackets in place.

The *Nenita's* loss of speed in the Columbia River channel occurred because of the fracture and failure of the no. 3 cylinder cooling jacket cover on the two-stroke crosshead-design Mitsui-MAN B&W 7S50MC-C main propulsion engine. Cooling water escaped from the fractured cooling jacket, which caused the no. 3 cylinder water outlet temperature to rise above 95 degrees C (203 degrees F), initiating an automated slowdown of the engine to protect it from further damage. The reduced speed resulted in reduced maneuverability. Steering was greatly affected, and despite the pilot's use of heavy rudder orders to maintain course, he was unable to keep the ship in the channel and it eventually grounded.

Cracked cooling jacket on main engine no. 3 cylinder, postaccident. Arrow shows one of four hex head securing bolts for the jacket cover. (Photo by Coast Guard)

Investigators reviewed maintenance records, standing orders, and engine room log books and found no. 3 cylinder cover was overhauled on June 11, 2016 (5 months prior to the accident), by the current operating company, which had taken over the vessel's operations one month prior, in May 2016. The cylinder had approximately 2,089 running hours since the overhaul. In the inspection reports completed during and after the overhaul of the cylinder, the remarks section of the maintenance report stated, "Check all parts found in good condition." There were no engine room log book entries or outstanding work orders for no. 3 cylinder listed in their corrective or preventative maintenance system. There was also no history of high jacket water temperature alarms prior to the engine casualty. The crew indicated that the jacket cooling water thermostatic valve operated as designed and no rapid temperature changes were recorded.

precautionary measure, the *Nenita's* technical manager, in agreement with the US Coast Guard and the vessel's classification society, Lloyd's Register, replaced the cooling water jacket covers on Nos. 1, 2, and 3 cylinders with spare covers and replaced the jacket cover securing bolts. The vessel remained in Longview until the temporary repairs were approved by the Coast Guard and the classification society on December 6. Provisional transit was authorized to allow the *Nenita* to offload the cargo of soybeans at its original destination in Qinzhou, China. Following the offload, the vessel proceeded to Guangzhou Shipyard in southern China for permanent repairs.

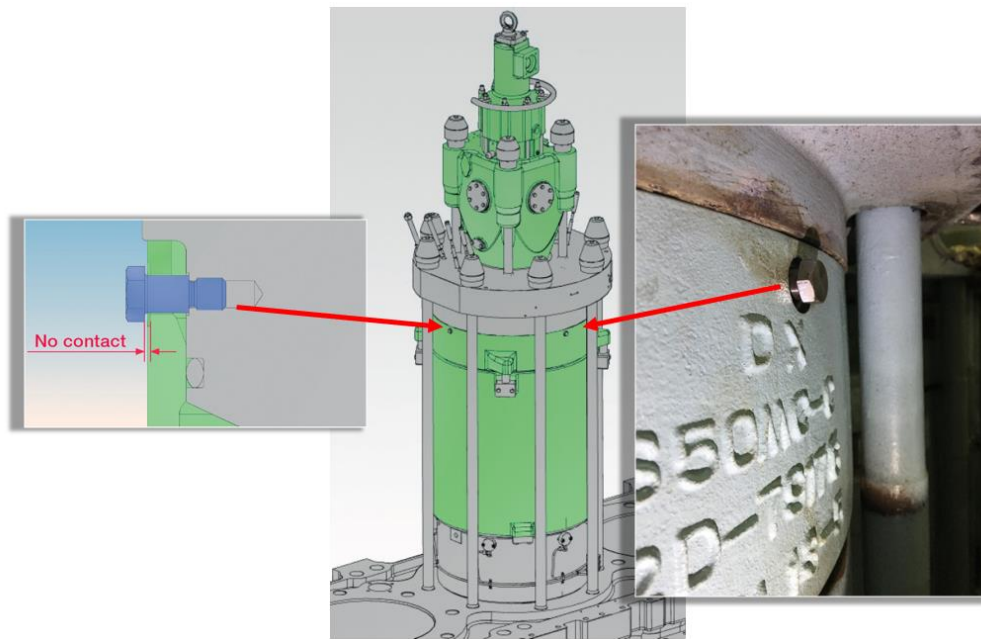
The MAN Diesel & Turbo service letter also discussed the securing of the cooling jacket to the cylinder cover by four specially machined bolts. Several different designs of fasteners were used on the *Nenita*'s engine model, and the one used aboard the vessel was a specially designed hex head bolt with metric machined threads and an unthreaded shoulder that was larger in diameter than the threads. The unthreaded shoulder acted as a spacer to provide expansion of the cooling jacket independent of the cylinder cover. The four bolts maintained the cooling jacket axial alignment without contact between the hex head and the cooling jacket (see illustration below).

Simplified drawings of the hex head bolt and cooling jacket space. At right is the replacement hex head bolt and new cooling jacket installed on *Nenita*'s no. 1 cylinder. (Diagrams by MAN Diesel & Turbo SE)

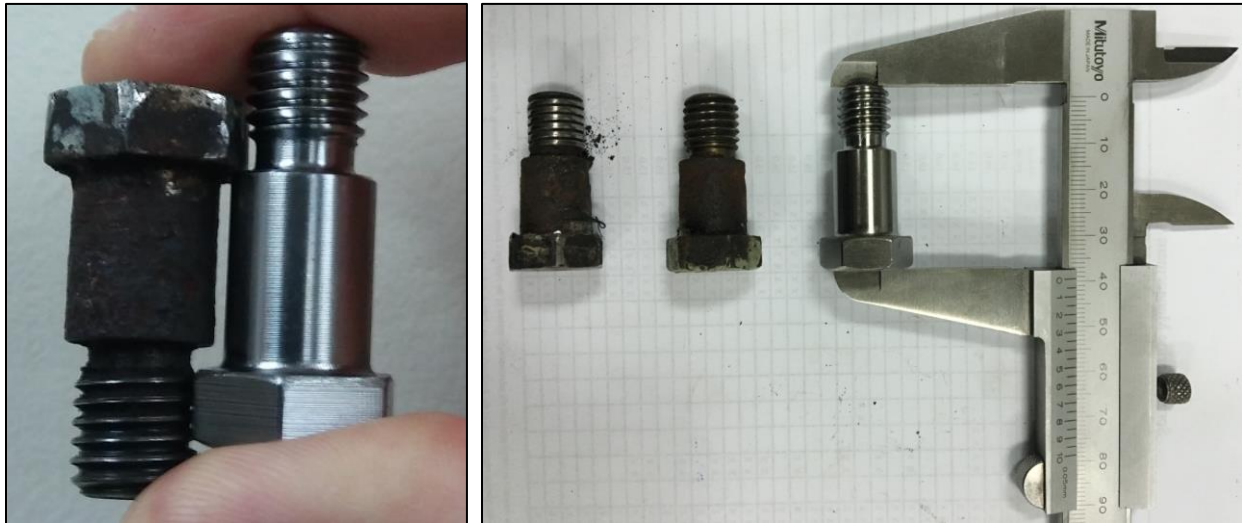
The technical manager provided investigators with the four bolts replaced on cylinder no. 3 cooling jacket after the accident. Investigators verified that the four bolts were produced by the OEM. One of the four bolts had damaged threads, an indication of a cross threaded condition (see photographs below). Also, investigators noted that the bolts used to replace the four removed bolts

were a slightly different design; they were the same diameter and thread length, but the unthreaded shoulder length was 2 millimeters longer. The difference in length is a potential design modification to provide additional radial expansion of the cooling jacket.

The correct tension or pre-load applied to a bolt is critical to the reliability of the bolted joint assembly, but the condition of three of the four bolts removed from the cylinder no. 3 cooling jacket indicated improper or excessive torque. The unthreaded shoulders near the threads expanded outward, an indication of compressive stress resulting in the deformation of the base of the shoulder.

Comparison of bolts removed from no. 3 cylinder cooling jacket and replacement bolts shows same diameter and thread length, but unthreaded shoulder length of the replacement bolt was 2 millimeters longer. Also note damaged threads on leftmost bolt in right photo.

Over the last two years, the NTSB has investigated three separate accidents that may have been caused by a failure to tighten fasteners on marine engines to the manufacturer's recommended torque settings. Undertorquing a fastener may cause excess vibration or allow the fastener to come loose, while overtorquing may lead to failure of the fastener or the machinery component being secured. When installing fasteners, mariners should use a calibrated torque wrench and follow the manufacturer's recommended tightening guide and torque values.
