National Transportation Safety Board

Airport Factual Report

Location:	Macon, Georgia
Date:	September 18, 2012
Aircraft:	Beech 400
Registration:	N428JD
Operator:	Private
NTSB Number:	ERA12FA567

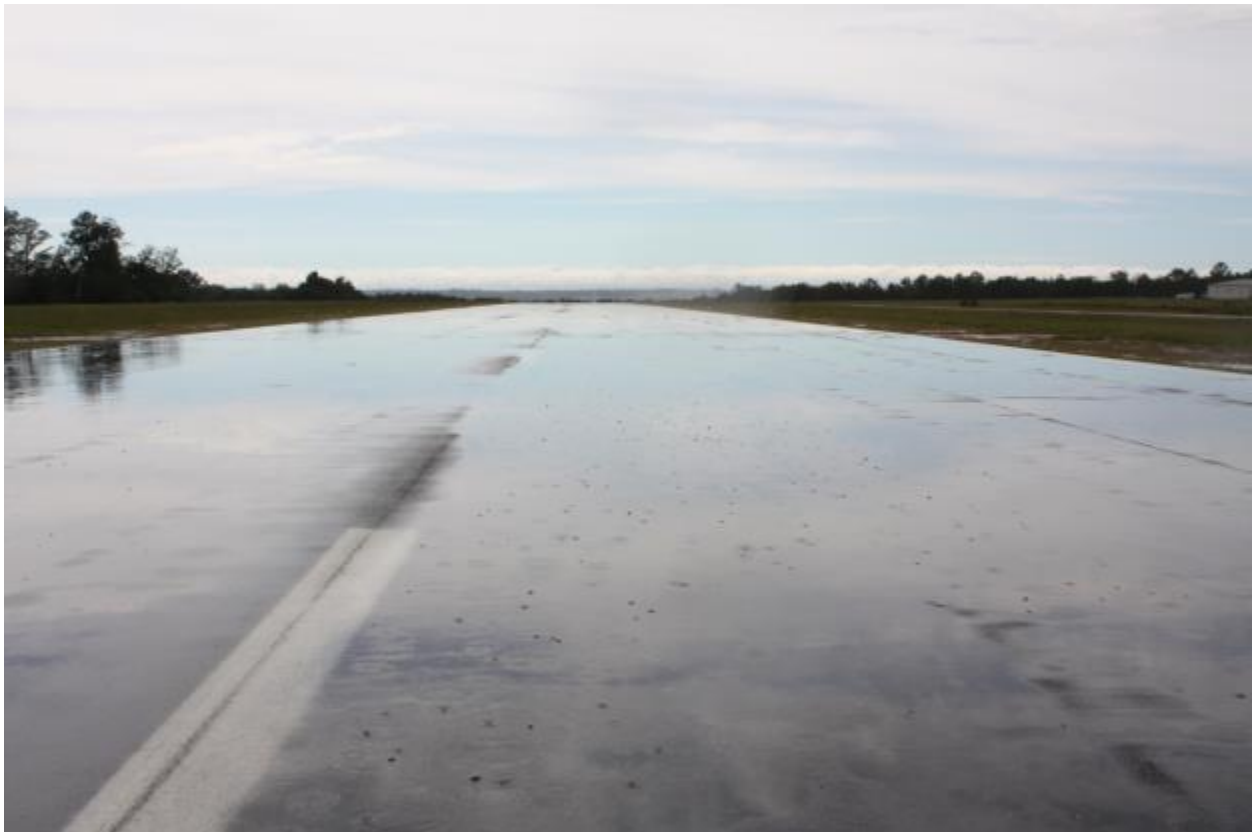
According to the accident pilots, shortly after activating the runway lights, the PAPI lights ceased operation and were no longer illuminated. During the accident sequence, after touchdown and brake application, the airplane began to hydroplane. Photographs provided by the operator taken a few hours after the accident and immediately following another rain shower revealed ponding of water on the runway, as shown in photograph 2.

Photo 2: Ponding Following a Rain shower Looking West on Runway 28 (Courtesy of the Operator)

On February 25, 2013, runway laser scan data was collected by a private company commissioned by the airport authority. Noted from the survey was that the contour for runway 10/28 had no crown section, most of the transverse grades on the 100-foot-wide runway sloped in one direction, and several areas indicated little to no slope. It was further noted in the FAA advisory circular standards that transverse slopes should be adequate to prevent the accumulation of water on the surface. Water will pond in flat areas and in some areas with transverse grades of less than 1.0%.⁶

The 5010 Master Record for MAC was updated to reflect a note stating "Potential for standing water on runway 10/28 during and after heavy rain events." This note will be included in the May 2014 publication cycle.

At the time of this writing, the Georgia Department of Transportation (GDOT) has requested additional survey data from the city of Macon and Bibb county in order to assess the existing condition relative to transverse grades.

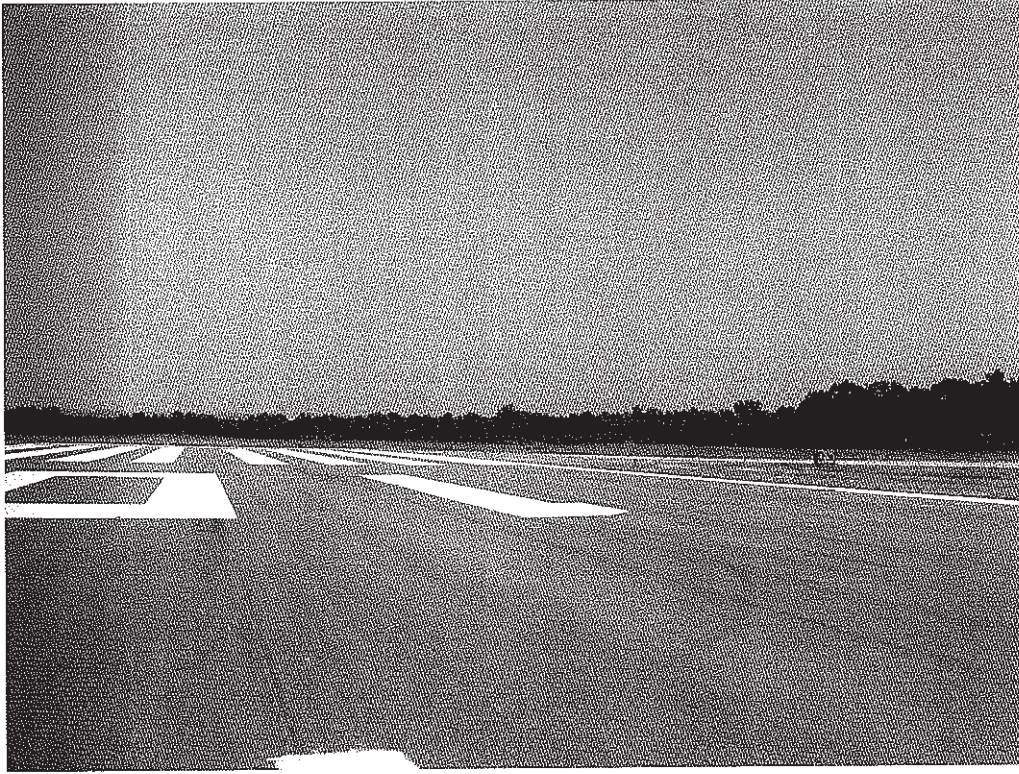
Runway 10

- **Runway 10** – Meets minimum state licensing requirements, but fails to meet federal requirements for a 34:1 obstruction-free non-precision approach. Trees 415' from the threshold and 215' left of the centerline provide only a 15:1 approach slope.

We encourage you to work with your project manager and airport consultant to fully identify all obstructions, and to remove the obstructions as soon as possible, but not later than October 31, 2011. Please contact Amanda J. Hill, our Aviation Planner, at (404) 505-4864 to discuss these inspection findings and to answer any questions concerning the inspection.

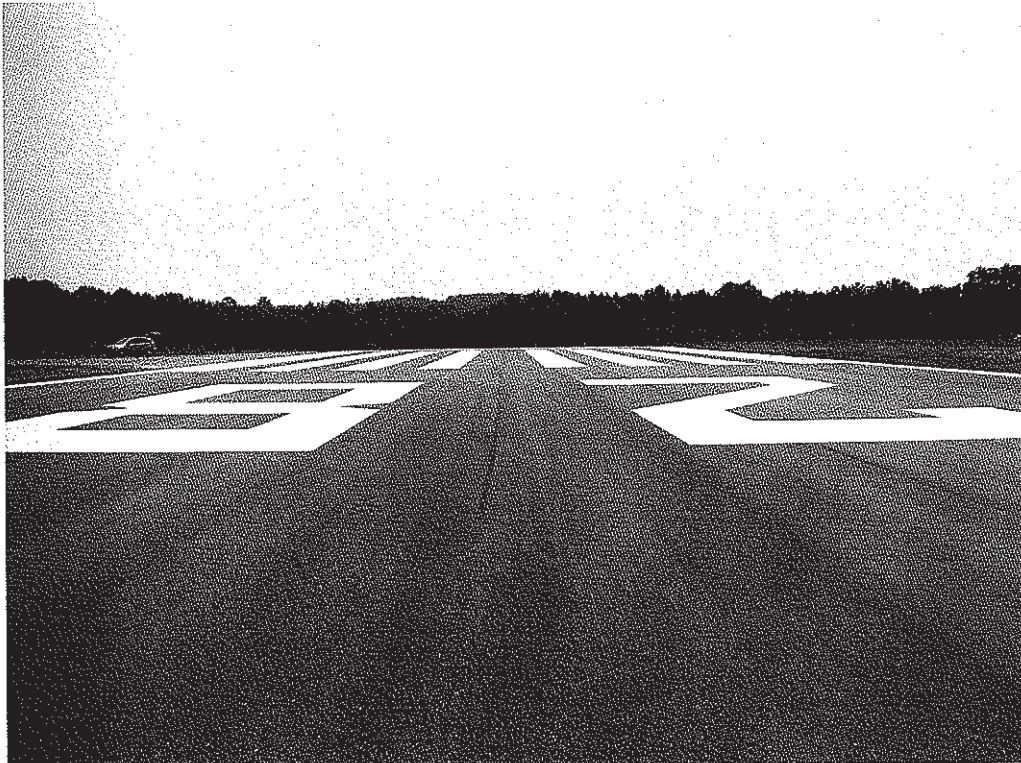
Runway 28

- **Runway 28** – Meets minimum state licensing requirements and but fails to meet federal requirements for a 34:1 obstruction-free non-precision approach surface. Trees 510' from the threshold and 200' left of the extended runway centerline provide only a 14:1 approach slope.

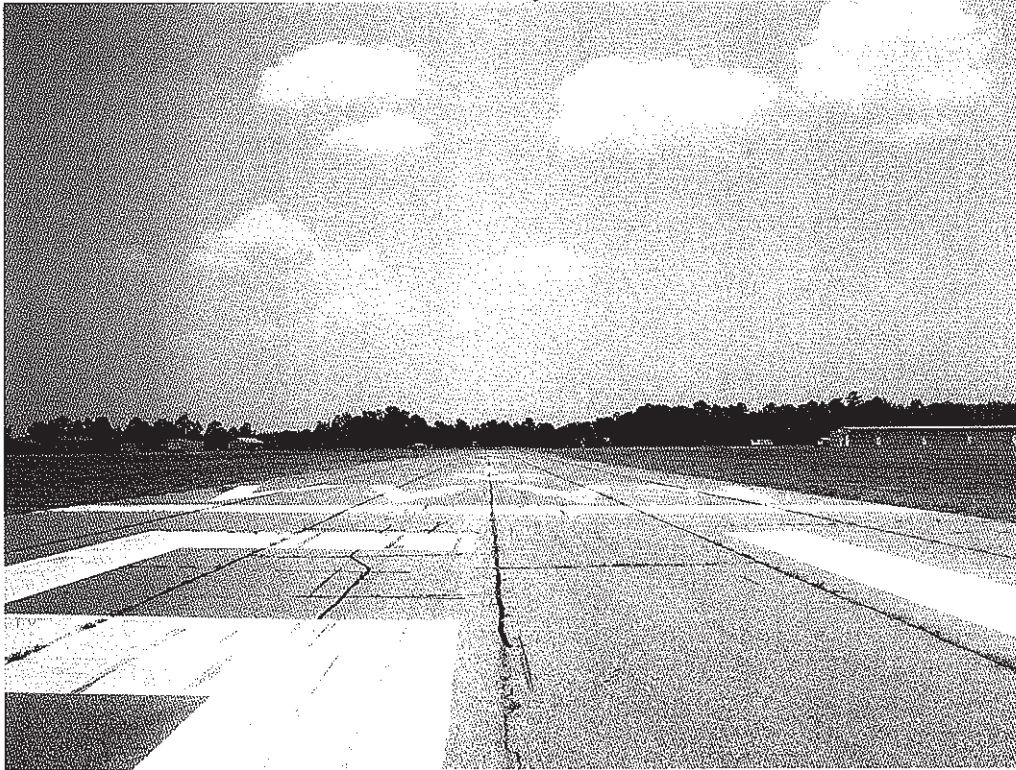
Runway 15

- **Runway 15** – Meets minimum state licensing requirements, but fails to meet federal requirements for a 20:1 obstruction free visual approach. Trees 1130' from the runway and 220' left of the centerline provide only an 11:1 approach slope to the runway end and a 25:1 approach slope to the displaced threshold.

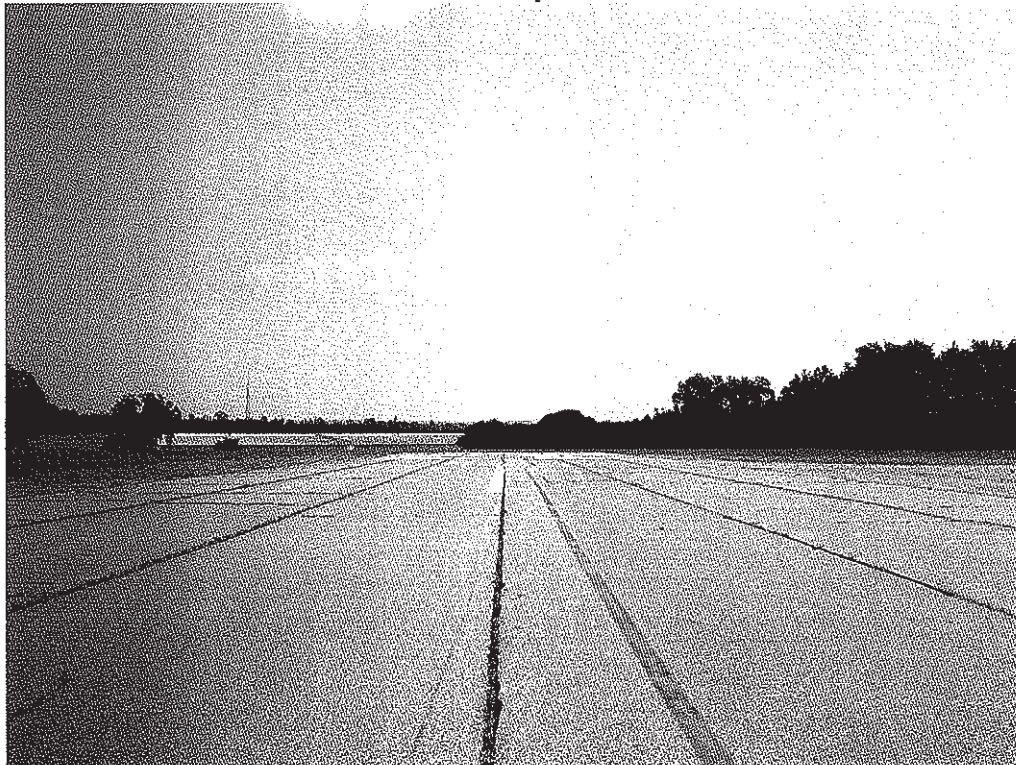
Runway 33

- **Runway 33** – Meets both state and federal minimum state licensing requirements for a visual approach slope of 20:1.
