NATIONAL TRANSPORTATION SAFETY BOARD - **Public Hearing**

Conrail Derailment in Paulsboro, NJ with Vinyl Chloride Release

Derailment of FC4230
Conrail Hazardous Materials Train
Paulsboro, New Jersey
November 30, 2012

Mechanical Group Factual Report

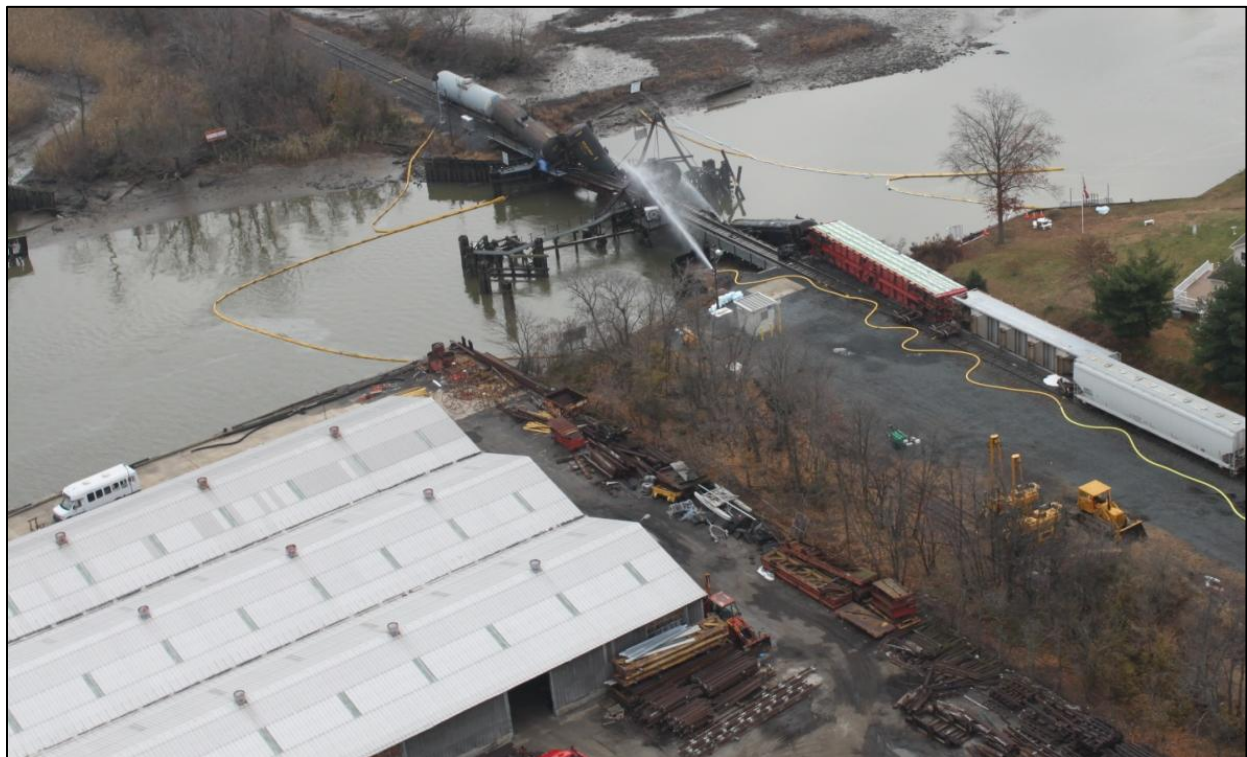
Figure 1-Aerial Photo of the Derailment

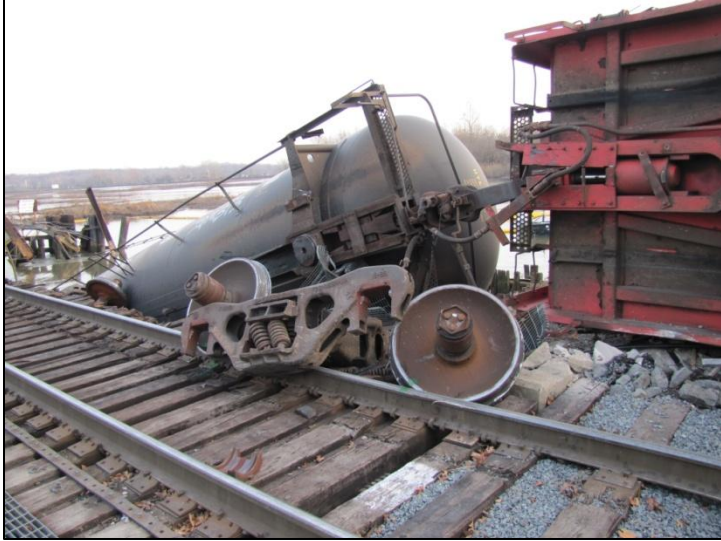
Figure 2-Photograph of UTLX 207938 Coupled to SGLR 6298

This car was lying on its side on the east side of the main partially submerged on the shoreline of Mantua Creek.

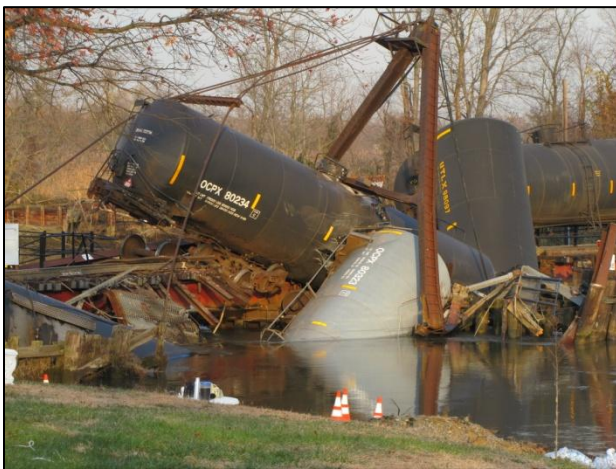
Figure 3-OCPX 80234

The 10th car (OCPX 80234) was derailed to the east side of the bridge. The tank car was resting on its right side (right side is defined by looking from the B-End) against the 9th car's A-End body bolster. OCPX 80234 sustained a breach at this contact area, releasing part of its product; vinyl chloride. See figure 3. And figure 4. The 13th car was left in place as an anchor and the trailing 70 cars were moved to Pavonia Yard in Camden, NJ.

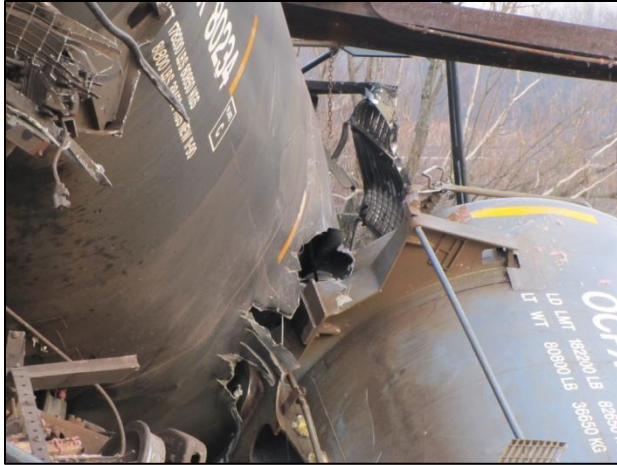
Figure 4-OCPX 80234 Torn open by OCPX 80323

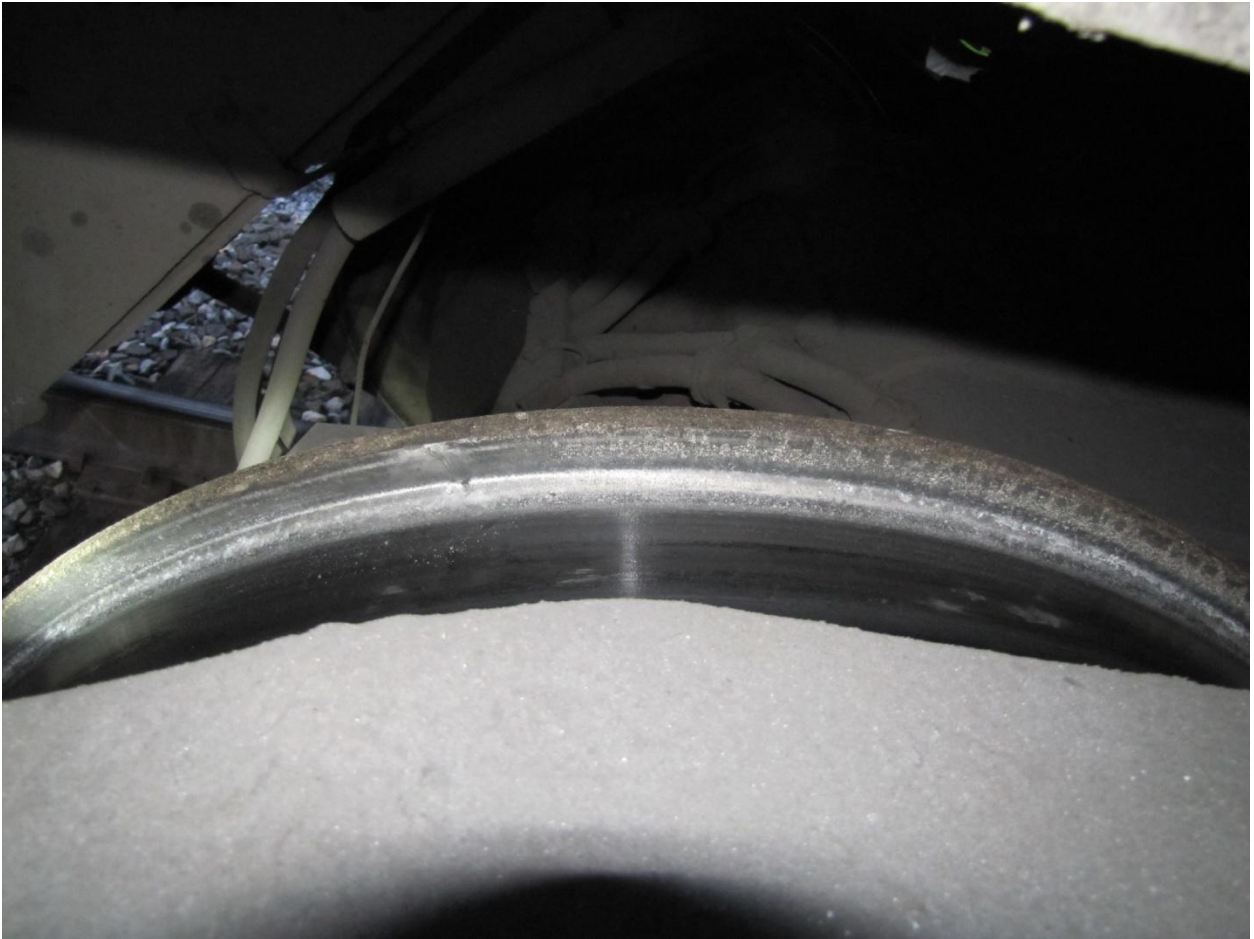
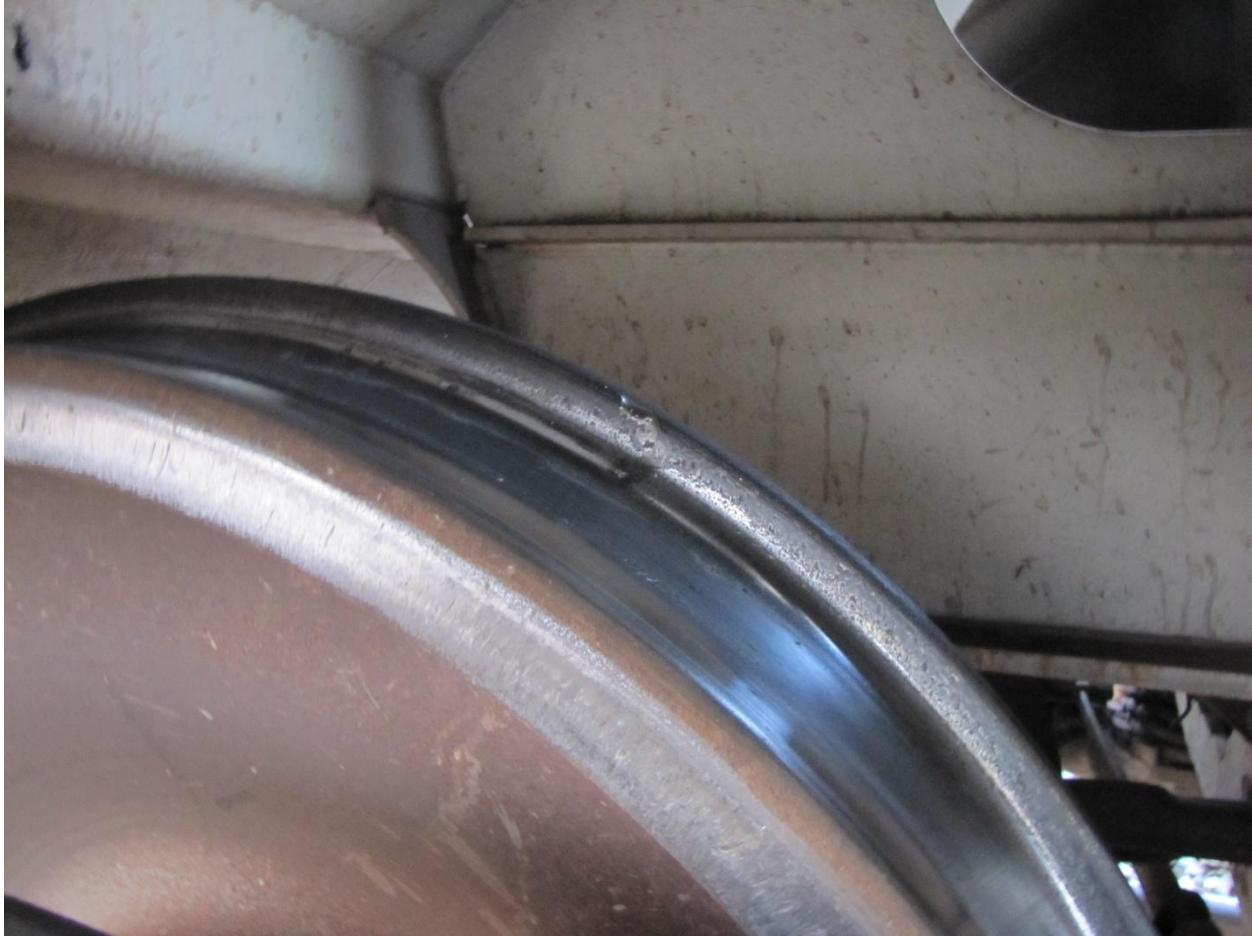
In all, each wheel on both locomotive units and the first five cars in the train that did not derail were closely inspected. The Conrail representative to the Mechanical Group stated "...we⁴ saw what I can best describe as a smudge or shadow on one of the trailing unit's wheels running perpendicular to the wheel tread...it looked like you could almost wipe it off with your finger. When we inspected the trailing cars we came to see the same type of mark repeating in the cars

described⁵ but each mark became more pronounced as the distance from the head end increased. All marks were confined to the east side of the equipment...”

Figure 5-Typical impact marks on the flanges of three wheels of the fourth and fifth rail cars

On the 5th car (EQUX 641124) and the 4th car (TTZX 866085) investigators observed freshly made impact marks on the flanges of three wheels on these cars.

- EQUX 641124, wheel R-3
- EQUX 641124, wheel R-1
- TTZX 866085, wheel L-2

The FRA representative to the Mechanical Group said “The gouges were ½” in length. Not very deep.”

Figure 6-Typical impact marks on the flanges of three wheels of the fourth and fifth rail cars

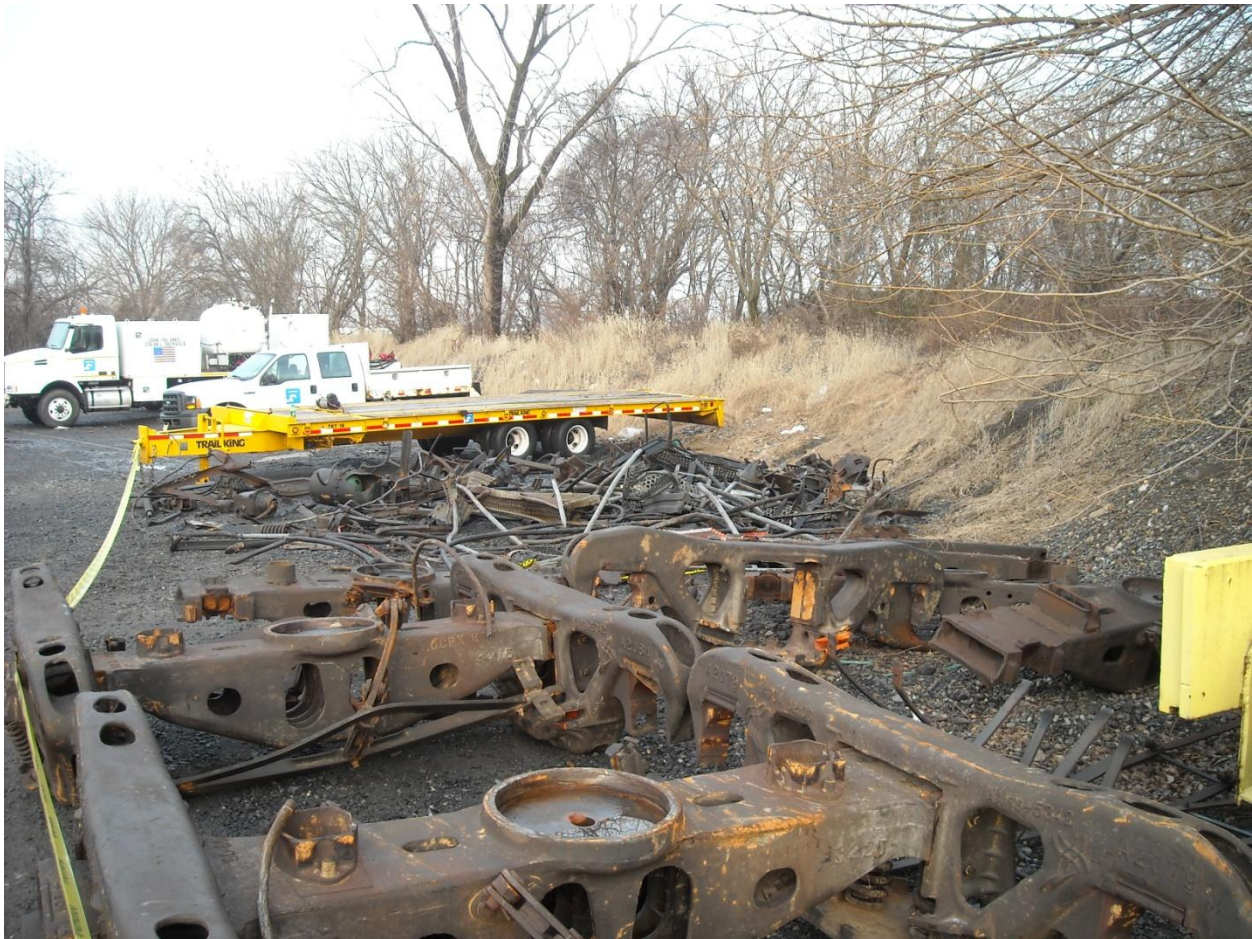
- 12 100-ton wheel sets,
- 7 truck bolsters,
- 7 truck side frames,
- 16 ½ brake beams,
- 3 broken coupler heads,
- Brake rigging; top rods, bottom rods, levers,
- 2 air brake control valves,
- Cross-over steps,
- Loose truck springs; inner coils, outer coils,
- Truck side bearing rollers,
- Air brake system reservoirs.

Figure 7 Recovered rail car components.

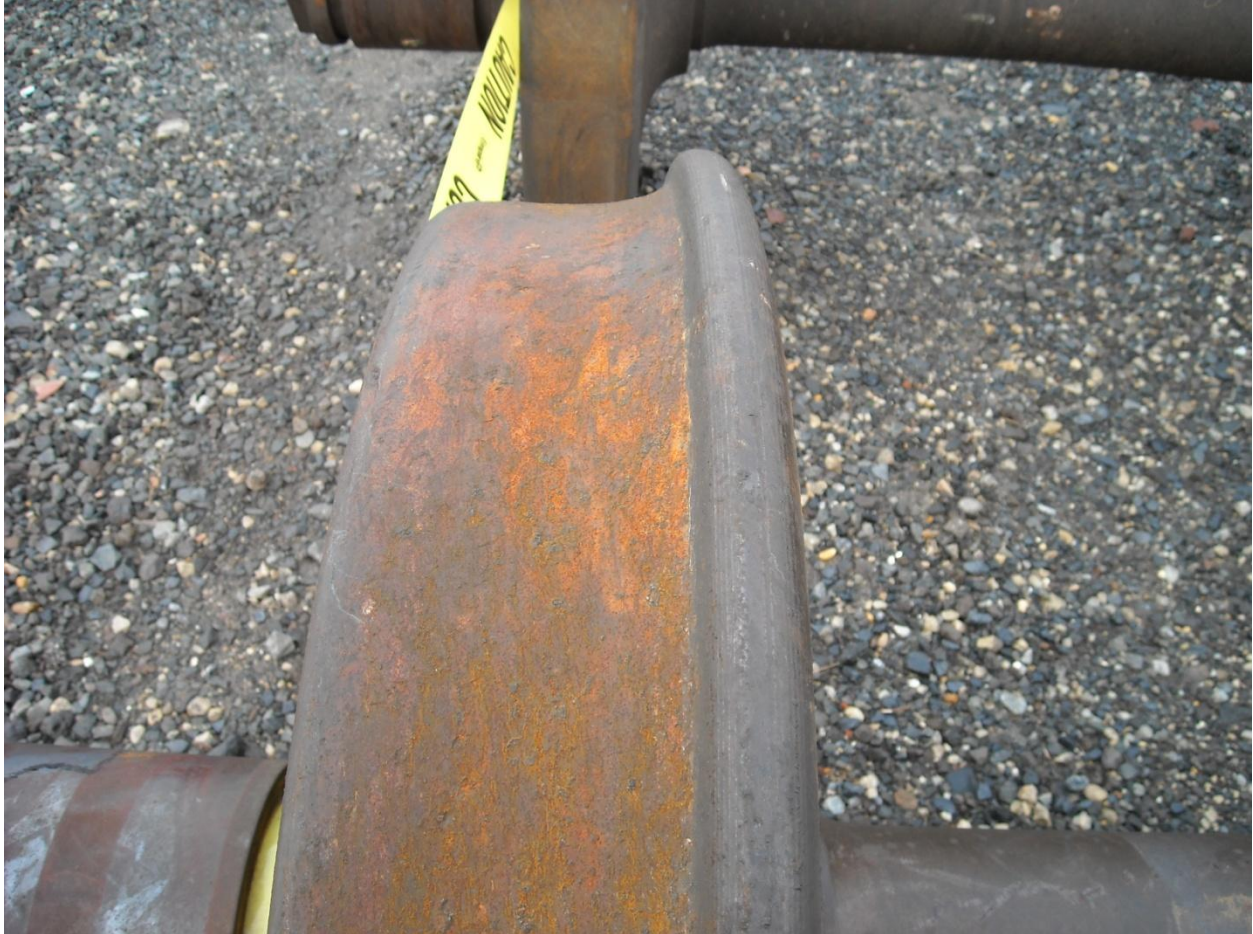
None of the wheels on any of the 12 sets had any type of flange profile defect. Each wheel set had 100-ton axles and 6 ½ by 12 roller bearings. Several roller bearings were broken but strike marks were evident at each broken location. One axle was bent with back-to-back readings of 50 inches and 57 7/8 inches.

Figure 8 Typical recovered wheel profile.

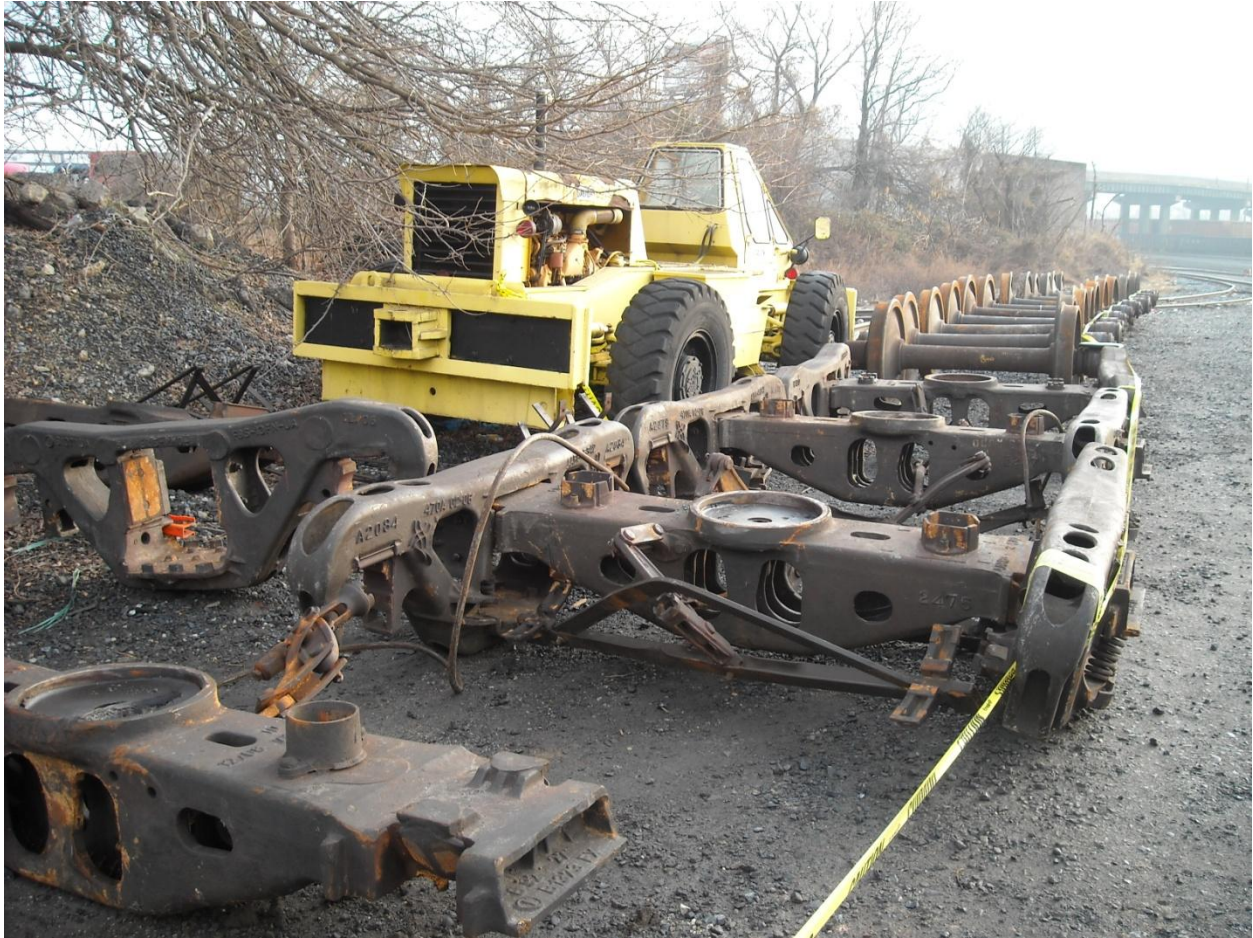
Figure 9 Recovered bolster, side frame, partial trucks and wheel sets.

The truck side frames were each properly sized and did not display any cracks or breaks. There was no excessive wear on any of the column wear guides. The spring seats did not display any evidence of spring rotation. There were no abrasion marks on the bottom of any side frame nor were there burn marks on any of the gussets. All friction wear plates were in place and did not have excessively worn contact surfaces or broken securements.

All the springs were within AAR free height requirements. None of the springs indicated heavy compression loading within the coils. There were no broken springs.

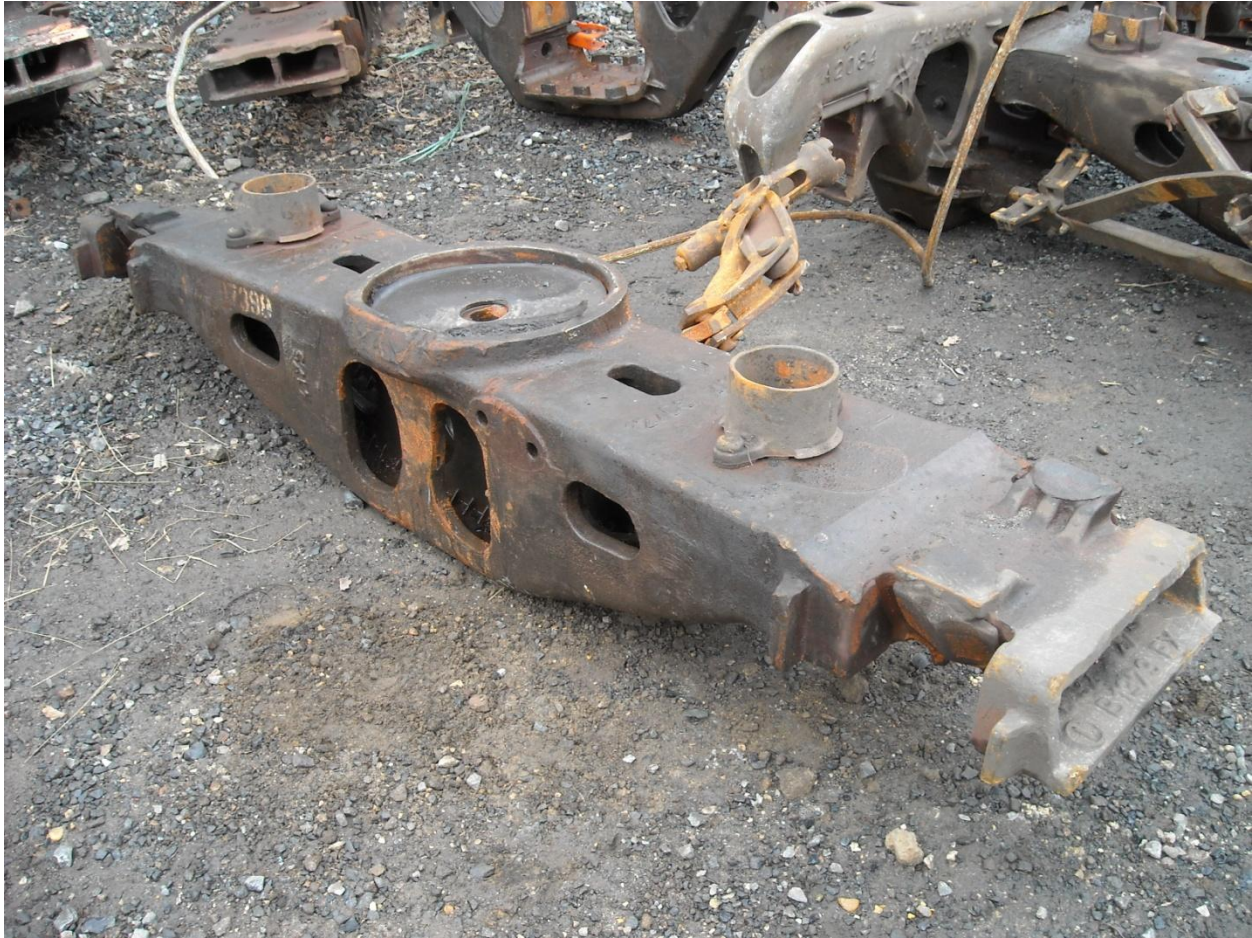
The bolster bowls were equipped with hardened steel wear liners. None of the bowls indicated abnormal wear patterns. Every gib, both inner and outer, was well within Association of American Railroads (AAR) tolerance. The bolsters were all standard rotation.

Figure 10 Typical recovered body bolster.
