NATIONAL TRANSPORTATION SAFETY BOARD - **Public Hearing**

Conrail Derailment in Paulsboro, NJ with Vinyl Chloride Release

## NTSB Hazardous Materials Group Chairman's Factual Report

Carrier: Consolidated Rail Corporation (Conrail)  
Train No.: FC4230  
Location: Paulsboro, New Jersey  
Date/Time: November 30, 2012, at 6:59 a.m. EST  
NTSB No.: DCA-13-MR-002

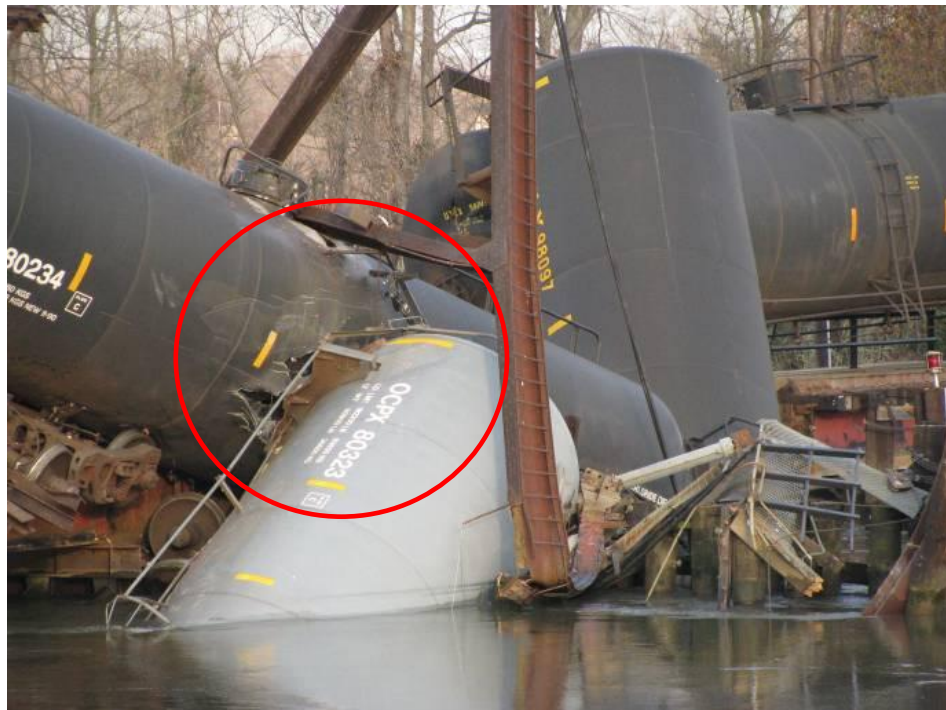
Tank car OCPX 80234 (position 10 in the train) containing vinyl chloride was breached during the accident, releasing approximately 20,000 gallons of product into the environment. A large vapor cloud was produced that blanketed the Mantua Creek basin and traveled into the Borough of Paulsboro, New Jersey. The breach in OCPX 80234 was in contact with the body bolster of tank car OCPX 80323, which was ahead of it in the train (position 9). While separating these two tank cars, the coupler and coupler shaft of OCPX 80323 were found inside the OCPX 80234 tank car. Examination of the derailed cars confirmed only one tank car was breached. None of the other tank cars released product during or after the accident.

*Figure 2 – Close-up photograph of tank car OCPX 80323 and the breach in tank car OCPX 80234 on November 30, 2012.*

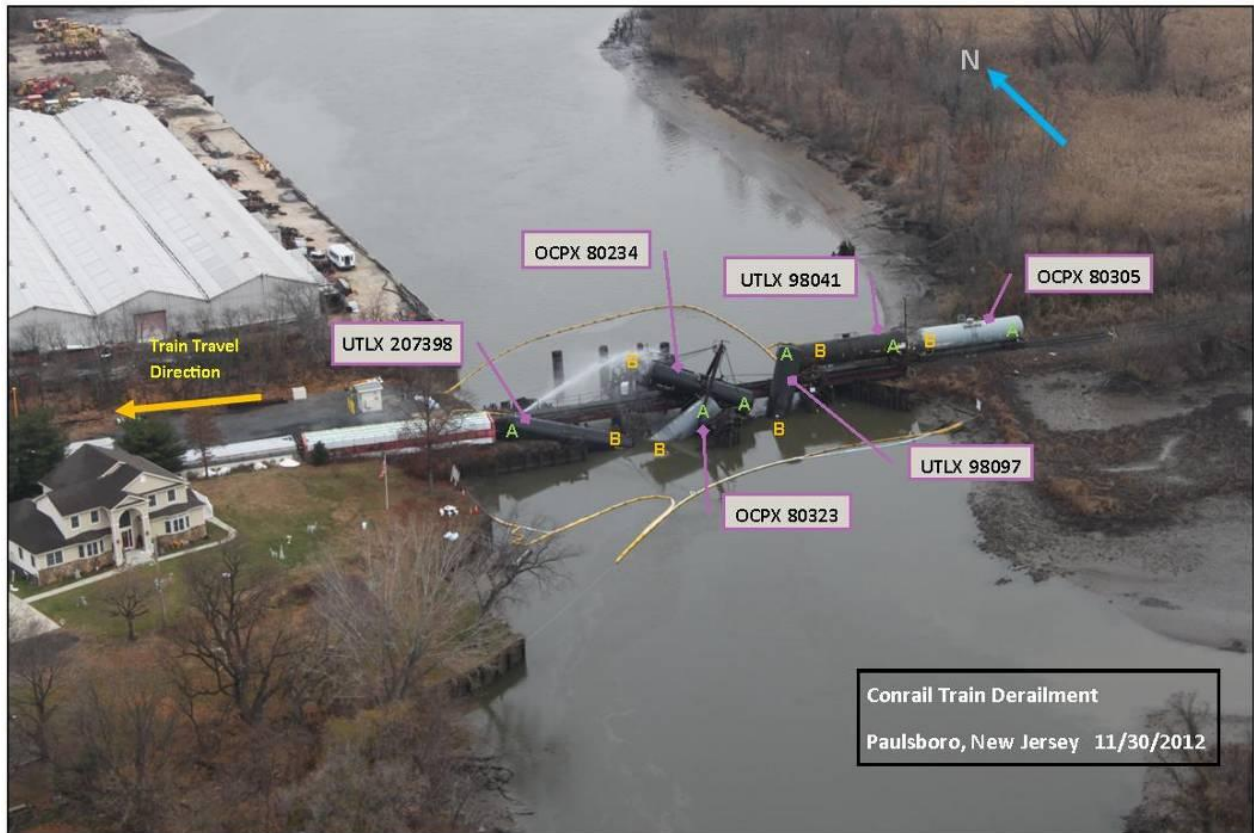
Tank cars OCPX 80323 and UTLX 98097, both containing vinyl chloride, fell into Mantua Creek. Tank car UTLX 98041 also containing vinyl chloride derailed, but remained on the bridge. It was coupled to and held in place by another vinyl chloride-containing tank car, OCPX 80305, which did not derail. Tank car UTLX 207398, containing denatured ethanol, fell onto its B-left side with approximately half of the tank car in the creek (during high tide). Figures 2, 3, and 4 show the positions and orientation of the tank cars after the derailment.

*Figure 3 - Aerial photograph (from the South) of the train derailment on the movable bridge in Paulsboro on December 1, 2012. (Photograph courtesy of the New Jersey State Police)*

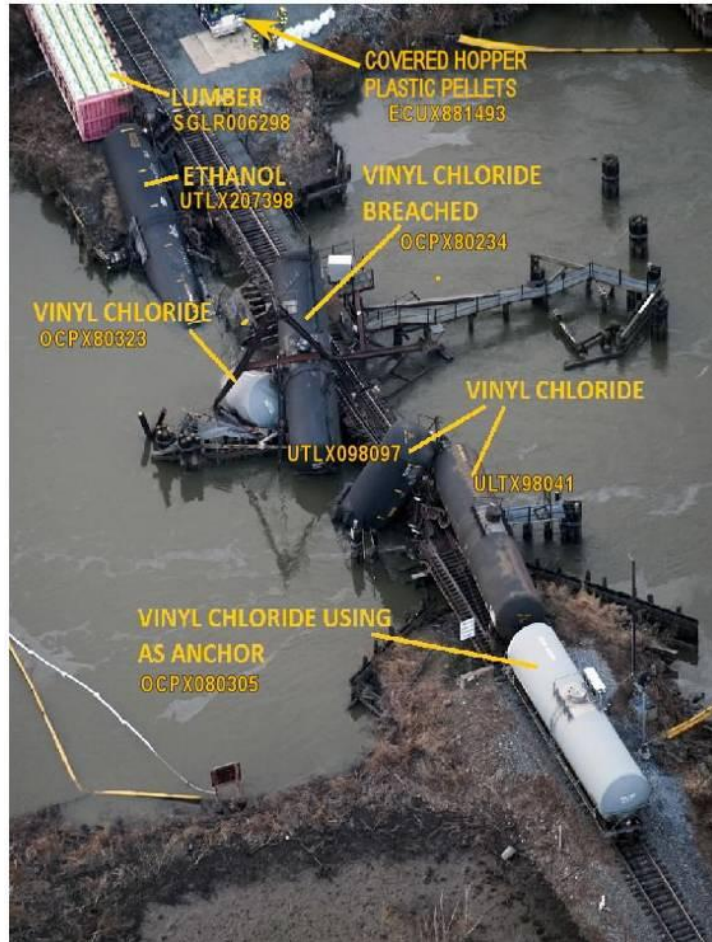
Figure 4 - Aerial image (from the East) of the train derailed on the Paulsboro movable bridge. (Photograph courtesy of the United States Coast Guard)

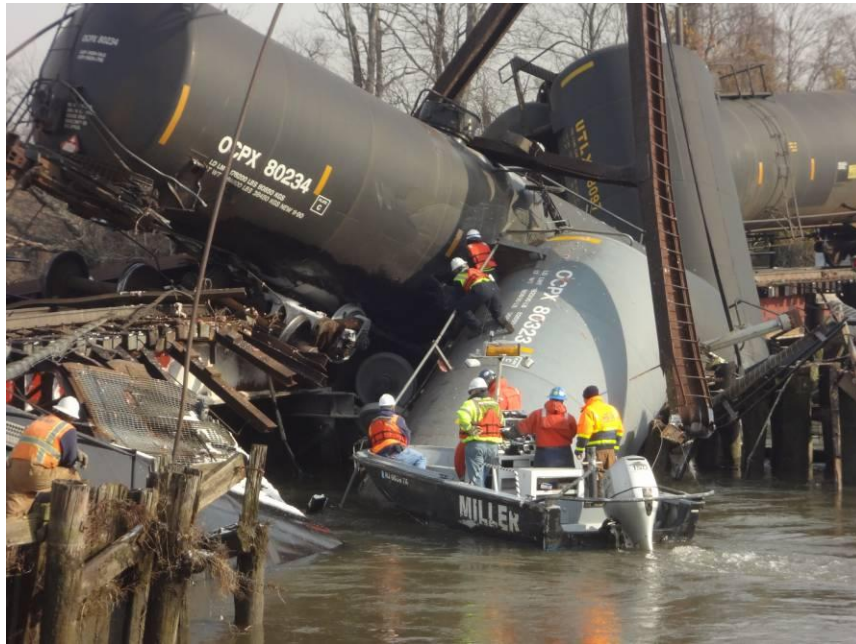
[CSX Hazardous Materials Representative]<sup>45</sup>...checked all the valves, opened up some of the dome lids, indicated there was no additional leakage, [and] assessed the one car that was breached. We noticed that there was snow [on] everything...so we know we definitely had a release. It was obvious. At that point, the [air monitoring] meter did go in[to] alarm. So we ... back[ed] off and ...re-approached in a different area. But we weren't getting alarms or anything on the meters, [we] completed the tank car assessment...

*Figure 12 - Image of emergency responders climbing on tank car OCPX 80323 to inspect the breach in tank car OCPX 80234 at 10:49 a.m. on the morning of the accident.<sup>46</sup> (Photograph courtesy of the wife of the Paulsboro Assistant Fire Chief)*

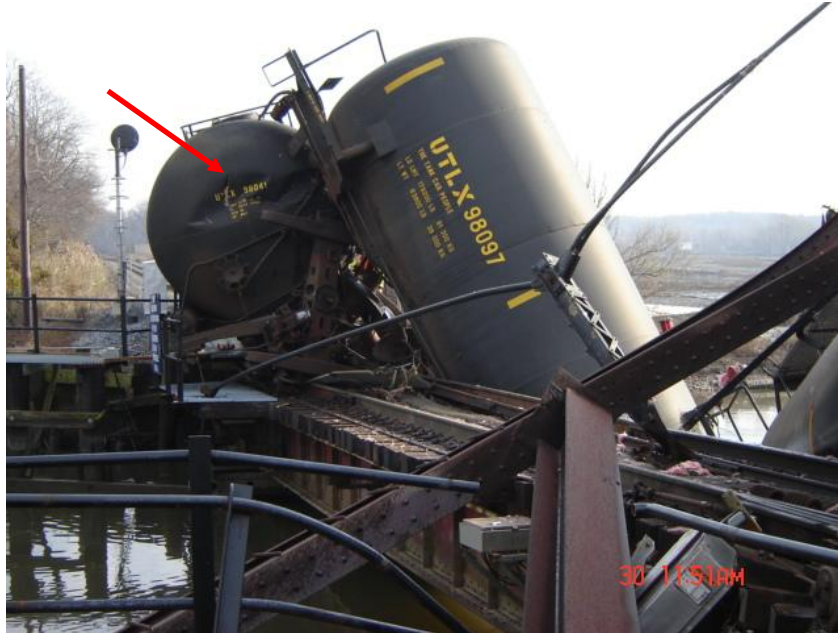
*Figure 16 - Image of head damage to UTLX 98041 on November 30, 2012.  
(Photograph courtesy of the FRA)*
