**G650 Flight Test Accident
Gulfstream Party Submission**

DCA11MA076

May 21st, 2012

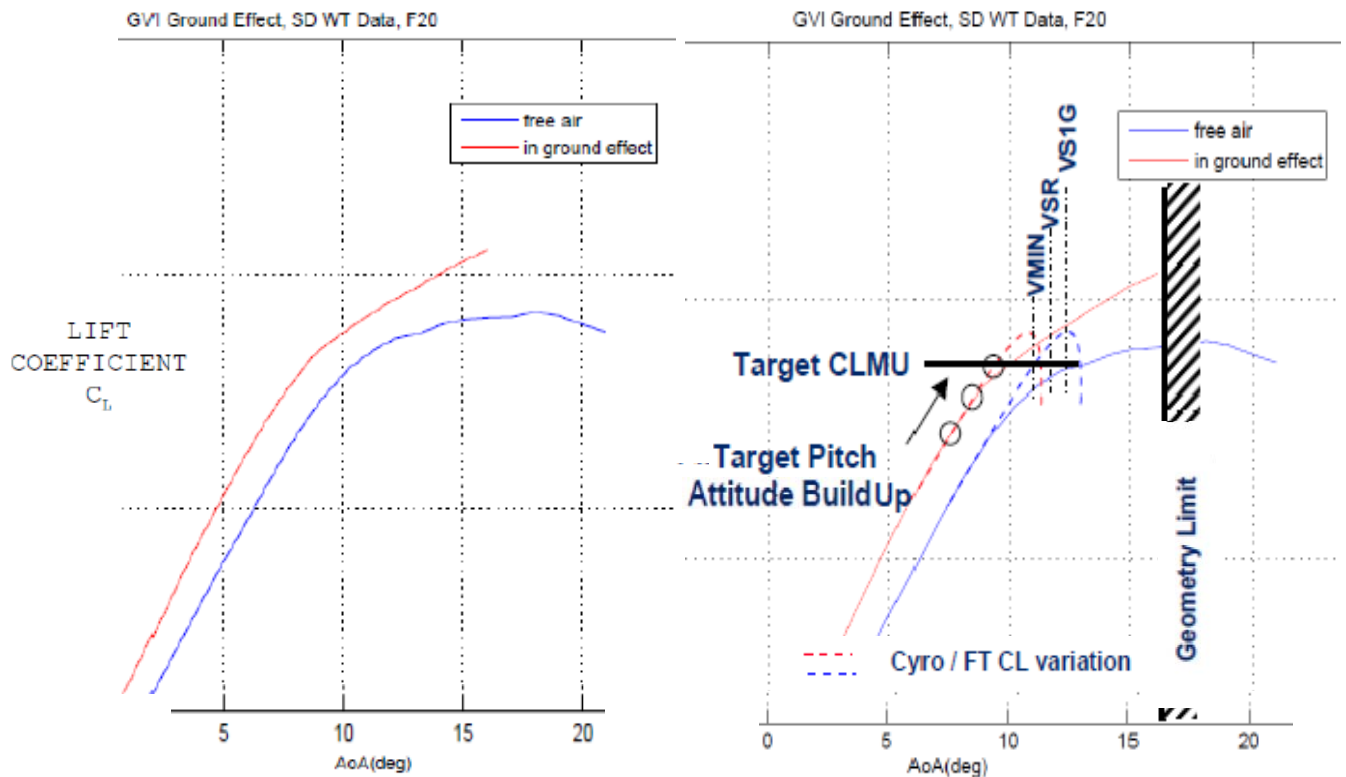
FIGURE 2 - BASIS FOR IGE STALL EFFECTS ASSUMPTIONS

These assumptions were apparently used to create the following slide (rightmost graph in Figure 2) prepared for the Flight Test Safety Review Board (FTSRB) in October 2010 in preparation for field performance testing. Low speed wind tunnel test data for the regime immediately prior to the onset of stall and prior to C_{LMAX} was also used to further refine the estimate for the IGE stall decrement for G650. This data was used appropriately as a baseline to illustrate the planned build-up procedure for V_{MU} testing. The original wind tunnel data (leftmost graph in Figure 2) and the FTSRB illustration of ground effects are presented side-by-side in Figure 2.

Gulfstream determined following the accident that both the assumption for the IGE stall angle decrement and the assumption that the C_{LMAX} at IGE stall was equal to the C_{LMAX} at free air stall were in error as applied to the G650 (see Section 7.1). A wider review using more refined methods should have occurred and might have indicated that the IGE stall angle decrement was being underestimated. However, Gulfstream has concluded that as of October 2010 when the C_{LMAX} assumption was made, the analytical tools being used by Gulfstream would likely not have alerted Gulfstream to the error in the C_{LMAX} assumption.

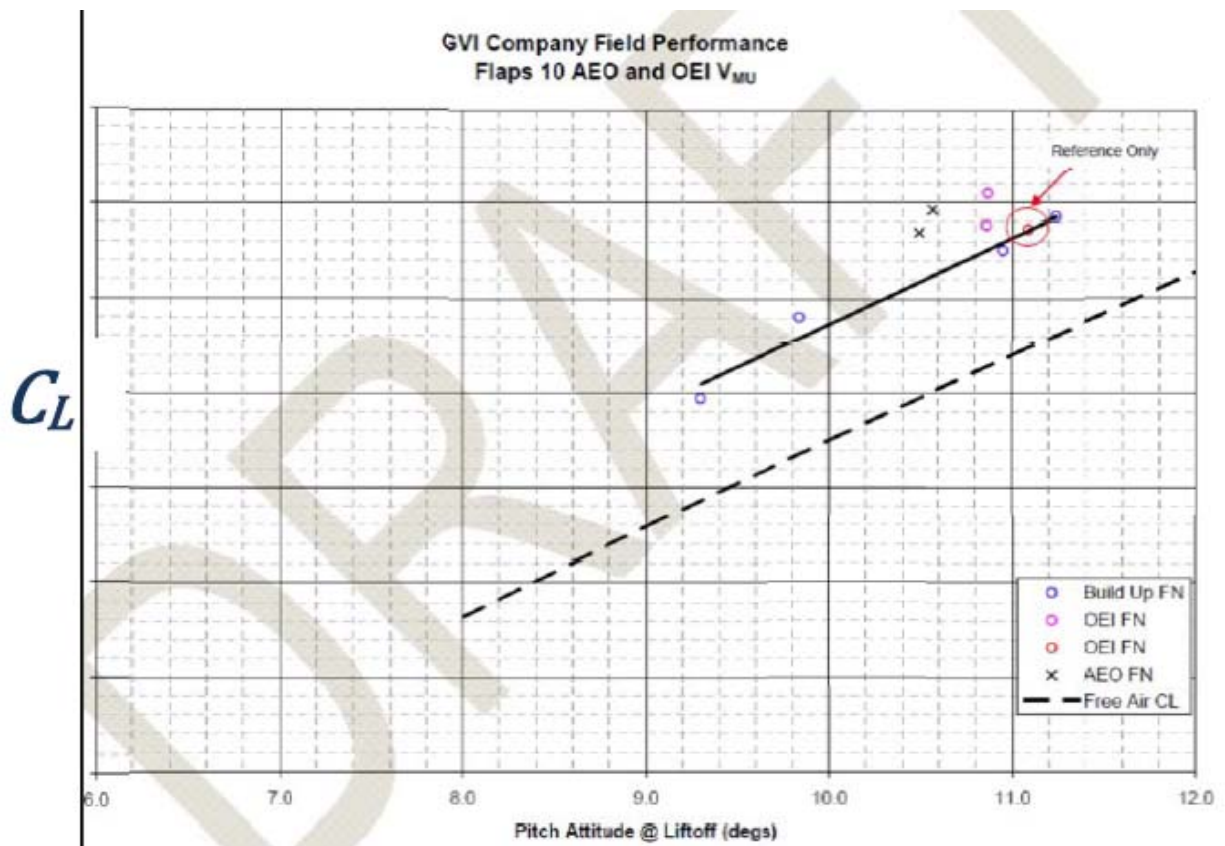
FIGURE 3 - FLAPS 10 PITCH VS. LIFT COEFFICIENT (FROM ROSWELL I V_{MU} DATA)

Several months after the completion of Roswell I testing, and just after resuming CTOs as part of Roswell II in late March 2011, the V_{MU} flight test data was reviewed and a preliminary flight test report prepared. The data analysis resulted in the following coefficient of lift (C_L) plot for Flaps 10 (where FN is thrust, in lbs):

This analysis assumed that the C_{LMAX} would be equal for both IGE and free air (which is consistent with the US Navy's textbook "Aerodynamics for Naval Aviators," previously set out in Section 3.1 and Figure 1). However, had Flight 088's roll-off been used as a data point representing stall in comparison to flight test derived free air stall, this assumption regarding C_{LMAX} would have been proven incorrect (see Section 7.1).

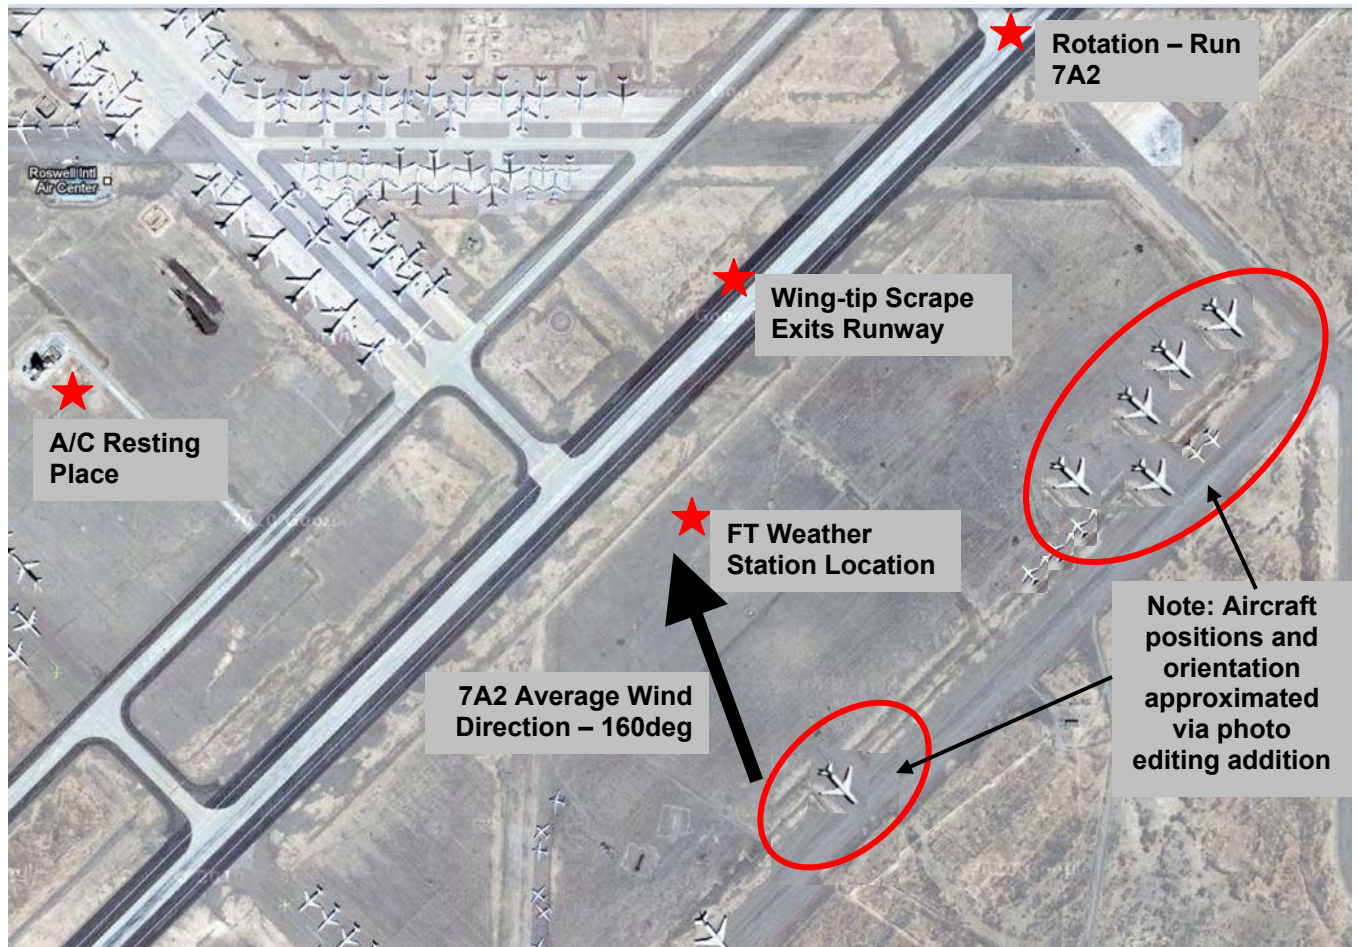
FIGURE 4 - WEATHER STATION LOCATION IN RELATION TO AIRPLANE DURING ACCIDENT RUN

Weather station data does indicate a gust between rotation and liftoff to approximately 8 knots, but it should be noted that the weather station was approximately 0.25 NM from the airplane at the time of rotation (see Figure 4).

Review of airspeed data for Runs 7A1 and 7A2 revealed that the airspeed value and trend for these runs was much more turbulent than for earlier runs on the day of the accident. This phenomenon was observed by the SIC after Run 7A1, and for this reason the crew agreed that Run 7A2 would be their last takeoff of the day. In general, the “noise” in the airspeed data increased as winds became more variable as the day progressed. Gulfstream also identified in its analysis after the accident the presence of several large aircraft to the left-hand side of the runway along the accident path, each of which would produce a wake that would eventually reach the region near the point of rotation for the aircraft. The position and orientation of these aircraft are approximated in Figure 4 (denoted by red ovals). Any wind effects transmitted by these parked aircraft may not have been recorded by the weather station.

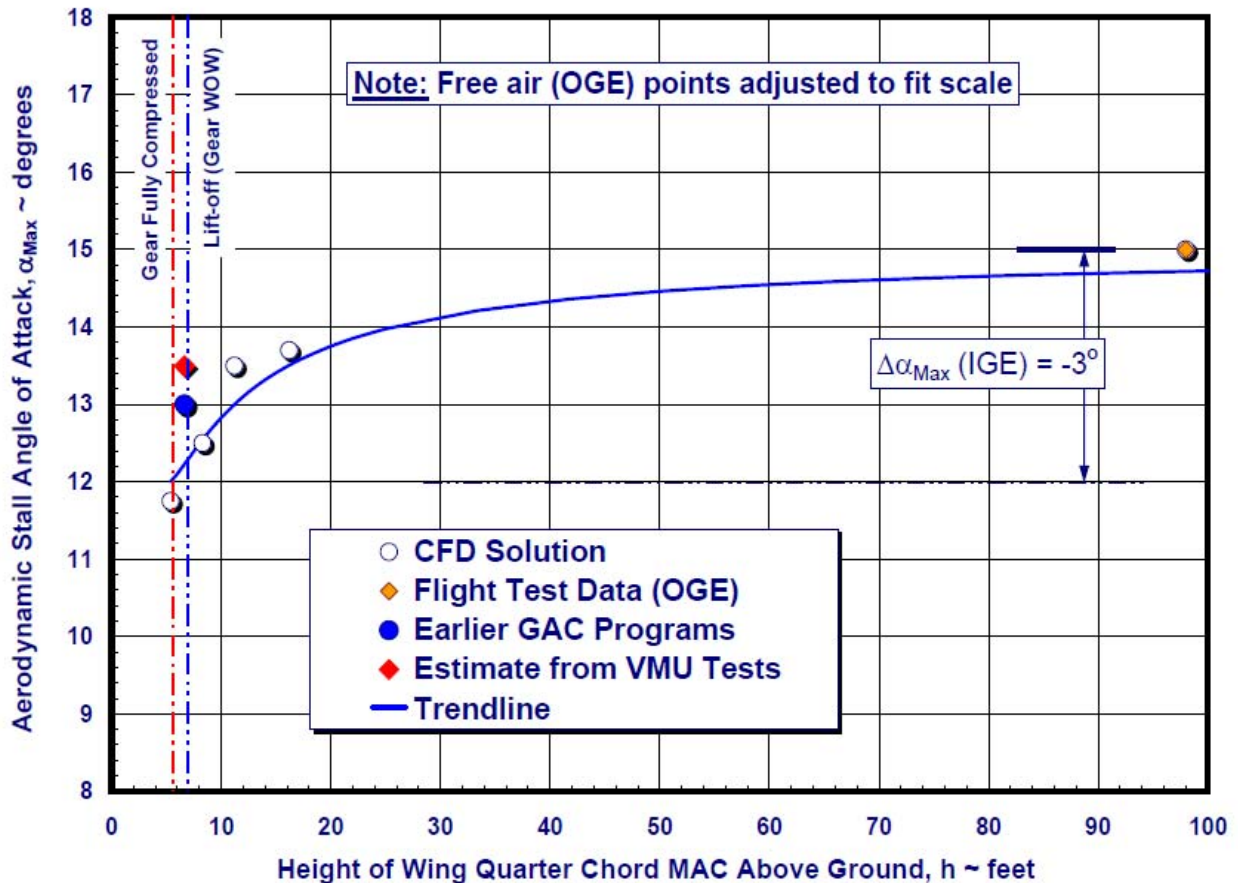
FIGURE 5 - GROUND EFFECT ON STALL AOA (FLAPS 10°)

Results of the CFD analysis with regards to IGE α_{STALL} are summarized in Figure 5. The analysis indicates that the Flaps 10 α_{STALL} is approximately 11.7° at ground height. Compared to free air α_{STALL} values, the analyses indicate a ground effect decrement of approximately 3° (versus a predicted ground effect decrement of 1.5° at the time of the accident). It was also noted that the ground effect decrement narrows quickly as the aircraft becomes airborne, with the aircraft α_{STALL} reaching pre-accident predicted values at approximately 16 ft (ground + 130"). A similar decrement was noted for Flaps 20.

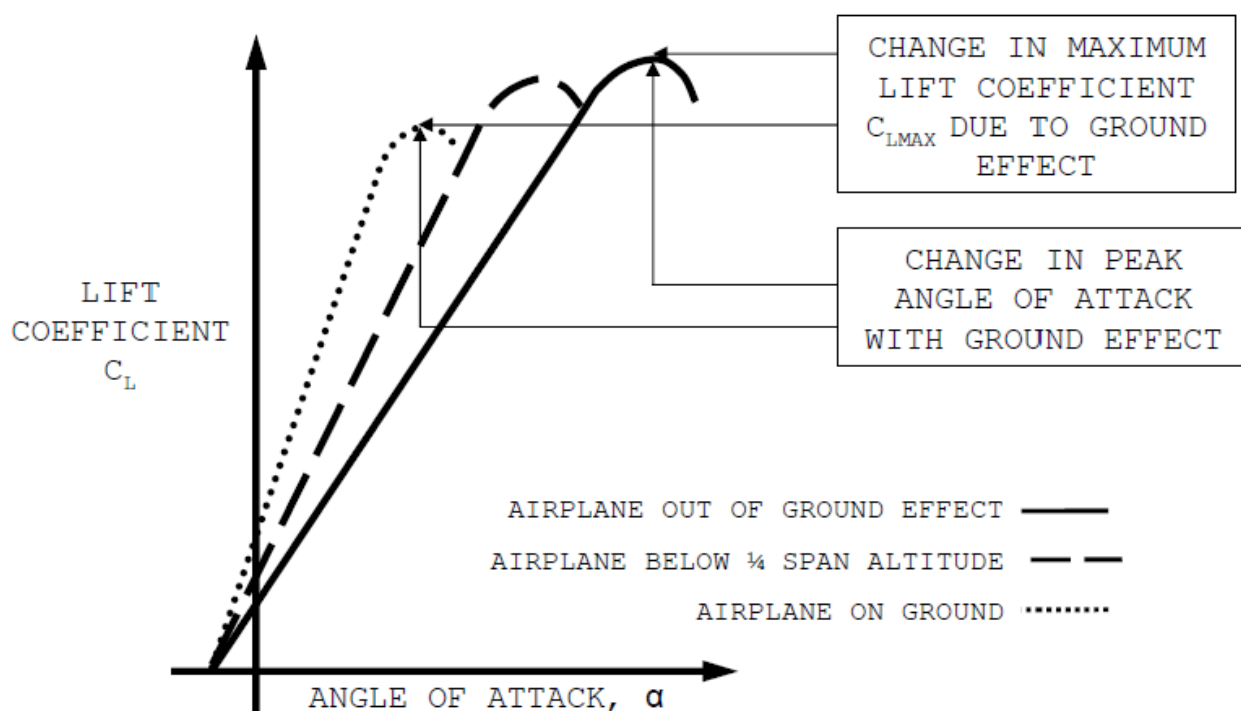
FIGURE 6 - GROUND EFFECTS ON C_{LMAX}

In addition to the overestimation of IGE stall angle, the CFD study also revealed that C_{LMAX} in ground effect was lower than the C_{LMAX} in free air (See Figure 6).

Figure 6 contradicts the widely-accepted industry literature illustrated by Figure 1. Reference 5, a paper focusing on the effect of leading edge contamination, also implies that the C_{LMAX} at ground effect stall is equal to the free air stall C_{LMAX} .
