Hageland Aviation Services, Inc.

Submission to the
National Transportation Safety Board
for the
Investigation of Hageland Aviation Flight 3153 Accident
near Togiak, Alaska, October 2, 2016

September 25, 2017

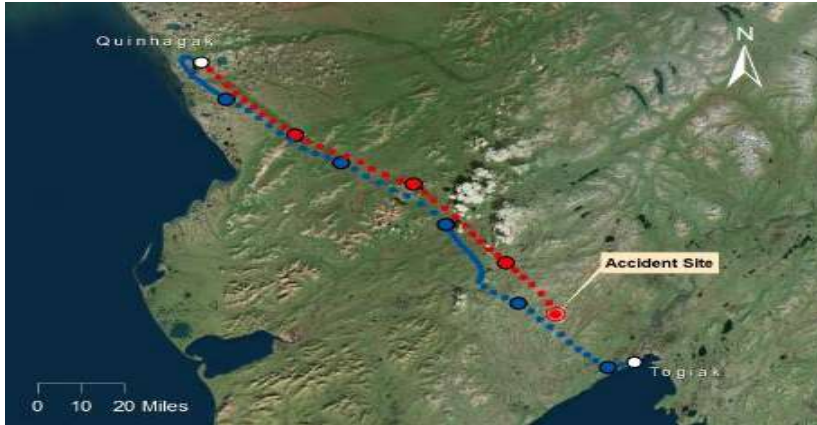
The below image depicts two separate routes flown on the day of the accident. IIC, p. 15. The data was derived from on-board flight tracking systems. Id. The track displayed in red is the accident flight. Id. This track is based only on the data points provided by Spidertracks because the aircraft's ADS-B was inoperative pending maintenance. IIC, p. 16; Ops, p. 11. The Spidertracks data points were each six minutes apart, with the last data point four minutes before the accident. Id. The exact path of the aircraft between these data points is unknown; the red line represents the flight path if the aircraft had flown on a direct line between the Spidertracks data points.

The track displayed in blue is from another airplane about five minutes behind the accident flight. IIC, p. 15. Unlike the track of the accident aircraft, this track is known with precision because the second aircraft had an operative ADS-B. As the below image shows, the second airplane was slightly west of the estimated track of the accident flight, and deviated around the mountain where the accident occurred. Id.

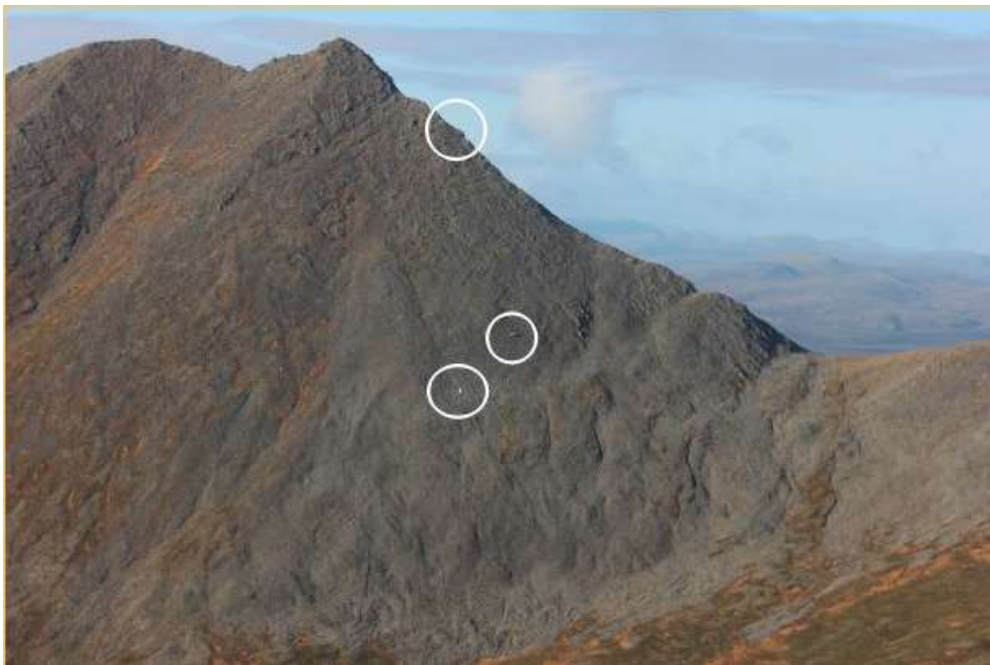
The picture below was taken the day after the accident. IIC, p. 16. It shows the accident location, as viewed from a helicopter that was positioned southeast of the accident site. Id. The white circle shows the location of the initial impact on the opposite side of the ridge, about 200 feet below the estimated 2,500 foot peak. Id. Investigation of the wreckage indicated the airplane was in a steep climb at the time of impact. Id. The point of impact was so close to the top of the ridge that the aircraft wreckage came to rest on the other side of the ridge, in the areas inside the two lower circles shown below. Id.
