"SS Norway"

Main Propulsion Boiler Number 24

Inspection Report

MI 7647

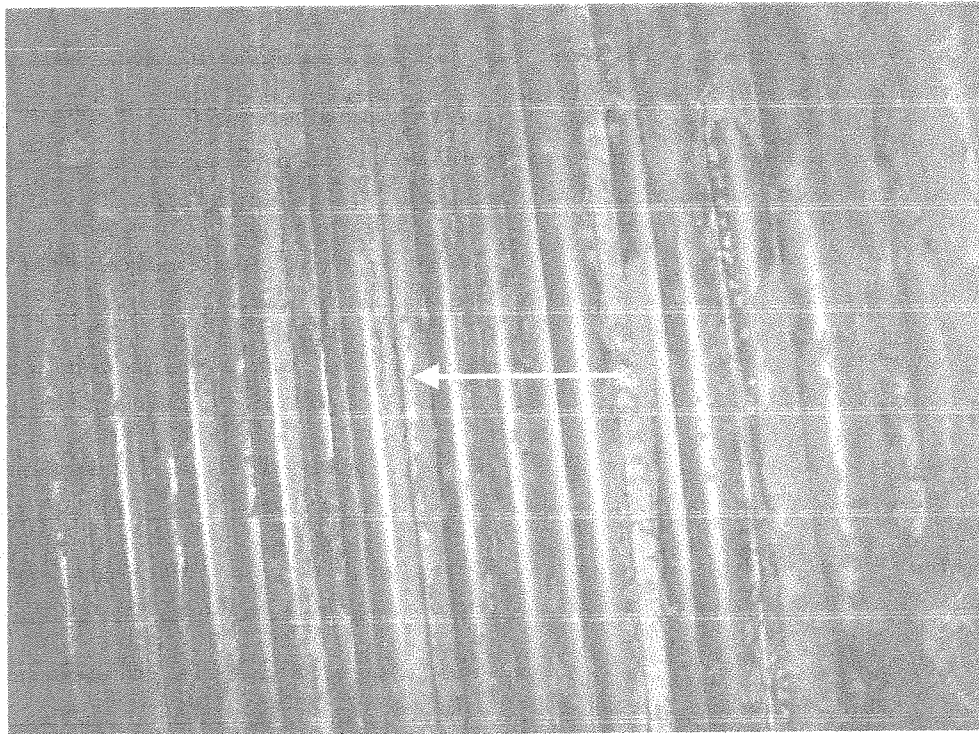
Fig 1.

The furnace of boiler #24 was found to be in a very poor condition. All tubes forming the furnace envelope were heavily coated in combustion products and unburned fuel. The tubes of the screen wall have experienced significant overheating and distortion as have the tubes of the generating bank behind. (see fig 1).

The most notable effect of the distortion is the closing of the gas spaces between the tubes of the screen wall and generating bank (see fig 1 above). The reduction in the gas spaces has allowed a built of slag to form in some areas thus further reducing the passage of the gas flow from the furnace.

The condition of the tubes forming the furnace envelope clearly indicate that they have been ~~exposed to excessive temperatures~~. The colour of the tubes where not coated in unburned fuel or combustion products indicates this. Distortion of the tubes can also be seen and this is more notable in the screen wall and generating bank. The distortion in the latter areas has had the effect of closing the gas spaces between each tube, the spaces of which are of utmost importance in providing an even flow path for combustion gasses to leave the furnace. ~~The causes for the distortion~~ found can be considered as a combination of the following:

1. Renewal of the tubes of the screen wall and generating bank.
2. To consider the renewal of the tubes forming the furnace roof, side wall and rear wall.
3. Renewal of all refractory in way of the furnace, burners, generating area, steam drum baffles.
4. Renewal of casings in way of the refractory repairs.
5. Renewal of both tube bundles of the desuperheater.
6. Renewal of the bare tube economiser. (NCL already aware of this item).
7. Sliding feet to be confirmed free and lubricated accordingly.
8. Carry out burner study.

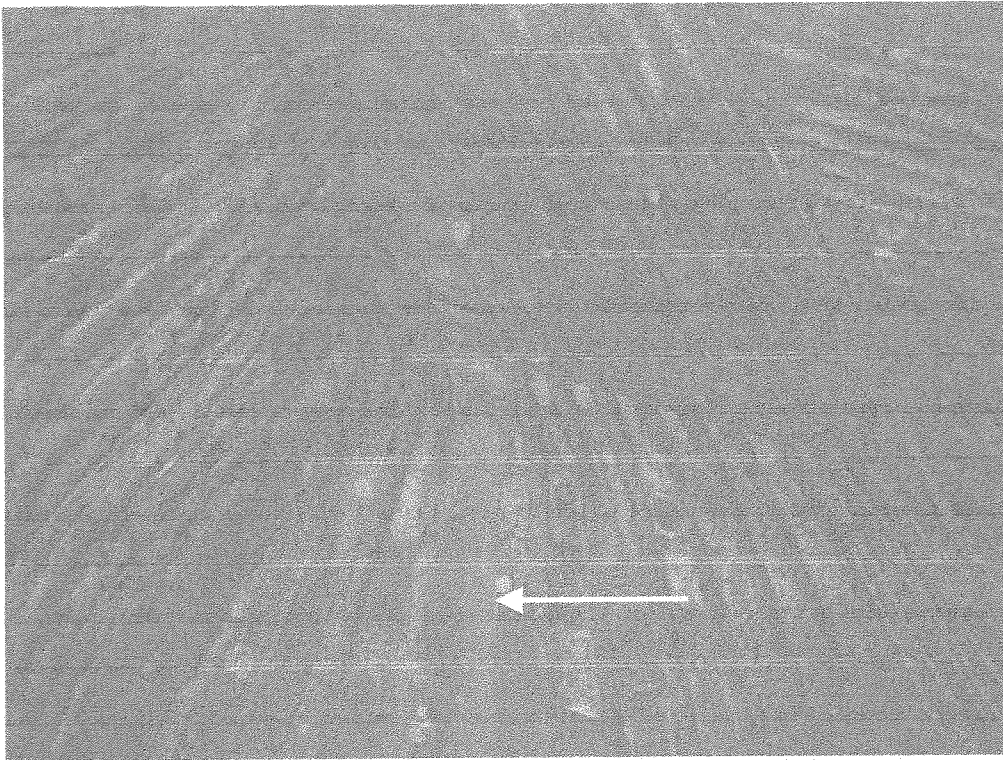
Fig 2.

One rear wall tube (see fig 2) has been plugged with the remaining tube having burned away.

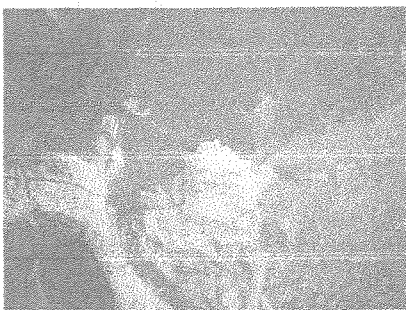
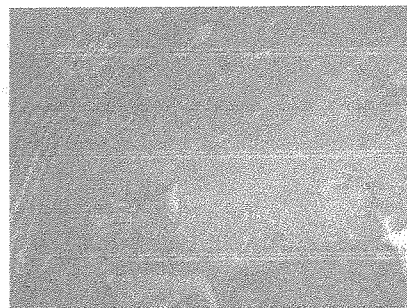
The refractory of the furnace is in an extremely poor condition. Severe slagging of the front burner wall, furnace floor and rear wall has occurred . Refractory around the burner quarls, approx. 50 – 80 mm thick, has spalled away in areas with the remaining refractory becoming insecure. (Figs 3 & 4).

In considering item 2 above first, it can be seen on entering the furnace that the combustion process is experiencing problems. Slagging of the furnace refractory has occurred with a significant amount, approx. 80mm thick, breaking away. Slagging is a process where incomplete combustion of fuel allows remaining deposits to soak into the surface of the refractory. The porosity of the refractory determines the rate at which these impurities are absorbed and the depth they penetrate. On shutting down and cooling of the boiler these impurities solidify to give a glass like surface. When the boiler is fired again this area expands at a faster rate than the refractory itself with the result that the contaminated area breaks away. This can be seen to have occurred in numerous areas of the furnace however the break down of refractory forming the burner throats directly affects the combustion process.

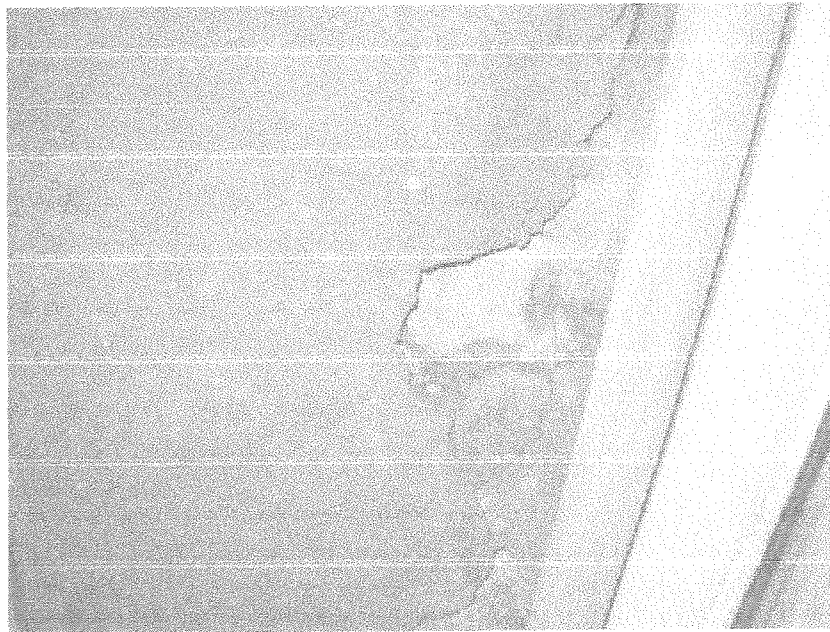
Fig 5.

The refractory of the front and rear walls in way of the ends of the screen and generating banks has fallen away in numerous areas thus exposing the steel casing of the windbox (Fig 5). The casing where this has occurred can be seen to have significant distortion.

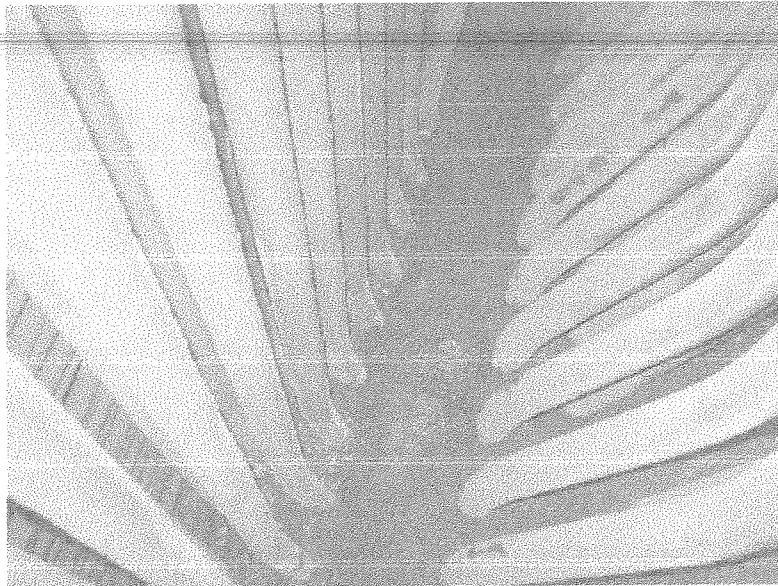
Fig 13.

The washing process had left a deposit of wet combustion products in the bottom of the arcade around the tubes. (fig 13).

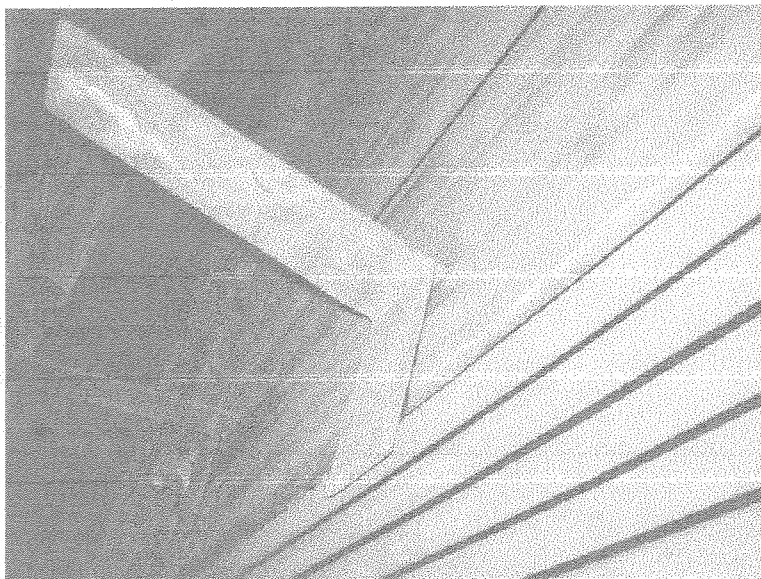
Fig 14.

Inspection of this area found all tubes, supports and refractory to be in good order. All drains were clear and opened up for the washing process. All stainless steel spacer brackets were found to be in good order and in place. (Fig 14).

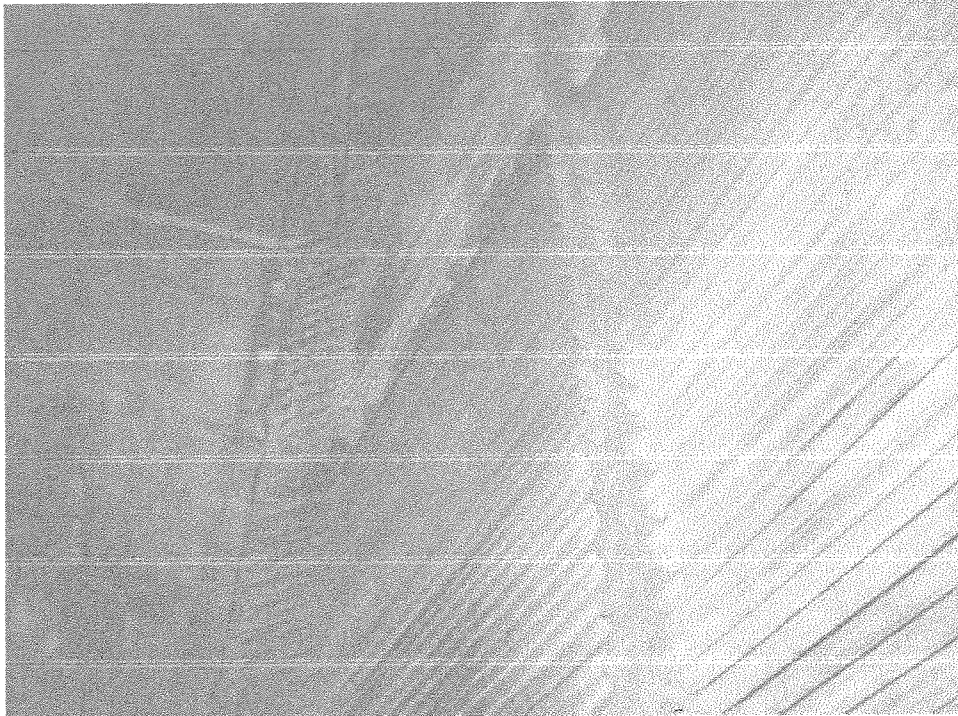
Fig 15.

The primary superheater was found to be in good order externally with all support brackets securely in place. (Fig 15).

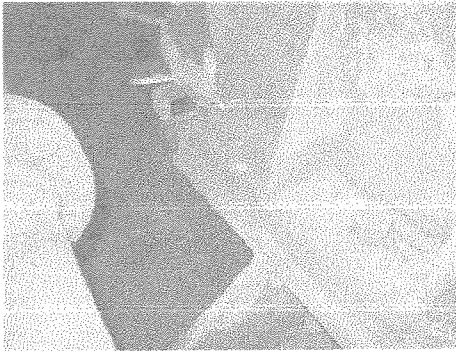
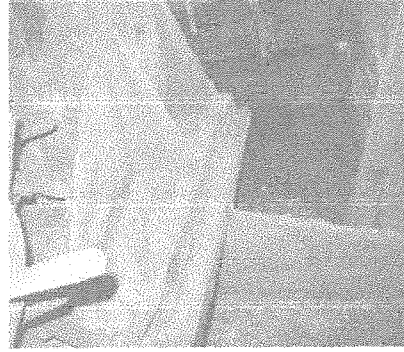
Inspection of the sliding feet showed no indication of movement. Lubrication pipework was in place however the feet appeared dry. (Figs 16 & 17).

The sliding feet, as reported showed no signs of lubrication. These are extremely important parts of the boiler construction and the ability to move during expansion should not be inhibited.

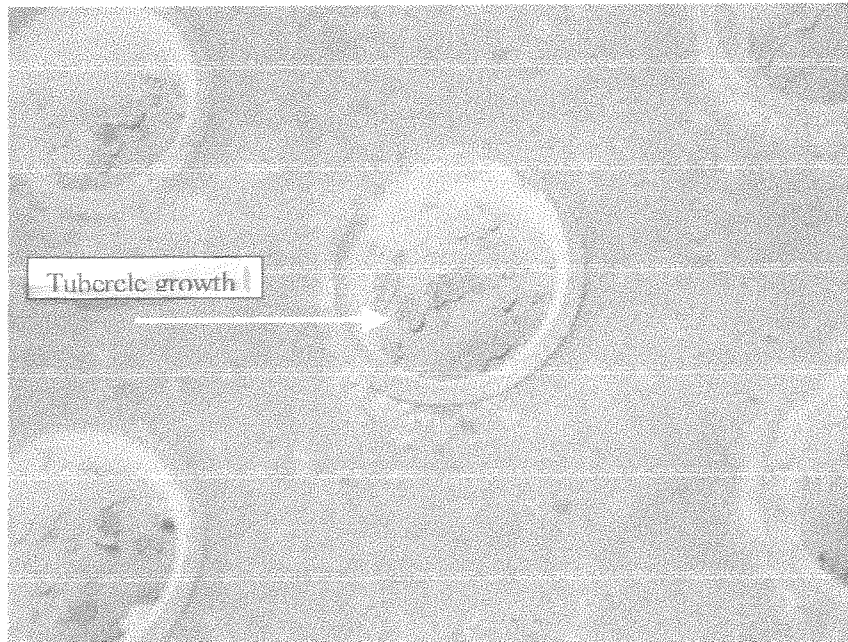
Fig 18.

Inspection of the steam drum revealed a significant amount of tubercle growth in all tubes. (Fig 18). Mechanical removal of sample tubercles, where accessible, showed the dark oxide from active corrosion. Clearing this oxide away revealed an underlying pit. Substantial numbers of these were noted during the fibre optic inspection of sample tubes in different areas of the boiler.

The fibre optic inspection also revealed a significant amount of tubercle growth in the tubes of the screen wall and generating bank. This tubercle growth was found in other areas however to a lesser degree. Tubercle growth is a hard covering that covers a site of corrosion. Removal of these where accessible revealed the dark oxide of active corrosion that when cleared revealed pitting. ~~The amount of tubercle growth and pitting found indicates that oxygen corrosion is active in this boiler.~~ ||

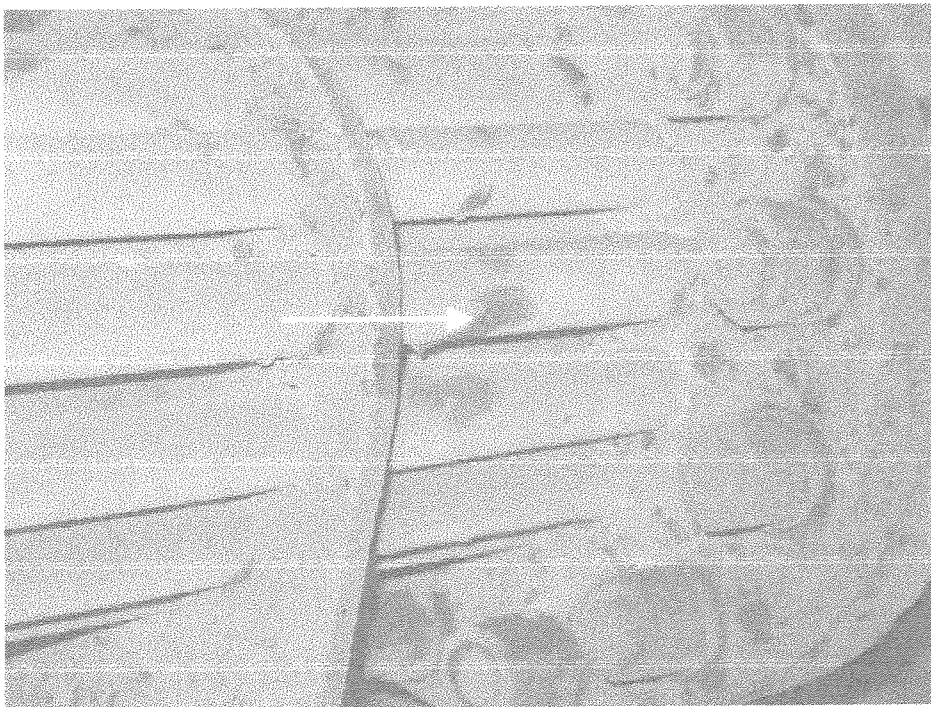
Fig 19.

The control desuperheater located in the steam drum was found to have areas of significant corrosion. The aft end of the inboard tube bundle was found to have an area of deep pitting adjacent to the support plate (highlighted fig 19). One individual pit is approx. 2-3mm in depth.

The condition of the steam drum located desuperheater gives great cause for concern. As highlighted in the report, areas of corrosion were noted particularly at the aft end of the inboard bundle. Severe pitting was noted along with grooves caused by fretting of the tube during expansion / contraction through the tube support baffle. Any failure of the desuperheater bundle will allow slugs of water to be carried back to the superheater. The effect of this would be quenching of the superheater header at the point of return and thermal shock. Evaporation of water droplets will also leave deposits normally washed away during the nucleate boiling process in the generating area of the boiler. Build up of these deposits will occur if any leakage goes unchecked and the problems that can develop are reduction in heat transfer, irregular heat transfer and corrosion.

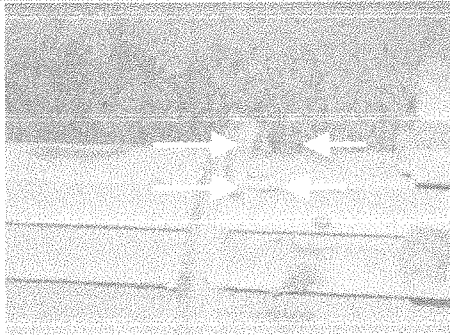
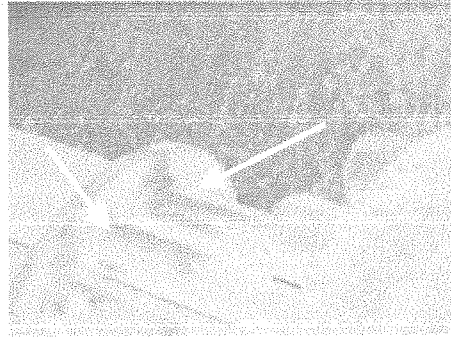
Also noted in way of the support plate was an area where fretting between tube and support sheet had worn away a portion of the tube (fig 20 & 21).
