NTSB File No.: ANC14LA068

Aircraft: Ryan Navion A

Registration No.: N4827K

PROPELLER TEARDOWN REPORT

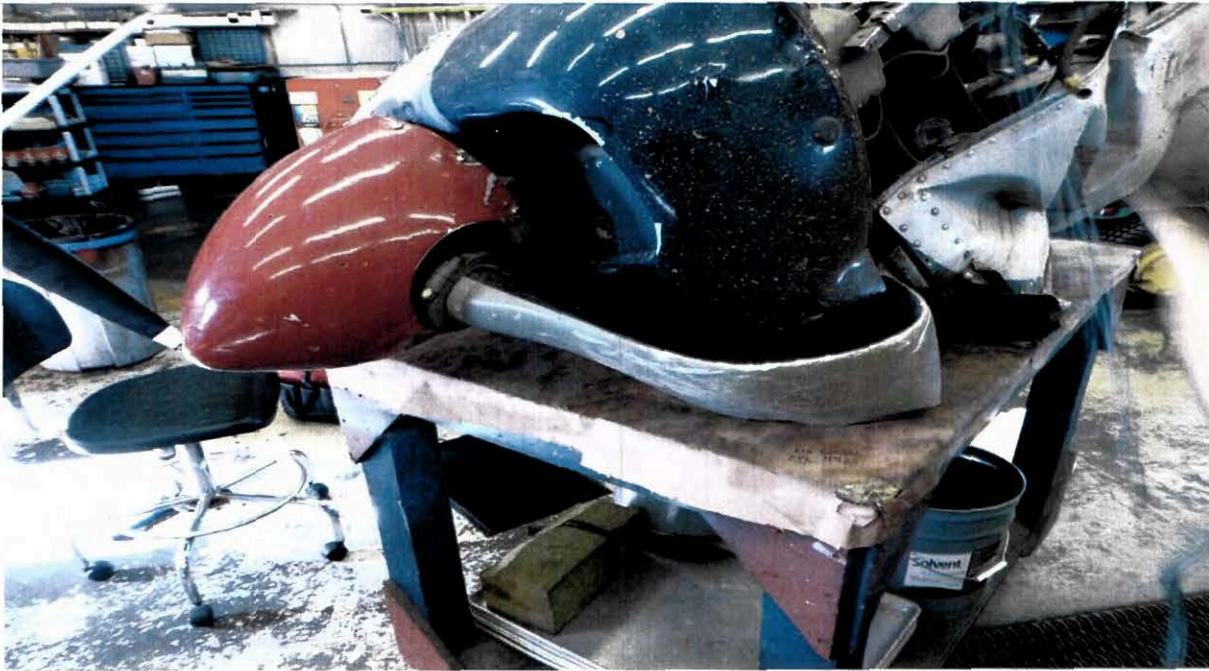
The propeller was still attached to the engine. One blade was missing. The other blade was bent aft about midblade and wedged into the engine cowl. The last 6” of the tip was missing. The blade had signs of rotational scoring, gouges, and scrapes. There were large amounts of grease in the hub butt of the missing blade and the grease was not thrown out in a centrifugal pattern. A broken clamp bolt head was lying on top of the clamp of the missing blade side.

Photo #1, propeller as received.

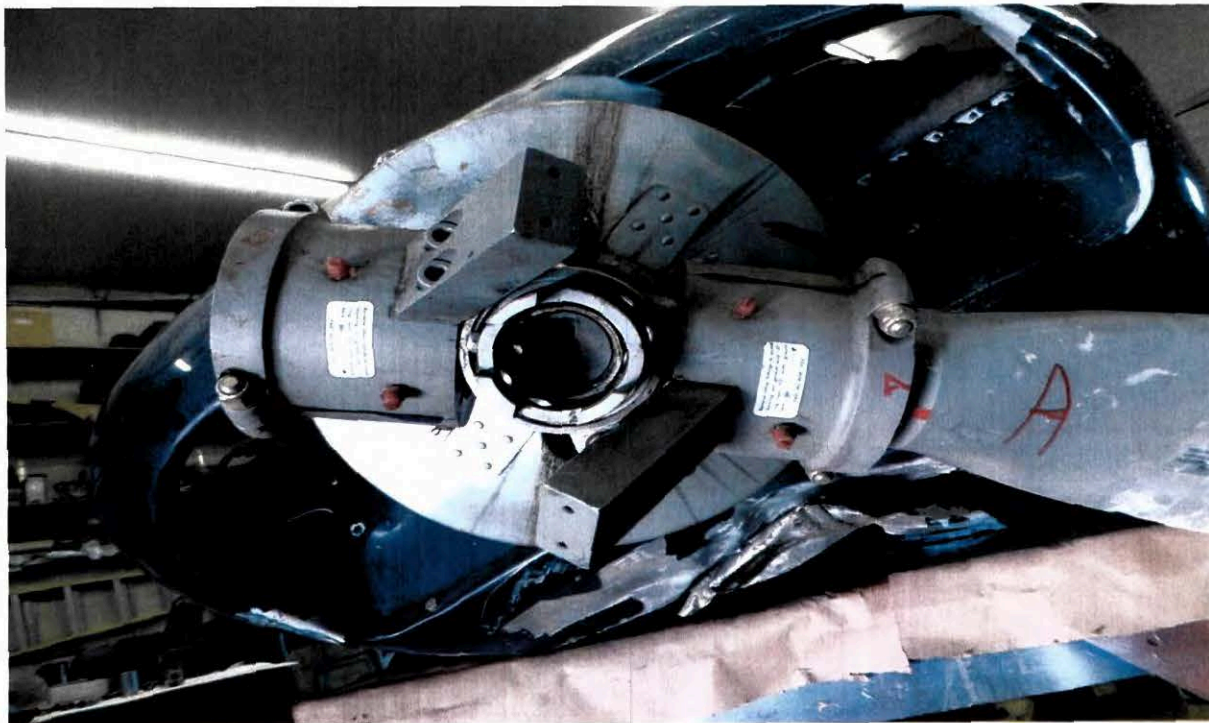
Photo #2, propeller as received.

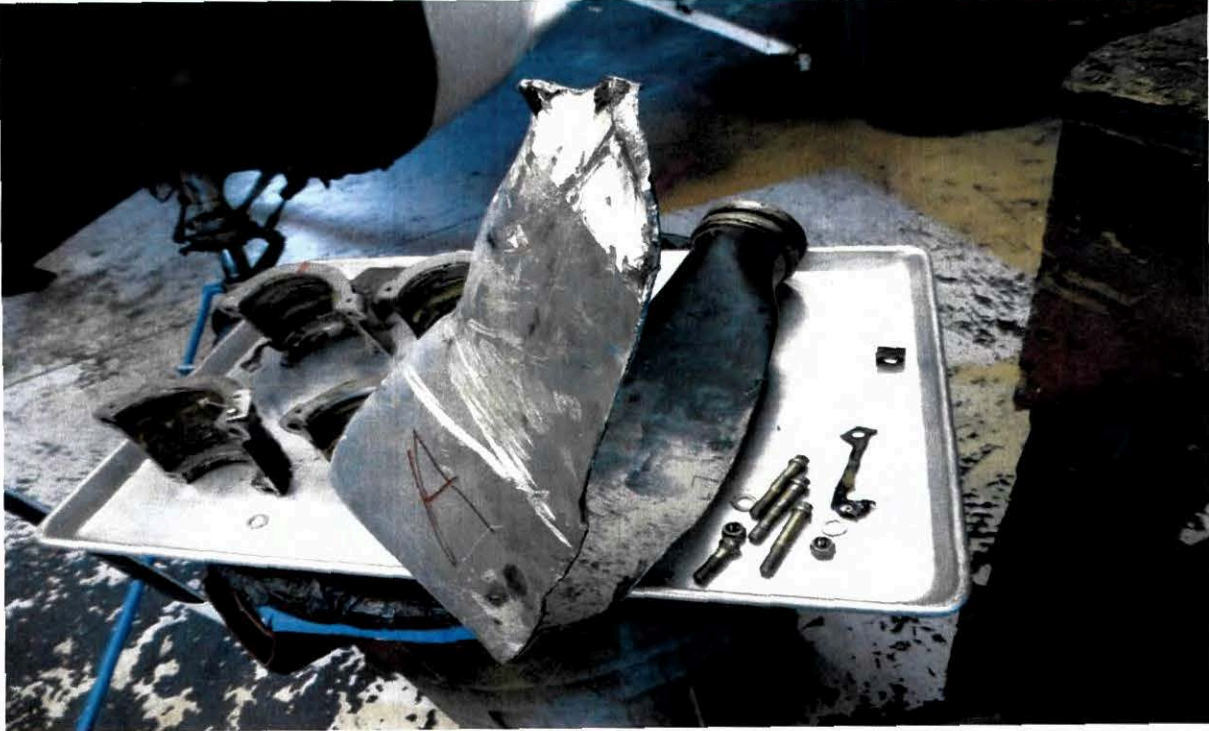
paint, camber side - gouges, scrapes, rotational scoring.
paint, flat side - scratched.
bend - bent aft 90° midblade.
twist - forward at midblade towards tip.
lead edge damage - gouges, scrapes, dents, tip missing.
trail edge damage - gouges, scrapes, dents, tip missing.
butt impression - none.

Photo #3, "A" propeller blade.

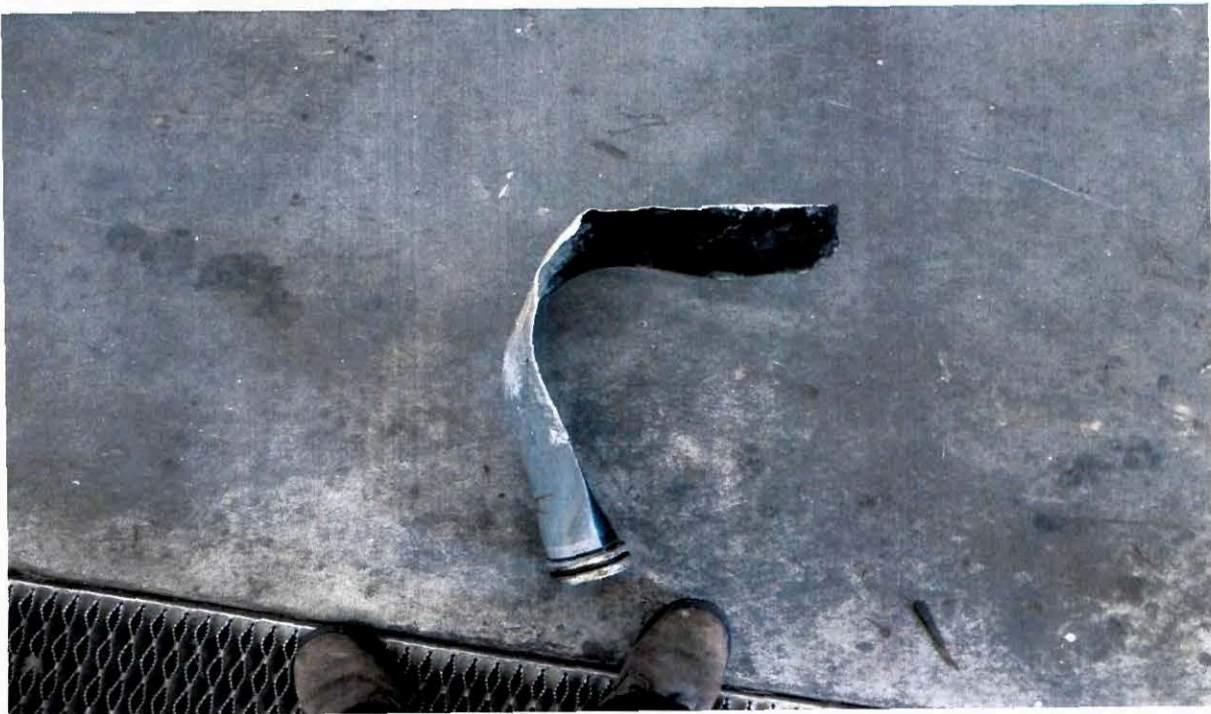
Photo #4, "A" propeller blade.

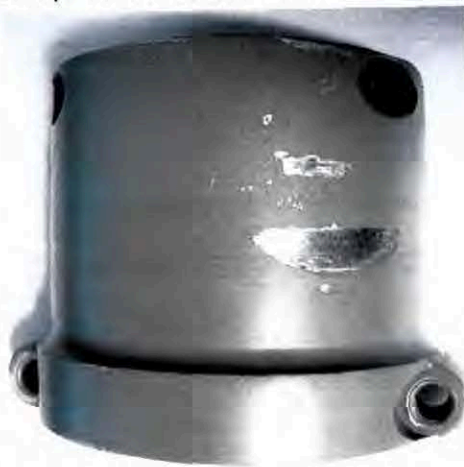
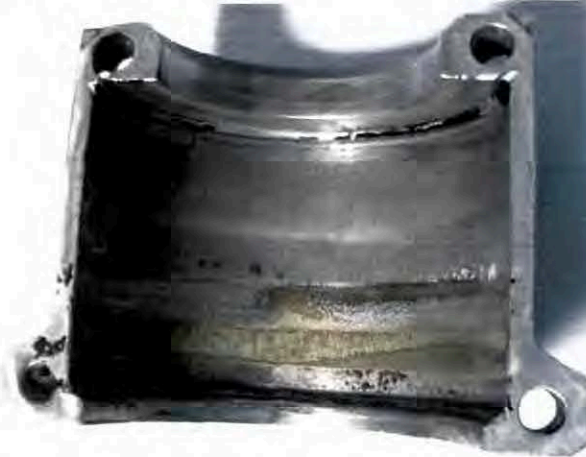
Sample ID: Clamp S/N 3126A; P/N D-6831-1A; Hub Arm B

The "A" clamp was intact; however one of the bolts was loose. The "B" clamp had two broken bolts and the flange of the clamp half was fractured during impact.

Test Summary: The crack in this Clamp half section resulted from tensile overload of a ductile material. There was no evidence of fatigue cracking.

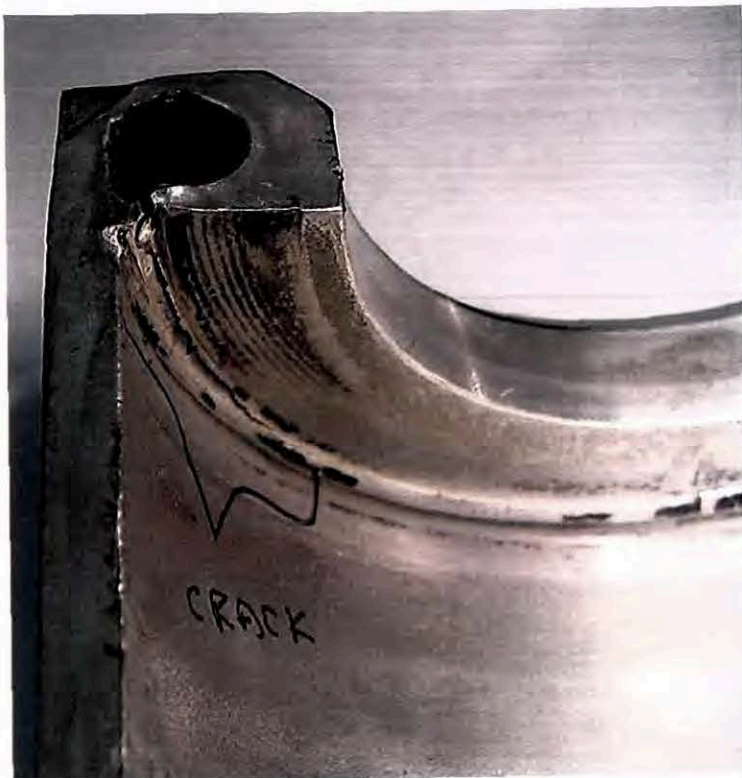
The crack extends from the bolt hole region and is accompanied by a considerable amount of plastic deformation.

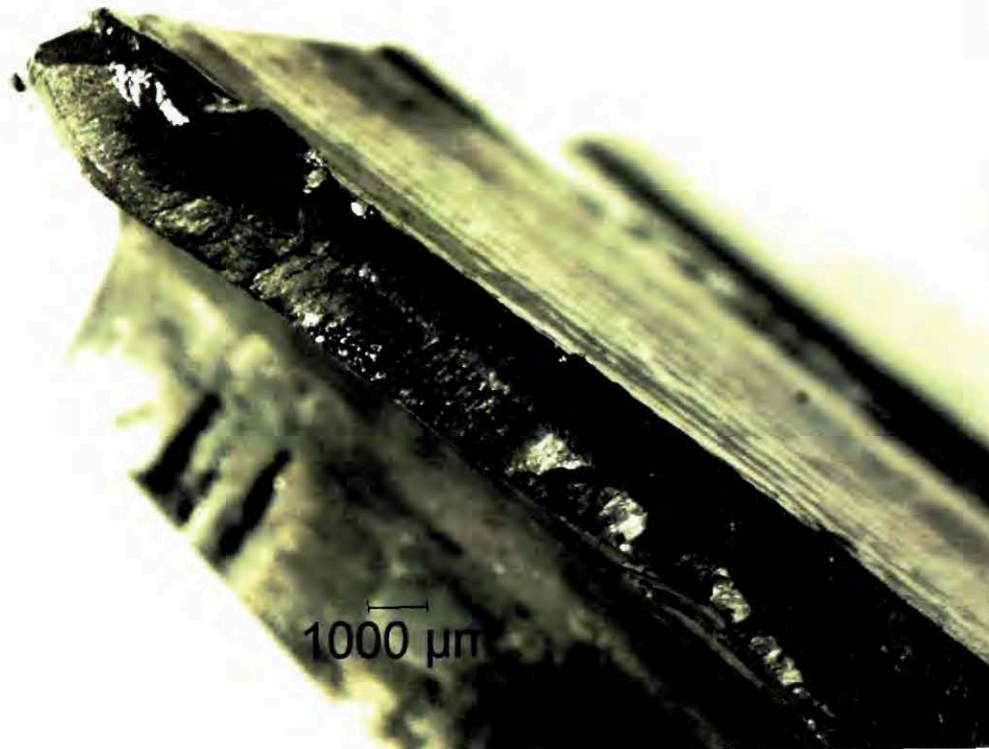
The fracture surface shows some obvious tearing as well as some smooth features and multiple origins stemming from the bolt hole surface. These features were examined using Scanning Electron Microscopy.

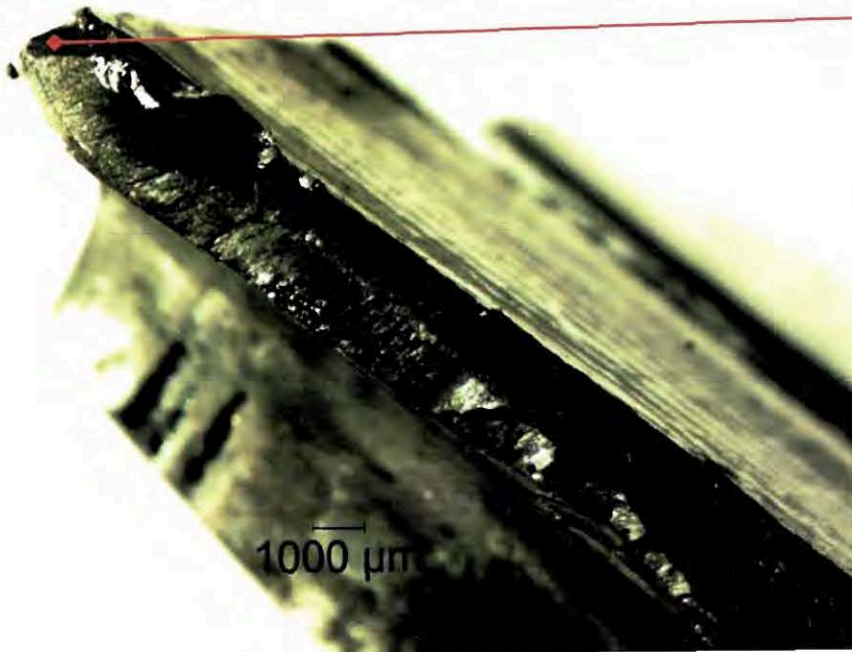
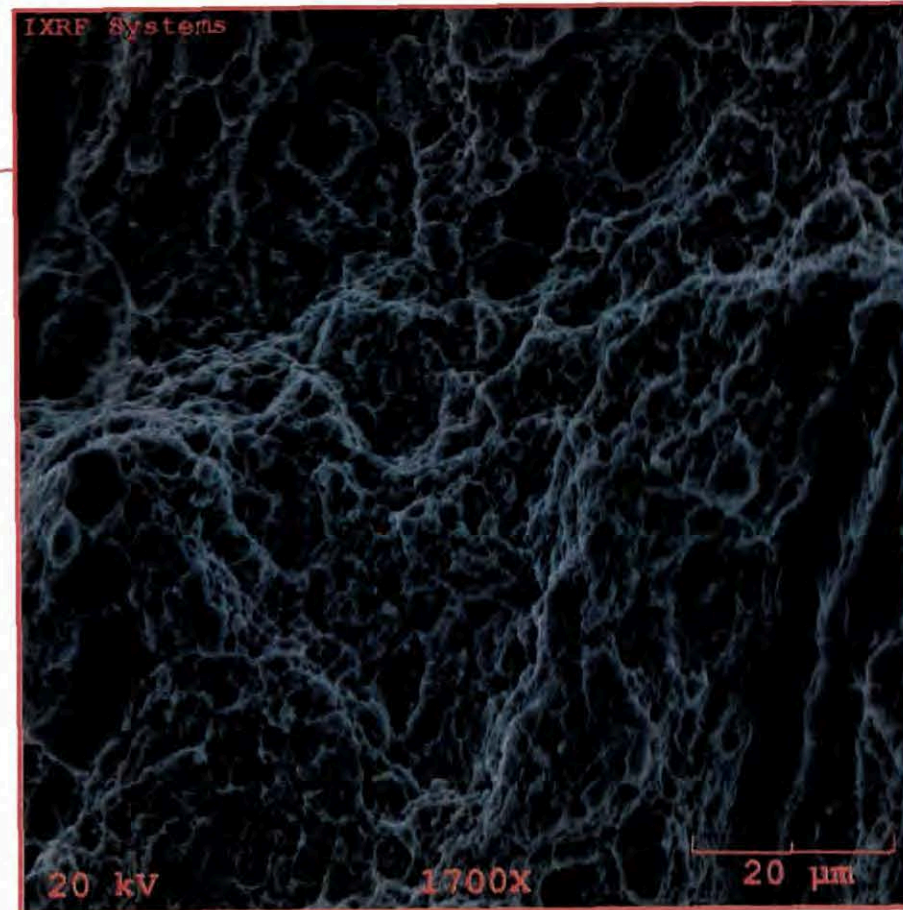
This corner of the fracture surface displays mixed fine dimples due to microvoid coalescence and is indicative of single load event failure of a ductile material.

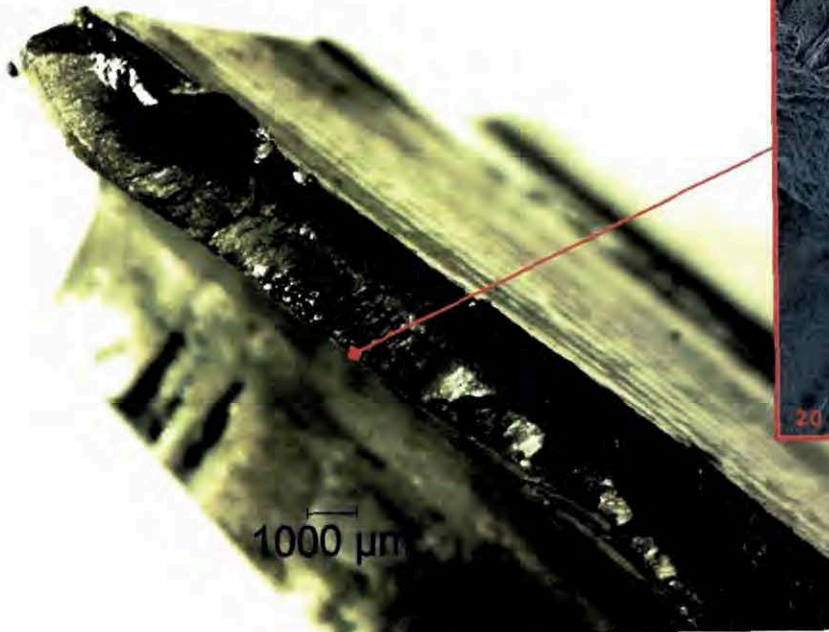
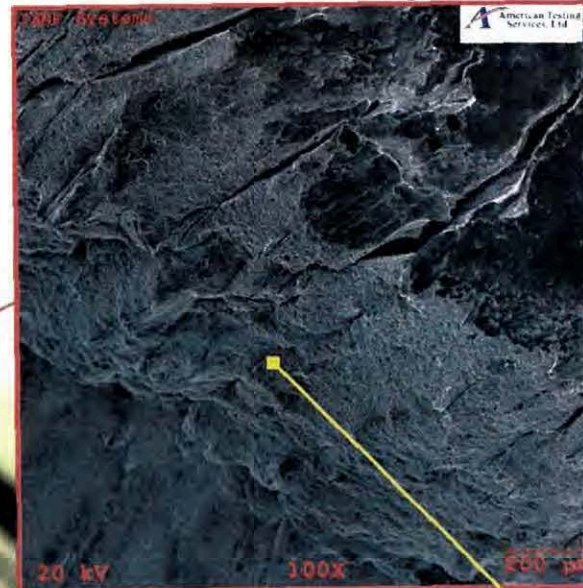
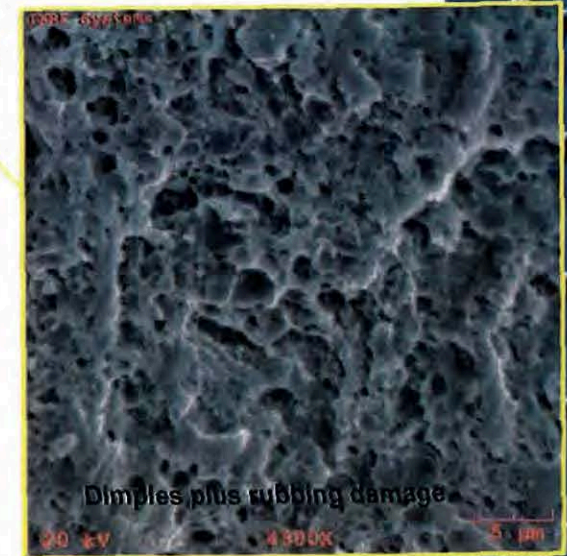
This view, near the bolt surface and origin, shows what appears to be a collection of fine near surface dimples and an area above of rubbing damage. As a general rule the fracture face displayed considerable damage due to rubbing of the surfaces, making interpretation more difficult. Higher magnification imagery confirmed the presence of ductile overload.

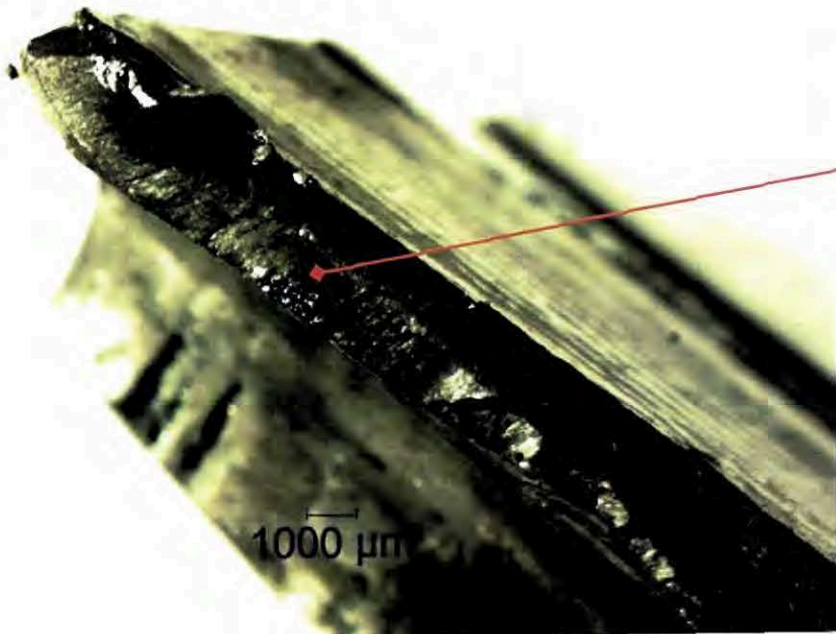
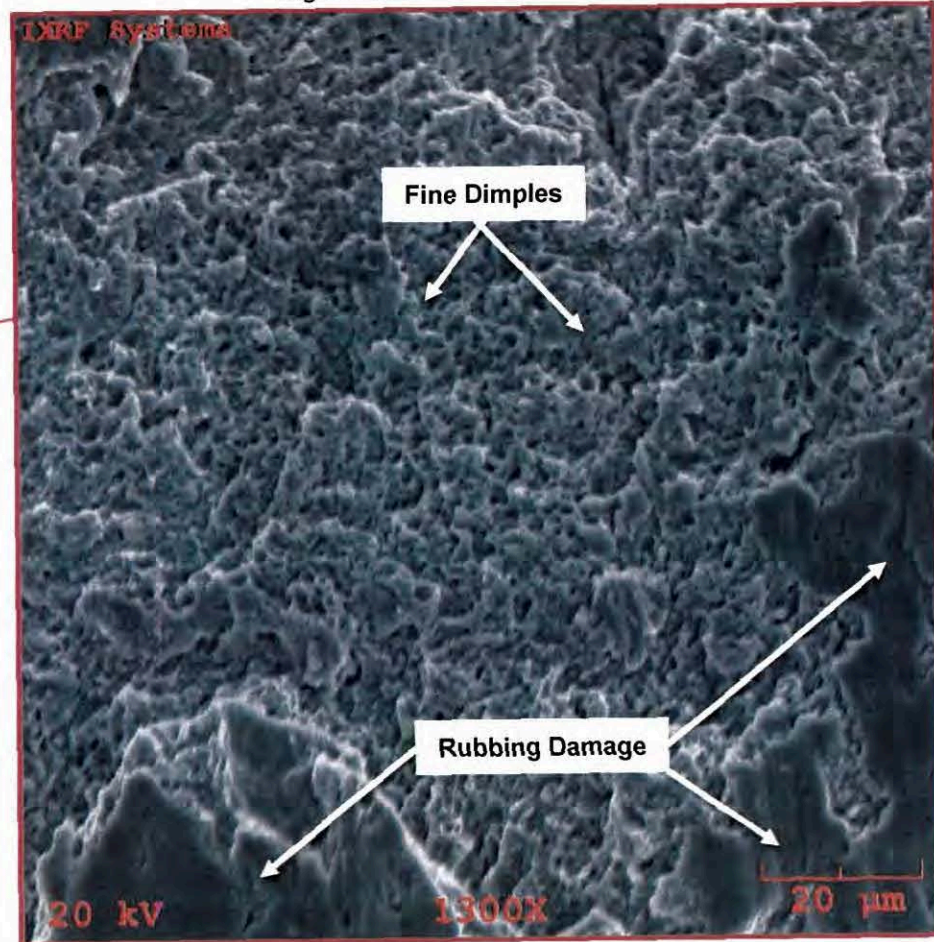
Just above this region of apparent rubbing damage the SEM examination, once again, confirms the presence of very fine shear dimples, indicative of ductile overload.

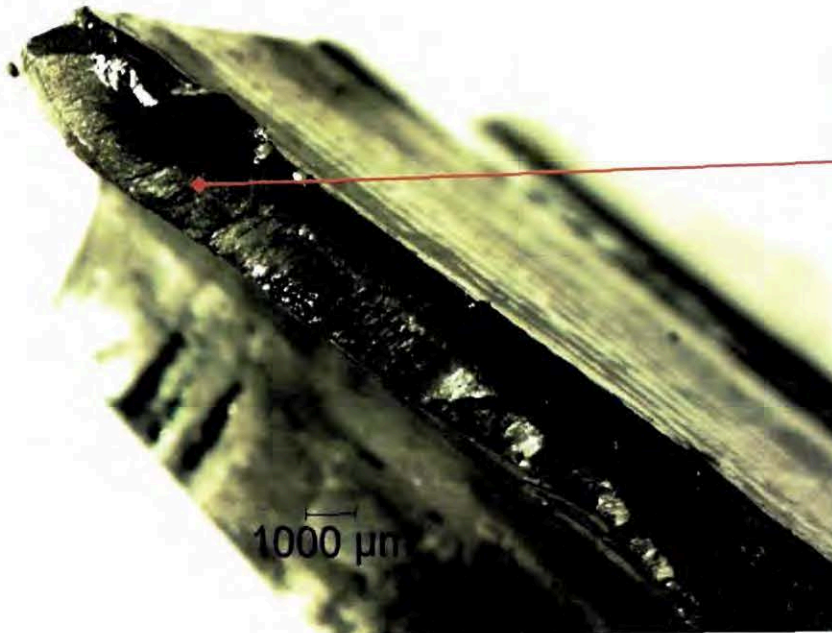
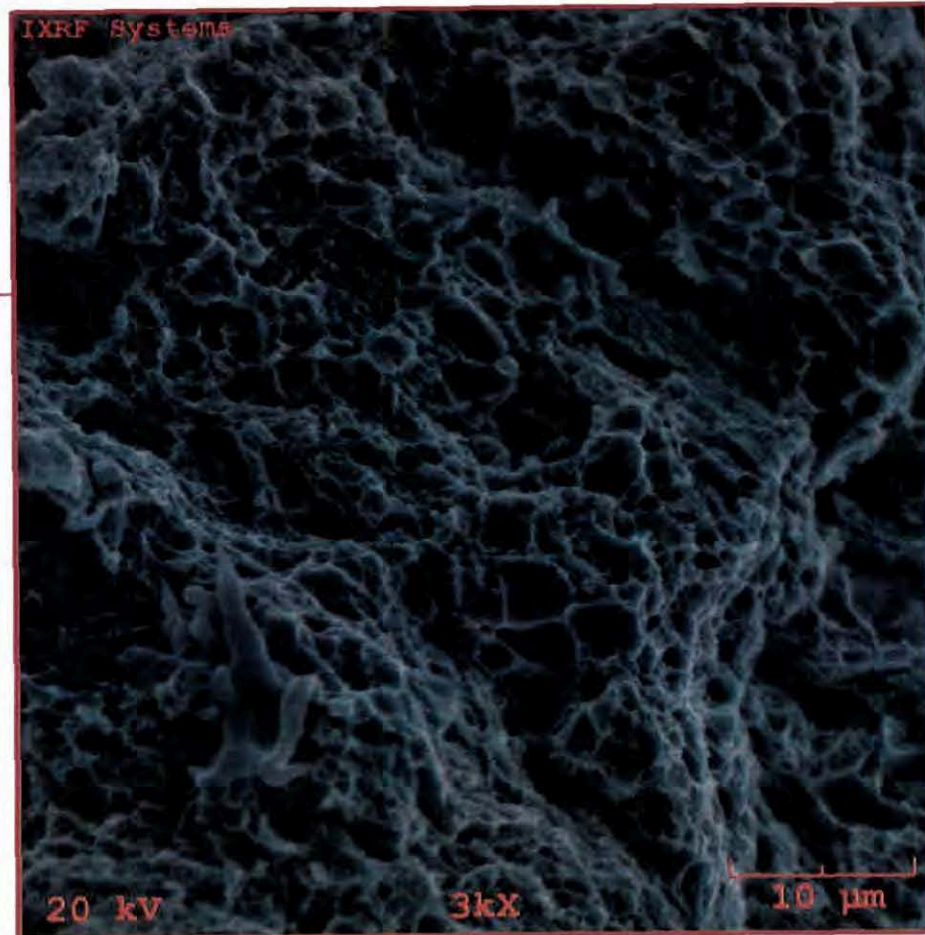
This SEM image at approximately 3000x magnification clearly shows the fine nature of the dimpled structure developed across this fracture face.

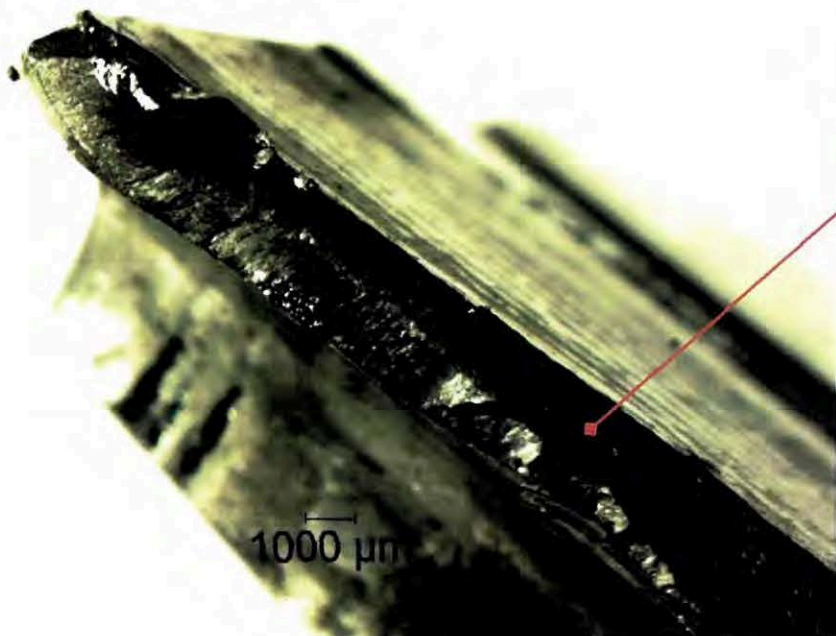
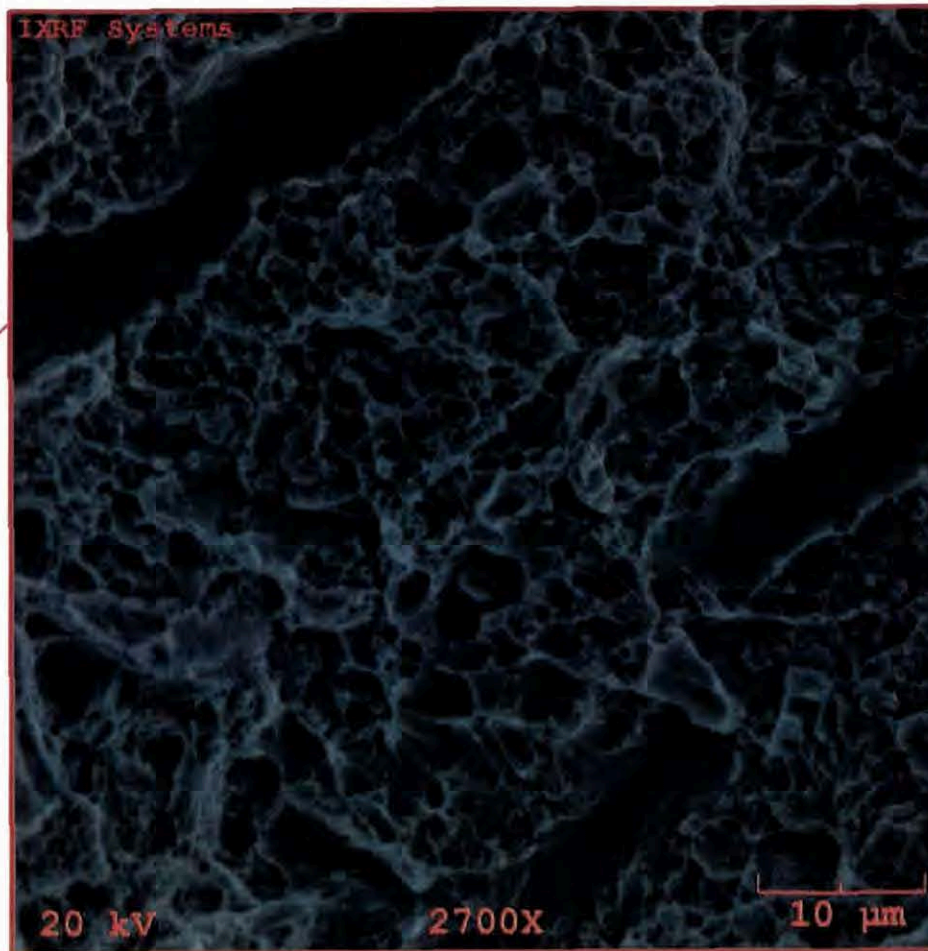
This coarser region of the fracture face contained more ductile tearing and less rubbing damage. Smooth parallel features seen in the view at right are believed to be related to microstructural features in the quenched and tempered steel.

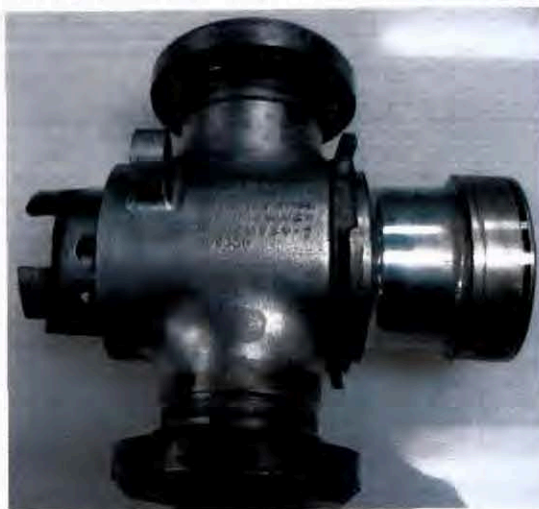
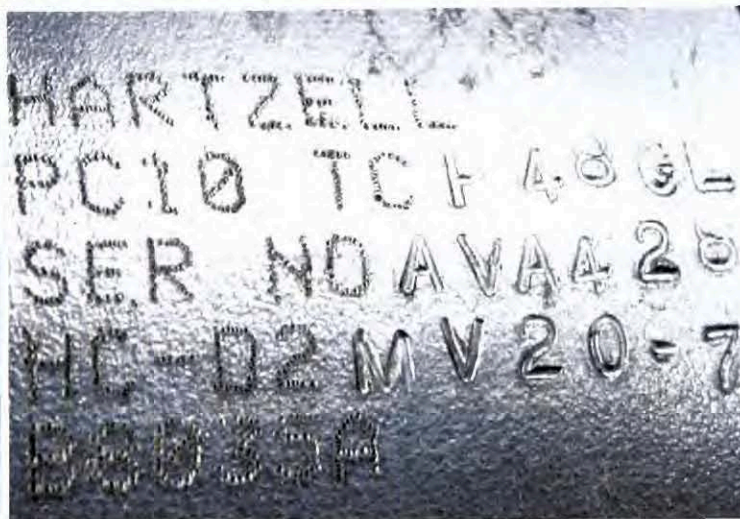
Sample ID: Prop Model HC-D2MV20-7; Hub S/N AVA428; Pilot Tubes Marked A and B

The pilot tubes were fractured on both blades due to impact.
The mounting flange was intact and unremarkable.
Cylinder attachment was intact and unremarkable.
There were no impression marks from blade butts.

Test Summary: Both Pilot Tubes failed by overload. There was no evidence of fatigue cracking.

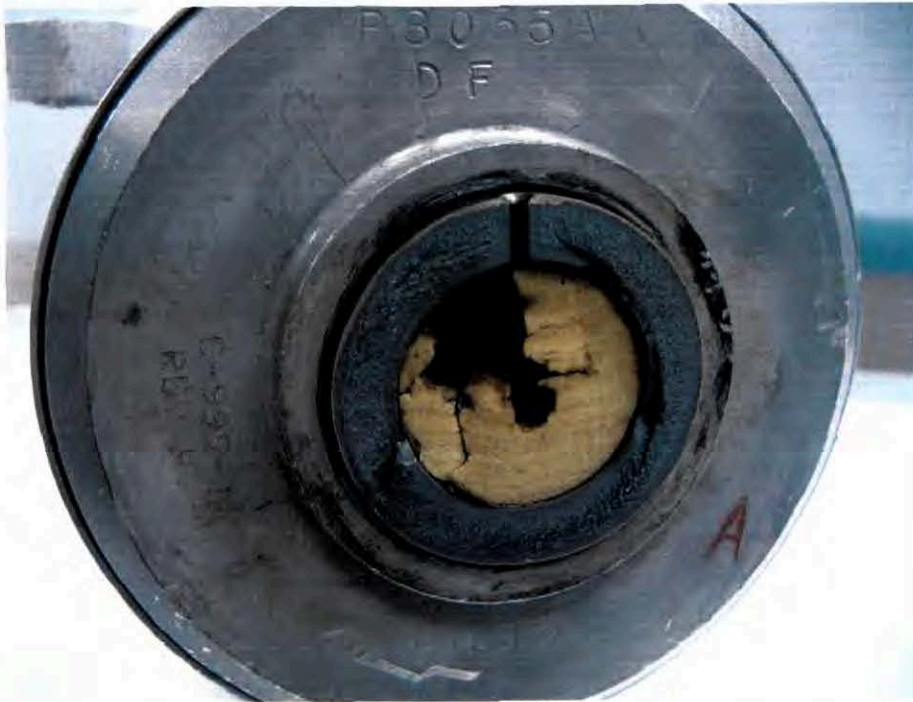
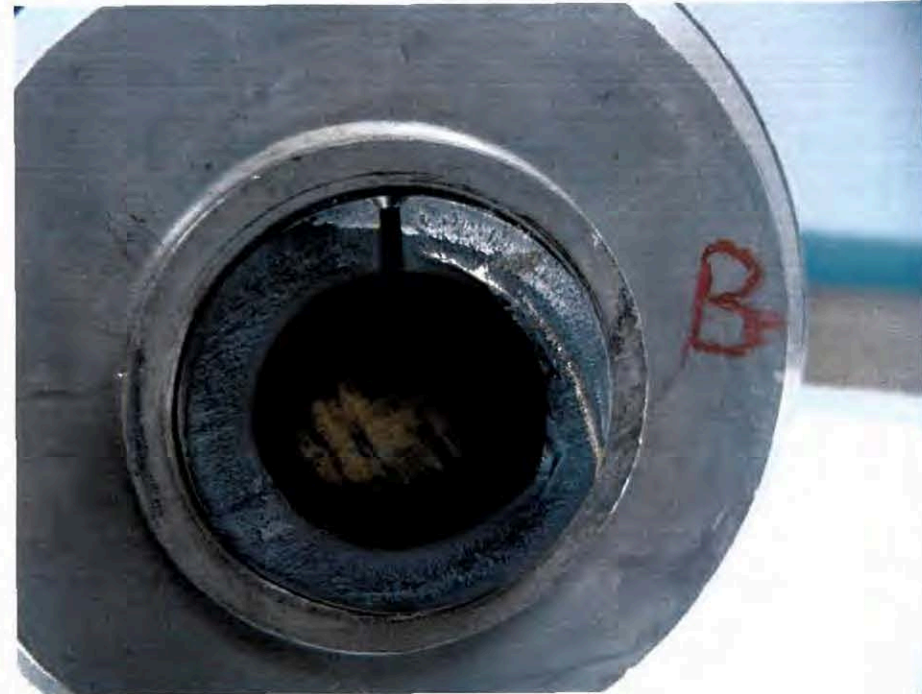
View of Pilot tube fractures, as received, and prior to removal for examination. Both tubes fractured immediately adjacent to the Hub face.

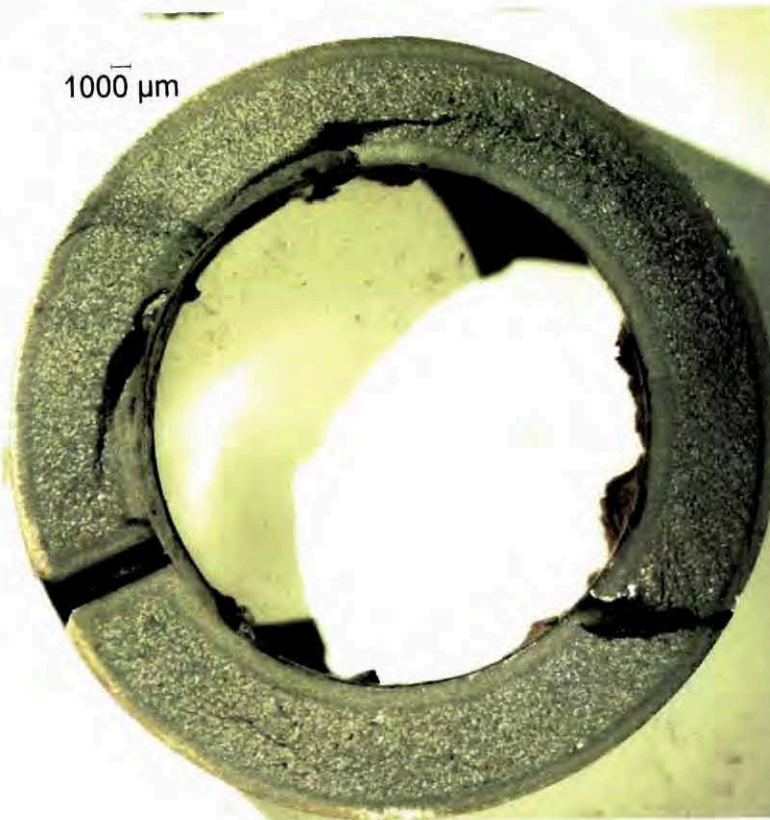
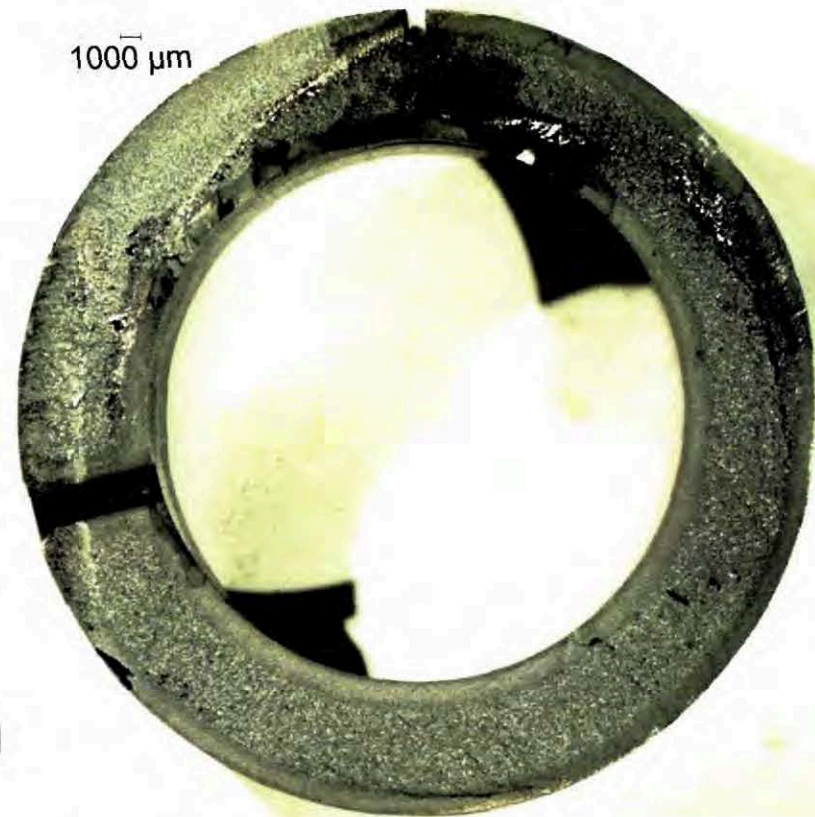
Both fractured Pilot tubes exhibit similar features. The fractures show bright crystalline facets indicative of cleavage fracture of a high hardness, quenched and tempered steel. The smooth, well defined bands adjacent to the OD and ID surfaces are case hardened zones.

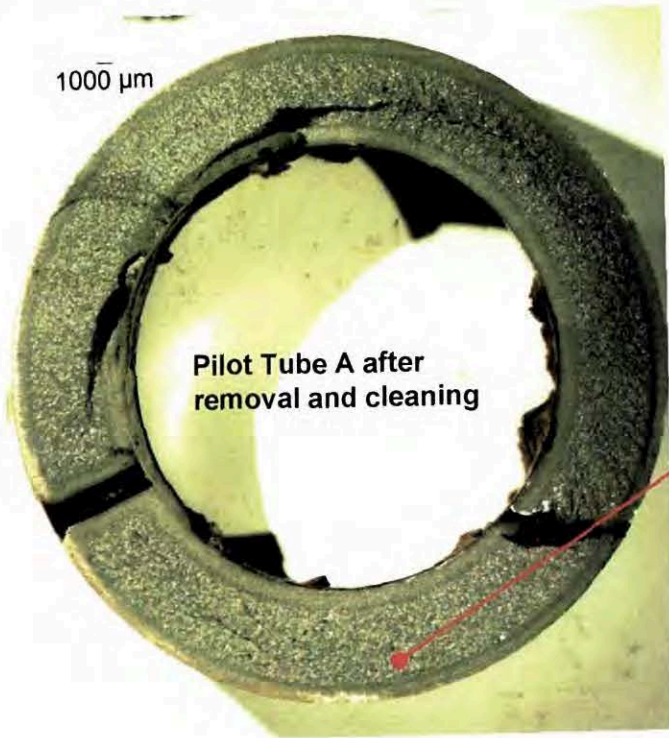
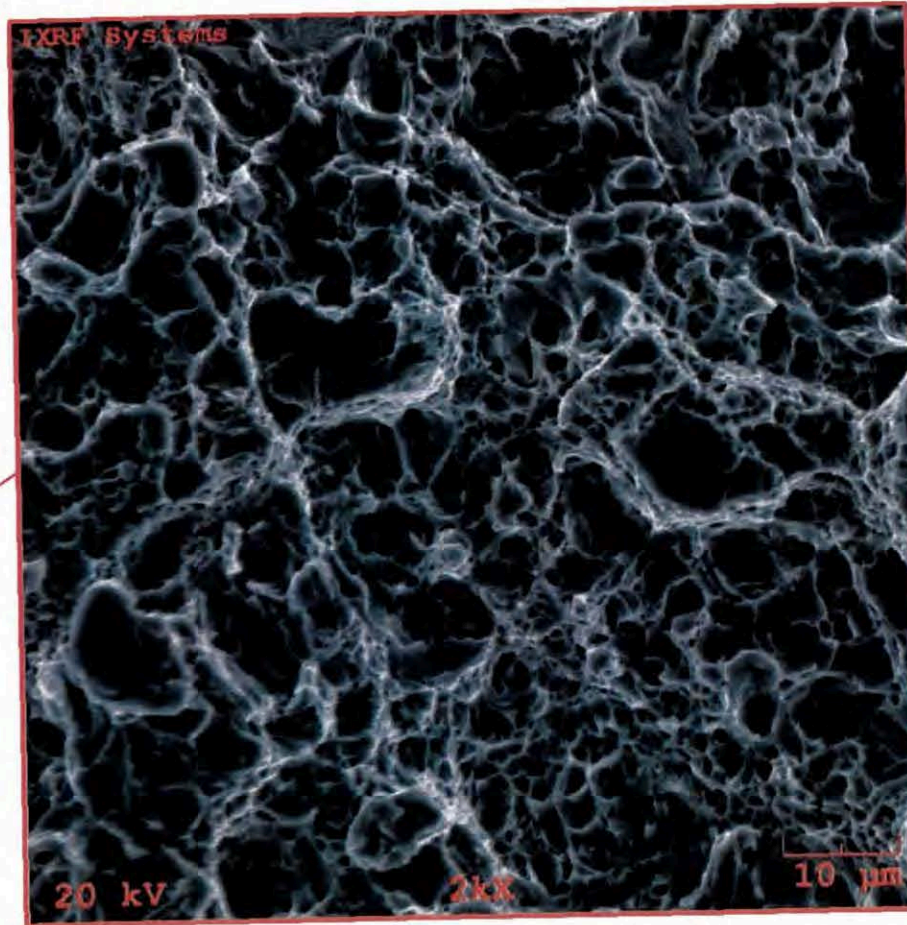
This fracture region is typical of many areas on the surface and displays a mix of microvoid coalescence and cleavage, both indicative of sudden overload.

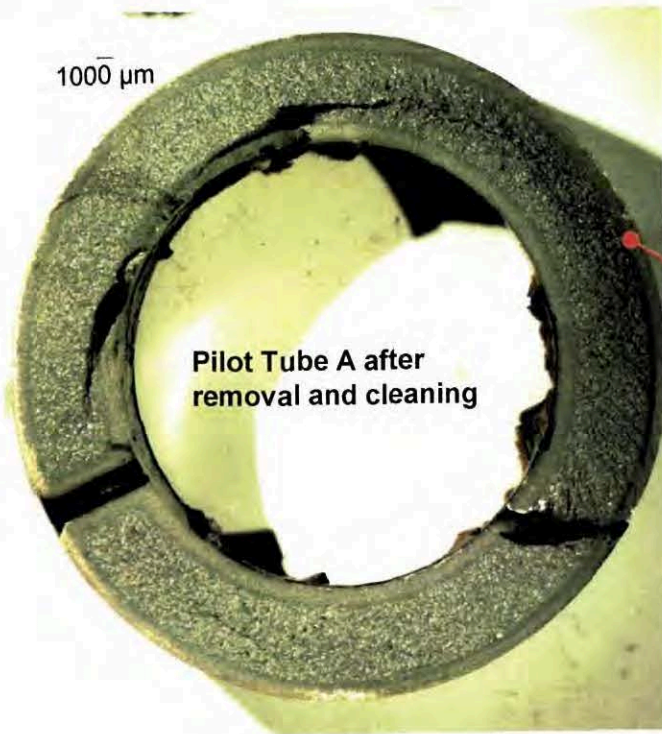
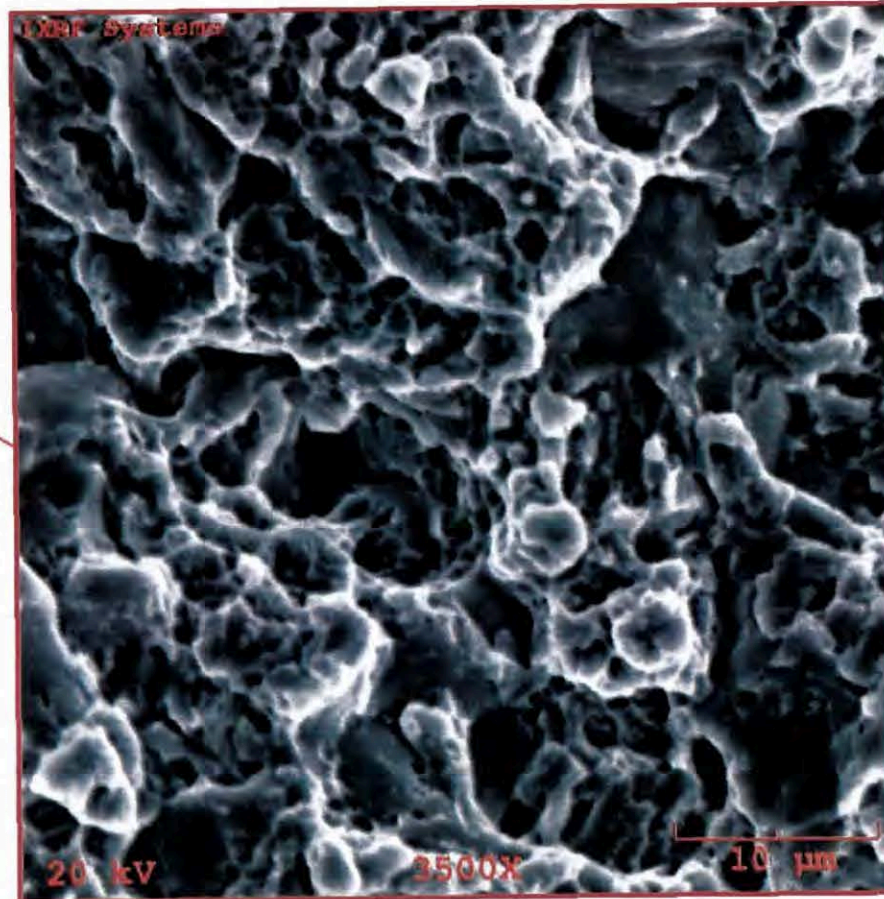
The case hardened band, near the OD surface appears to have failed by a mix of fracture at the prior austenite grain boundaries and quasicleavage. Some microvoid coalescence is also visible. These case hardened bands would display less ductility than the softer core.

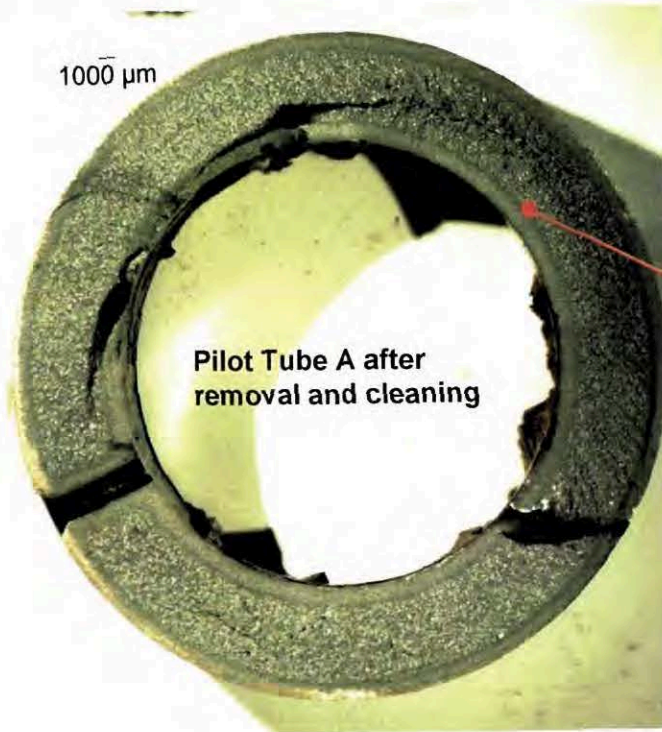
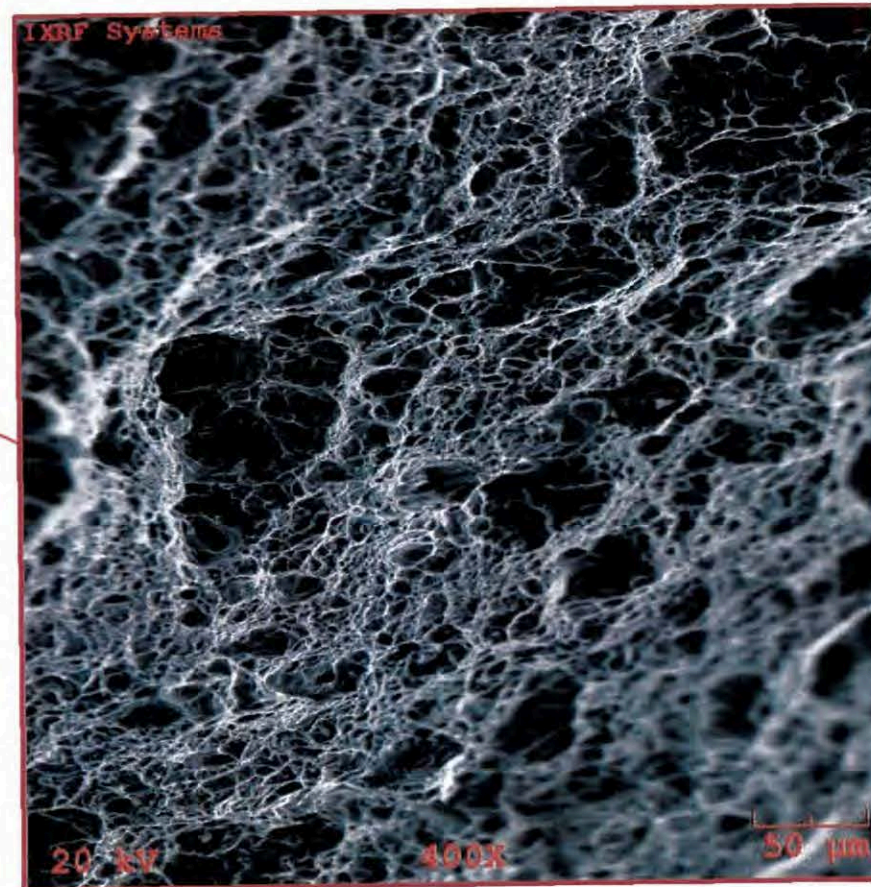
The transition zone, just below the inner case hardened zone, shows a mix of microvoid coalescence (dimples) and cleavage fracture. This zone is more ductile than the hardened case, as expected.

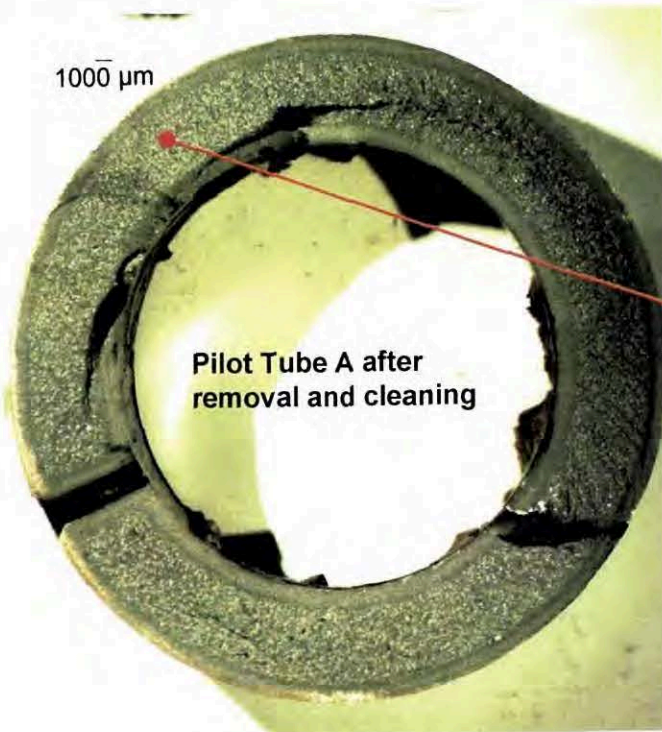
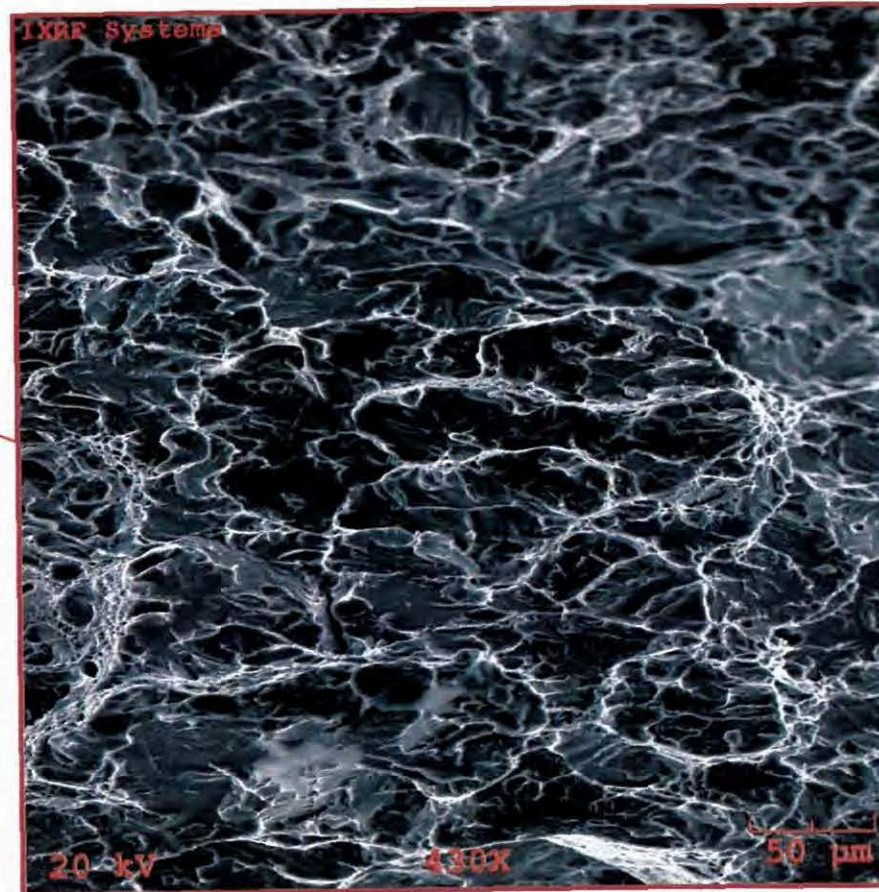
This area of the fracture surface is predominantly cleavage fracture, indicating the crack front was moving quickly through this region.

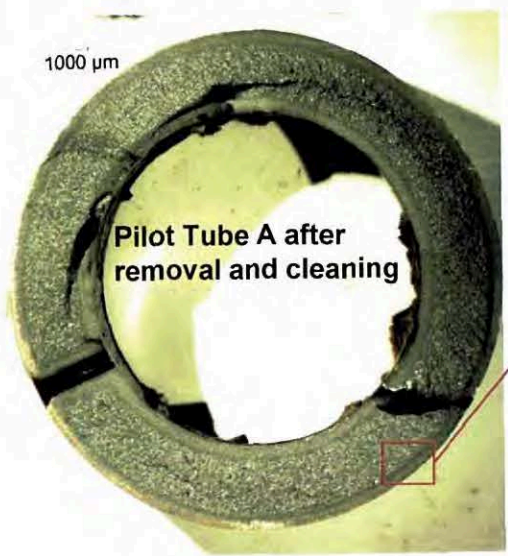
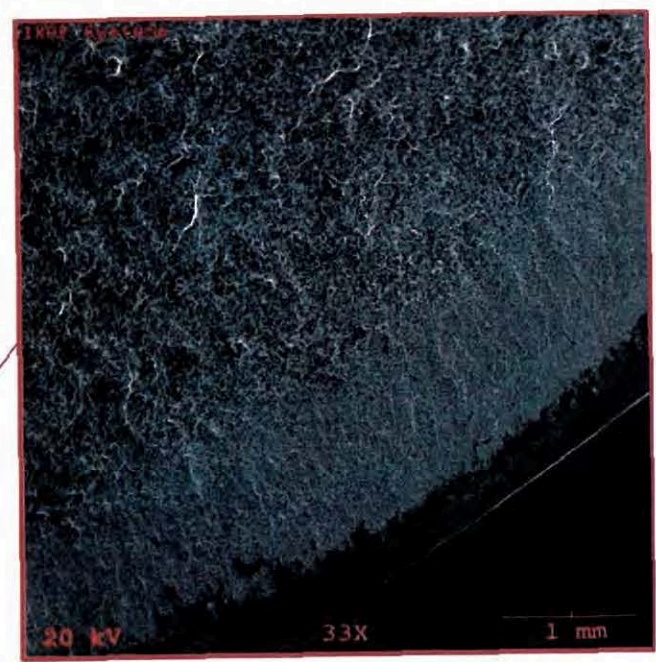
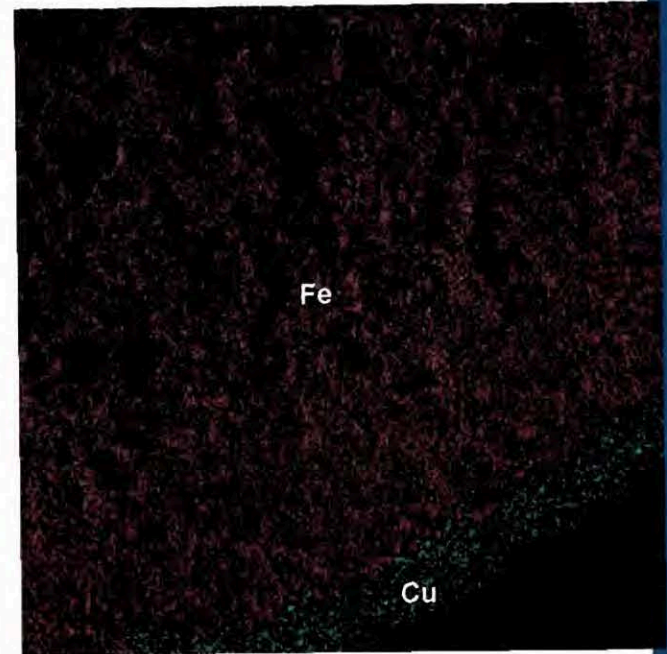
Material transfer along a portion of the outer edge of the fracture surface was determined to be Copper. The Client reports that a bronze bushing may have come in contact with this surface after failure.
