NTSB File No.: ANC14LA068

Aircraft: Ryan Navion A

Registration No.: N4827K

PROPELLER TEARDOWN REPORT

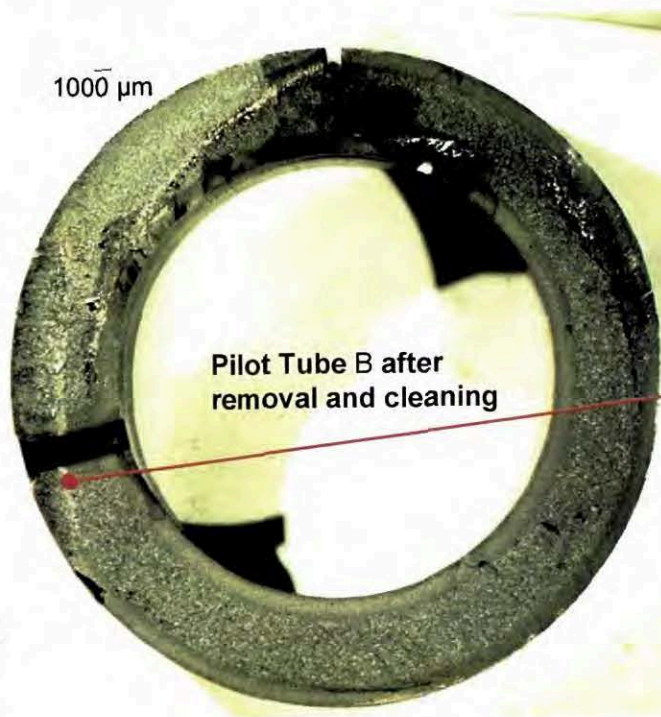
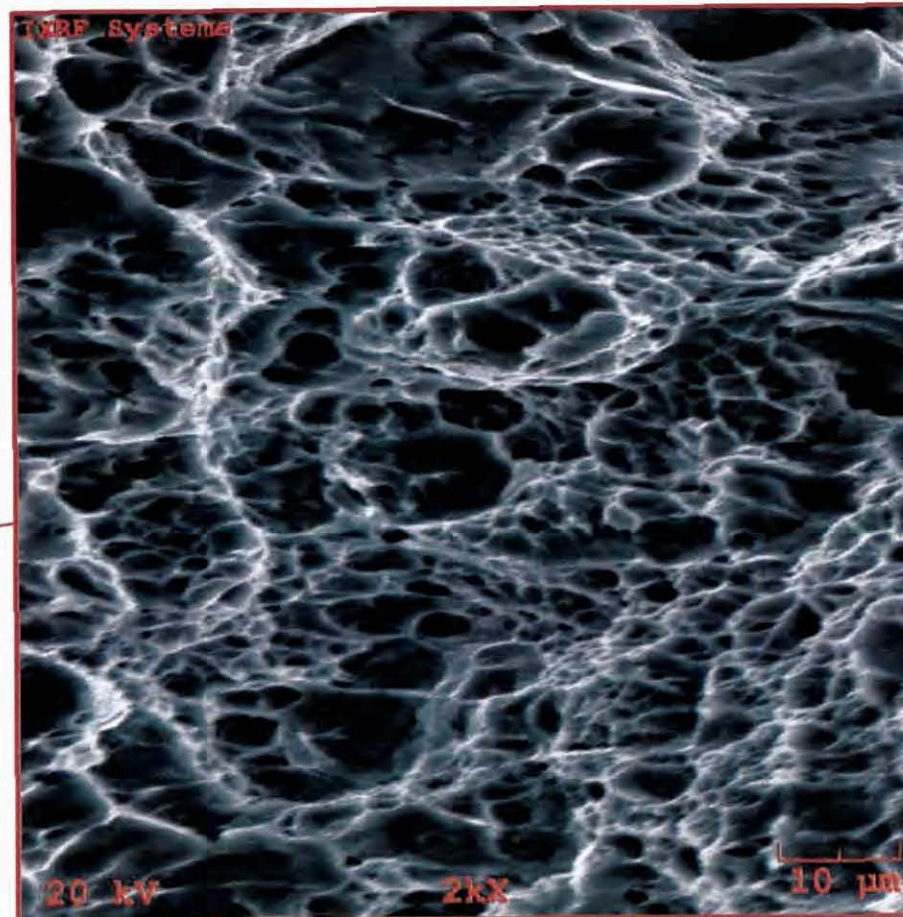
This fracture region is typical of many areas on the surface and displays a mix of microvoid coalescence and cleavage, both indicative of sudden overload.

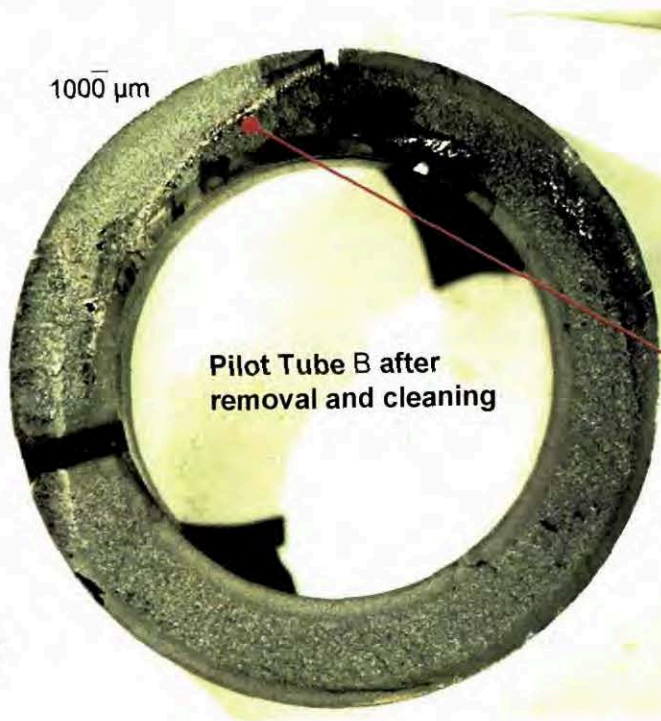
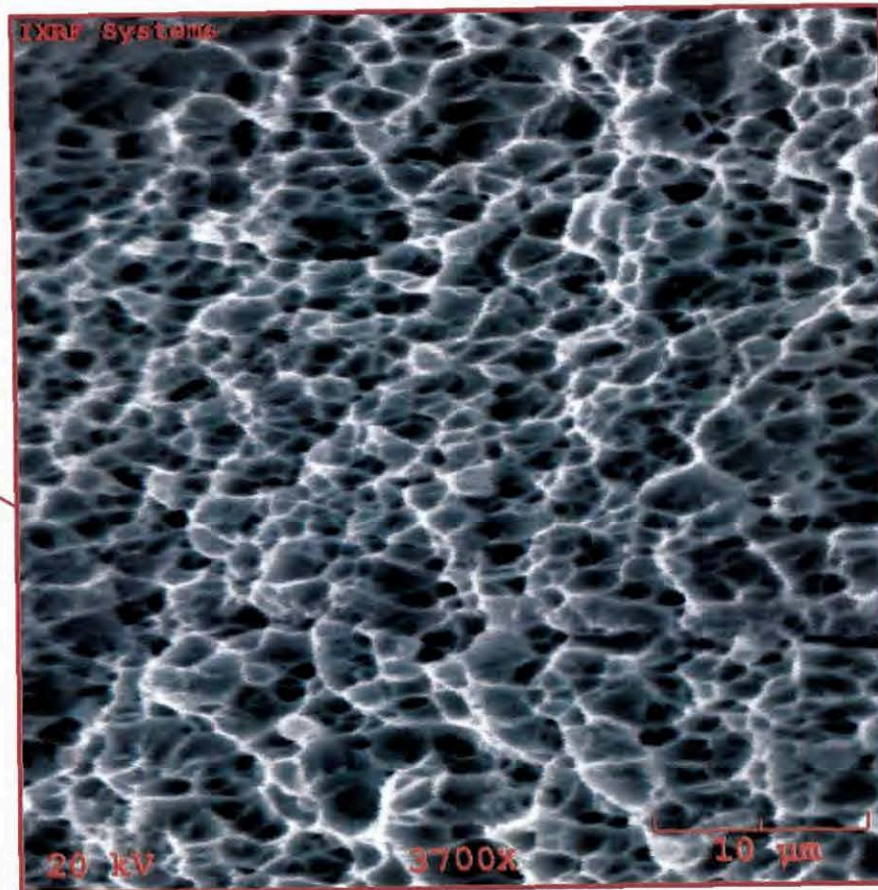
This area of the fracture face is comprised primarily of fine ductile dimples resulting from microvoid coalescence. Failure was by tensile/shear overload of a ductile material.

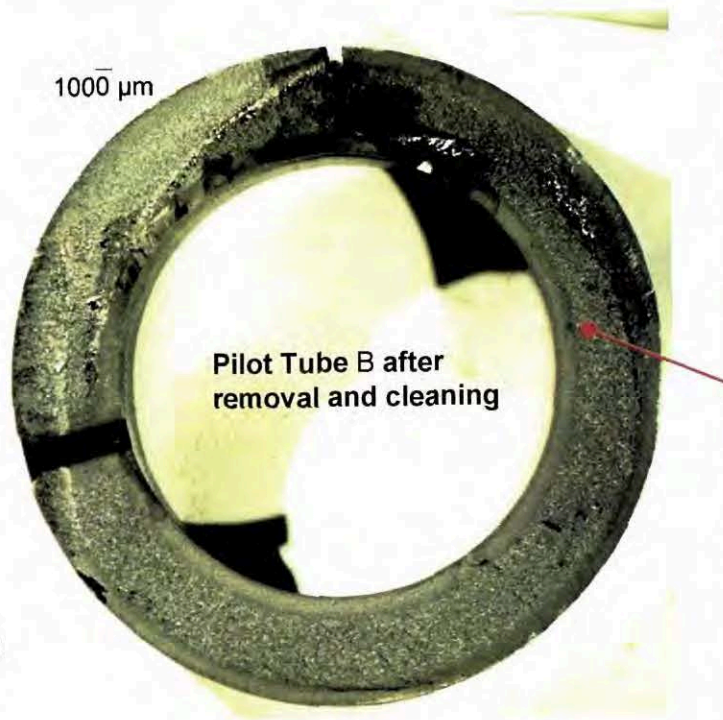
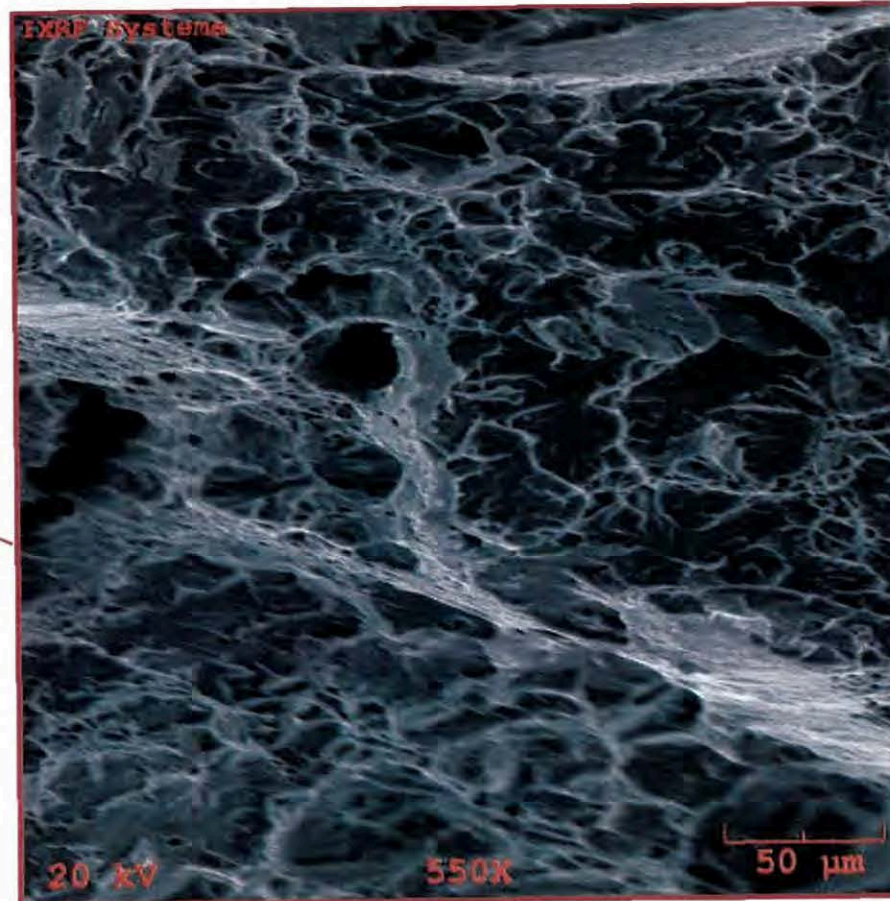
This region consists of coarse cleavage facets with some microvoid coalescence. The crack front was progressing quickly through this area.

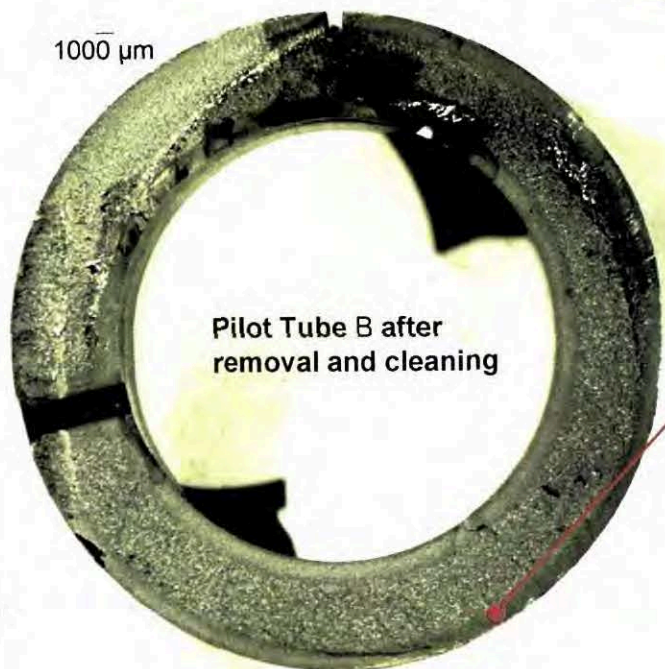
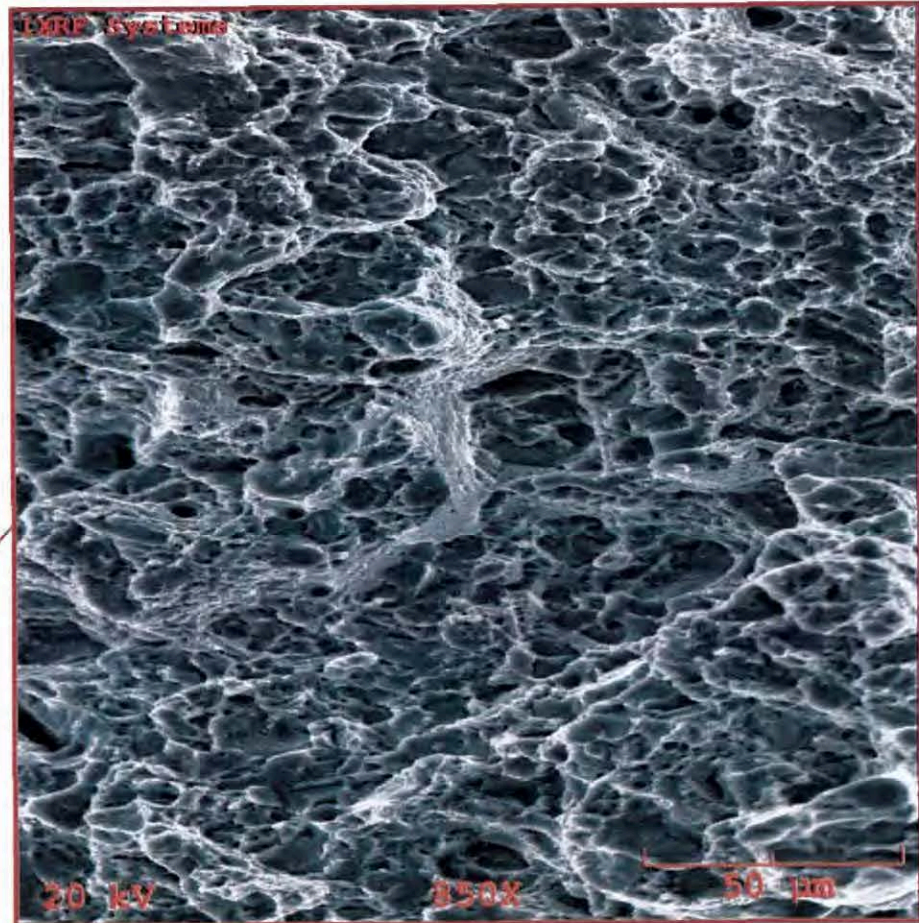
The outer case hardened zone has failed by intergranular separation and quasicleavage due to it's higher hardness and lower ductility.
