# HARTZELL PROPELLER INC.

# **ENGINEERING REPORT NO. 3945**

Report for A1-B Governor Inspection Performed on January 28, 2015 at Hartzell Propeller

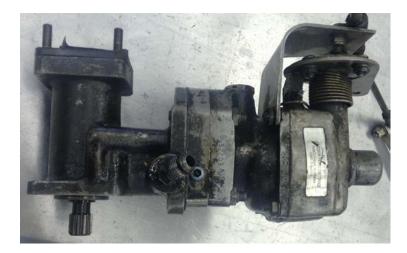
Figure 1: A-1B Governor and T-drive

The governor, as received, was still attached to the T-drive assembly and the first portion of the inspection was verifying the governor and T-drive had not seized. The drive shaft of the T-drive could be freely rotated by hand verifying that the combined assemblies had not seized.

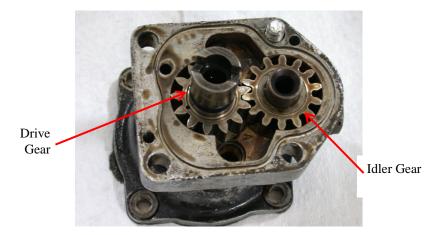
Figure 3: Pump Cavity in Governor Body with Gears Installed

The gears and shaft did not show any abnormal wear and there was no metal debris found in the pump cavity. Additionally, the wear surfaces of the governor base and body in contact with the gears did not show abnormal signs of wear. The wear surfaces can be seen in Figure 4. Finally the relief valve was removed and inspected and did not show anything that would prevent proper functioning.
