Aircraft Accident/Incident Report No.: 111222

NTSB File No.: ERA12FA120

Aircraft: Cessna 441 Conquest II  
Registration No.: N48BS  
Serial No.: 441-0125

**PROPELLER TEARDOWN REPORT**

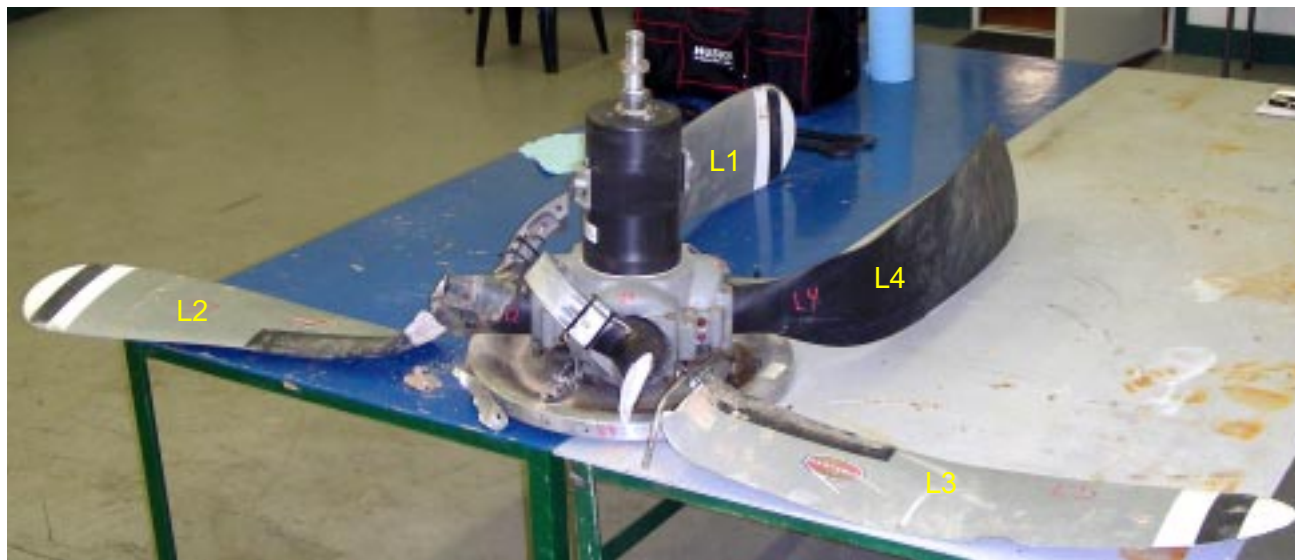
The propeller had been removed from the engine and the spinner dome had been removed. One blade was in the feather position. One blade was disconnected and could be manually turned in the hub. The other two blades were at a low pitch position, but at different angles. The feather stop nut was 1-1/32 inch from the feather stop.

All four blades were bent forward of the plane of rotation. L2 and L3 blades were fractured at the shank.

Photo 1. Left propeller, as received

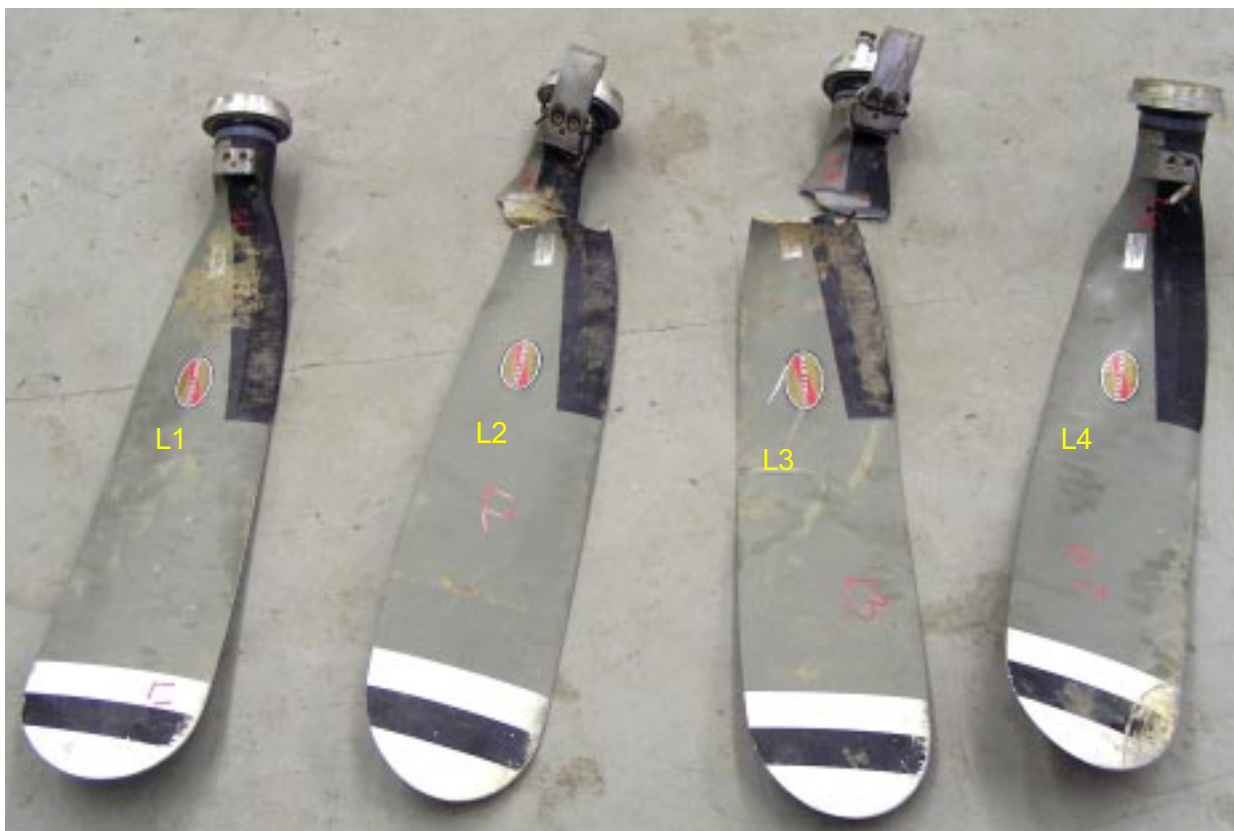
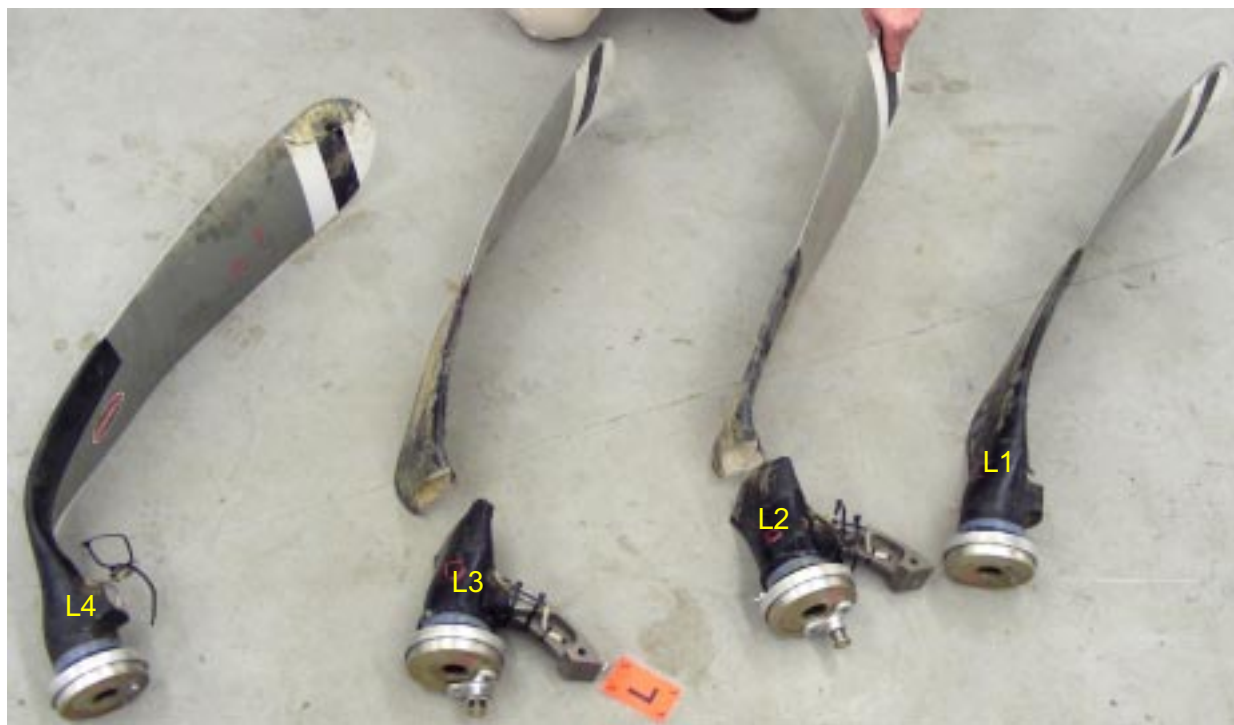
Blade L1 was bent forward approximately 20° at 1/4 radius. It had slight additional forward bending further outboard (large radius). The counterweight had separated from the blade; bolts stripped. The tip was straight and not twisted. The tip had no significant leading edge damage or tearing.

Blade L2 was fractured at the shank due to forward bending. The tip was straight and not twisted. The tip had no significant leading edge damage or tearing.

Blade L3 was fractured at the shank due to forward bending. The tip was straight and not twisted. The tip had no significant leading edge damage or tearing.

Blade L4 was sharply bent forward approximately 60° at 1/4 radius. The counterweight had separated from the blade; bolts stripped. The tip was straight and not twisted. The tip had no significant leading edge damage or tearing.

Photo 2. Left propeller blades

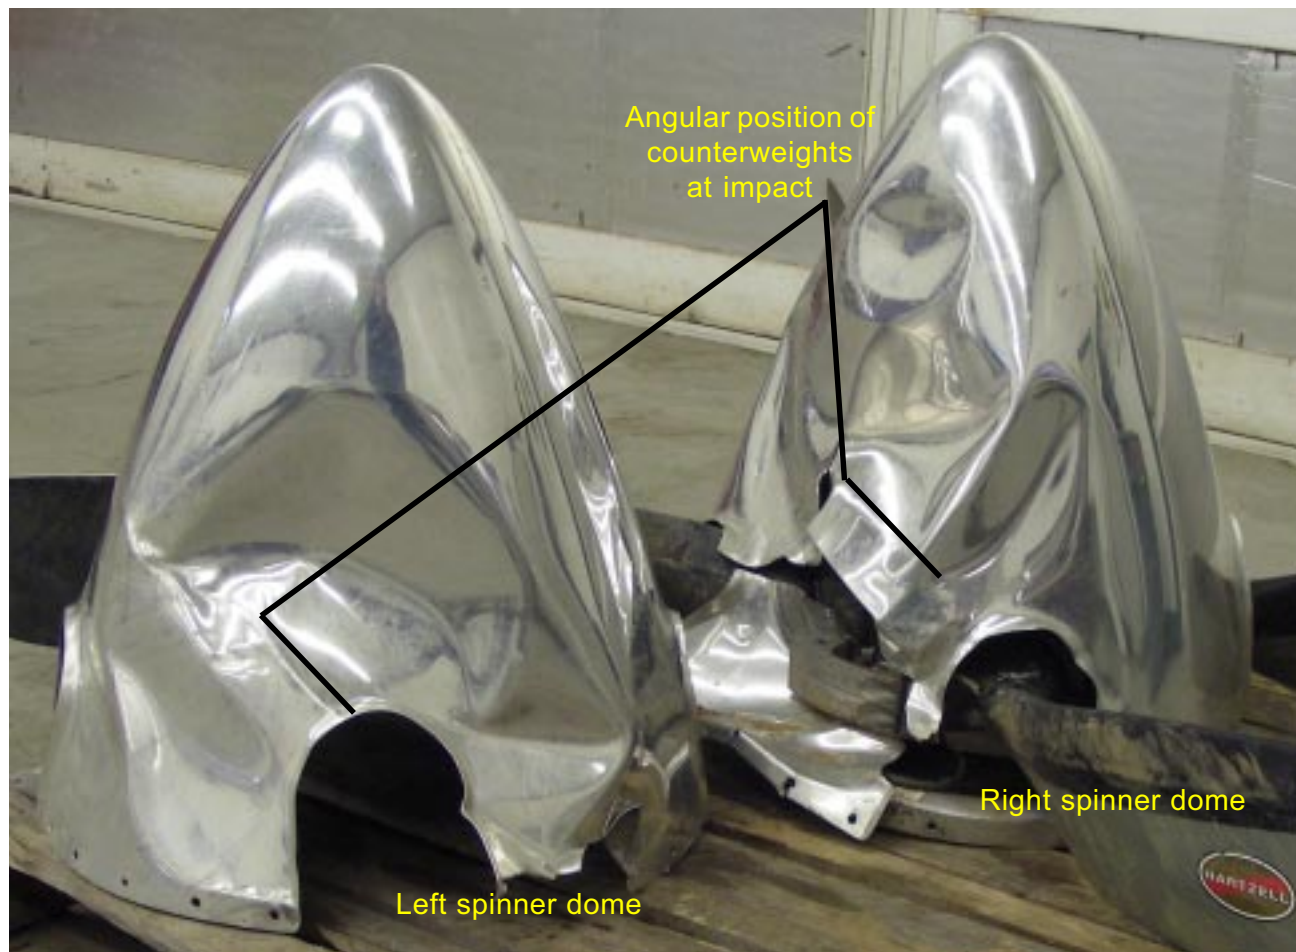
The spinner assembly had an impact mark from one blade counterweight. The blade was at a low pitch position (in the normal operating range) when the spinner was crushed. The dome was crushed on one side with no frontal crushing.

Photo 4. Both spinner domes

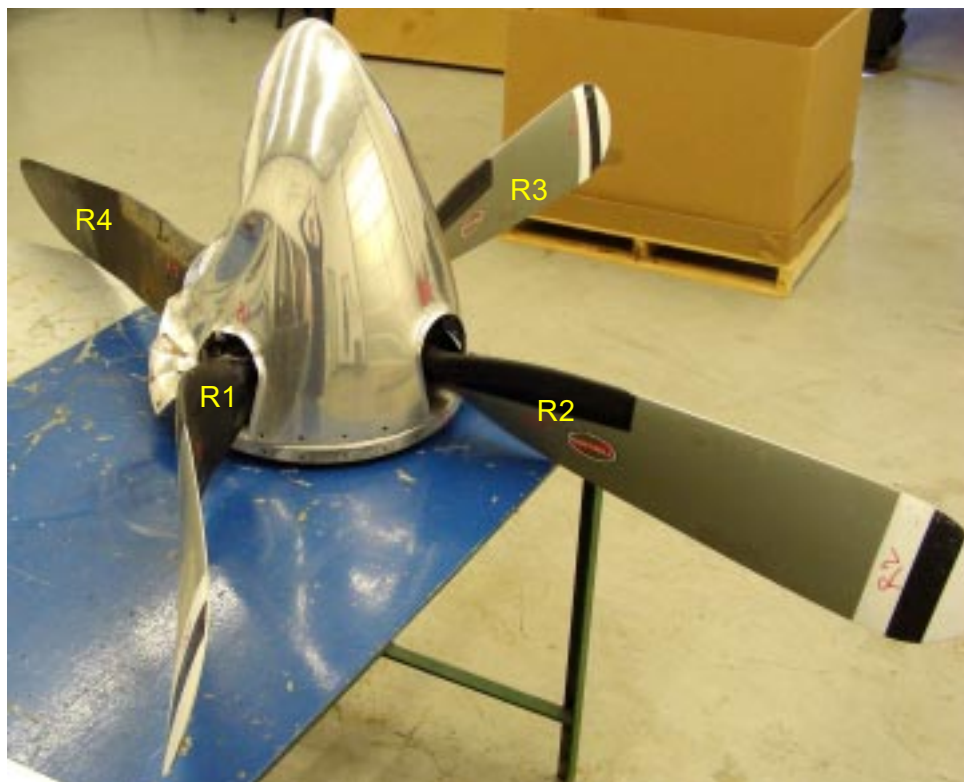
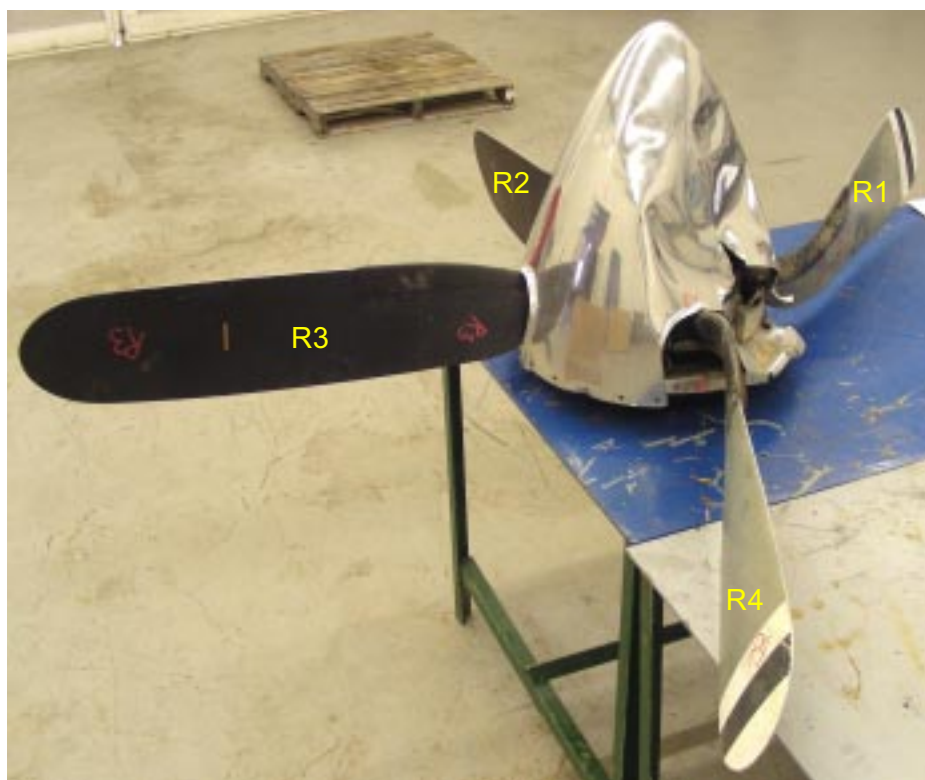
The propeller had been removed from the engine. The spinner dome had been removed but had been put back on the propeller. All four blades were at the feather position. The piston was at the feather position.

Photo 5. Right propeller, as received

Photo 6. Right propeller, as received

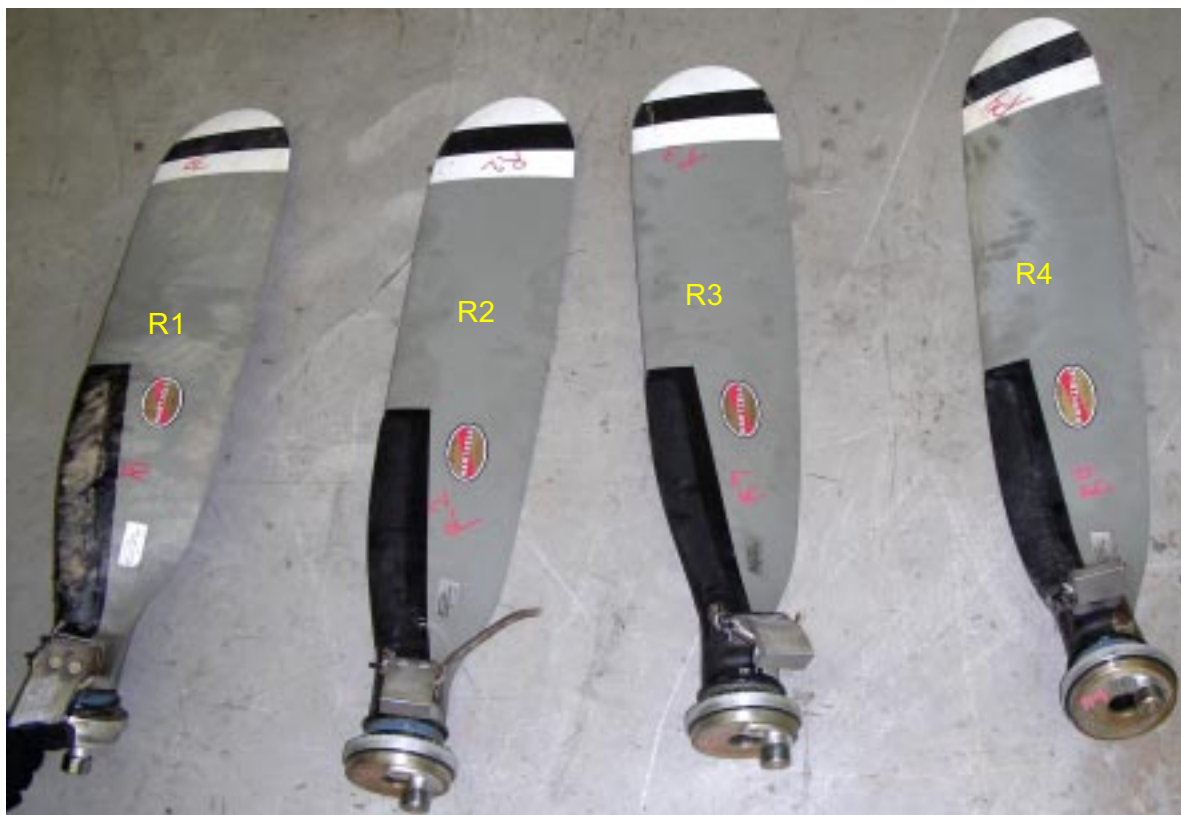
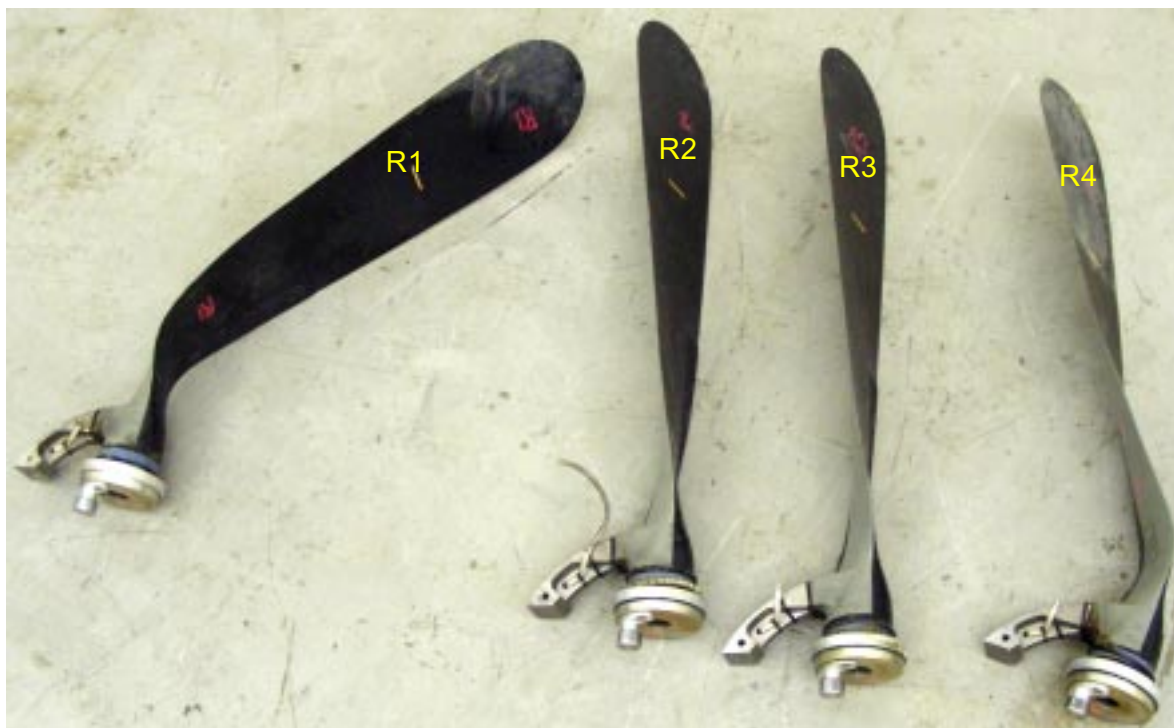
The blade counterweight was intact on all four blades.

The tips of all four blades were straight and not twisted with no significant leading edge damage or tearing.

Blades R2 and R3 were straight with bending or twisting; no evident damage.

Blade R1 was bent aft approximately  $45^{\circ}$  at  $1/4$  radius.

Blade R4 was bent forward approximately  $30^{\circ}$  at  $1/4$  radius. The outer  $1/2$  of the blade was slightly twisted toward lower pitch and slightly bent aft.

Photo 7. Right propeller blades

Photo 8. Right propeller blades
