NTSB File No.: DCA17FA109

Aircraft: Shorts SD3-30

Registration No.: N334AC

Written by: Les Doud
Air Safety Investigator – Hartzell Propeller Inc.

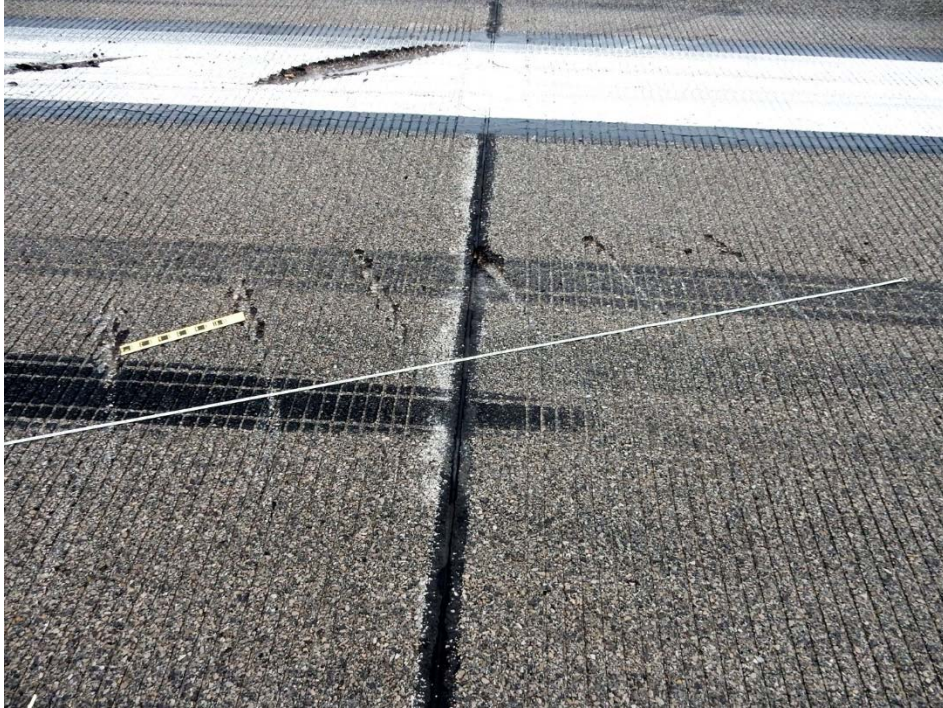
The initial indication of left propeller rotation were blade strike marks on the runway (see Photo #1). The first six strike marks (one full revolution) exhibited a fairly consistent distance of approximately 16 inches. NTSB analysis of video and radar data indicated the aircraft speed at impact was approximately 92 Knots. That combination of strike mark distance and aircraft speed results in a calculated propeller RPM of approximately 1400.

Photo #1 – Left Propeller Strike Marks in Runway (photo courtesy of NTSB)

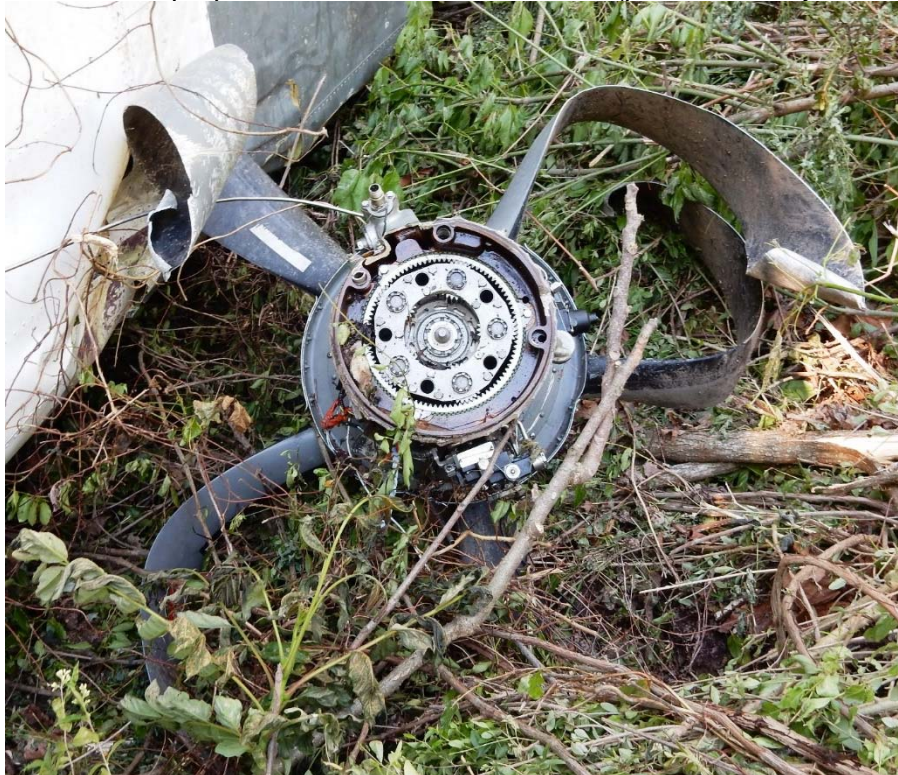
Photo #2 – Left propeller and forward RGB in-situ (photo courtesy of NTSB)

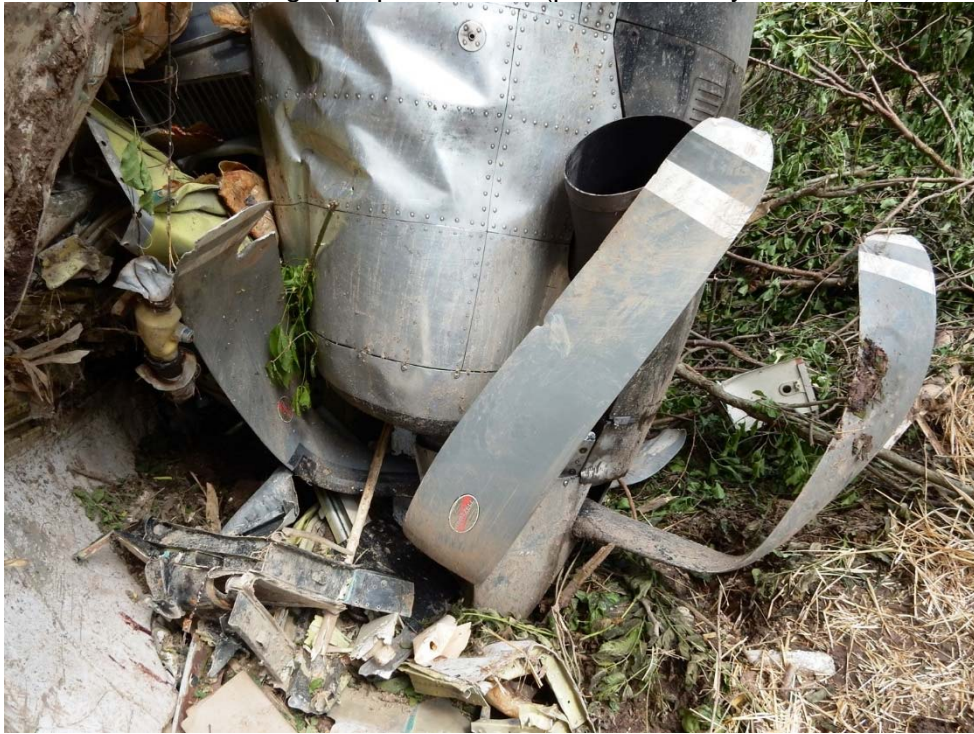
Photo mapping of the accident scene conducted by the NTSB indicated the aircraft initially struck near the Runway 5 centerline approximately 400 ft. from the runway threshold line, on a heading of approximately 16° (34° left of runway heading). A security camera on the airport terminal captured the aircraft striking the runway in a left bank, nose low attitude. The left propeller with a section of the engine Reduction Gearbox (RGB) separated from the engine during the initial impact sequence and traveled with the main wreckage down a tree-covered hillside (Photo #2). The right propeller remained attached to the right engine and also traveled with main wreckage, which came to rest approximately 580 ft. from the initial impact point on the north side of Runway 5 (Photos #3 and #4).

Photo #3 – Right propeller in-situ (photo courtesy of NTSB)

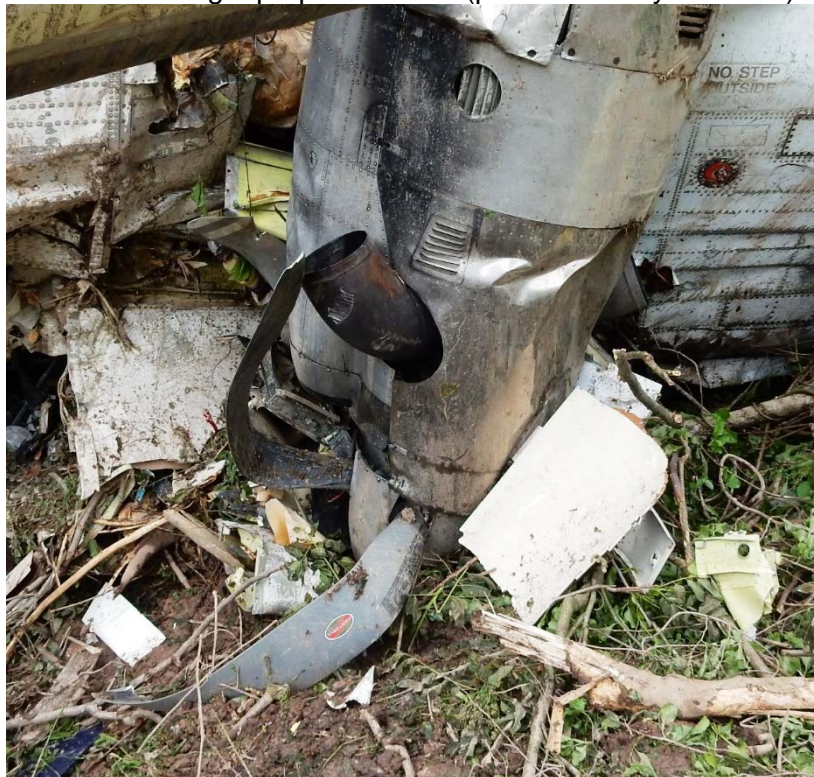
Photo #4 – Right propeller in-situ (photo courtesy of NTSB)

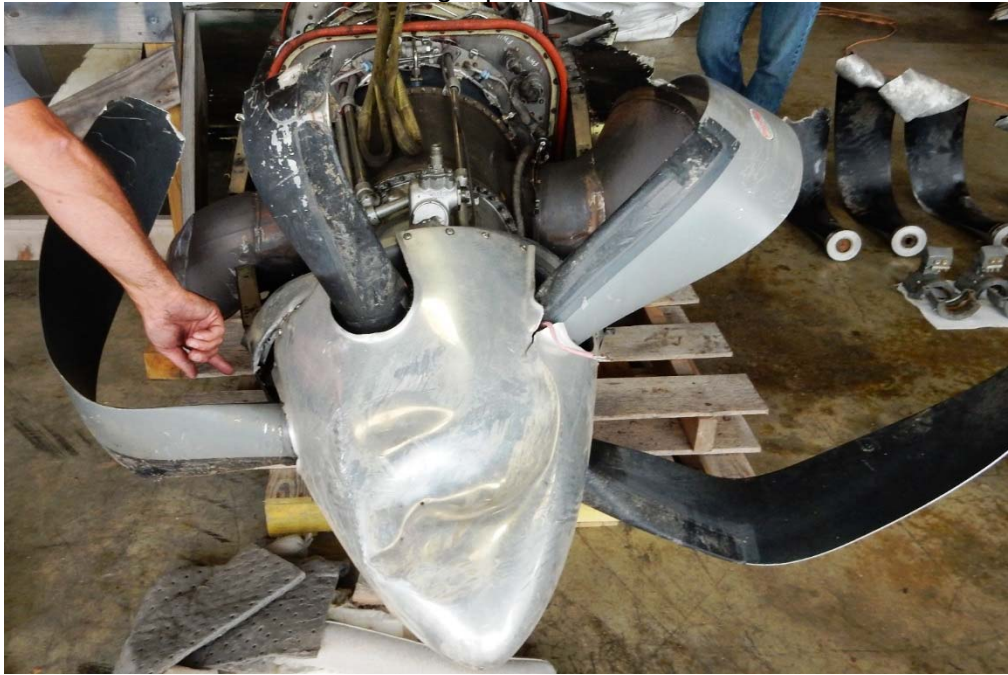
“As Received” Condition: The right propeller was presented for examination as shown in Photo #5. The right propeller remained attached to the engine propeller shaft. The prop shaft could not be rotated by hand. The spinner was dented but remained attached to the spinner bulkhead. The nacelle with the engine and propeller still attached was placed on sawhorses to facilitate disassembly of the propeller. The propeller is shown in Photo #6 with the spinner dome removed before disassembly. All five blades remained attached to the hub assembly. One blade had been intentionally cut approximately 15” from the blade butt during the aircraft recovery operation. Three blades were bent aft. Two blades appeared to have rotated 180° and bent aft (face side forward). One blade had approximately 4” of the tip fractured and another had fractured approximately 17” from the butt; the fractured portion was not presented for examination. The piston was in an extended, low pitch position and four link arms had been pulled from their link screws but all five link arms remained attached to the piston. Four of the five clamps were forcefully rotated beyond the reverse position, one appeared in a low pitch position. The hub and clamp area was wet with oil and various amounts of dirt and vegetation (tree bark, pine needles, grass, etc.). Some of the de-ice boot leads had torn from their terminal blocks.

Photo #5 – Right propeller as-received

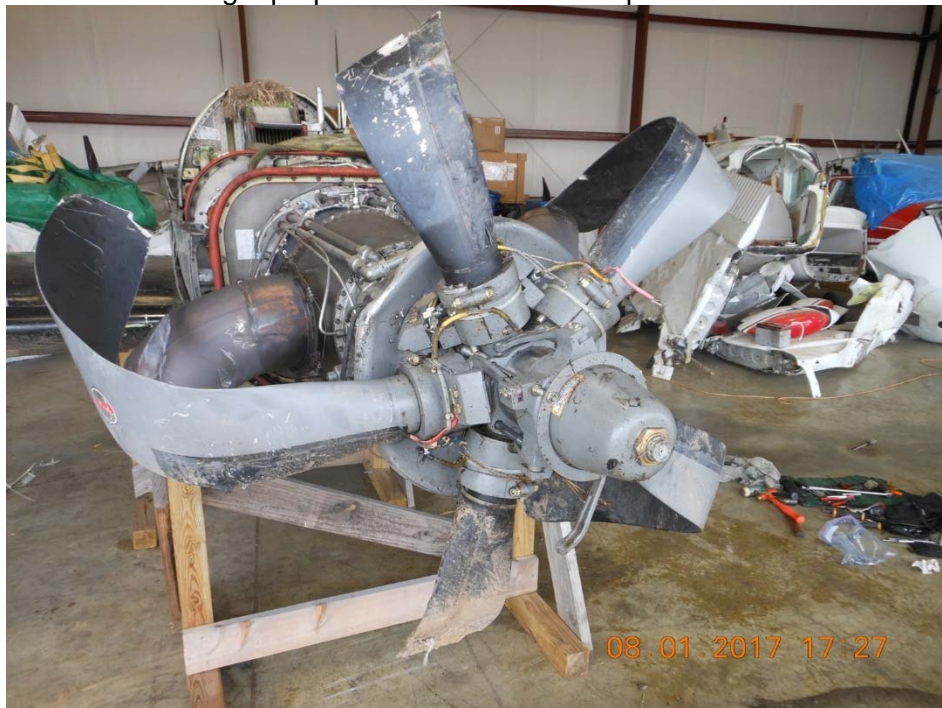
Photo #6 – Right propeller as received with spinner dome removed

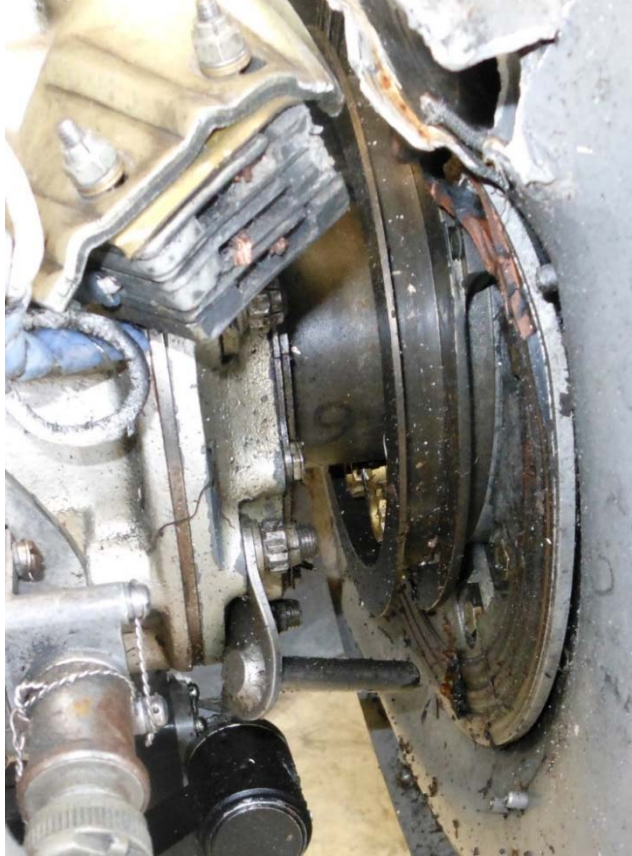
Engine/Propeller Mounting: The propeller remained attached to the propeller shaft flange and the mount appeared undamaged with all hardware present and safety wired. The de-ice brush block bracket was bent. The de-ice slip ring was fractured/torn adjacent to R2 where the spinner bulkhead was punctured by the counterweight. (see Photo #7).

Photo #7 – Right propeller mounting flange area

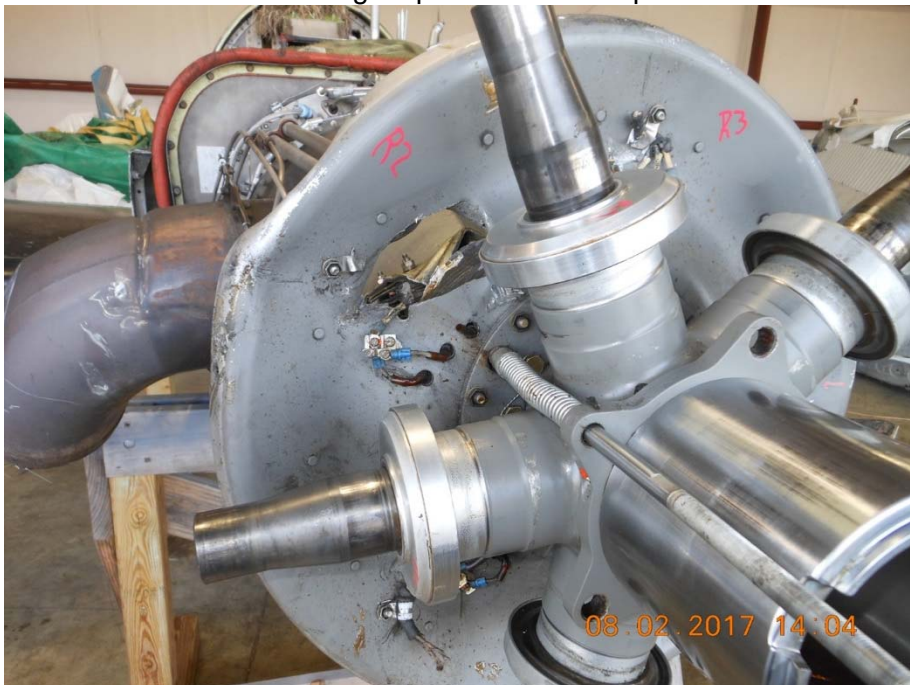
Spinner Bulkhead: The spinner bulkhead remained in one piece and attached to the propeller hub but with the dome attach flange bent adjacent to blade R2. There were counterweight punctures and dents behind the R2, R3, R4 and R5 blades (Photo #8).

Hub Unit: The hub spider was intact and appeared undamaged with no visibly detected cracks or fractures (Photo #8). One pilot tube (R5) was fractured, all others were intact and the blades separated from the pilot tubes without significant binding. The mounting flange appeared intact with all mounting hardware in place and safety wired. The cylinder attachment was intact. There were only two blade-to-hub contact marks; a letter transfer on the R5 blade arm flange and a small impact crescent on the trailing edge/camber quadrant of the R2 blade arm.

Photo #8 – Right spinner bulkhead puncture

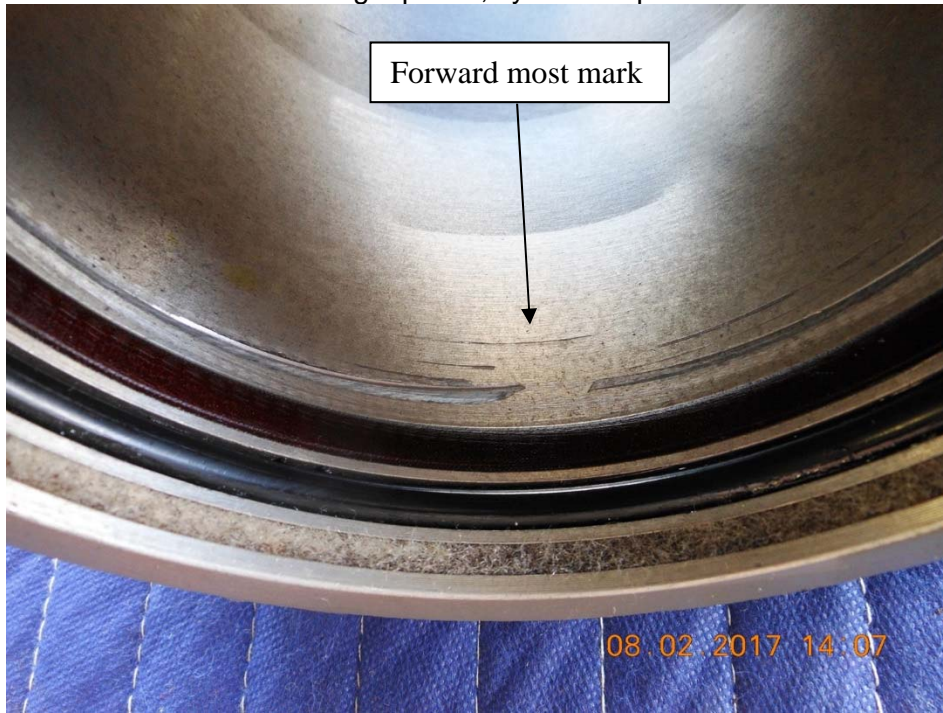
Piston: The piston was intact with all link arms attached. The piston was in an extended/low pitch position against the low pitch adjust nuts. There were impact marks in each link arm slot where the link arm contacted the piston when the clamps rotated over-center. There were cylinder-to-piston contact marks on the internal surface of the piston from approximately 1.84” from the bottom edge down to the phenolic guide bumper (see Photo #9). The 1.84” distance equates to an approximate blade angle of 13°.

Photo #9 – Right piston, cylinder impact marks

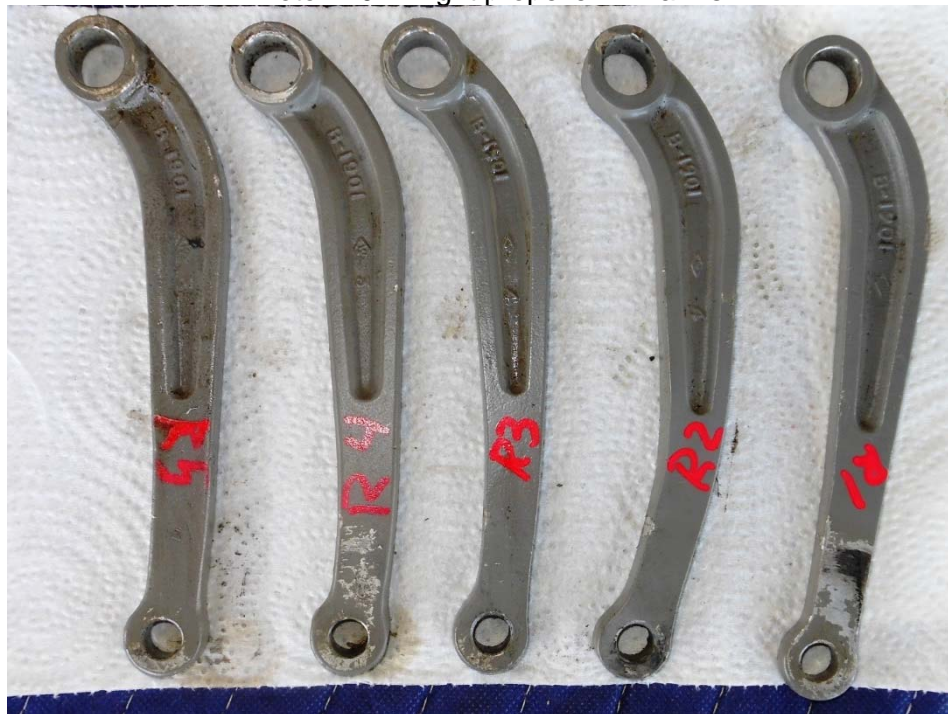
Link Arms: (Photo #10) All five link arms displayed a contact mark from the piston indicating the clamps were forcefully rotated toward low pitch, beyond the reverse stop.

Link Arm	Link Arm Condition
R1	Not remarkable
R2	Bent in compression, link screw hole stretched
R3	Not remarkable
R4	Link screw hole stretched
R5	Link screw hole stretched

Photo #10 – Right propeller link arms

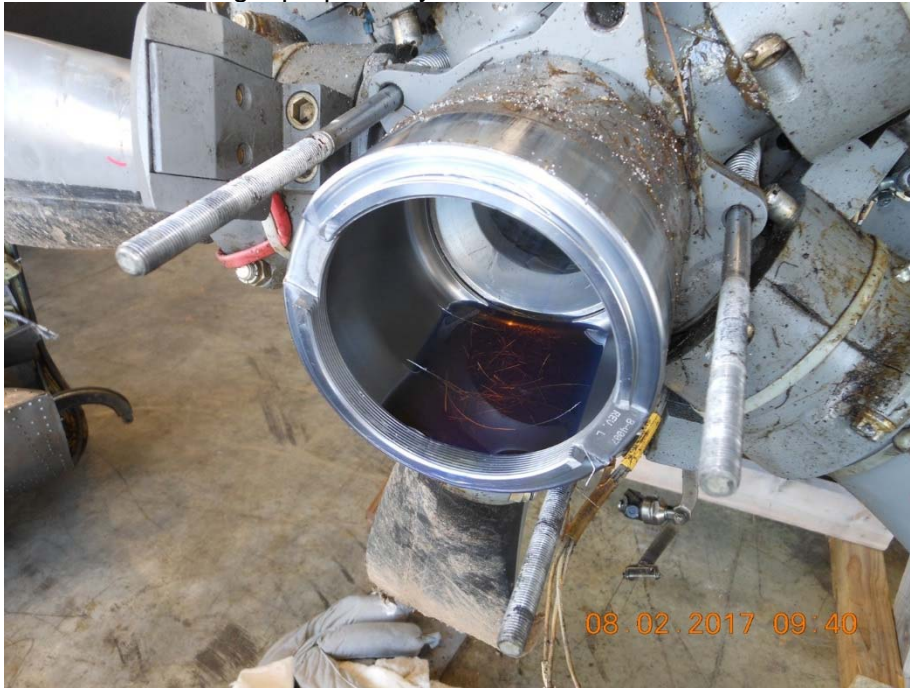
Cylinder: The cylinder remained attached to the propeller hub. There was residual oil in the cylinder with aluminum thread whiskers from the forward spring cup (Photo #11). The cylinder was dented/creased approximately 1.75” from the top/forward corner (see Photo #12).

Photo #11 – Right propeller cylinder internal with thread whiskers

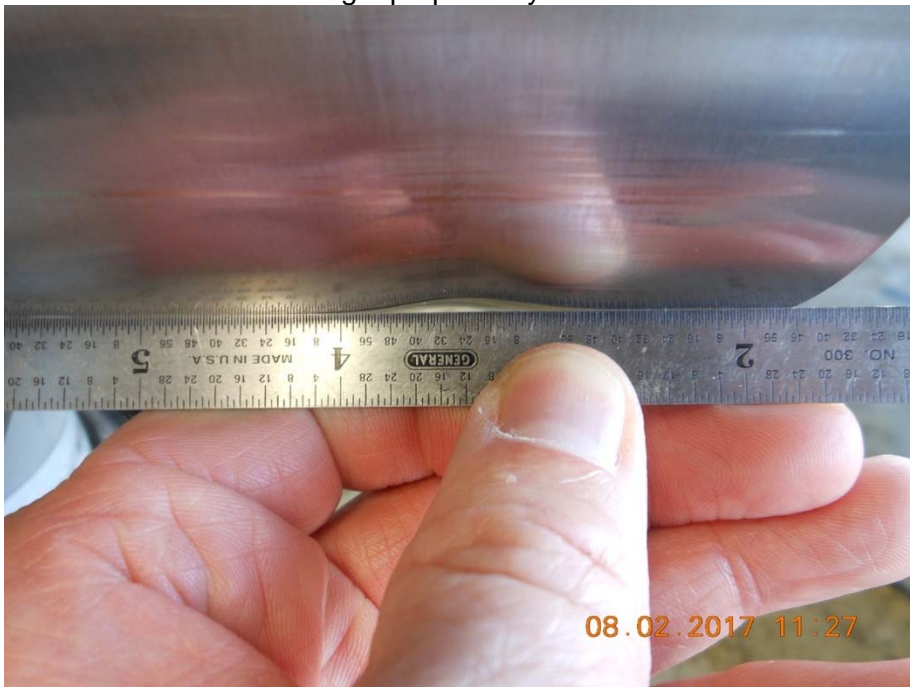
Photo #12 – Right propeller cylinder crease/dent

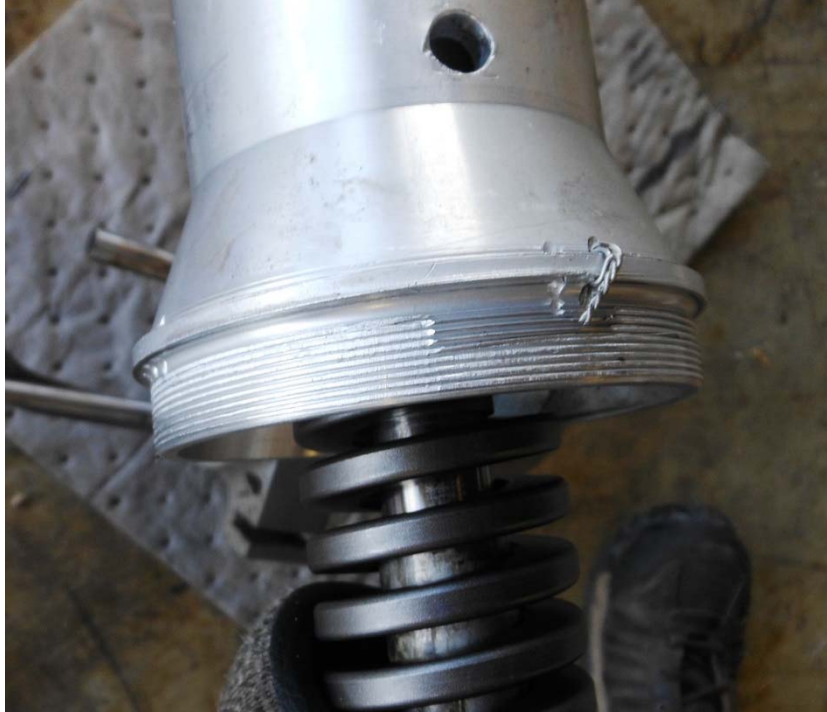
Feathering Spring Assembly: The feathering spring was loaded on the pitch change rod with the spring keepers in place. The spring appeared intact and undamaged and no attempt was made to remove/release the spring. The forward aluminum spring cup had been forcefully pulled from the steel cylinder and the cup threads were stripped (Photo #13); there were aluminum thread whiskers in the piston and cylinder cavities.

Photo #13 – Right propeller forward spring cup stripped threads

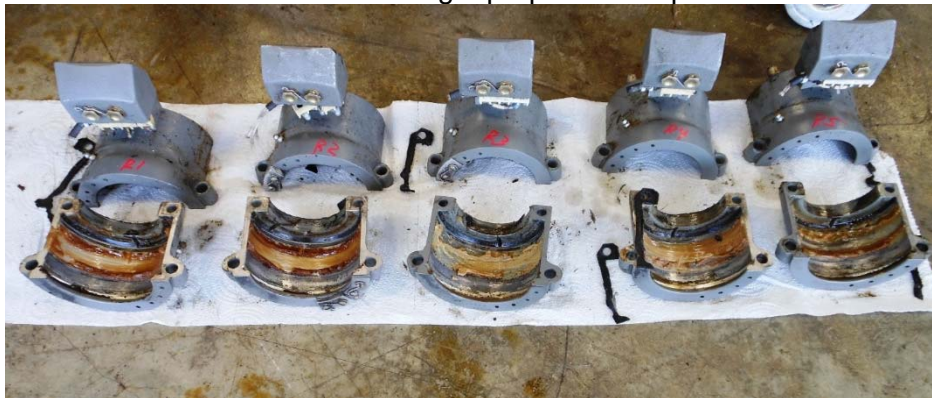
Clamp Pos.	Clamp S/N	Clamp Condition	Counterweight Condition
R1	E4127	Intact	Intact
R2	E3966	Intact, link screw bent opposite low pitch	Arm and slug scored/gouged on inboard face
R3	D6522	Intact	Arm and slug scored/gouged on inboard face
R4	E3971	Intact	Intact
R5	D6510	Intact	Slug dented/gouged on inboard face

Photo #14 – Right propeller clamps

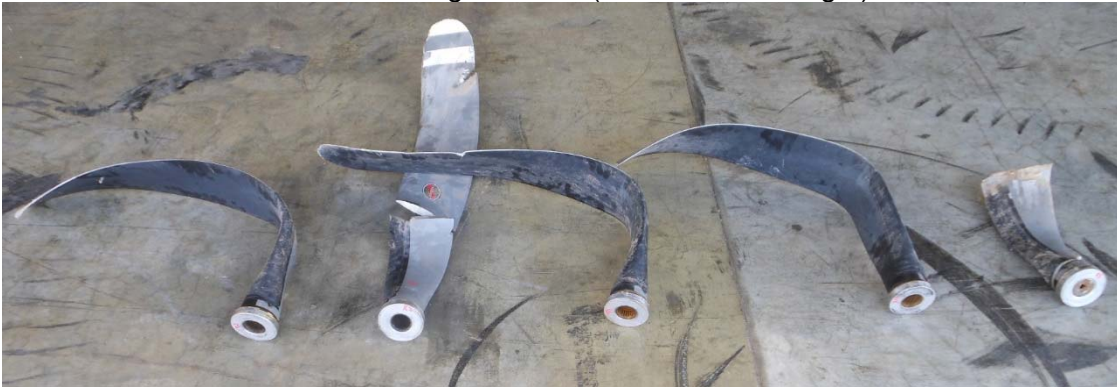
Photo #15 – Right blades (R1 to R5 left to right)

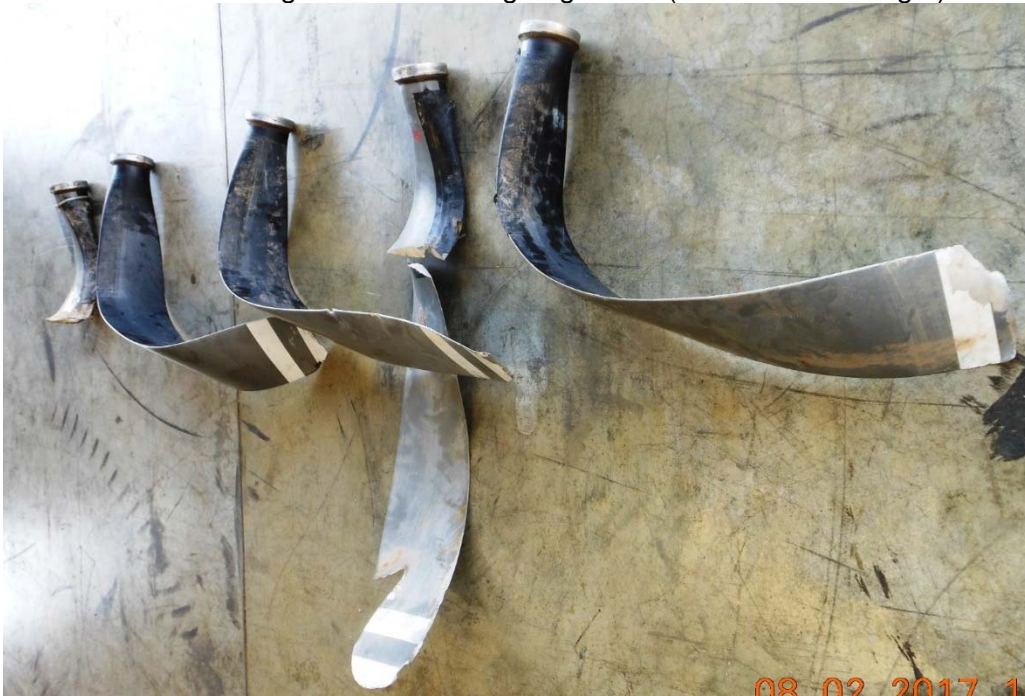
Photo #16 – Right blades leading edge view (R5 to R1 left to right)

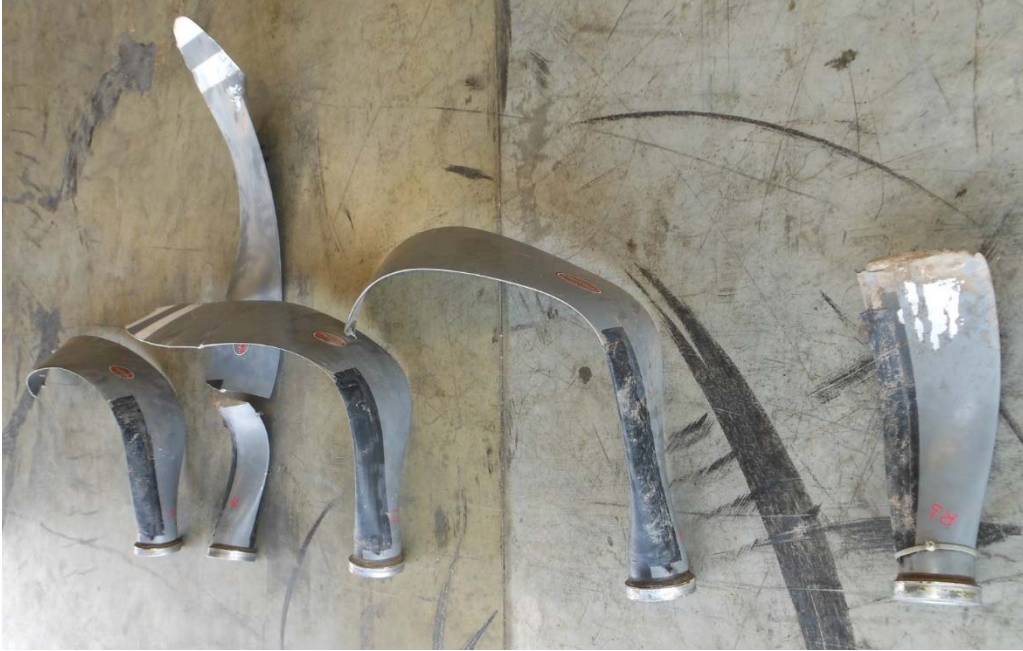
Photo #17 – Right blades trailing edge view (R1 to R5 left to right)

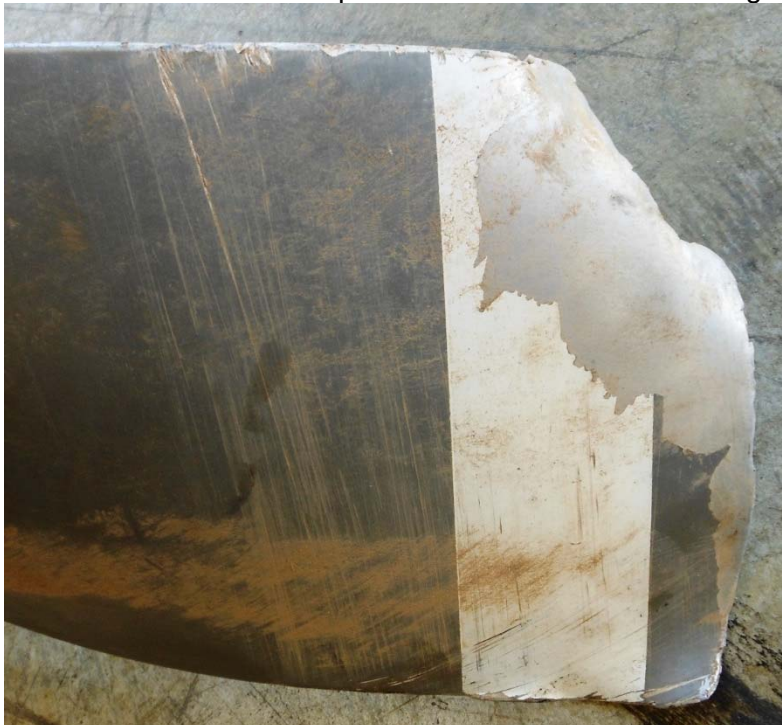
Blade # R1 – 3-4” of the tip was fractured from the blade in the aft/leading edge down direction. The fractured piece was not recovered/presented for examination.

Camber side	Chordwise/rotational scoring last 10” of blade
Face side	Random scratches
Bend	Aft
Twist	Leading edge down
Lead edge damage	Nicks last 10” of blade
Trail edge damage	Localized bending last 10” of blade
Blade bearings	Intact
Butt/shank impact marks	Hub arm pilot tube shoulder impressions, one “smile” impact line in trailing edge quadrant
De-Ice boot	Torn on camber side

Photo #18 – R1 blade tip fracture and chordwise scoring

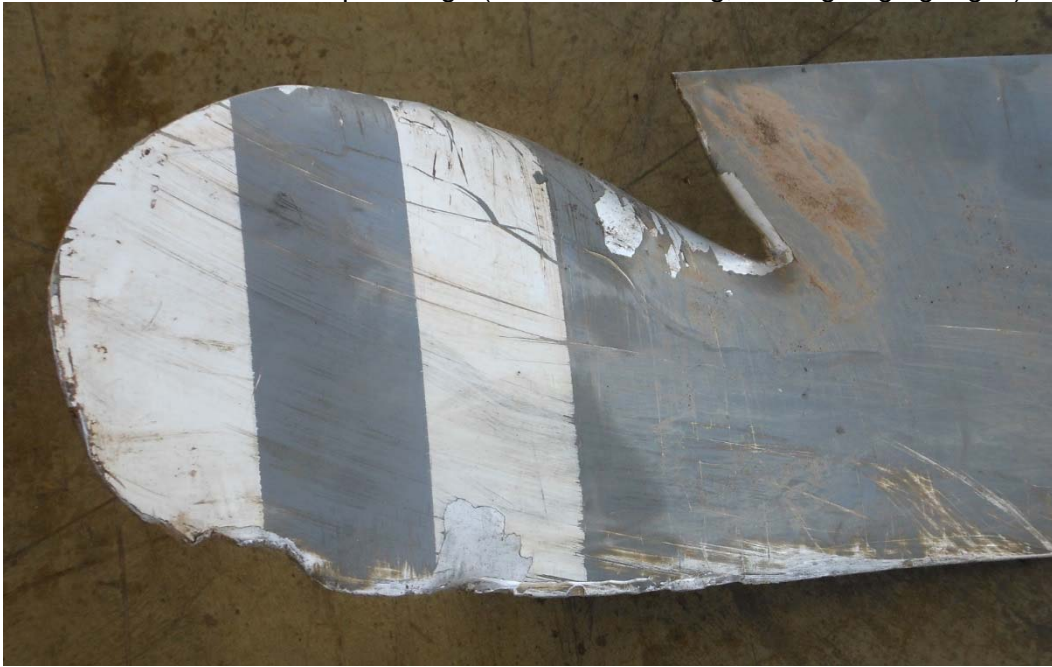
Camber side	Chordwise/rotational scoring
Face side	Spanwise scoring
Bend	Fwd (face toward camber)
Twist	Leading edge down
Lead edge damage	Gouging last 10”
Trail edge damage	Tear through 40% of chord 8-10” from tip
Blade bearings	Intact
Butt/shank impact marks	Hub arm pilot tube shoulder impressions
De-Ice boot	Tear in leading edge and face side

Photo #19 – R2 blade tip damage (chordwise scoring, leading edge gouges)

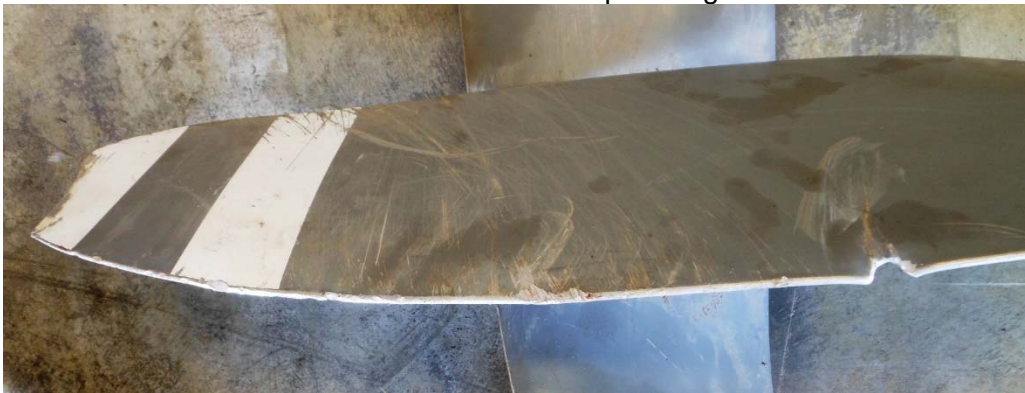
Camber side	Chordwise/rotational scoring near tip/spanwise mid-blade
Face side	Chordwise/rotational scoring near tip
Bend	Aft
Twist	Leading edge down
Lead edge damage	Nicks, 1/2” gouge 16” from tip
Trail edge damage	Not remarkable
Blade bearings	Intact
Butt/shank impact marks	Hub arm pilot tube shoulder impressions
De-Ice boot	Intact

Photo #20 – R3 blade tip damage

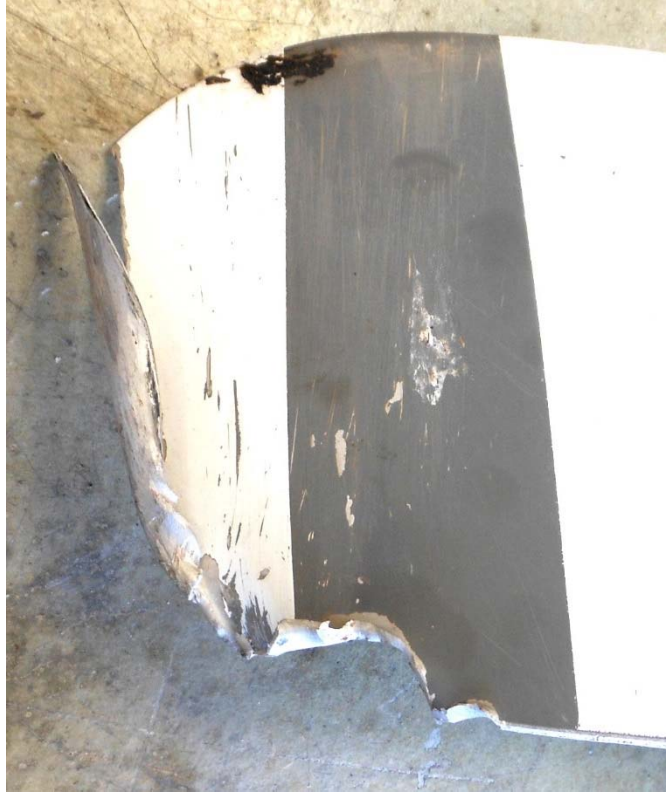
Camber side	Chordwise/rotational scoring near tip
Face side	Not remarkable
Bend	Aft
Twist	Leading edge down
Lead edge damage	Gouging last 4"
Trail edge damage	Not remarkable
Blade bearings	Intact
Butt/shank impact marks	Hub arm pilot tube shoulder impressions
De-Ice boot	Intact

Photo #21 – R4 blade tip damage

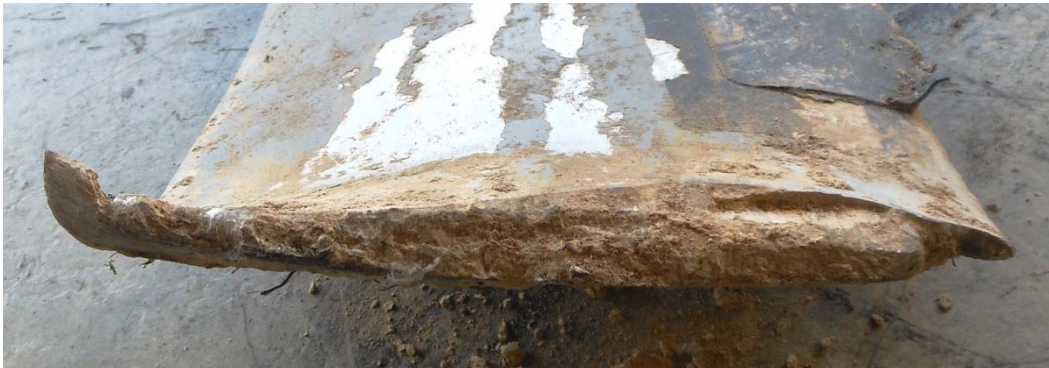
Blade # R5 – Fractured ~17" from butt, piece not recovered/presented for examination

Camber side	Paint chipping
Face side	Chordwise/rotational scratching/scoring
Bend	Forward (face toward camber)
Twist	Indeterminable
Lead edge damage	Not remarkable on recovered portion
Trail edge damage	Not remarkable on recovered portion
Blade bearings	Intact
Butt/shank impact marks	Impact crescents camber/trail and face side of blade. Hub arm pilot tube shoulder impressions.
De-Ice boot	Torn

Photo #22 – R5 blade failure

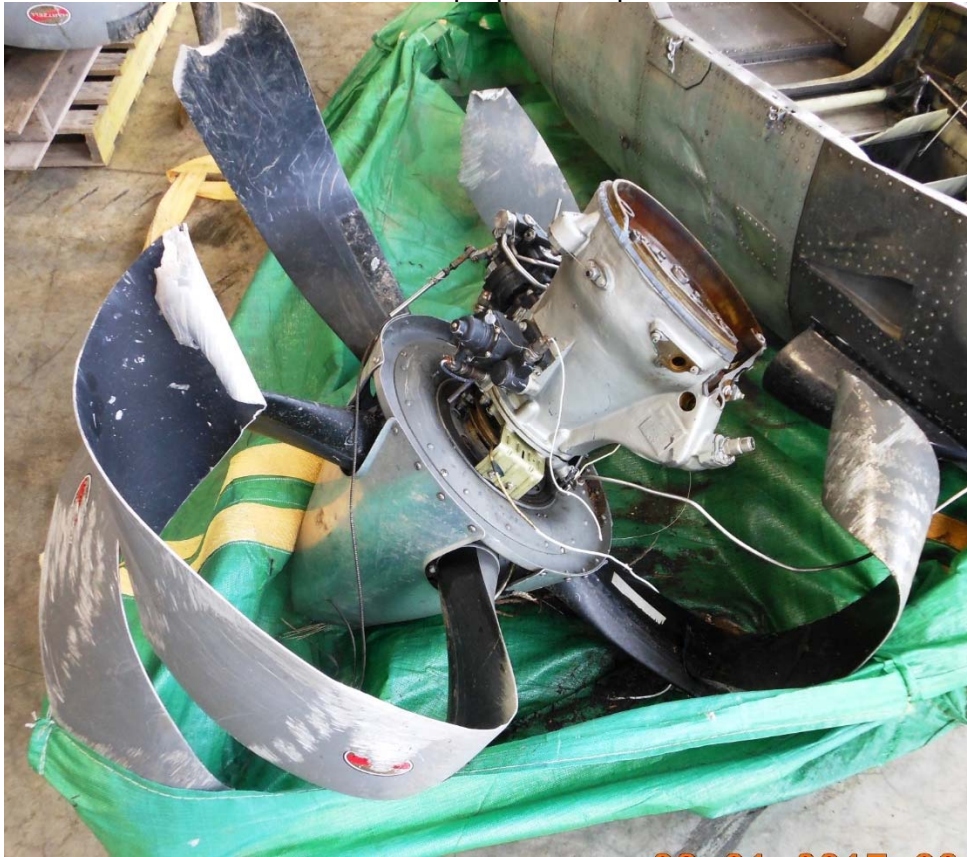
“As Received” Condition: The propeller remained attached to the forward portion of the RGB and propeller shaft and was presented for examination in the condition shown in Photo #23. No attempt was made to remove the propeller from the engine propeller shaft flange. The propeller was positioned on the RGB as shown in Photo #24 for disassembly. The spinner was dented but remained attached to the spinner bulkhead. All five blades remained attached to the hub assembly; one blade was bent forward, the others bent aft. Two blades had a measureable amount of the tips fractured. The piston appeared to be forcibly rotated/twisted clockwise (in direction of rotation) on the cylinder, bending the piston guide rods opposite rotation. The piston was in an extended position, against the low pitch/flight idle stop nuts. Two link arms (L1 and L2) had fractured at the piston attach point and were sitting loosely in the hub area. Four of five blade clamp assemblies had rotated toward low pitch beyond the reverse stop position. Some of the de-ice boot leads had torn from their terminal blocks.

Photo #23 – Left propeller as-presented

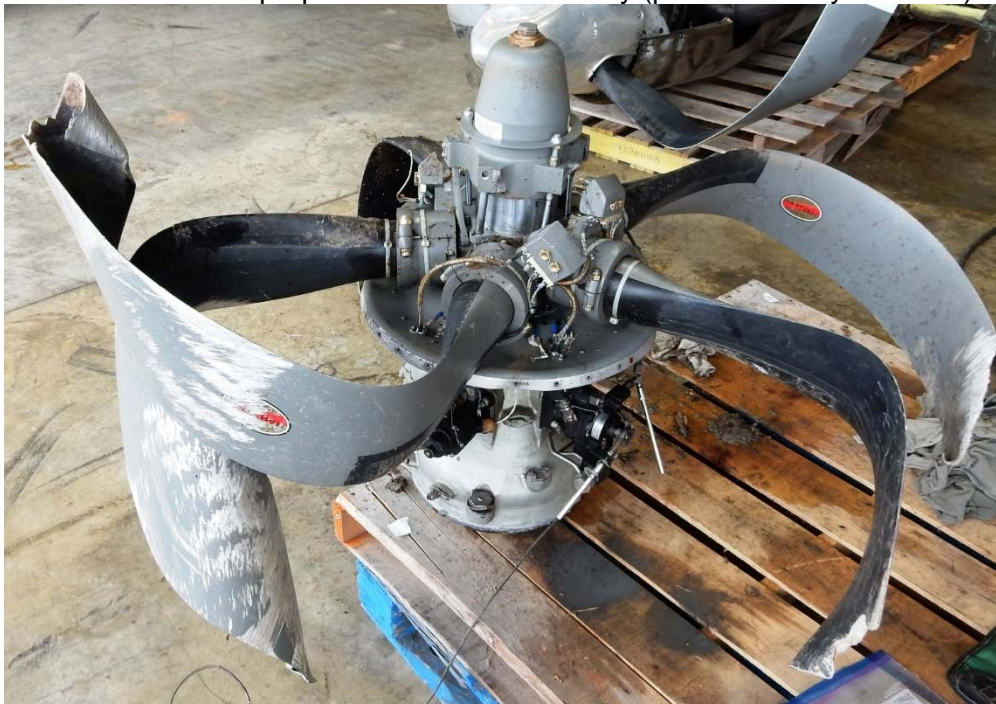
Photo #24 – Left propeller before disassembly (photo courtesy of NTSB)

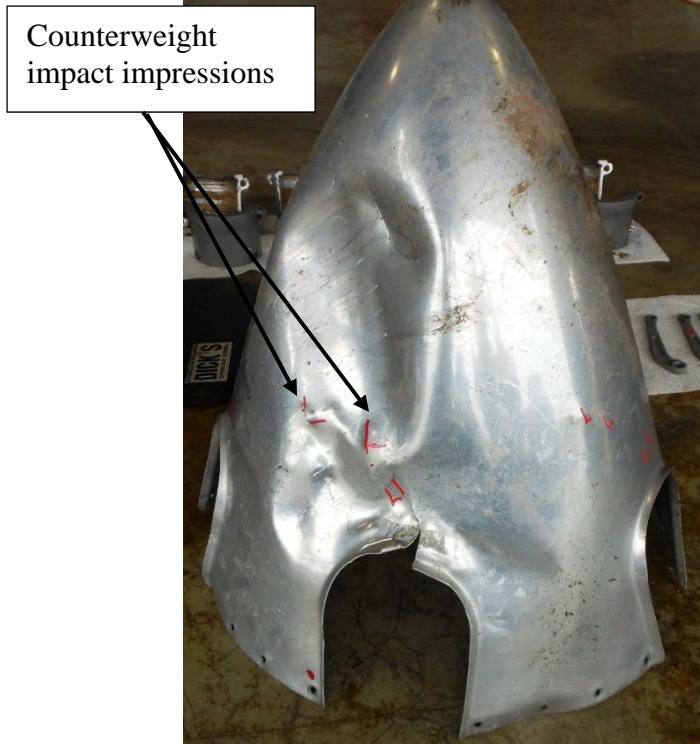
Spinner Dome: The spinner dome remained attached to the spinner bulkhead but was dented and scored. The dome was dented adjacent to L1 and L4. The blade opening around blade L1 was torn. There were counterweight/slug impressions in the dome from the L1, L2 and L5 counterweights corresponding to blade angles between the range of approximately 9-23° (Photo #25).

Photo #25 – Left propeller spinner dome

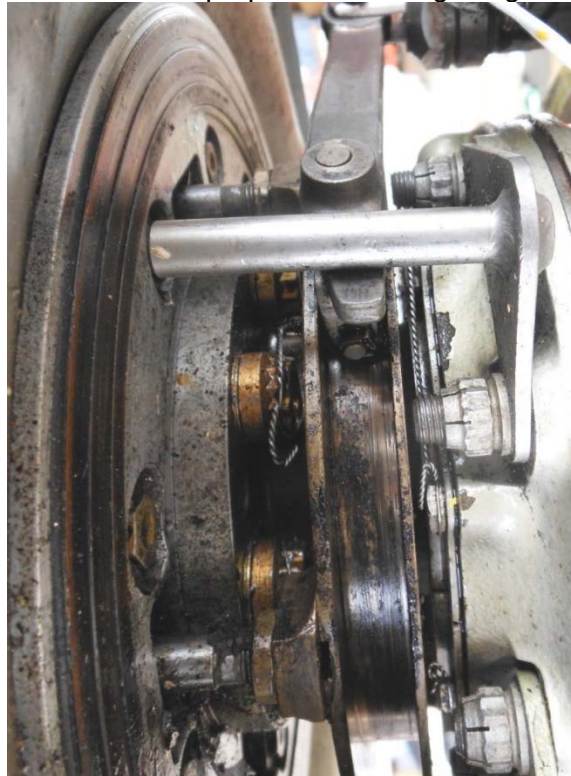
Engine/Propeller Mounting: The propeller mounting appeared intact and undamaged. The mounting bolts appeared properly installed and safety wired. The beta arm was installed below the guide pin and the carbon block was intact. (see Photo #26).

Photo #26 – Left propeller mounting flange area

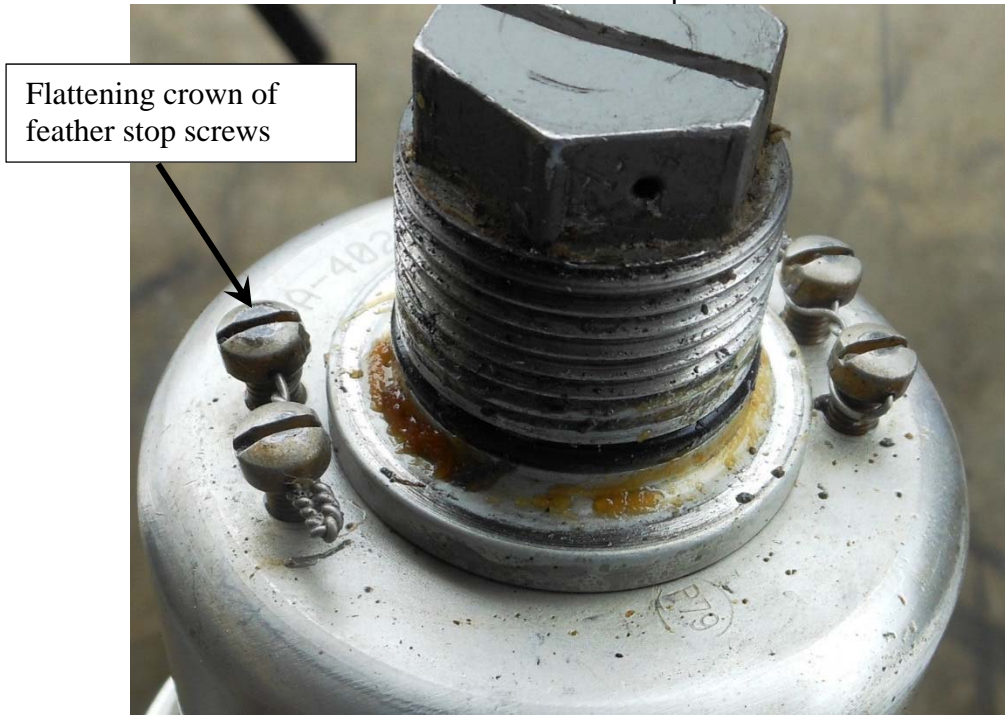
Feather Stop: The crown of the feather stop screws were flattened where they contacted the piston but otherwise appeared undamaged (Photo #27); the installed height was approximately 0.41”.

Photo #27 – Feather stop screws

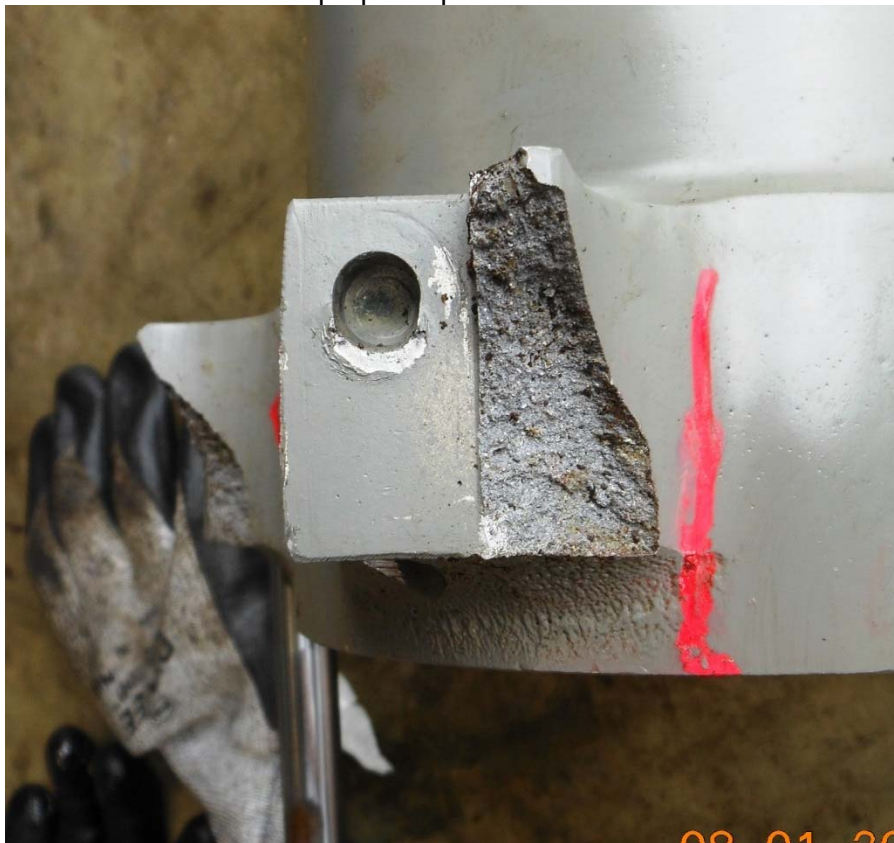
Piston: The piston remained on the cylinder and attached to the pitch change rod with two link arm/pin attach points (L1 and L2) fractured (Photo #28). Only one of the two fractured pieces was recovered. There were impact marks in each link arm slot where the link arm contacted the piston when the clamps rotated over-center. Two discernable cylinder-to-piston contact marks were measured at approximately 1.6 and 1.9 inches from the aft edge (see Photo #29). These distances equate to an approximate blade angle position of 4.5° and 15° respectively.

Photo #28 – Left propeller piston link arm fracture at L1

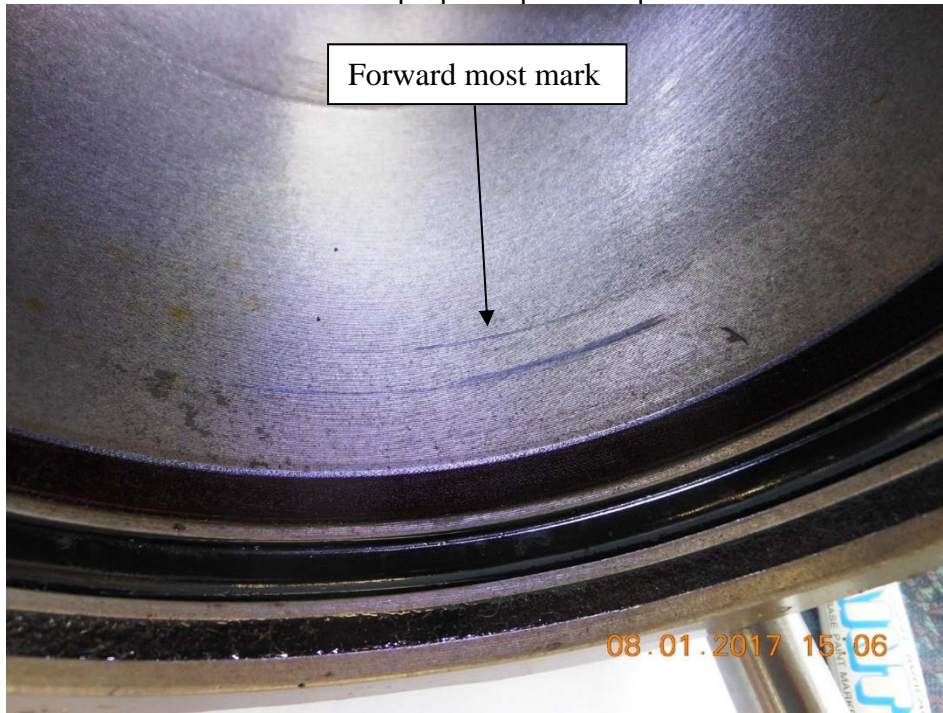
Photo #29 – Left propeller piston impact marks

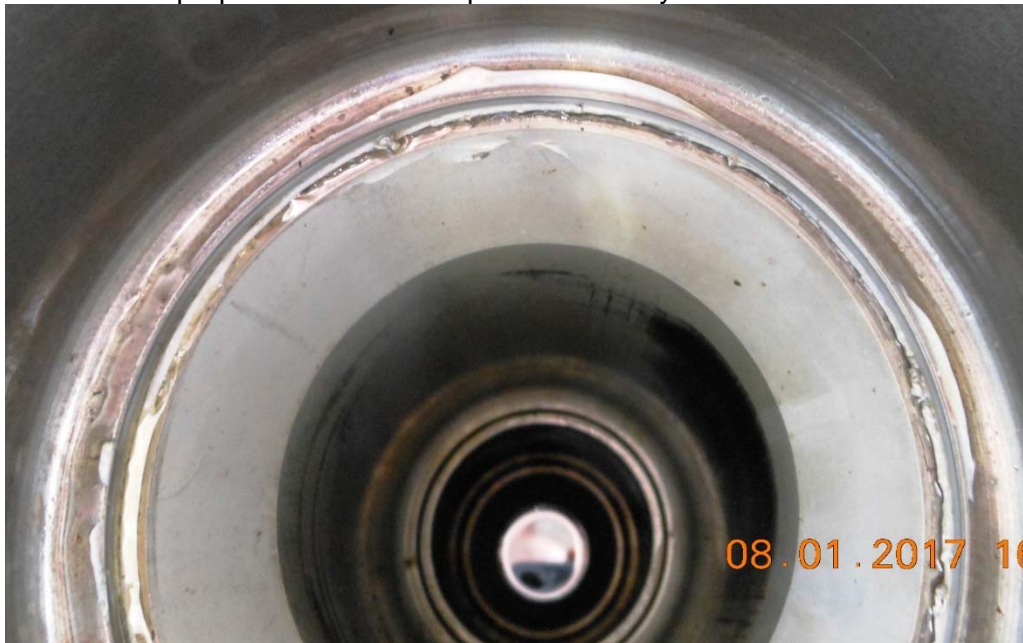
Photo #30 – Left propeller white RTV squeeze-out at cylinder/hub threaded connection

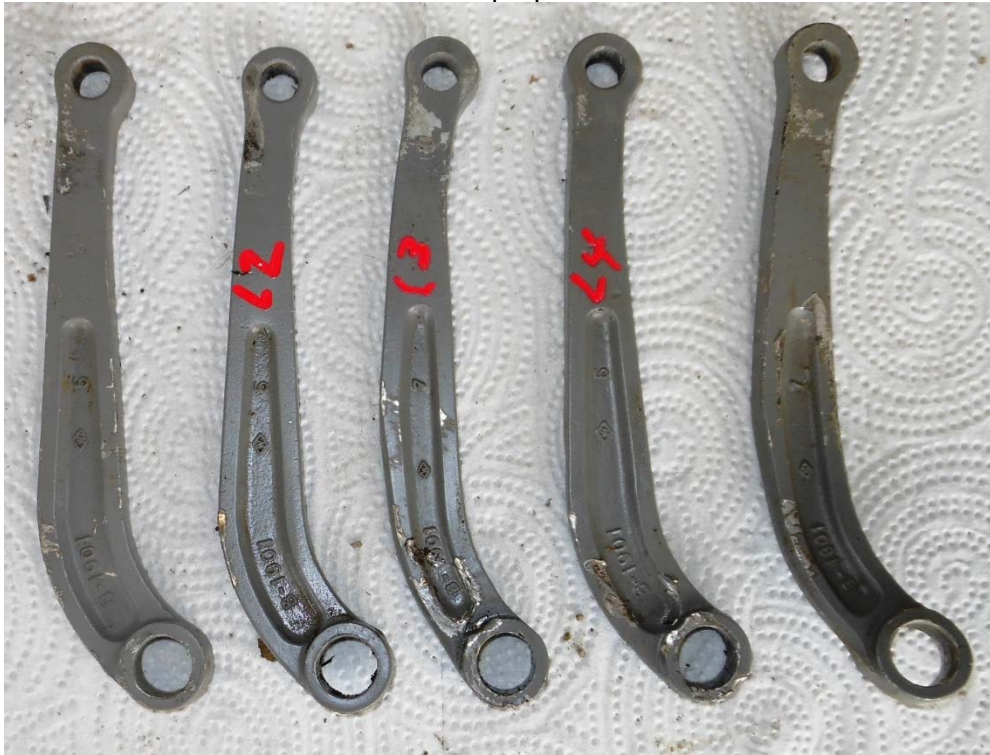
Link Arms: All five link arms had a contact mark from the piston indicating the clamps were forcefully rotated over-center, toward low pitch, beyond the reverse stop (Photo #31).

Link Arm	Link Arm Condition
L1	Bent in compression
L2	Bent in compression
L3	Bent in compression, link screw hole stretched, link screw contact damage
L4	Bent in compression, link screw contact damage
L5	Bent in compression, link screw hole stretched

Photo #31 – Left propeller link arms
