NTSB File No.: DCA17FA109

Aircraft: Shorts SD3-30

Registration No.: N334AC

Written by: Les Doud
Air Safety Investigator – Hartzell Propeller Inc.

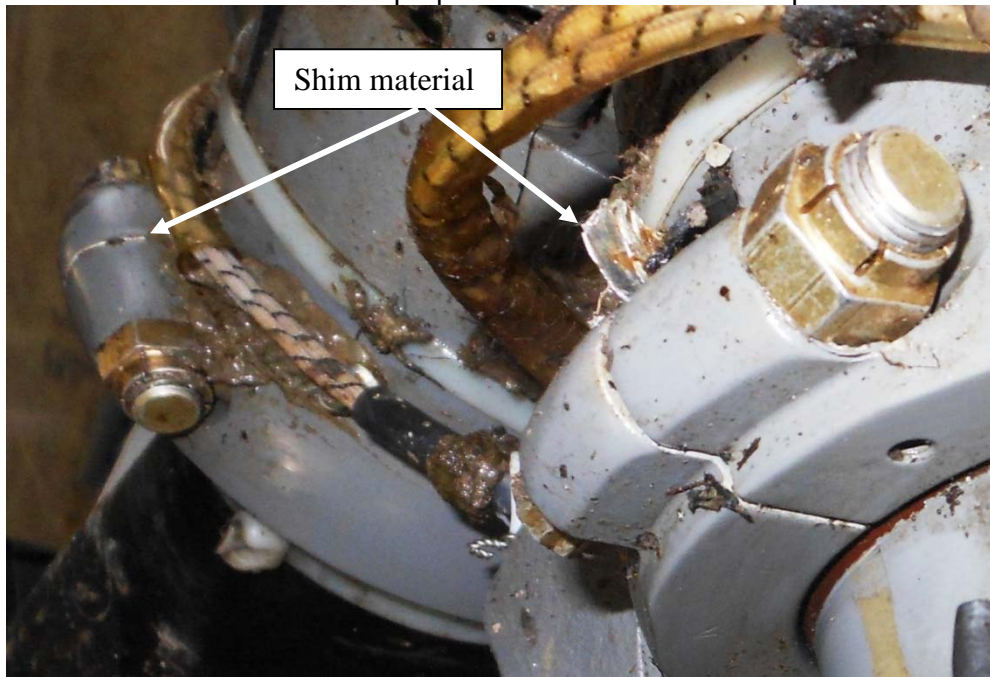
Clamps and Counterweights: (see Photo #34) On clamps L3, L4 and L5 there appeared to be an unapproved, metallic shim material between the clamp halves near the outboard, trailing edge clamp bolts; it is unknown why this was used (Photos #32 and #33). However, the shim did not appear to affect the ability of the clamp to hold the blade.

Photo #32 - Left propeller shim material in clamps

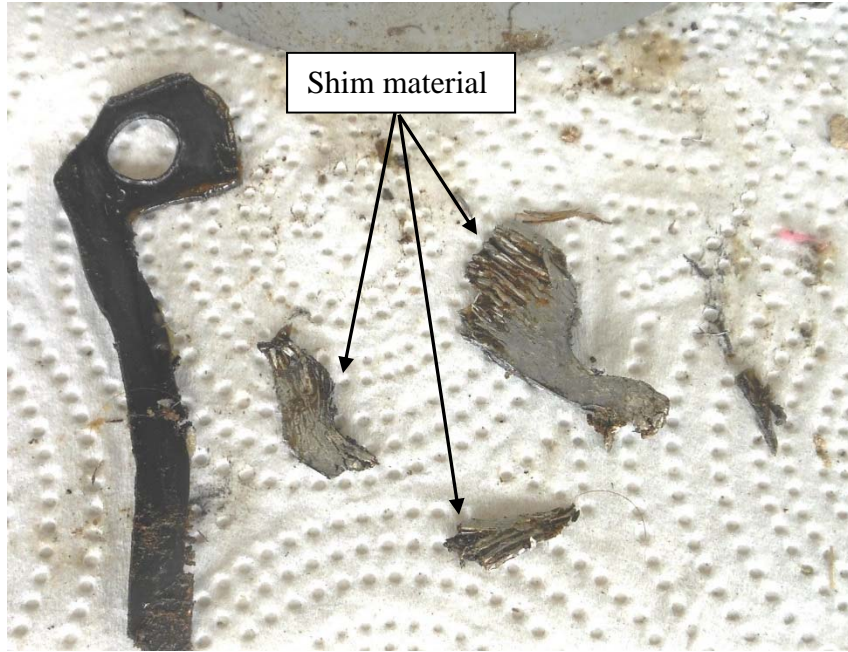
Photo #33 - Shim material when removed

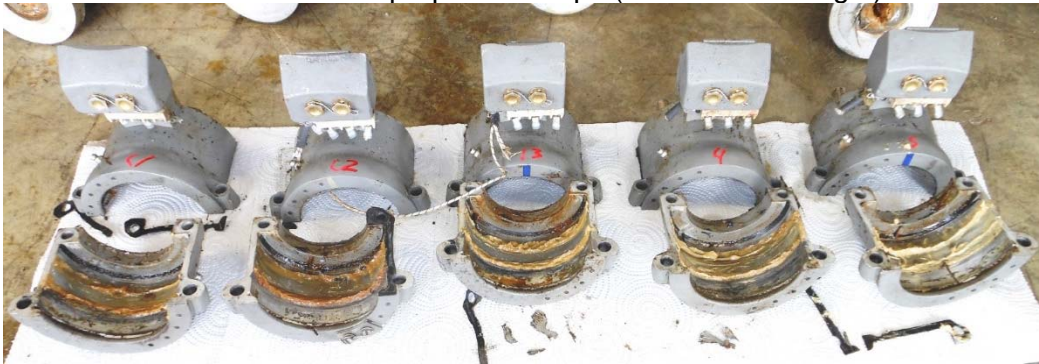
Clamp Position	Clamp S/N	Clamp Condition	Counterweight Condition
L1	D7996	Intact	Intact, arm and slug scored/gouged on inboard face
L2	D8034	Intact	Intact, arm and slug scored/gouged on inboard face
L3	D8055	Intact but end of link screw damaged.	Intact, arm and slug scored/gouged on inboard face
L4	D8137	Intact, link screw bent opposite low pitch with marred cotter key holes	Intact, arm and slug scored/gouged on inboard face
L5	D7359	Intact	Intact

Photo #34 – Left propeller clamps (L1 to L5 left to right)

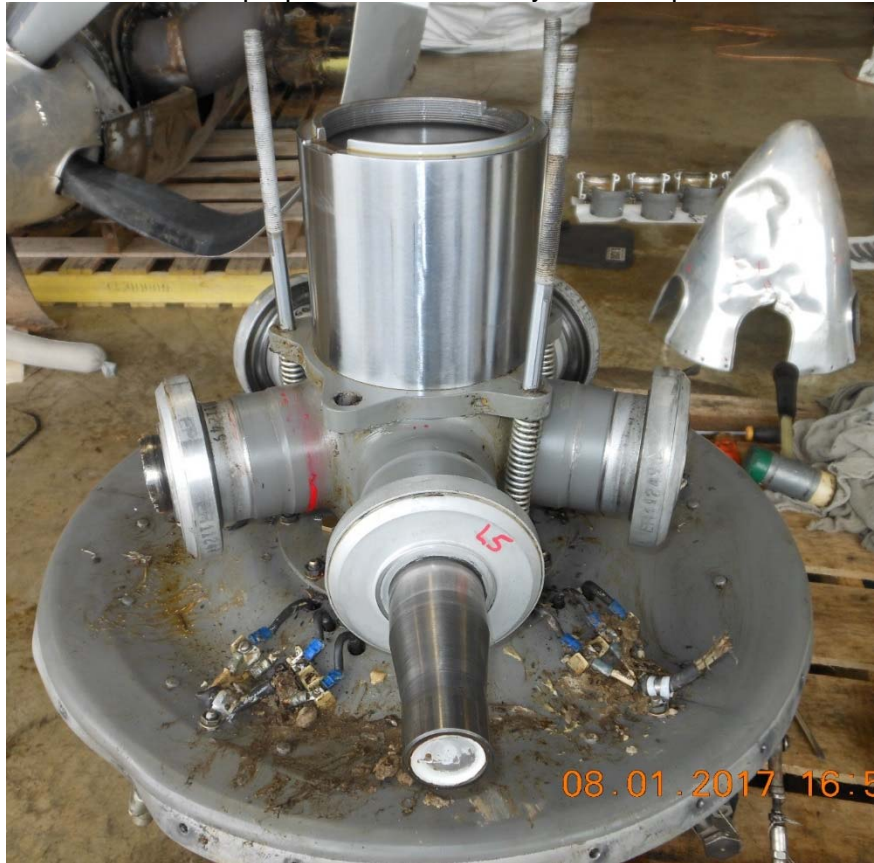
Hub Unit: The hub-prop shaft mounting was intact and appeared undamaged. Four of the five pilot tubes fractured (Photo #35). There were discernable impact marks on the L1 blade arm in face side/trail edge quadrant representative of helical angles of approximately 3.5° and 45° (Photo #36). There also appeared to be a letter stamping transfer on the L2 blade arm.

Photo #35 – Left propeller hub assembly with one pilot tube intact

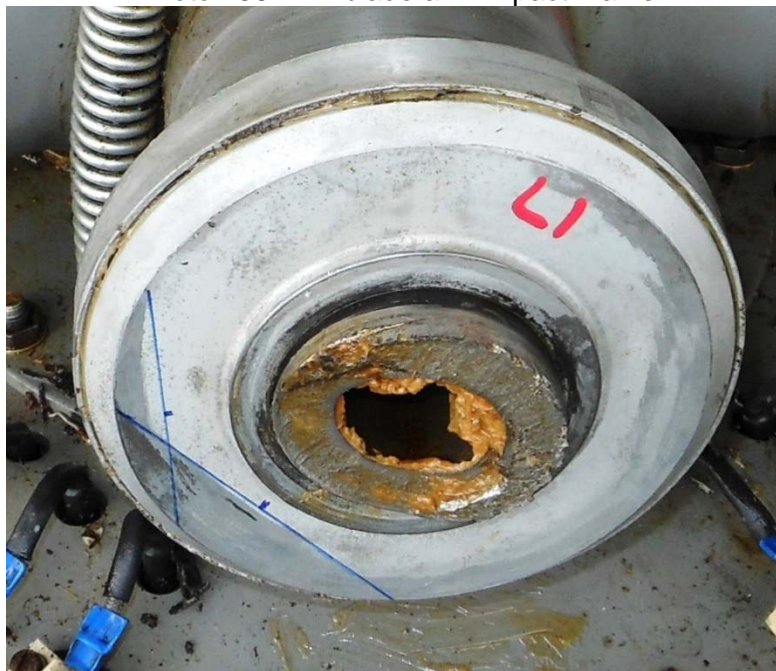
Photo #36 – L1 blade arm impact marks

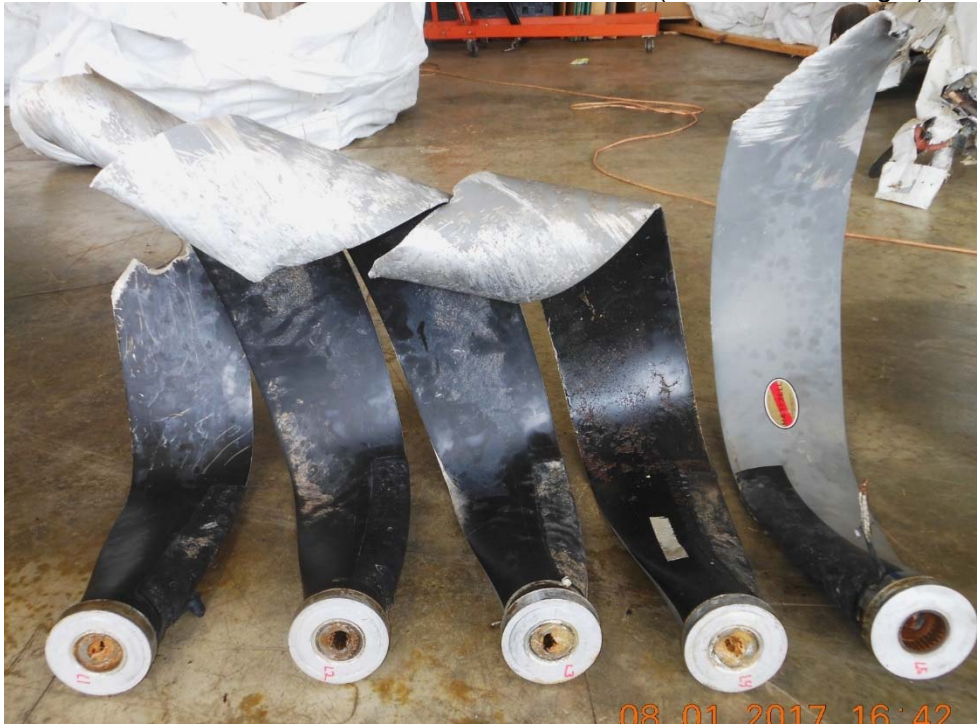
Blade Properties: (Photos #37 through #41) All of the blades exhibited a “striped scoring pattern” at varying angles across the blade that appeared to be consistent with the runway drainage groove width and spacing.

Photo #37 – Left blades view from shank/butt (L1 to L5 left to right)

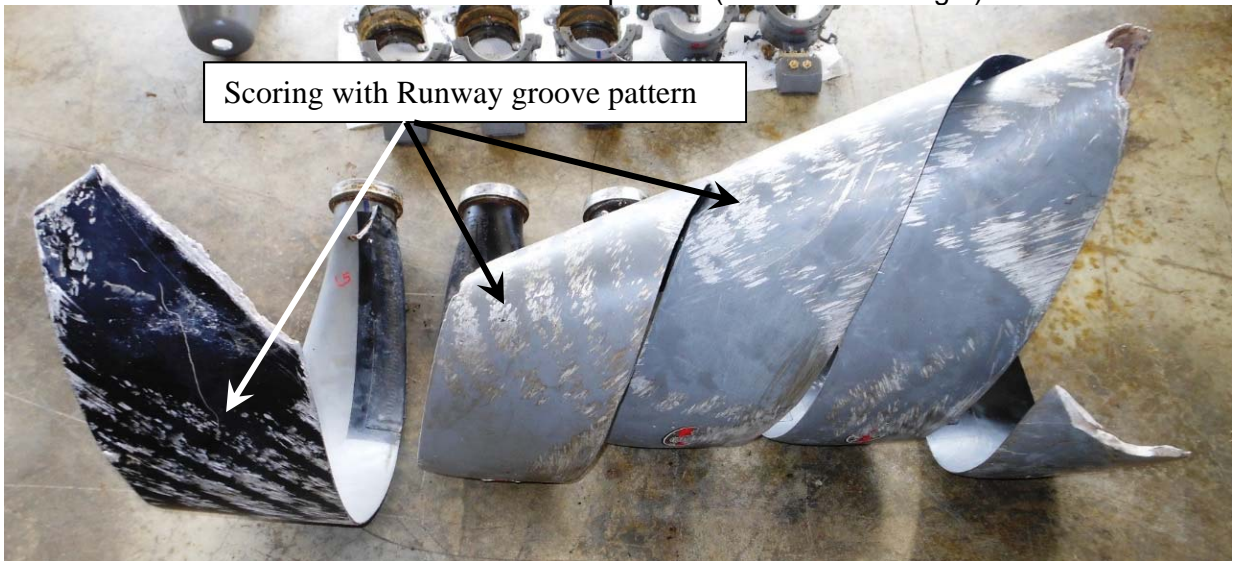
Photo #38 – Left blades view of tip areas (L5 to L1 left to right)

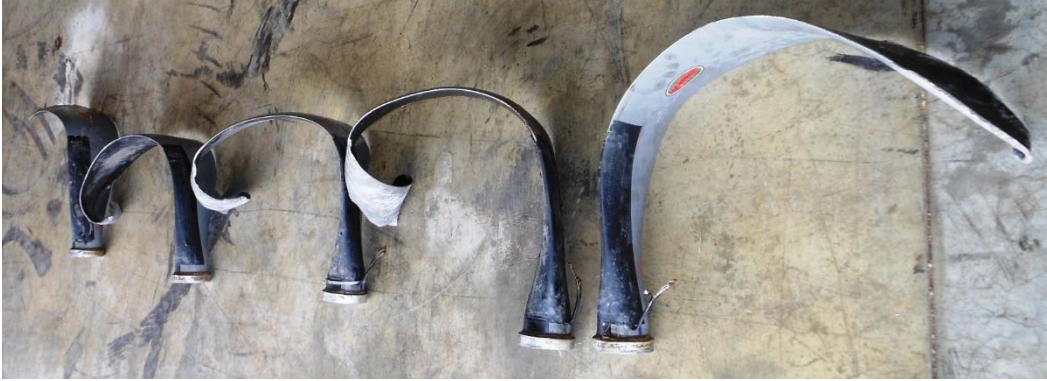
Photo #39 – Left blades leading edge view (L1 to L5 left to right)

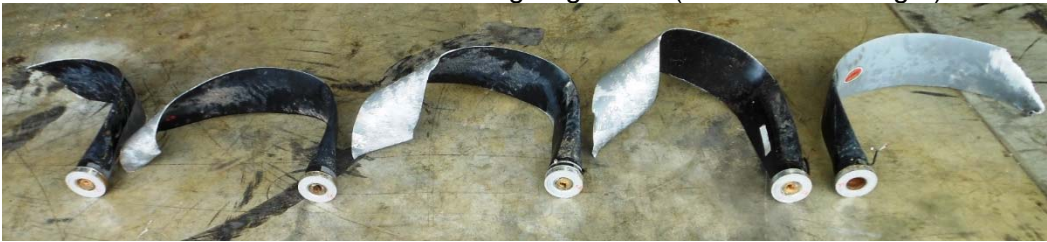
Photo #40 – Left blades leading edge view (L1 to L5 left to right)

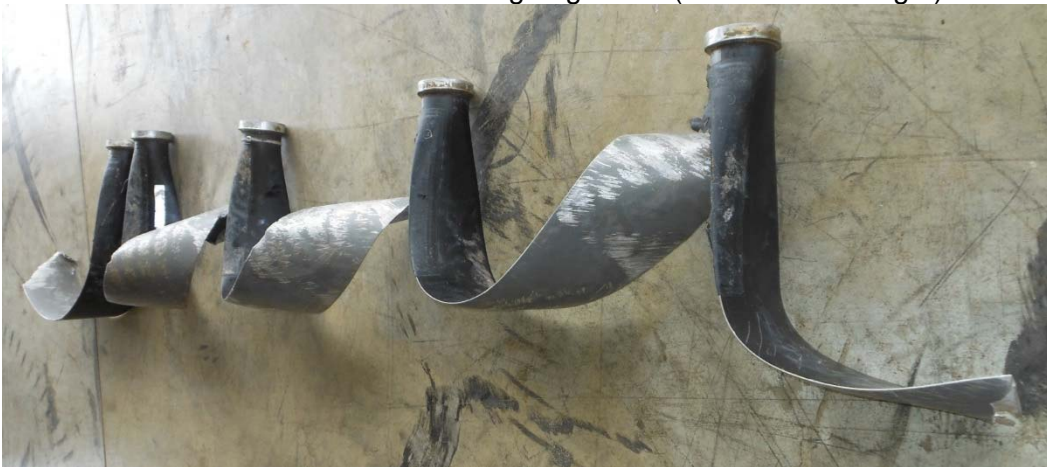
Photo #41 – Left blades leading edge view (L5 to L1 left to right)
