Aircraft Accident/Incident Report No.: 090821

Date of Accident: August 21, 2009  
Location: Teterboro, NJ

Aircraft: Beech 58 Baron

**Propeller Teardown Report**

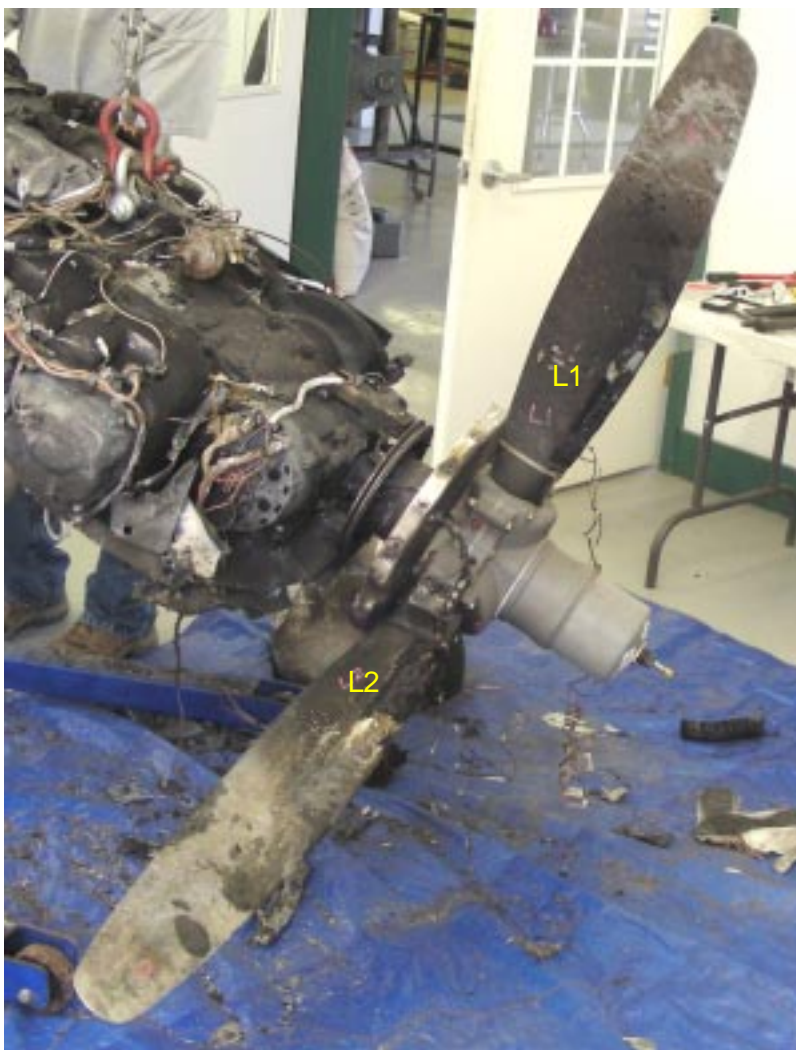
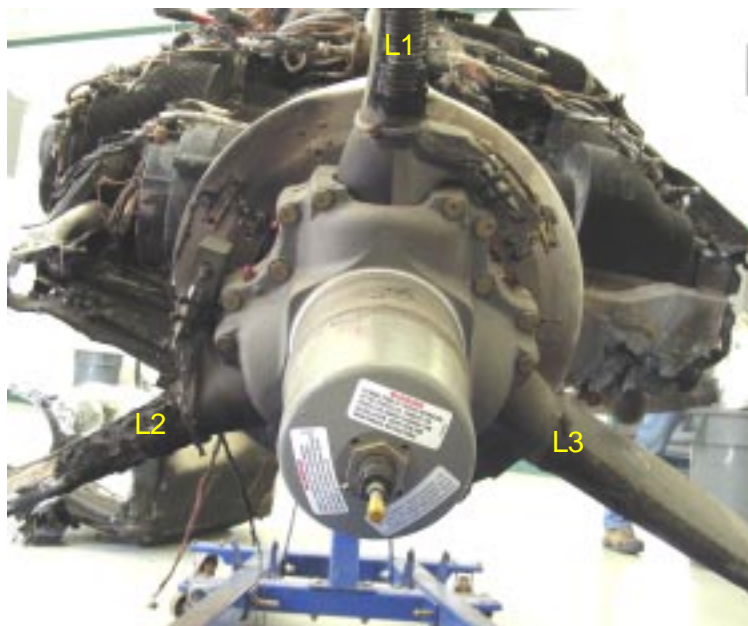
The propeller had not been removed from the engine and the spinner dome had not been removed. All three blades were in the feather position.

L1 blade counterweight had penetrated the spinner dome. The blade/counterweight was at the feather position when the damage occurred.

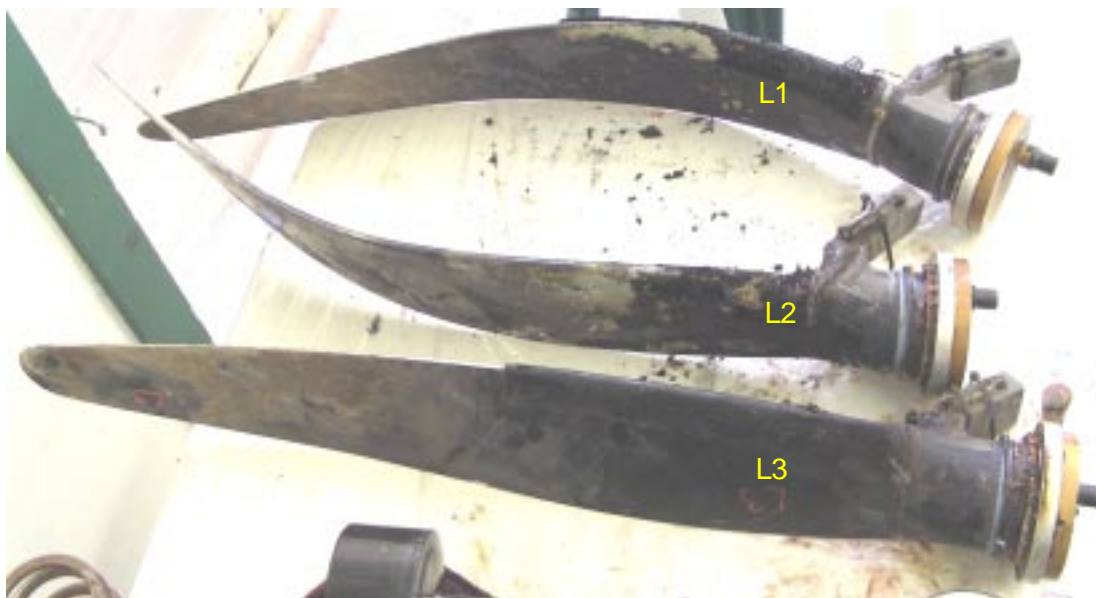
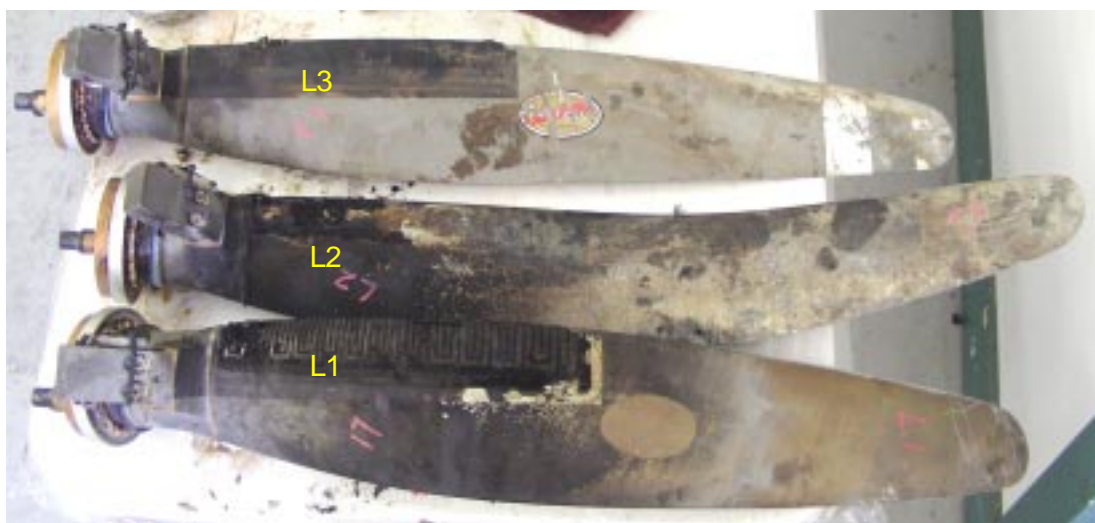
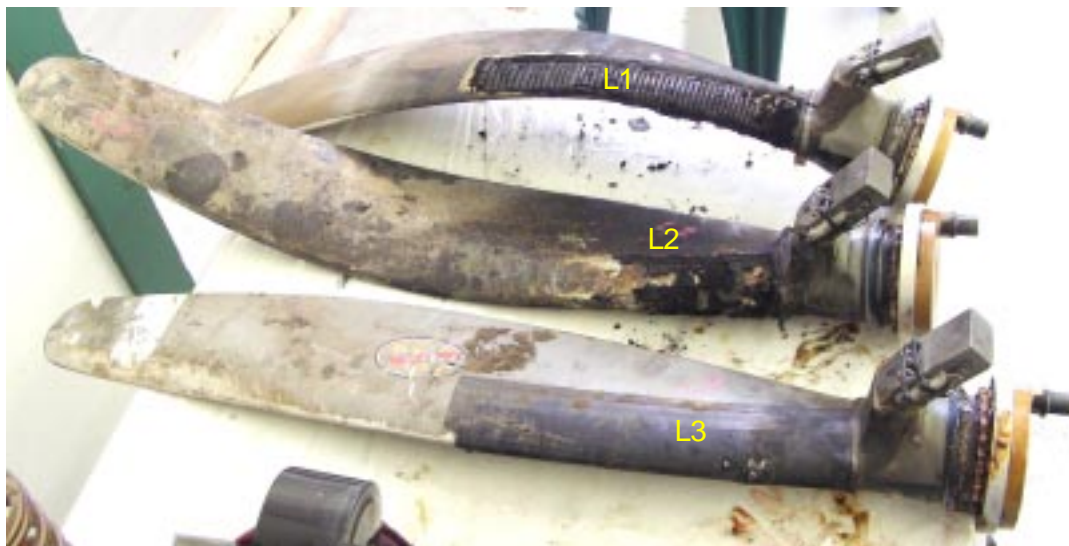
L1 blade was bent aft approximately 30° at 1/3 radius with a large radius bend. It had light angular scoring on the camber side at mid-blade. The pitch change knob and counterweight were intact and unremarkable.

L2 blade was bent forward approximately 30° with a large radius bend at mid-blade. It had spanwise scoring on the flat side on the outer 1/3 of the blade. It had thermal damage to the paint and deicer boot. The pitch change knob and counterweight were intact and unremarkable.

L3 blade was bent slightly aft at mid-blade. Paint was abraded on the camber side on the outer 1/3 of the blade. The pitch change knob and counterweight were intact and unremarkable.

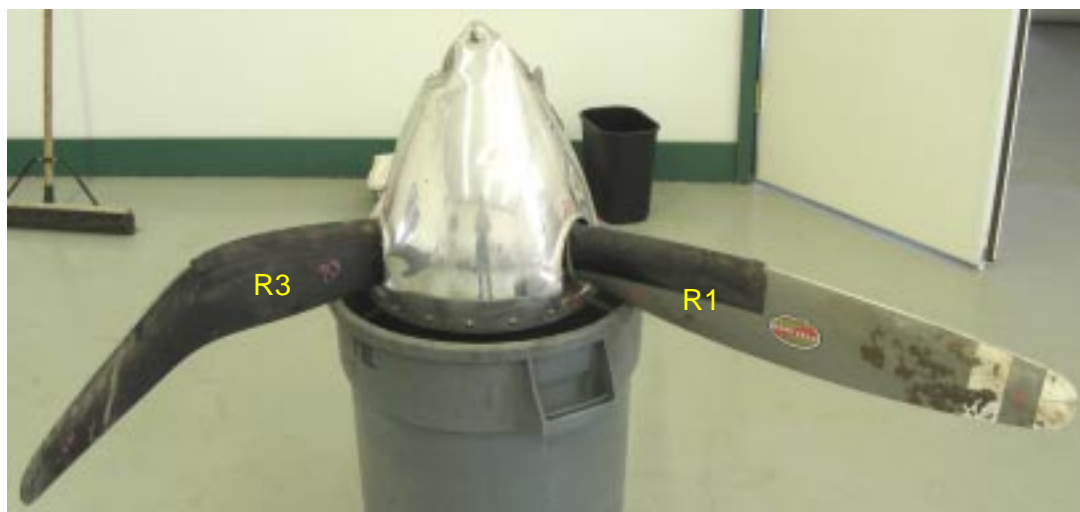
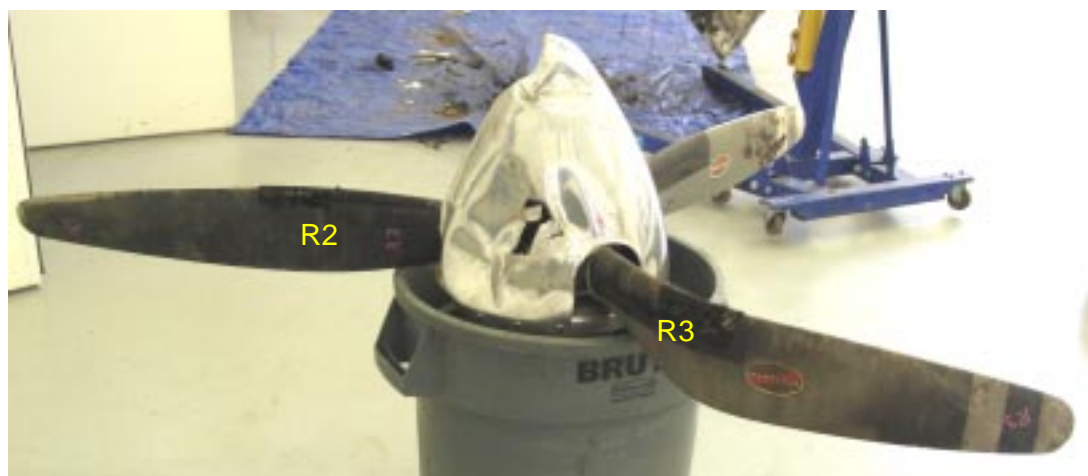
The propeller had separated from the engine and the spinner dome had not been removed. The engine crankshaft was fractured approximately two inches aft of the propeller flange. All three blades were in the feather position.

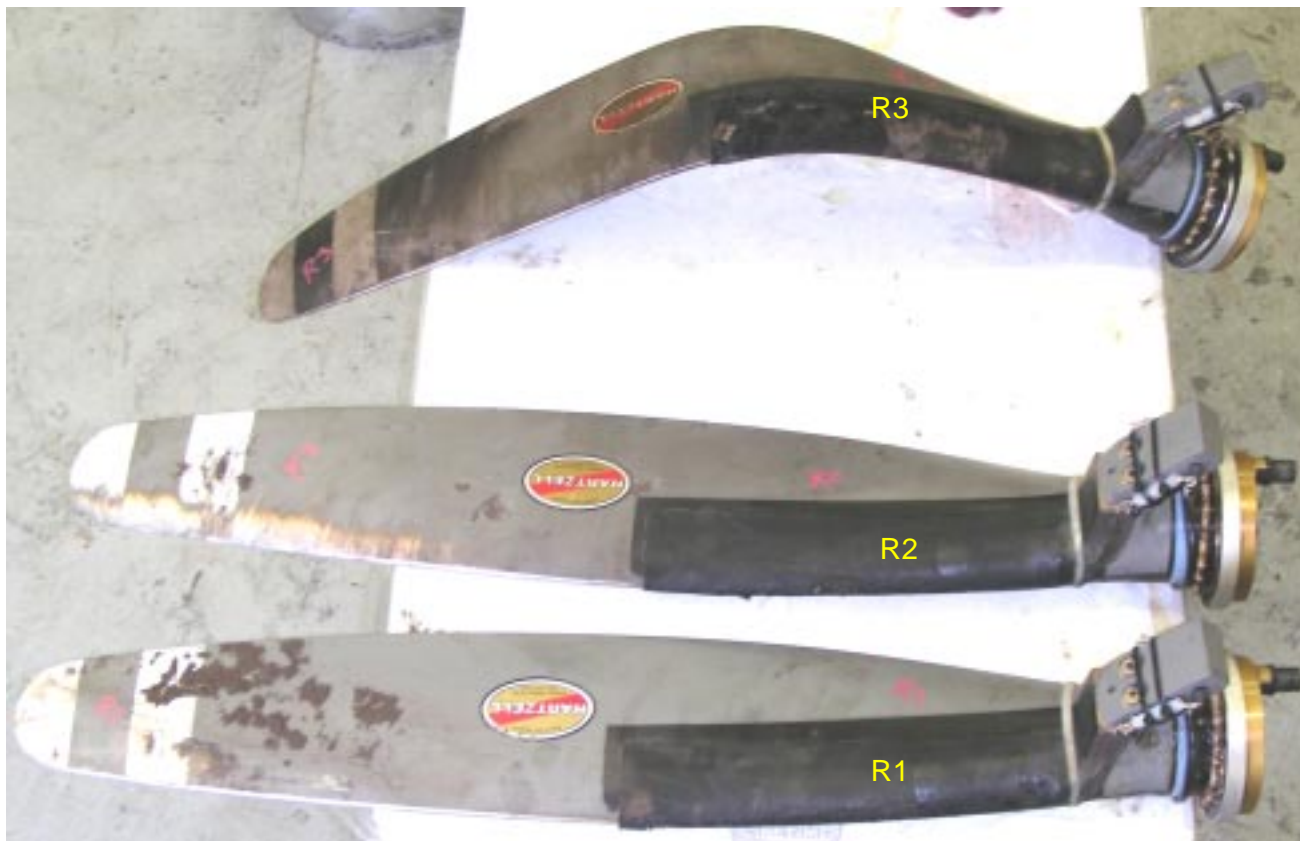
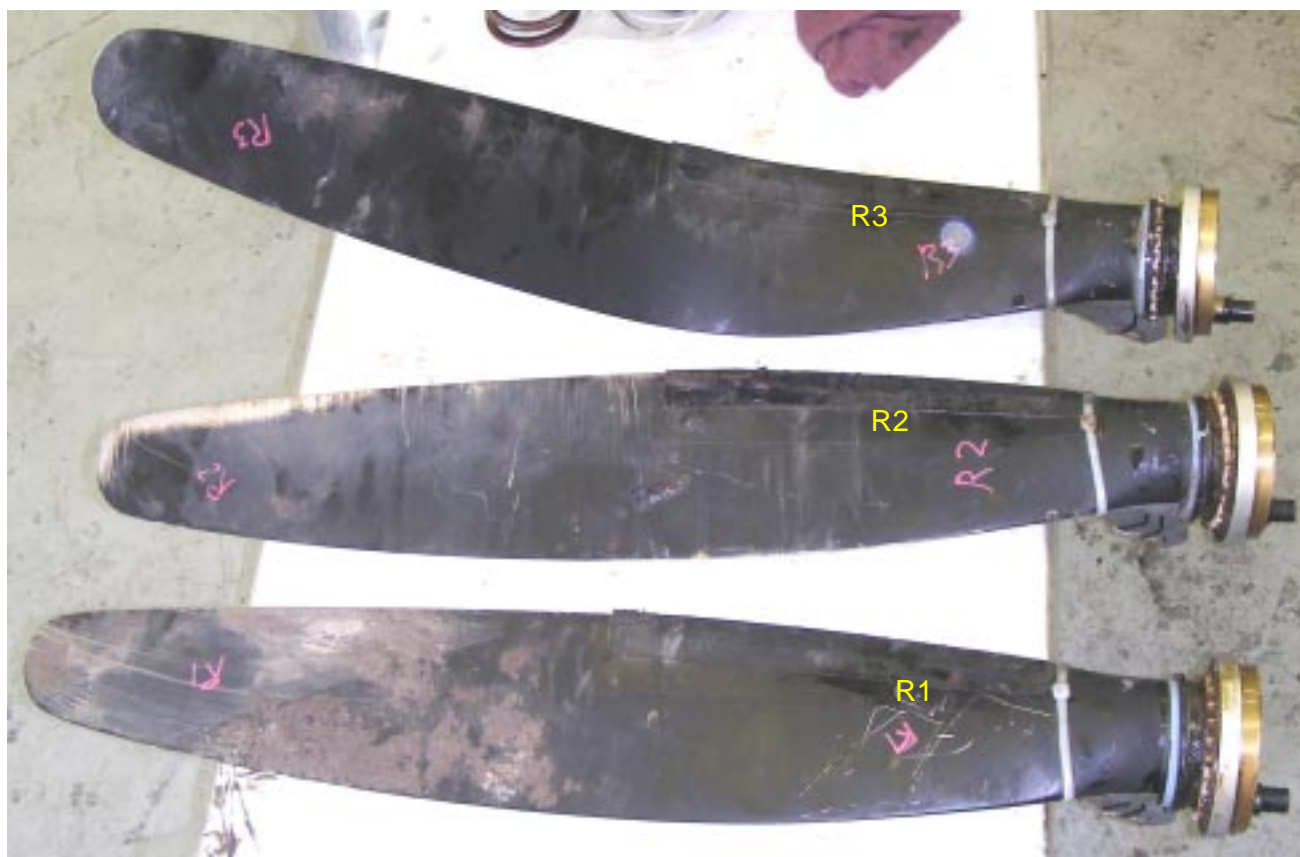
R1 blade was straight with no bends or twisting. It had gouges along the leading edge from the outer end of the de-ice boot to the tip. The pitch change knob and counterweight were intact and unremarkable.

R2 blade was straight with no bends or twisting. It had chordwise scoring in the paint along the leading edge on both the camber side and flat side of the blade. It had thermal damage to the de-icer boot. The pitch change knob and counterweight were intact and unremarkable.

R3 blade was bent aft approximately 45° at mid-blade. The pitch change knob and counterweight were intact and unremarkable.

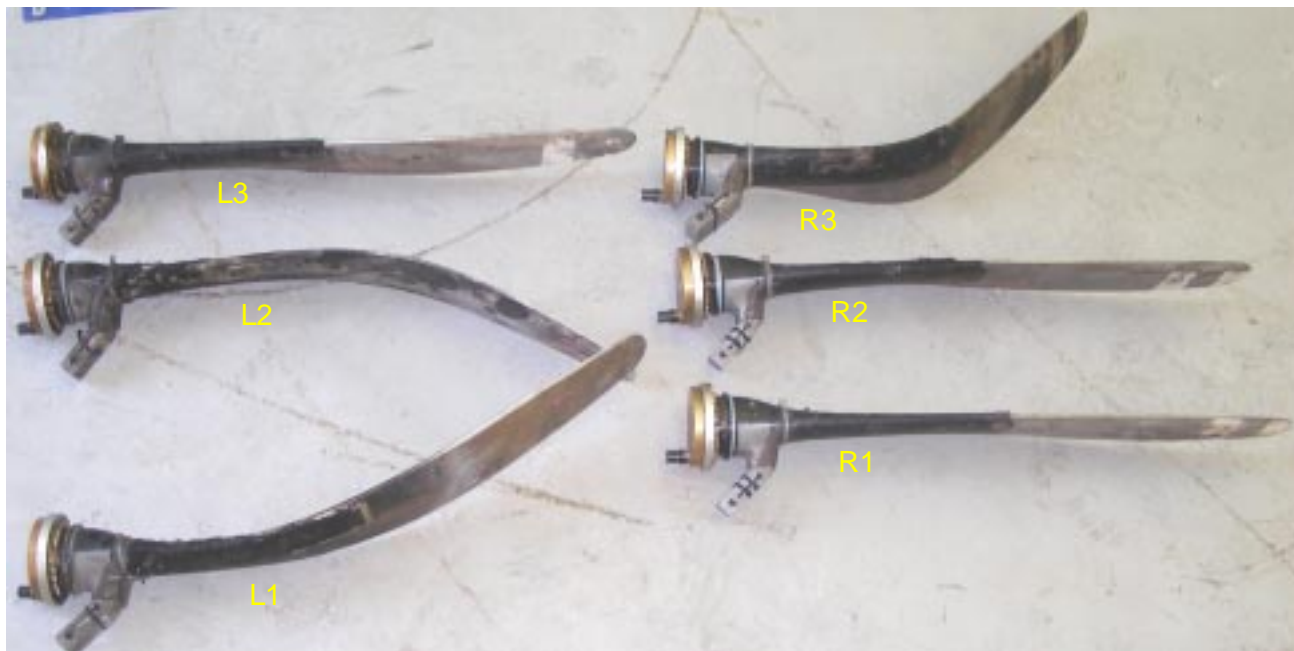
All Six blades

The damage to both propellers was remarkably similar. The piston, cylinder, and complete pitch change mechanism were intact on both propellers. Blades from both propellers had very mild bending with no twisting damage, which suggests little or no power at the time of impact. Prior to disassembly, both propellers were in the feathered position. Each spinner dome had impact damage from one blade counterweight while in the feathered position.

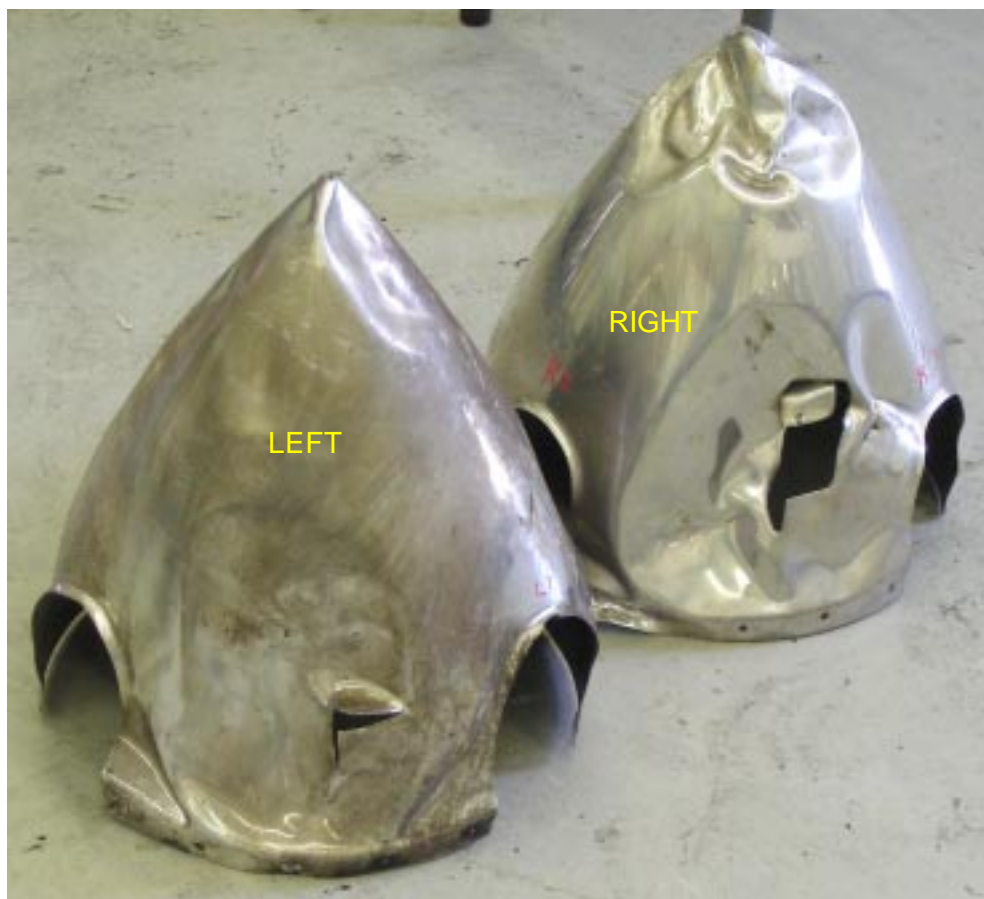
Both spinner domes

R3 blade counterweight had penetrated the spinner dome. There were two distinct impacts from R3 blade counterweight, one was at the feather position and one was at a low pitch position.
